# Tailings decommissioning options at Mount Nansen, Yukon, Canada<sup>©</sup>

Y.T.J. Kwong *CANMET Mining and Mineral Sciences Laboratories, Natural Resources Canada, Canada*

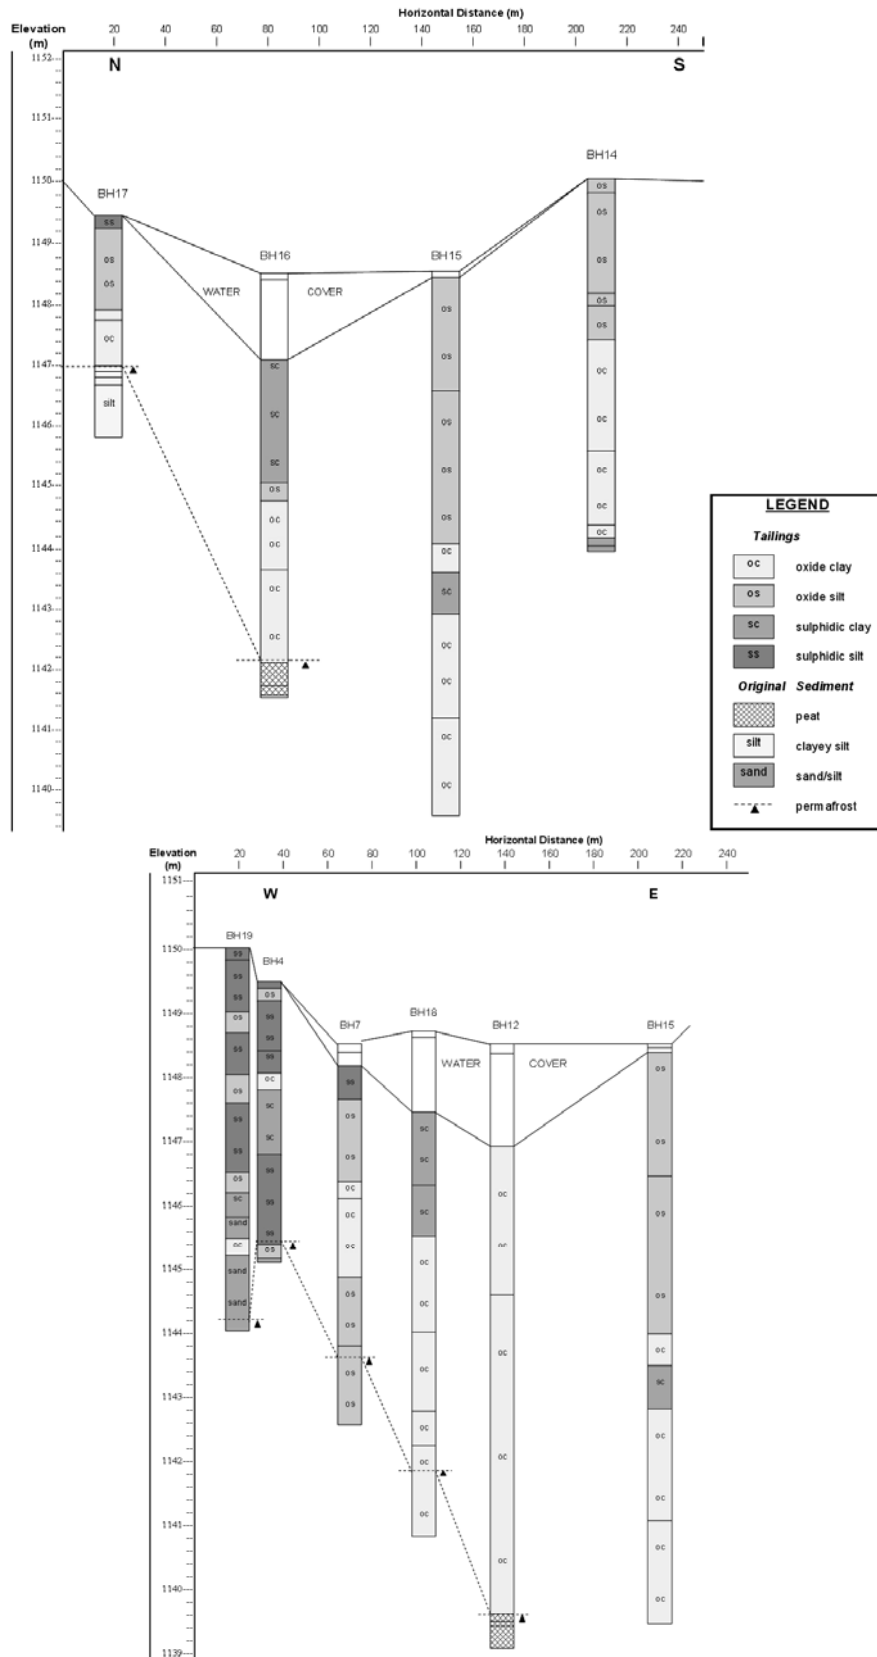
Figure 2 shows two cross sections of the impounded tailings (one in a north-south direction parallel to and about 50 m from the containment dam and the other in a west-east direction across the middle of the impoundment) illustrating the spatial distribution of the various types of tailings, pond water and the permafrost table. Unfrozen ground was encountered only in the southeast corner of the impoundment adjacent to the containment dam. Seepage is likely most intense in this area.

**Figure 2** Selected N-S (left) and W-E (right) cross sections of the Mount Nansen tailings impoundment, showing the distribution of various tailings types and the location of the permafrost table

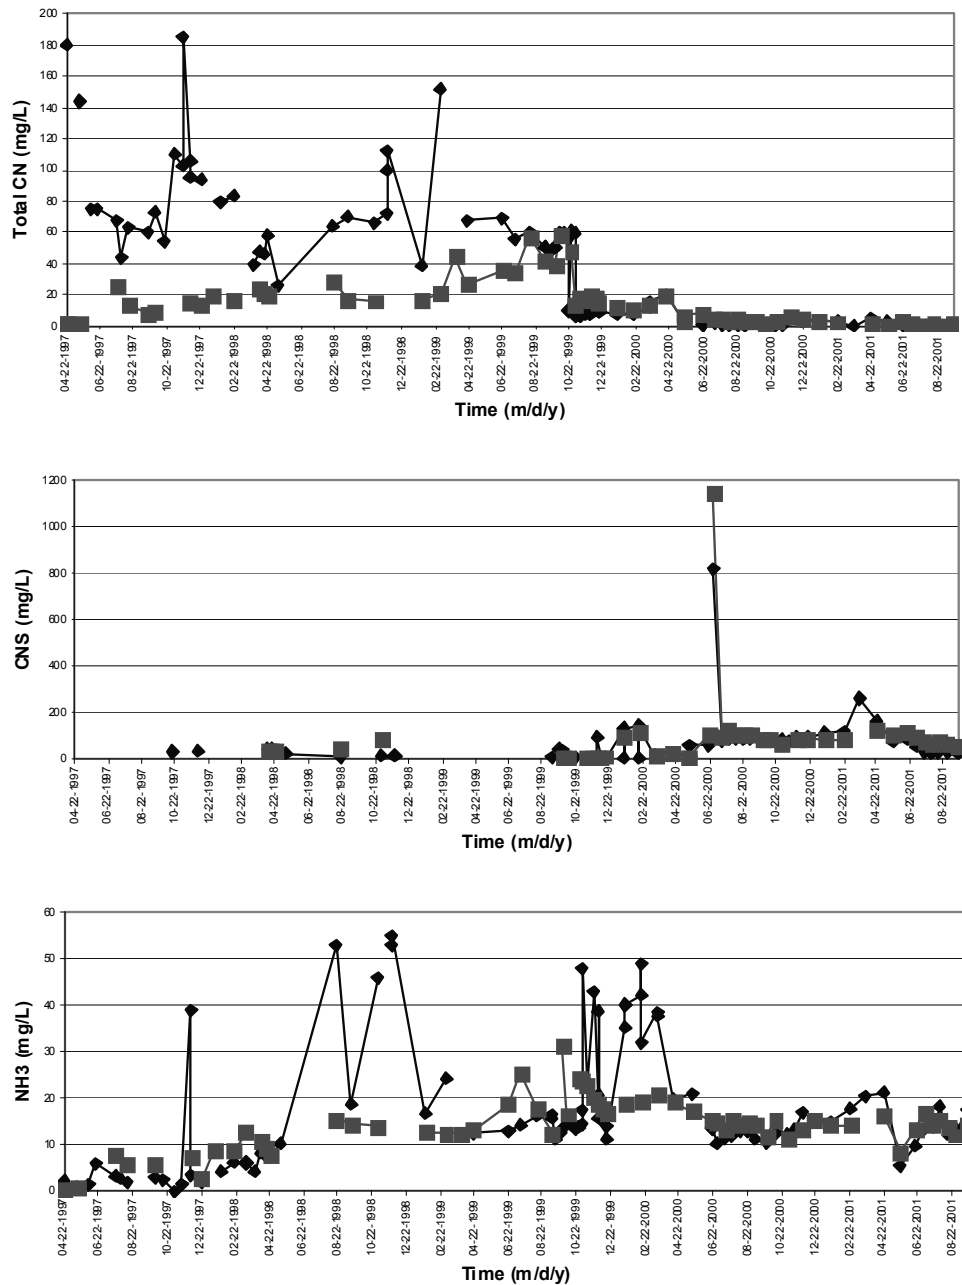
related compounds accumulated in the impoundment, the NH<sub>3</sub> level has remained elevated in the pond water and seepage even after mine abandonment (Figure 3, bottom plot).

**Figure 3** Temporal variation of total CN (top), CNS (middle) and NH<sub>3</sub> (bottom) in the tailings pond water (diamonds) and seepage return (squares) at the Mount Nansen Mine site from April 1997 to September 2001

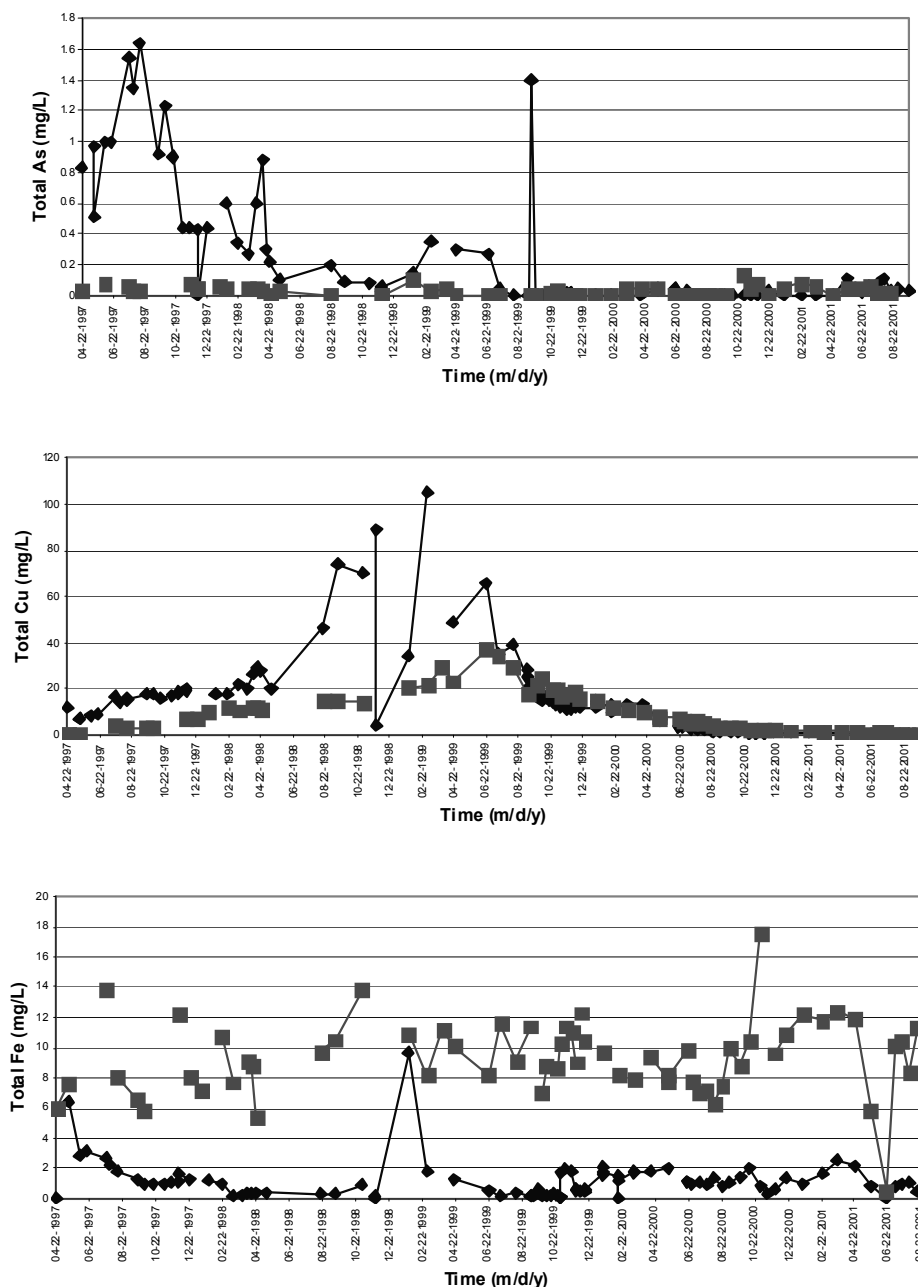
At closer examination, the temporal variation of total Cu in the seepage return water (Figure 4, middle plot) also correlates with that of total CN in the seepage return (Figure 3, top plot). This suggests the formation of copper cyanide complex in the tailings pore water during mining operation. The total CN and total Cu concentrations in both the tailings pond water and seepage return have been greatly reduced since mine abandonment.

**Figure 4 Temporal variation of total As (top), total Cu (middle) and total Fe (bottom) in the tailings pond water (diamonds) and seepage return (squares) at the Mount Nansen site from April 1997 to September 2001**

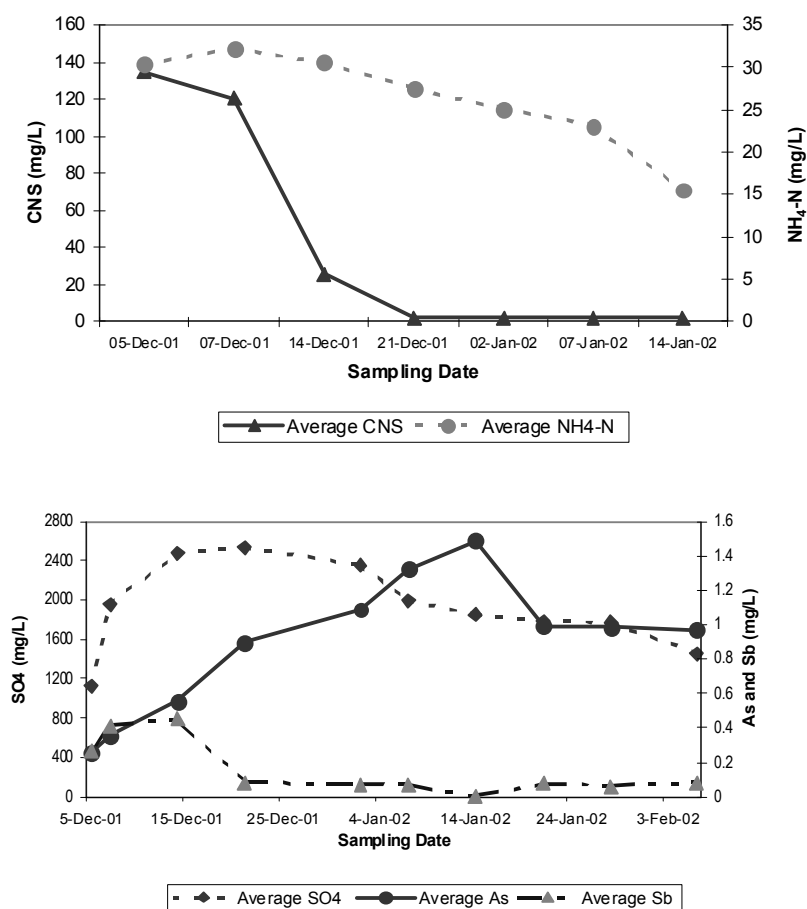
**Figure 5 Time series of the average concentration of thiocyanate, ammonia, sulphate, arsenic and antimony in the weekly leaches of the flow-through column experiment**
