Waste rock dump rehabilitation to a new level – Telfer WD13 constructed mesa landform

J.A. Mifsud *Care of Our Environment, Australia*

E. Ryan-Reid *Newcrest Mining Limited, Australia*

M. Wealleans *Newcrest Mining Limited, Australia*

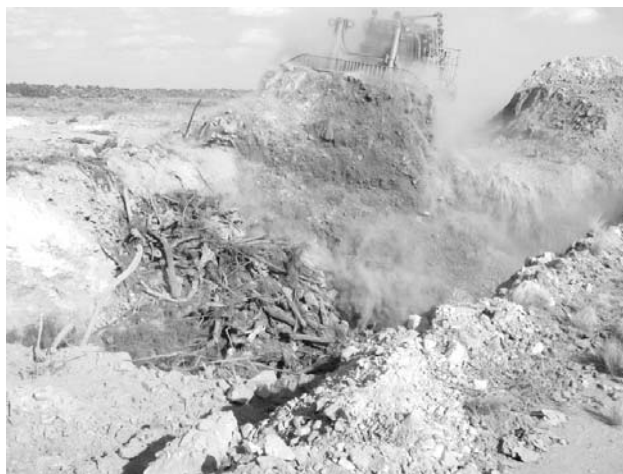
Figure 8 Burying of Athel Pine

A D10 and a grader were used to remove the weeds mainly Athel Pine or Tamarisk (*Tamarix aphylla*) and Kapok bush (*Aerva javanica*) from the waste dump surface. Around five Athel Pines were buried in holes dug next to the trees (Figure 8).

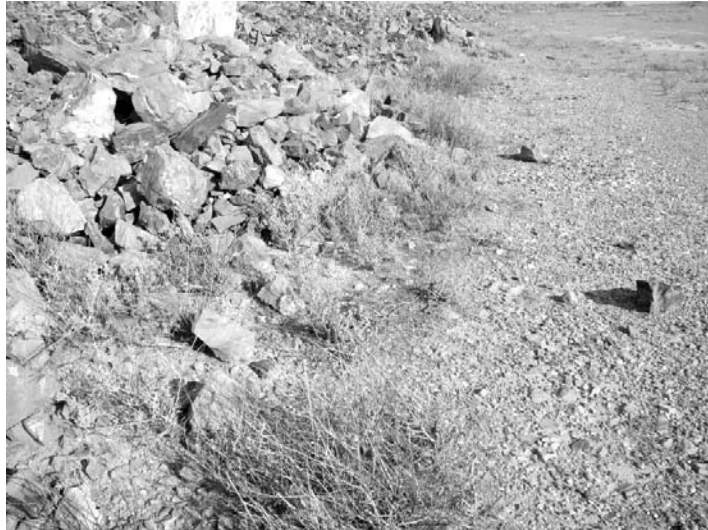
Figure 9 Kapok weed growing in difficult to reach places

The predominant weed was Kapok bush at the time it was mostly in seed. The weeds and rubble were pushed into small piles around fissures for the burial. Kapok bush were seen growing amongst the end dumped waste rock and on the north face of WD13, which could not be reached by the grader (Figure 9). Although the grader was successful in removing and burying around 95% of the weed some seeds would have dispersed over freshly prepared surfaces from the hard to get plants in the rock stockpiles and on the north face.

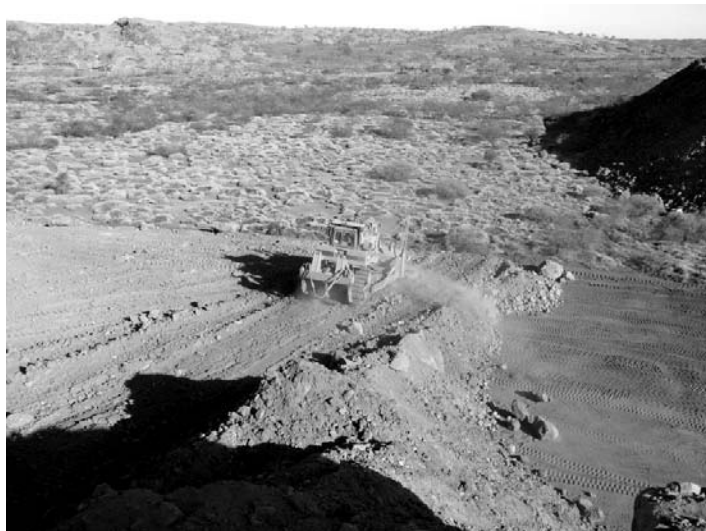
Figure 11 D10 bulldozer pushing lower slope of constructed mesa landform

The 16 and 7° slope angles were achieved using a D10 equipped with an inclinometer. Unfortunately, GPS equipment was not available in time for the work, which resulted in additional demand on surveyors.

Despite this minor setback the design slopes were generally achieved to within $\pm 1^\circ$ (Figure 11). The net effect was that the final mesa landform was visually similar to the surrounding topography (Figure 12).

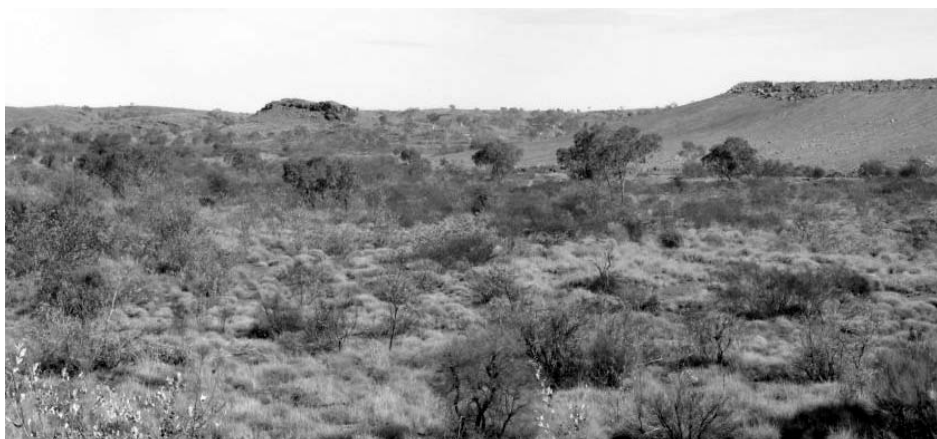
Figure 12 Final constructed mesa landform (natural mesa on left)

A 2 to 2.5 m rock bund was constructed around the perimeter of WD13 shoulder. This bund gave a visual effect similar to a mesa duricrust (Figure 12). No topsoil was used in the perimeter bund.

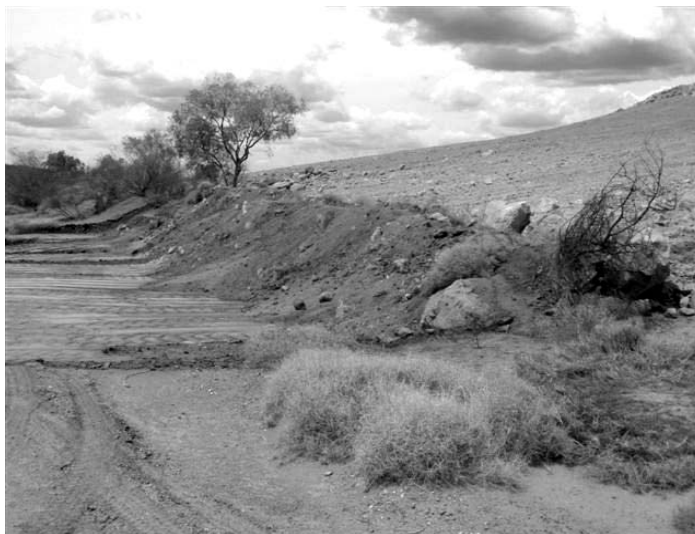
Figure 15 Repairs to shoulder of Rudall River Road

As stated earlier, some large boulders rolled down the face of the dump. Whilst large boulders can be seen on some natural mesa Landforms it was decided to remove these boulders for aesthetic and safety reasons. A

D10 was used to push the boulders to the toe of the dump and repair any damage to the rock armouring. Some unavoidable damage to the Rudall River Road berms occurred in removing the boulders (Figure 15). This berm was repaired after the boulders were properly tucked into the toe of the dump.

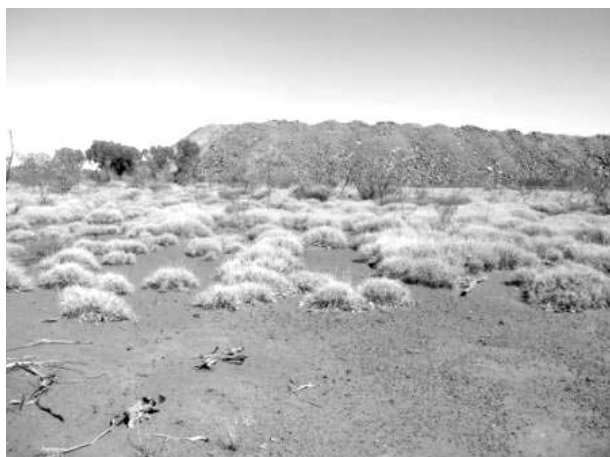
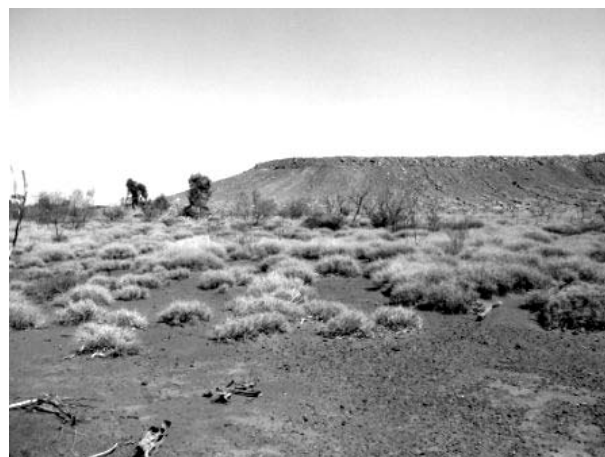
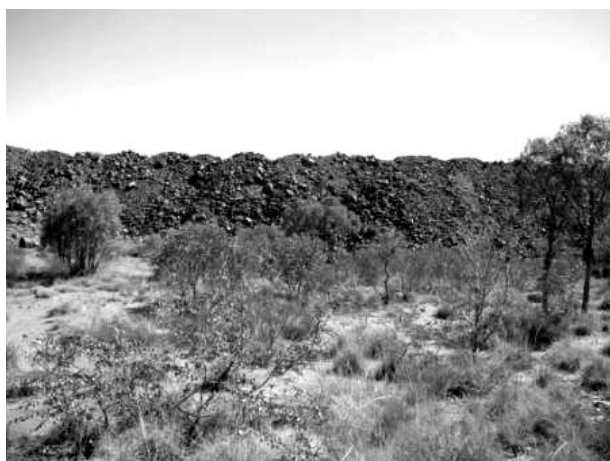
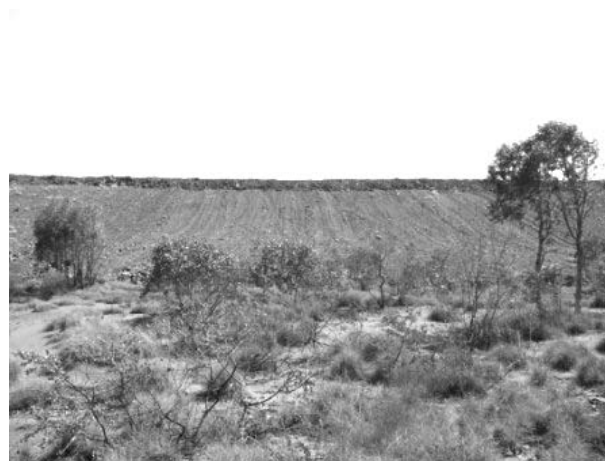
Figure 16 Before and after photo monitoring points: photos on left taken in November 2008; photos on right taken in October 2009

- Photo point monitoring and soil quality sampling have provided evidence of structural and chemical stability of the mesa landform (Figure 16).
- The EFA monitoring documented minor erosion on the mesa slope, consistent with expectations.

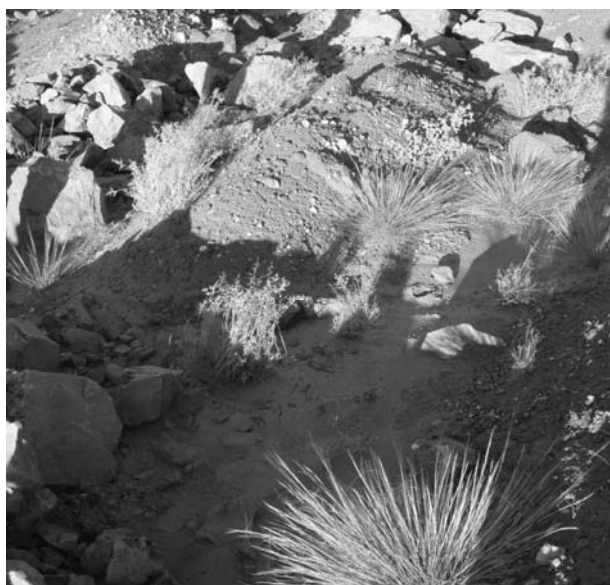
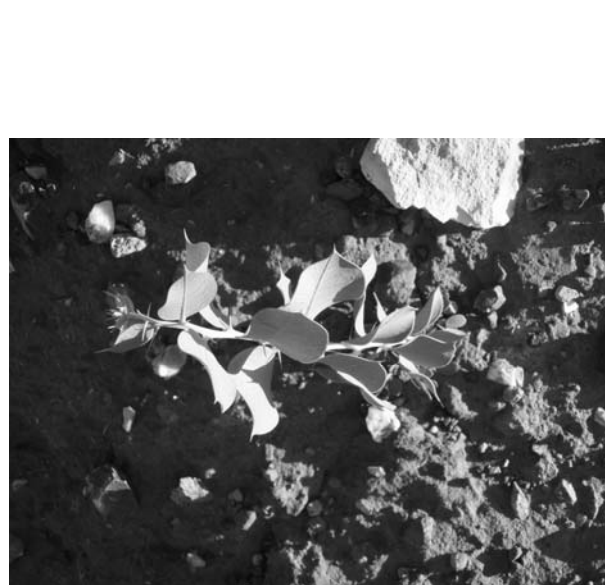
Figure 17 Photograph of two plant species (left: Native grasses (*Triodia pungens*); right: *Grevillea wickhamii*) growing on the constructed mesa landform at Pit 13, June 2010

- The dominant native vegetation found on WD13 in year one was spinifex (*Triodia Sp.*) the vast majority being the soft spinifex (*Triodia pungens*) followed by *T. basedowii* and *T. longiceps* and a Bluebush species (Figure 17). Acacia species identified on transects were *Acacia ancistrocarpa*, *A. aneura* var. *aneura*, *A. pyrifolia* and *A. maitlandii*.

- *Grevillea wickhamii* was recorded on both the slopes and hummocks (Figure 17). *Atalaya hemiglauca*, *Corchorus lasiocarpus* and *Tribulus suberosus* were noted; *Ptilotus calostachyus*, *Ptilotus exaltatus*, *Ptilotus obovatus* and *Solanum lasiophyllum* were also prevalent.

- The vegetation was in early growth stages and suffering from heavy grazing, camels were observed on WD13 during the monitoring program.
- Kapok bush was the only weed recorded but it was by far the most dominant plant species on WD13.
