# Effective ground support system design to manage seismic hazard in a high stress diminishing pillar at a Vale mine

A.R. Punkkinen *Vale Limited, Canada*

N.R. Mamidi *Vale Limited, Canada*

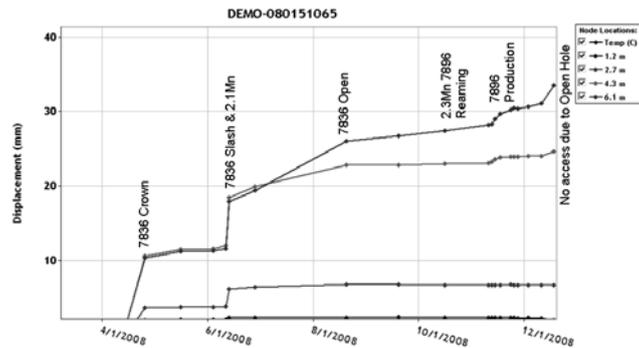
3350 Level: Figure 11

At the south end of the monitoring area, only the displacement reading was available. Load readings were unavailable due to a pinched cable. When the 7836 crown blast undercut the instrumented pillar above the topsill, total displacement increased to 10mm. The 'slash' increased the reading to 18mm which increased to 26 mm while undercut prior to the fill cycle. Mining of the 7896 further increased displacement to 33 mm, no reading was available after the 7896 crown due to restricted access to the readout location. Note that only three of the cables four load meters were physically installed in the 4.5 m hole (1.2, 2.7 and 4.3 m).

Figure 11 MPBX #65 3350 topsill

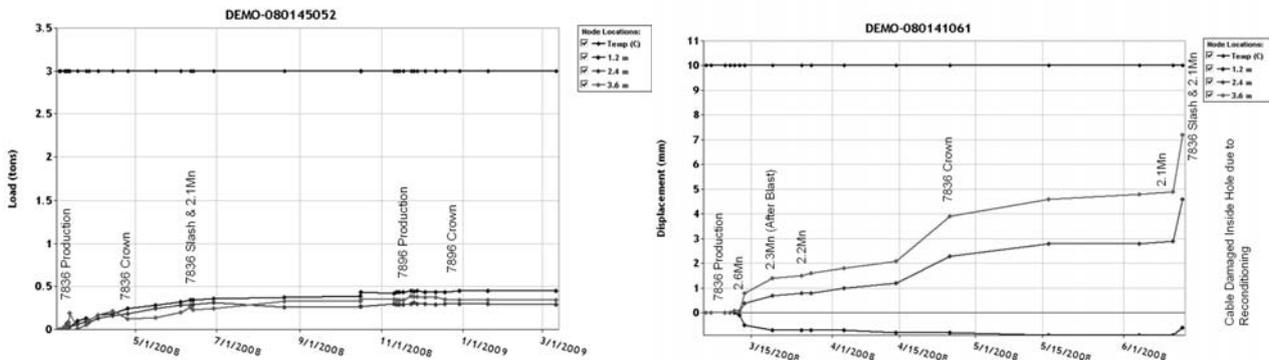
3350 Level: Figure 12

At the north end of 3350 Level, even when undercut by mining of the 7896 panel, less than ½ ton of load is observed. This corresponds to a gradual accumulation to 7mm with mining activity until the MPBX was damaged. Little change in load/displacement results were observed throughout the mining cycle at this location.

Figure 12 Detect Cable #52 & MPBX #61 3350 topsill

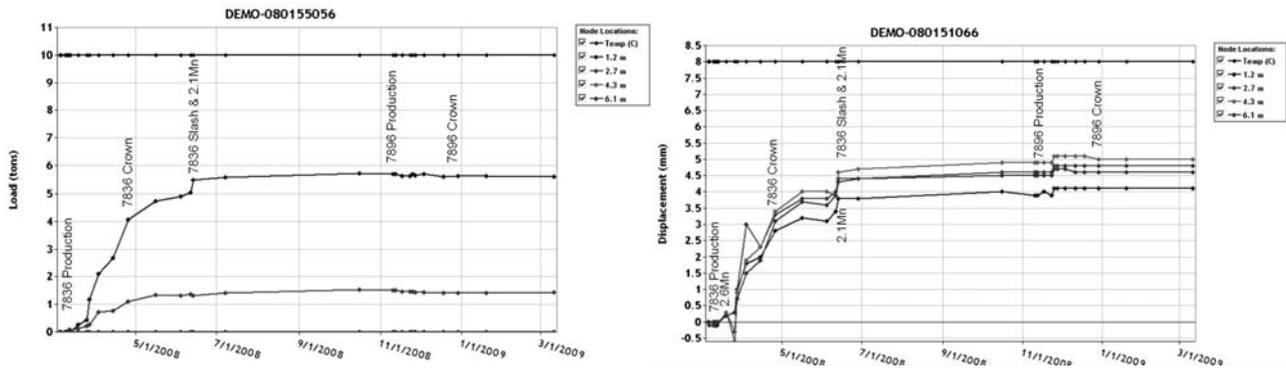
3540 Level: Figure 13

Located at the south end of the monitoring area, these instruments were installed slightly to the footwall of the ore zone. No tangible increases in load (~ ¼ ton) were recorded until after the seventh blast and a 2.3 Mn event which followed. As mining of the 7836 panel continued, the bulk of total displacement progressively increased to 4 tons after the crown was blasted and to 5 ½ tons after the 7836 slash. The gradual increase to displacement corresponds with changes in load as the mining front approached. A total displacement of approximately 5 mm was measured, little load or displacement was observed after the mining front passed the instrumentation location.

Figure 13 Detect cable #56 & MPBX #66 3540 bottomsill

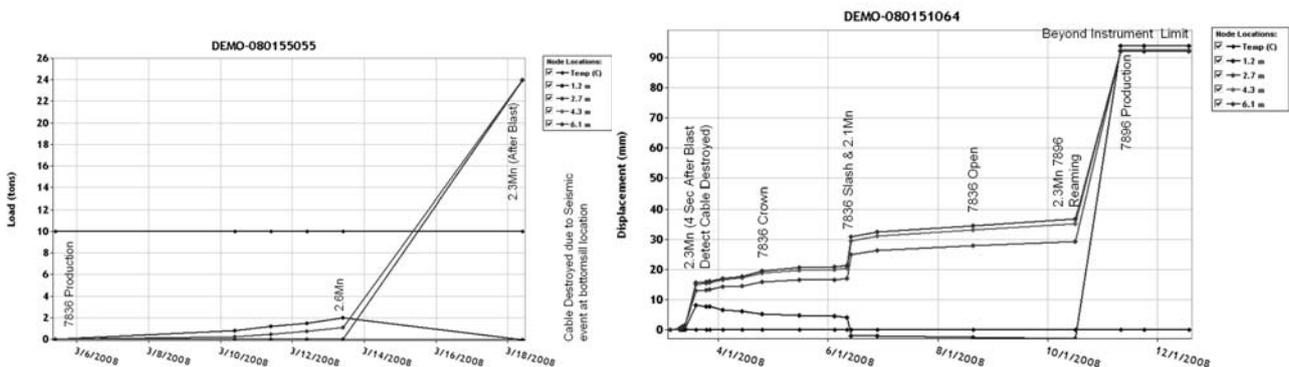
3540 Level: Figure 14

Approximately ½ ton of load was measured along the north end cable until the seventh blast, after which a subsequent 2.3 Mn event destroyed the instrumented cable bolt. The read-out confirms that the bolt broke between the 1.2 and 2.7 m point due to dynamic loading as a result of the local event. Prior to this, minimal displacement (approx. 1½ mm) had been observed, after which an increase to 16 mm coincided with the seismic event. As mining progressed, a linear increase to 20 mm occurred with the several blasts leading up to the slash, increasing to 30 mm following it. By the time reaming had been completed in the 7896 Stope raisebore slot, increases to 37 mm were apparent. When 7896 production physically approached the MPBX location in November 2008, displacements reached the full limit capacity of the instrumentation (>94 mm).

Figure 14 Detect cable #55 & MPBX #64 3540 bottomsill

The first blast in the next panel, Panel 7986 was fired November 10, 2008, bringing bottomsill MPBX #64 within two meters of the newly established stope brow. Displacement readings maxed out the instrumentation to 94 mm at each load meter position (refer to Figure 14).

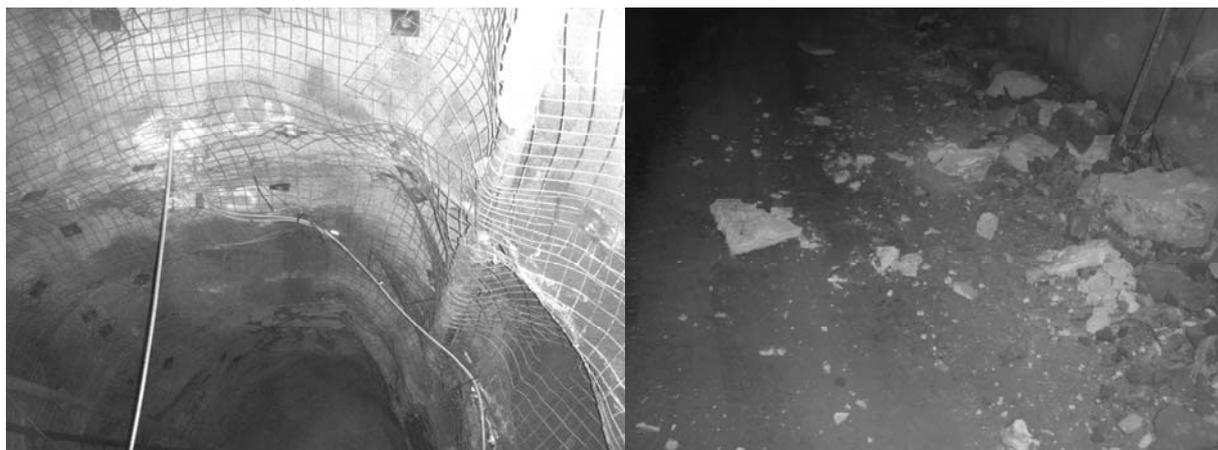
An event registering a magnitude of 2.6 Mn occurred 13 March 2008 resulting in damage in the 3350 topsill area (refer to Figure 15 ‘topsill location’). The proper protocols and investigations were completed following this event. Most damage was observed in the walls of the topsill access drift. For a distance of approximately 40 m, shotcrete was observed as having peeled from both walls and cracked along the back, with increasing intensity to the sill drift intersection. This event resulted in damage to both mechanical as well as friction bolts at intermittent locations. The topsill had been reconditioned November 2007 to February 2008 with secondary support in the form of #4ga mesh installed with 2 m length, (fs46™) friction set bolts installed over arches and shotcrete and remained in good shape. The source location of the seismic event plotted within the stope. The stiff arch and enhanced yielding ground support system combination performed well.

**Figure 15 Back and floor of 7836 bottom and topsill following the March 13, 2008, 2.6 Mn event**

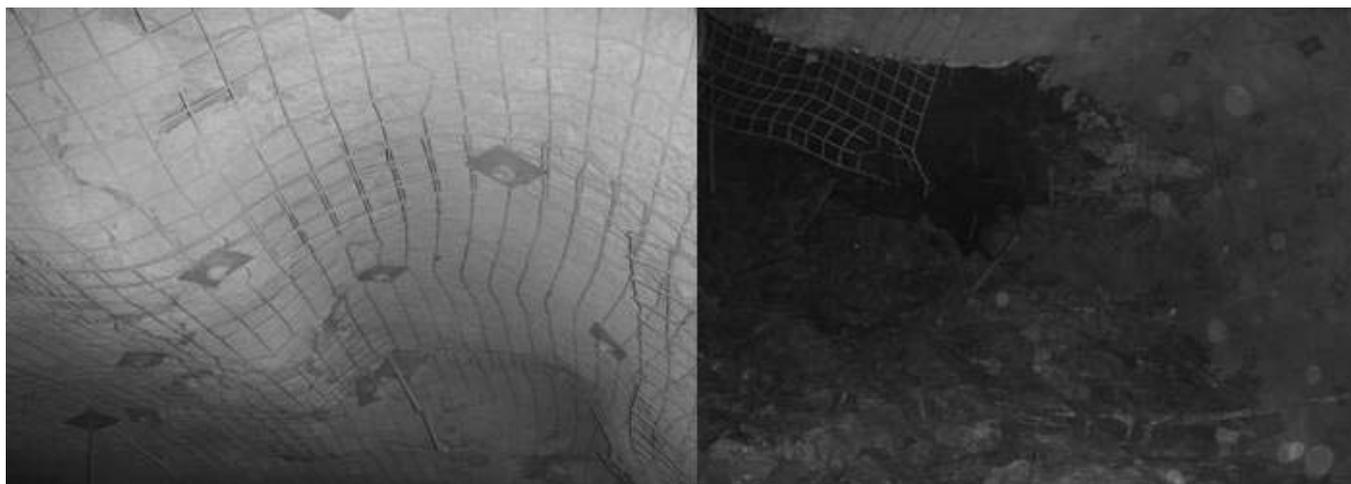
The event resulted in a rockburst which destroyed MPBX #64 with displacement at the brow and wall corner at the bottomsill. By this point, the original arch-shaped bottomsill drift contour as shown in Figure 15 had extensively deformed (refer to Figure 16). Ground conditions were at a point that it was decided that the remaining ore in the stope was to be mucked out remotely from a safe location at the remote stand.

The majority of the displacement was from the brow itself. In essence, the brow burst into the unconfined opening of the stope. The yielding-over-stiff ground support system once again protected the opening from greater damage. Only the wall corner was rehabilitated, the brow area was left unsupported and remaining stope mucked out remotely from 15 m back.

**Figure 16** Back and brow of 7896 bottomsill following rockburst

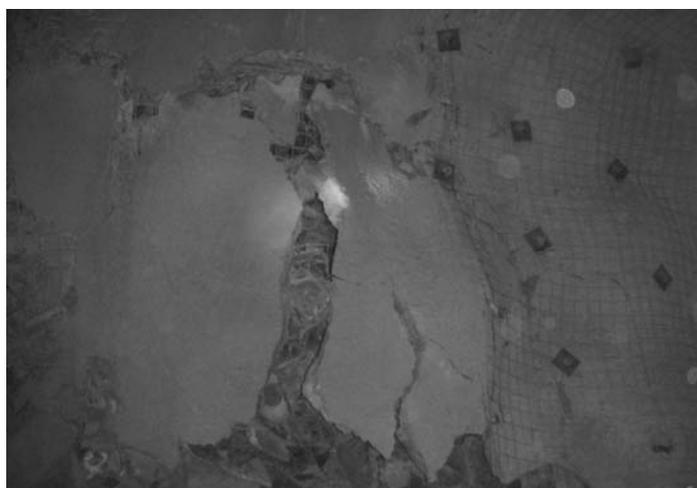
The system's effectiveness was proven by examination of the wall displacement. The area had previously been shotcreted, but not screened due to logistical problems of bolting corners with the hydraulic bolter being used. The brittle shotcrete system violently spilled out of the high grade sulphide bulking beneath, stopping only where the #4 mesh installed with the (fs46™) friction set was installed (refer to Figure 17), proving its value as enhanced support system.

**Figure 17** Unscreened corner of brow following rockburst
