Reclamation of the Silver Bell tailings impoundment, San Juan Mountains, USA

C.L. Foulk *MWH Americas Inc., USA*

Abstract

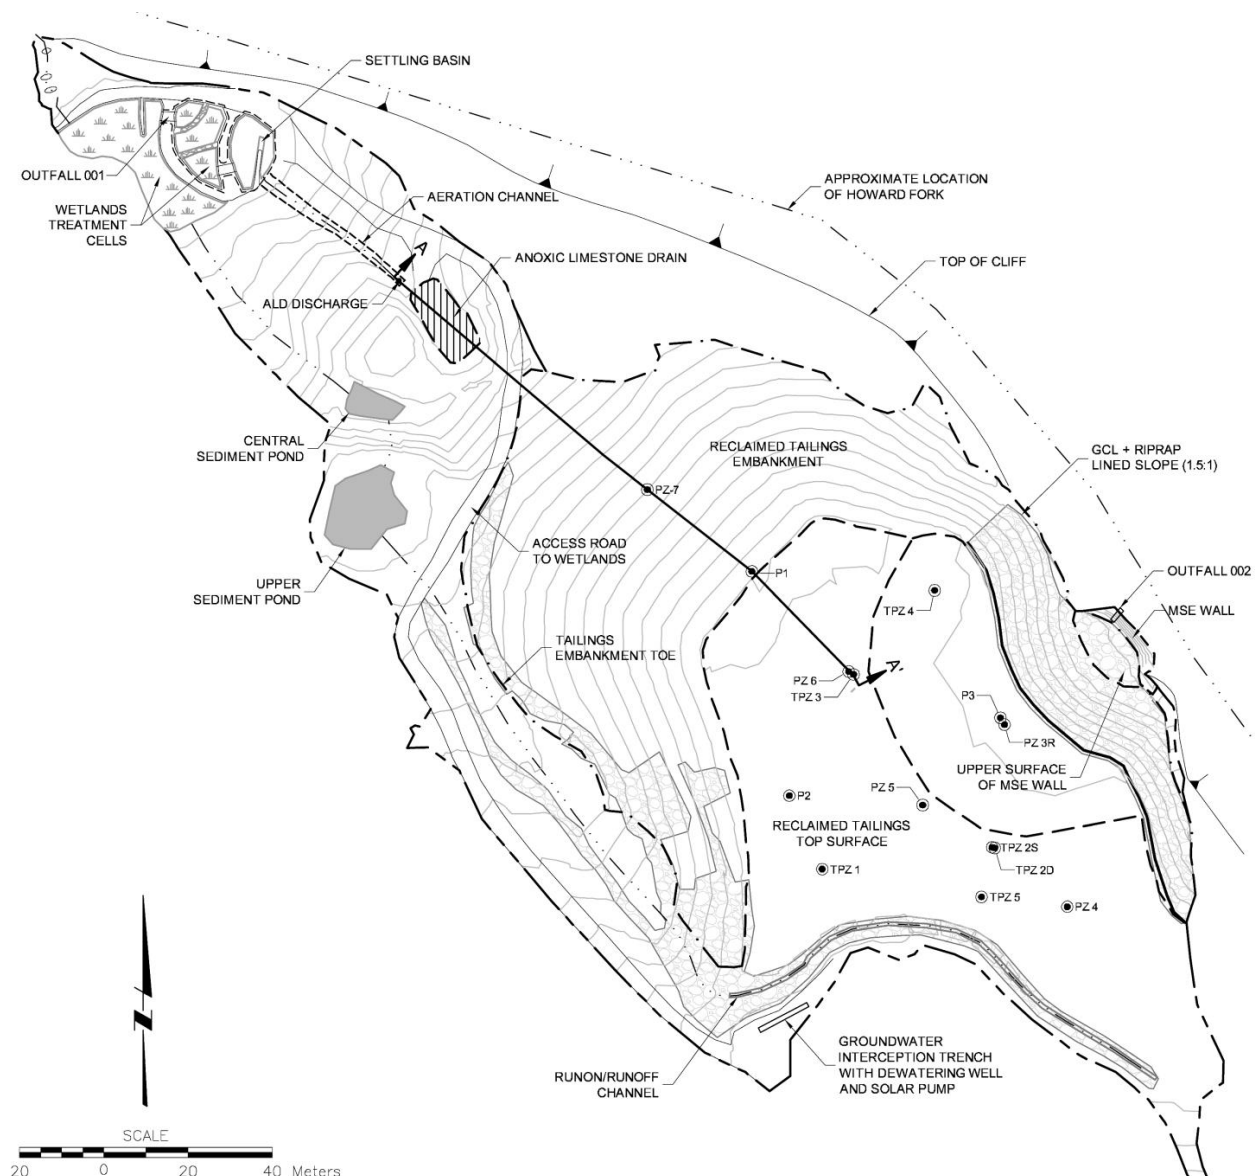
Figure 2 Schematic of Silver Bell tailings impoundment configuration following initial and follow-up reclamation activities; piezometers (P, PZ and TPZ) are shown, as well as the location of cross-section A – A' that is presented as Figure 3

The piezometric mound at TPZ-1 was adjacent to a swale in the hillside where bedrock atypically is not exposed. A trench was excavated in this area just outside of the tailings impoundment during summer 2009 (Figure 2). An approximately 5.5 m deep soil-filled incision was found in the bedrock surface. At the time of the excavation, groundwater was flowing into the trench from the uphill side. It appears that groundwater in this soil-filled bedrock incision is channelled and flows beneath the surface run-on diversion and recharges the impoundment. Subsequent dewatering system piezometric monitoring in the spring of 2010 indicated that the water level at this location was a mere 0.3 m below ground surface, but dried up in the late fall.

The ALD is approximately 7.6 m wide and 10.7 m long (see Figure 2) with an average depth of about 1.8 m. Construction of the ALD in the stormwater pond included dewatering of the pond, installation of piping for collecting and delivering tailings impoundment seepage to the ALD, installation of a seepage distribution header in the pond bottom, filling of the ALD excavation with 40 to 50 mm crushed limestone, and installation of an outlet line. The upper limestone surface was covered with a geotextile fabric and high density polyethylene liner over which 91.4 cm of locally available fill material was placed. By late October 2006, the voids within the ALD had filled with the seepage and discharge from the ALD had begun.

To specifically address the discharge through Outfall 001, treatment cells were constructed in the area between the wetland and ALD to provide additional passive treatment for the seepage prior to entering the wetland and mixing with the off-site flows. Two treatment cells were created. The first receives the ALD discharge and is intended to settle the iron and other metals that precipitate as the result of increased pH from the ALD. The second area includes flow-through limestone berms to provide additional water quality polishing. The water from the second cell discharges into the existing well-vegetated wetlands area which also receives other acidic off-site inflows. A weir was placed after the second treatment cell for Outfall 001 monitoring. This location is identified in Figure 2.

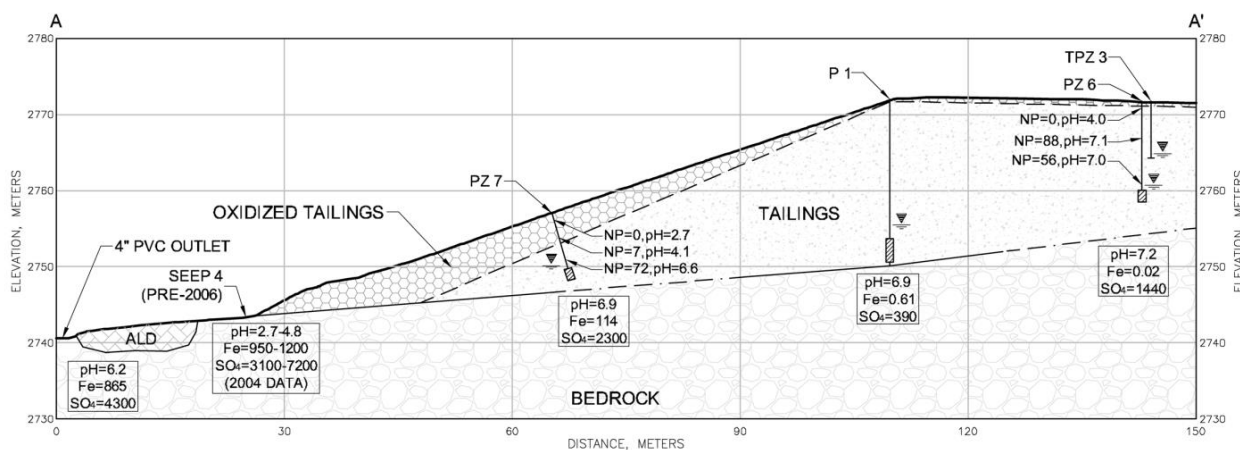
Six tailings samples were collected during the drilling of piezometers and submitted for the analysis of ABA parameters and metals using SPLP extraction. The pH of the tailings was measured using the paste pH method along with the pH of the SPLP leachate. The samples were collected from the boreholes for piezometers PZ-6 and PZ-7. The PZ-6 borehole is located at the top of the northern embankment above the ALD, and PZ-7 is located about midway down the embankment slope between the ALD and PZ-6 (Figures 2 and 3). Table 1 presents the analytical results for these samples.

The PZ-7 borehole was advanced at a slight angle from vertical into the tailings impoundment. Oxidised tailings were noted to a depth of approximately 4.0 m below ground surface. Two samples were collected in the oxidised tailings, and a third sample was collected in the deeper unoxidised tailings. This is expressed in the analytical results with the shallower two samples being depleted or nearly depleted neutralisation potential. The presence of unoxidised tailings is indicated in the deep sample by the occurrence of both acid neutralisation and acid generation potential. Neither is depleted. The shallower samples also have acidic pH and higher concentrations of SPLP leachable metals.

The PZ-6 borehole is located on the crest of the tailings embankment and has only a thin layer of oxidised tailings. This is evident by a depleted neutralisation potential in the shallow sample and an acidic pH, whereas the deeper samples have significant neutralisation potential remaining. The concentrations of SPLP leachable metals are between one and two orders of magnitude higher in the oxidised tailings sample except for manganese.

Figure 3 also shows water quality data for pH, iron and sulphate for piezometers PZ-6 and PZ-7, as well as the older P-1 piezometer, the ALD discharge, and historical pre-2006 data for Seep-4. Seep-4 was the tailings seepage discharge location prior to construction of the ALD. Table 2 presents data for additional analytes and includes additional piezometer locations in the central portion of the impoundment (P-2, PZ-3R, PZ-4, and PZ-5 as shown in Figure 2).

Figure 3 Longitudinal cross-section through northern Silver Bell tailings embankment showing ABA neutralisation potential (NP) and paste pH and water quality results (in boxes); cross-section location is shown on Figure 2 and is oriented in a northwest to southeast direction
