# Louvicourt Mine – a recent mine closure case study

**R. Ouellet** *Golder Associates Ltd, Canada*

## Abstract

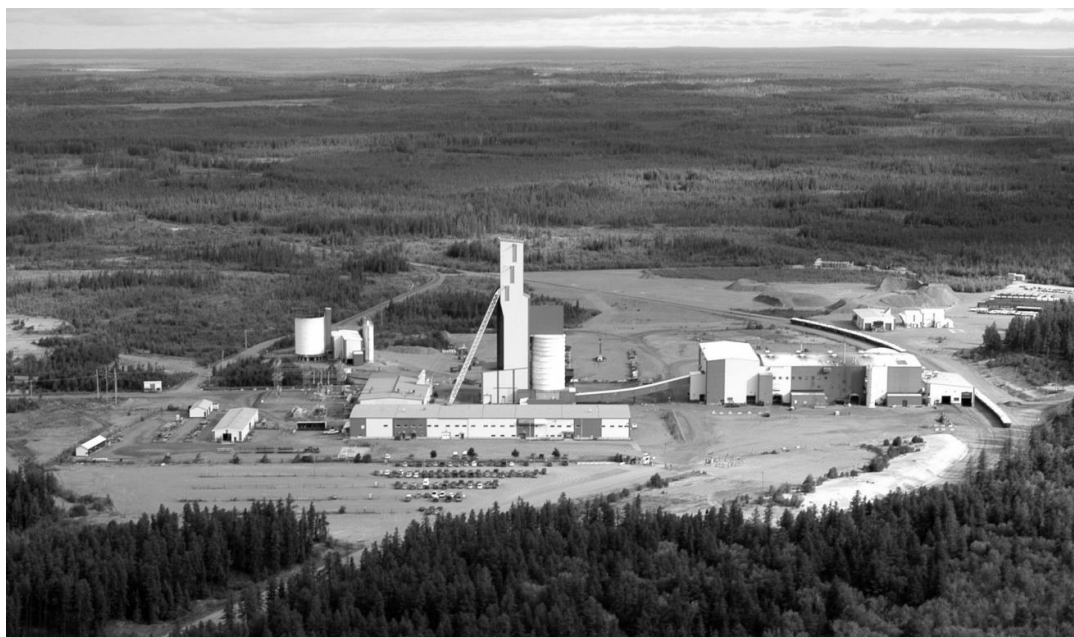
At the mine site (Figure 1), the major components were: the concentrator, the production shaft and ore storage bin, the conveyor, the ventilation shaft, the exhaust raise, the office, warehouse and maintenance shops building, the hoist room, the paste backfill plant, the service railroads and rail spur, the electrical sub-station, and the waste rock storage area.

**Figure 1** View of the mine site in 2004, before closure (looking north)

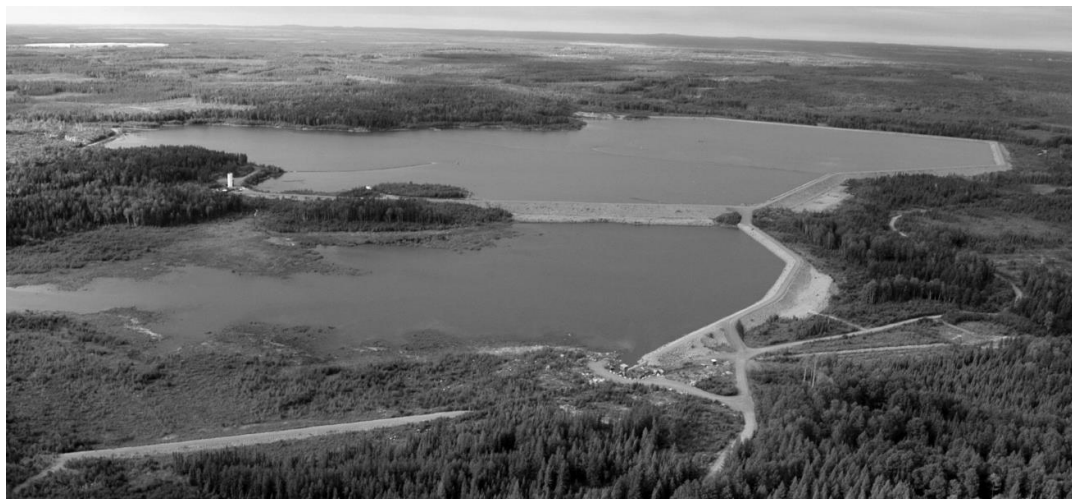
Initial investment for construction of the tailings facility was C\$ 10,000,000. Figure 2 shows the infrastructure, with the tailings pond in the background and the polishing pond in the foreground.

**Figure 2** View of the tailings pond infrastructure in 2004 (looking southwest)

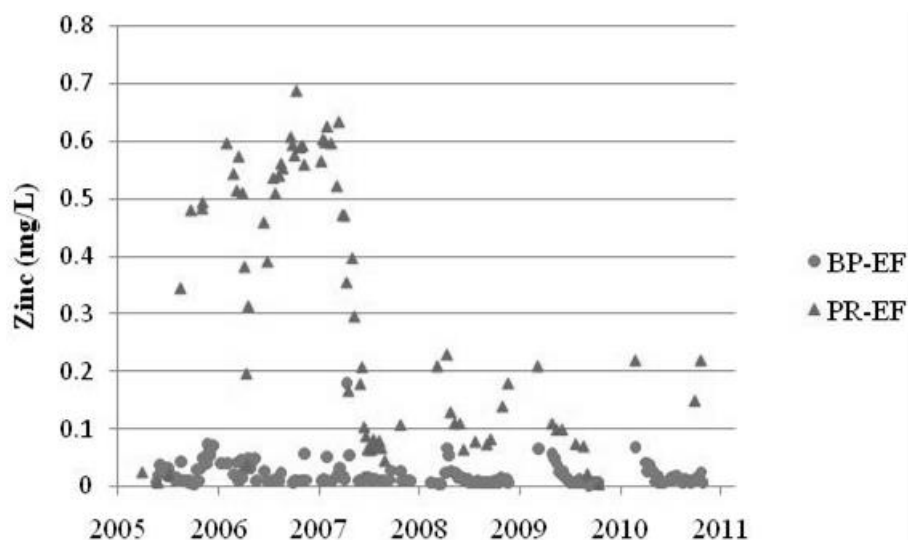
**Figure 3** Zinc concentrations in the tailings pond (PR-EF) and the polishing pond (BP-EF) for the 2005–2010 period

The graph shows that zinc values at the tailings pond have significantly decreased since the mine closure. Late in 2006 and early 2007, zinc concentrations at the tailings pond increased. Water treatment using caustic soda was carried out in the fall of 2006 and the spring of 2007. Since then, zinc concentrations have

decreased and remained in the range of 0.2 mg/L or lower, which is in compliance with Directive 019 on mining industry (MDDEP, 2005), even though the effluent of the tailings pond is not a final effluent and the Directive does not apply. The acceptable monthly average of Directive 019 for zinc is 0.5 mg/L.

The zinc concentrations in the polishing pond final effluent are steady and below 0.1 mg/L since 2005. From 2007 to 2010, the polishing pond was closed during winter. Zinc values are slightly higher in the spring when the pond is re-opened. Zinc decreases gradually during summer. Zinc values at the polishing pond effluent are in compliance with Directive 019 and also below Quebec surface water quality criteria, acute toxicity (MDDEP, 2009).

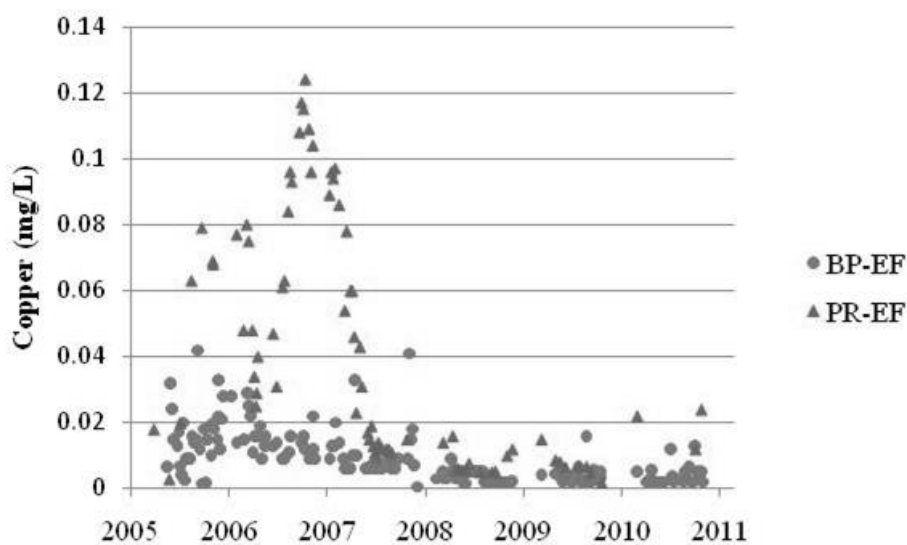
Figure 4 presents a graph of copper values in the tailings pond and the polishing pond spillways since 2005. Since water treatment in 2006 and 2007, the copper concentration in the tailings pond has decreased and remained steady at or below 0.02 mg/L. The acceptable monthly average of Directive 019 is 0.3 mg/L. In the polishing pond, the copper values have decreased since the mine closure and have been consistently below 0.02 mg/L since 2008.

**Figure 4** Copper concentrations in the tailings pond (PR-EF) and the polishing pond (BP-EF) for the 2005–2010 period
