Closing out gold mining legacies in the Porcupine Camp

T.M. Sulatycky *Porcupine Gold Mines, Goldcorp Canada Ltd., Canada*

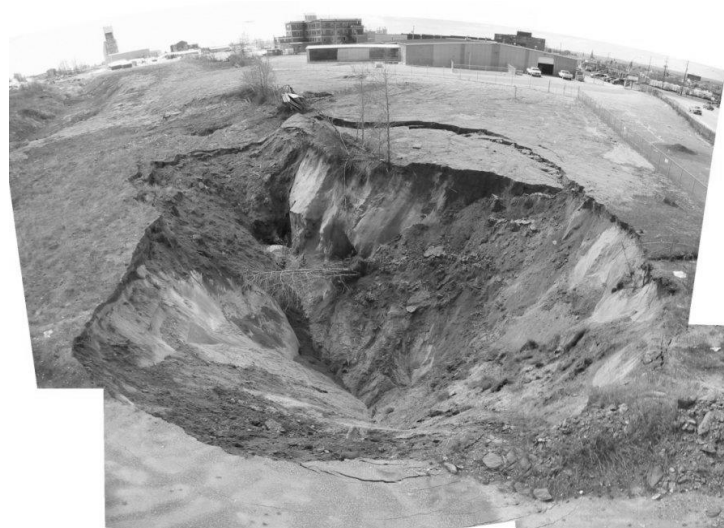
Using a risk-based approach, KGC began prioritising their safety and environmental liabilities, laying out a plan that the MNDMF would be satisfied with and KGC could reasonably manage. Mine openings such as shafts, raises and open stopes as well as unstable crown pillars presented immediate threats to community safety, for example, and were targeted for rehabilitation immediately. The Hollinger and McIntyre Mine presented the greatest risk due to the mining methods of the day, the proximity of the mine to the City as well as the number of mine hazards. Also, when the mine dewatering system associated with the McIntyre mine was decommissioned, subsidence of unstable crown pillars began to occur near local businesses (Figure 2).

Figure 2 Subsidence near downtown Timmins

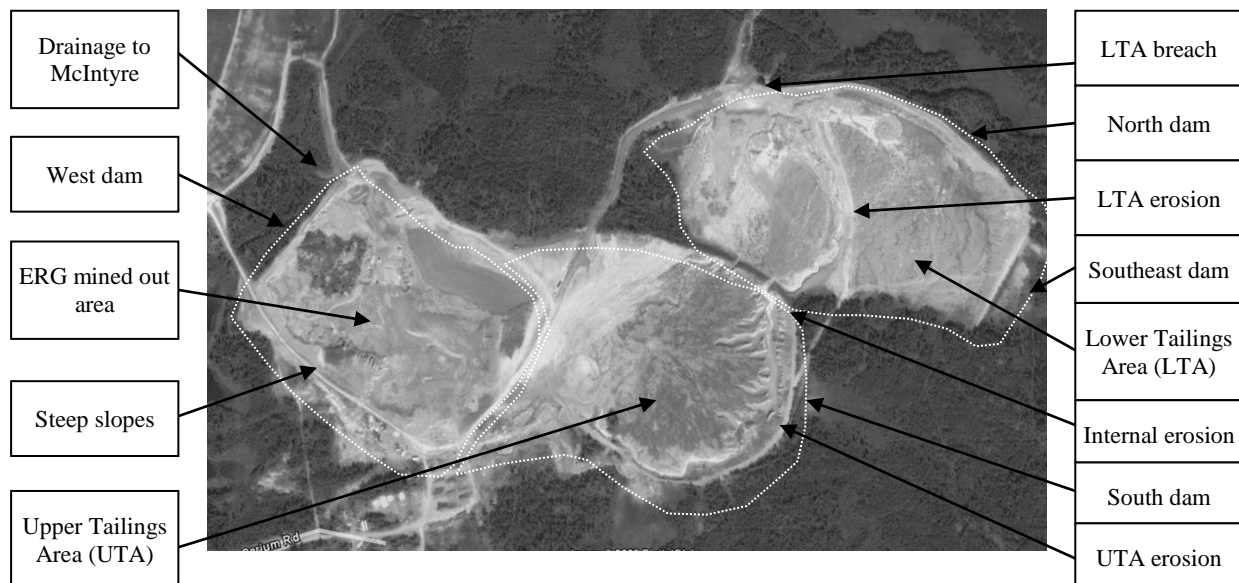
During the period of operation, tailings were deposited into a two tiered tailings facility consisting of the Upper Tailings Area (UTA) and Lower Tailings Area (LTA), a total of 58 hectares. The pre-mining topography allowed tailings to be naturally contained by high ground along most of the perimeter as can be seen in Figure 3.

Figure 3 Coniaurum Mine tailings facility pre-construction (2002)

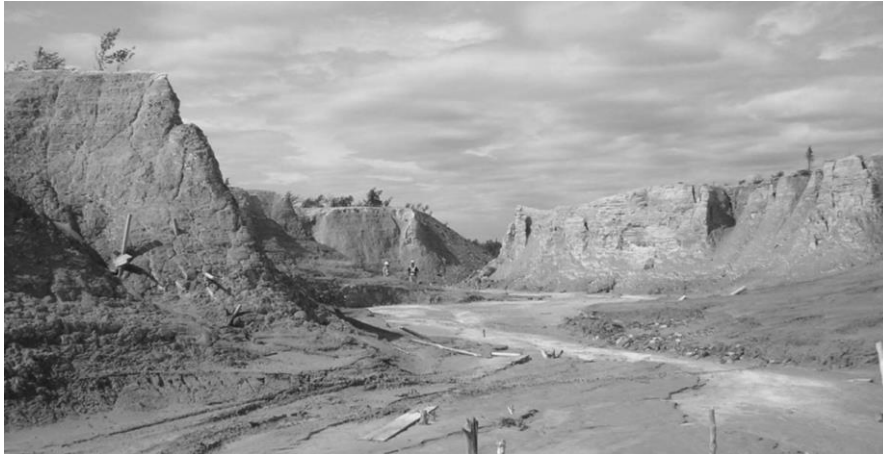
Figure 4 Internal dam breach at Coniaurum tailings facility

The eastern portion of the UTA drained east towards the LTA via two internal dam breaches. The lack of erosion protection accelerated the process cutting deep gullies with steep side slopes over a forty-five year period (Figure 4). The LTA discharged to the Porcupine River (PR) via a breach in the North dam carrying fine tailings. The western portion of the UTA drained west towards the McIntyre tailings area, a result of the hydraulic mining method used by ERG. Steep 5 m to 6 m faces were left further elevating the release of tailings into the PR.

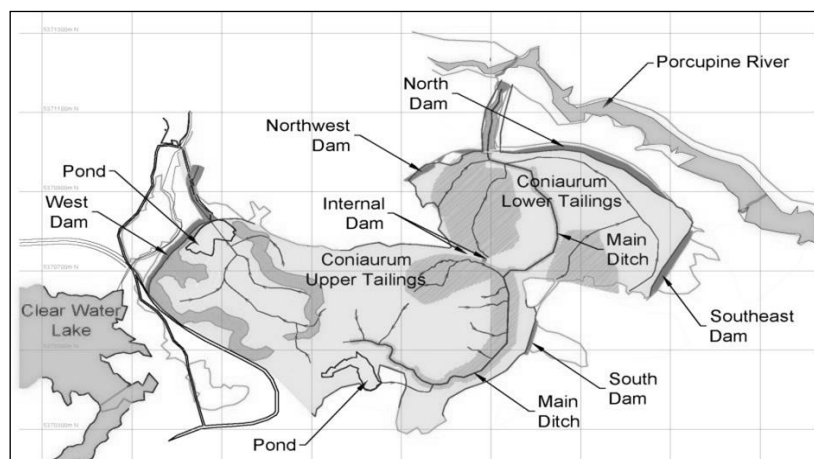
Figure 5 Rehabilitation measures proposed

To facilitate the design criteria, the tailings facility was divided into three distinct watersheds; the UTA west, UTA east and LTA (Figure 5). Runoff would be directed from the UTA east via the main erosion gully which would be stabilised from further erosion with rip rap and become the main ditch. Secondary feeder channels would be constructed peripheral to the main ditch to encourage rapid drainage towards the LTA. A sedimentation pond constructed at the outlet of the main ditch would tie in secondary drainage from the LTA with the main ditch prior to discharge to the PR. On the west side, multiple drainage ditches were constructed to move water towards a second discharge point leading to the McIntyre tailings sump.

Significant sloping would take place to ensure long term stability of the existing dams. The north and southeast dam would be graded to a 3.5 horizontal to 1 vertical slope and covered with rockfill. A rockfill buttress would be placed at the toe of south dam. The exposed faces from ERG at UTA west would be graded to a 5 horizontal to 1 vertical slope. Following construction, the entire site would be covered with biosolids and seeded.

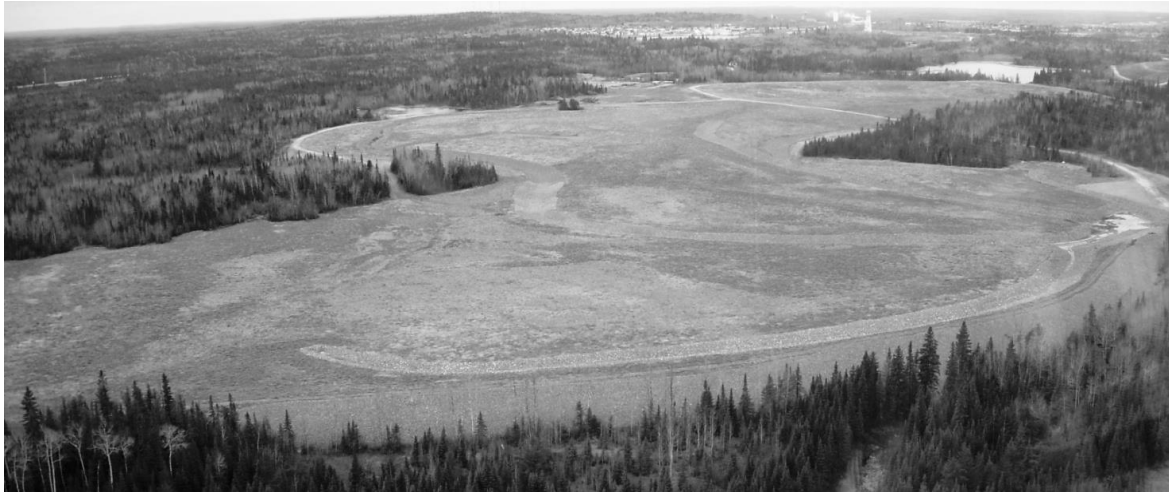
Figure 6 Post closure aerial photo looking southwest (2010)

Further monitoring of the tailings reclamation work is showing signs of stabilising and future monitoring requirements will likely be reduced as justified by the overall improvement to both physical and chemical stability. PGM intends to allow access to the site as a nature trail system in consideration of future land use.

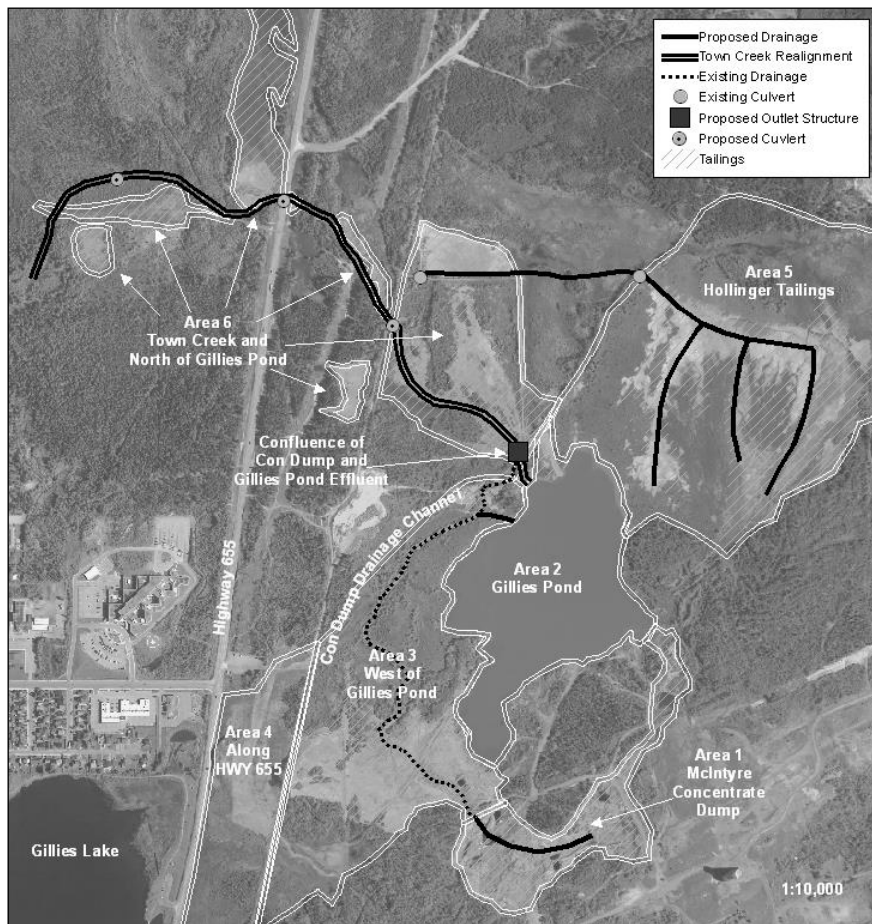
As erosion protection was not constructed, a significant quantity of tailings from both impoundments migrated downstream into Town Creek, likely under severe storm events. Some of the migration of tailings is attributed to ERG during their operation. Figure 6 depicts existing conditions and proposed measures for reclamation.

Figure 7 HTMA site plan and proposed rehabilitation measures

Phase 1 focuses on Town Creek (Area 6) by removing acid generating tailings and constructing a new outlet control structure and channel. Drainage from the MCD will be managed by diverting runoff into the south end of Gillies Pond while the lower reach will be diverted into the north end of Gillies Pond. Closure activities in Areas 5 and 6 will also be carried out in this phase of the project.

Phase 2 focuses on the relocation of concentrate within the MCD and acid generating tailings from Area 3 and 6 into the pond. Following the relocation of the concentrate and tailings, the remaining exposed tailings in Areas 1 and 3 will be covered with a layer of acid-consuming tailings and a vegetative cover. Drainage channels will be constructed in the rehabilitated areas, as required. Reshaping and stabilisation of the shoreline around Gillies Pond and the remediation of two former settling ponds east of Gillies Pond will also be undertaken in this phase of the project.

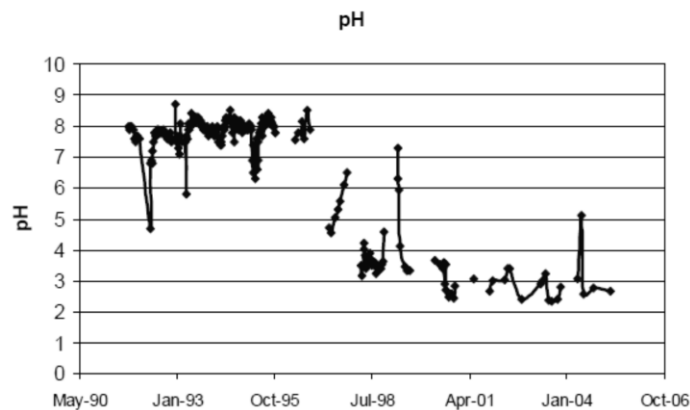
the exception of an annual blip during spring runoff, up until 1997. An explanation to this is that the discharge channel from the MCD contained appreciable neutralising capacity in addition to dilution effects. Post 1997, the pH continued to drop year after year until stabilising around a value of 3 (Figure 7). The transition is assumed to be caused by the depletion of neutralising minerals in the drainage channel. Following the degradation of water quality at the HTMA, water quality downstream showed signs of degradation and increased metal content.

Figure 8 Historic pH at combined discharge

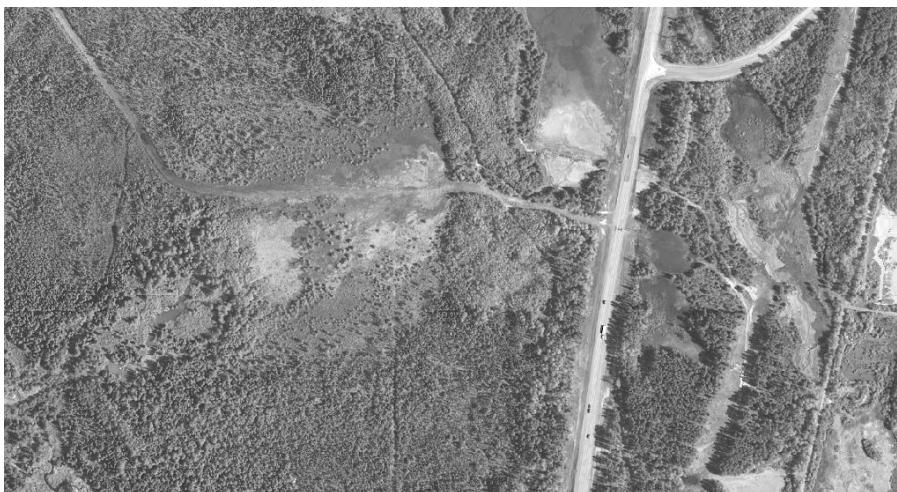
Figure 9 Town Creek pre construction (2006)

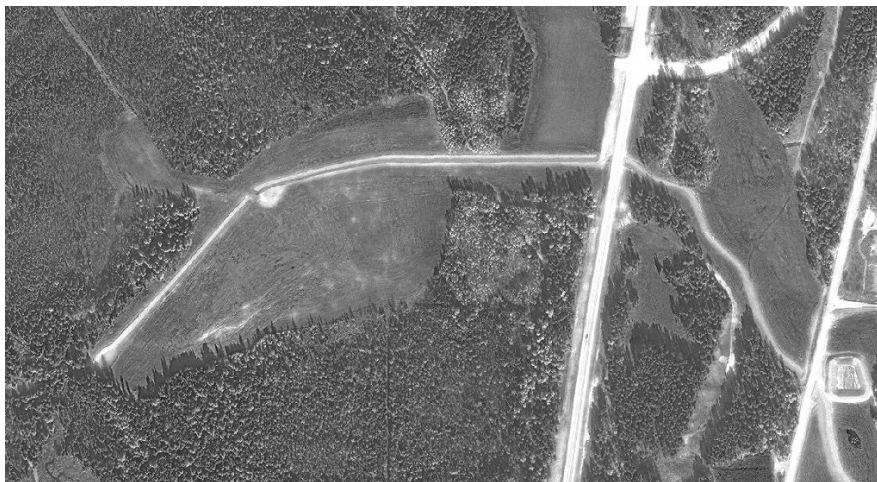
Figure 10 Town Creek post-construction (2010)

As the project was phased to rehabilitate from the end backward, control of effluent from Gillies Pond and the MCD was essential. Gillies Pond would be divided into three sections, the north, central and south, to allow a phased deposition of tailings while maintaining adequate retention time. In 2010, tailings were excavated from Area 6 and Area 1 and deposited in the south and central cells of Gillies Pond. The year 2010 was wrapped up following the installation of a drainage ditch from Gillies Pond to Town Creek and the subsequent spreading and seeding of biosolids, (Figure 9).
