Pillara Mine closure and rehabilitation

A. Prasad *Lennard Shelf Pty Ltd, Australia*

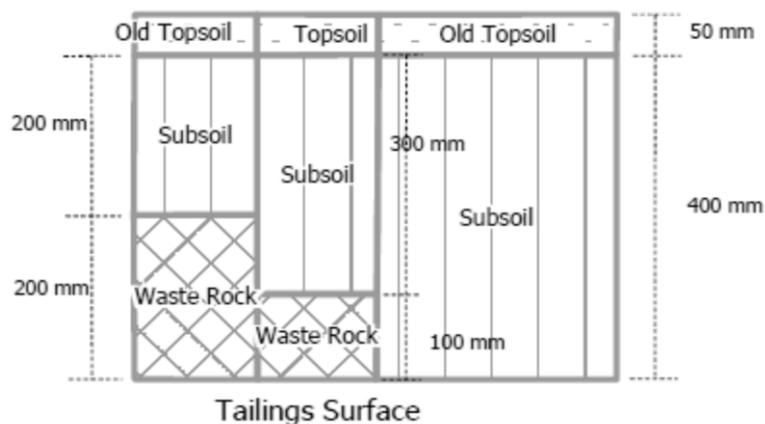
A trial area was located adjacent to the discharge ramp and covering an area of approximately 3 ha. Three zones were prepared with alternative cover designs consisting of the different rock/soil ratios shown in Figure 1.

Figure 1 Trial TSF cover designs over three zones (MBS Environmental, 2009)

The results of the TSF rehabilitation trial indicated that all of the three trial covers met the rehabilitation requirements. The inclusion of the 200 mm waste rock cover as a subgrade layer was considered the most robust defence against erosion compared with a subsoil only cover plus this minimised the quantity of subsoil required, whilst utilising waste rock from other areas of the mine site (ROM, hardstand areas and waste dump).

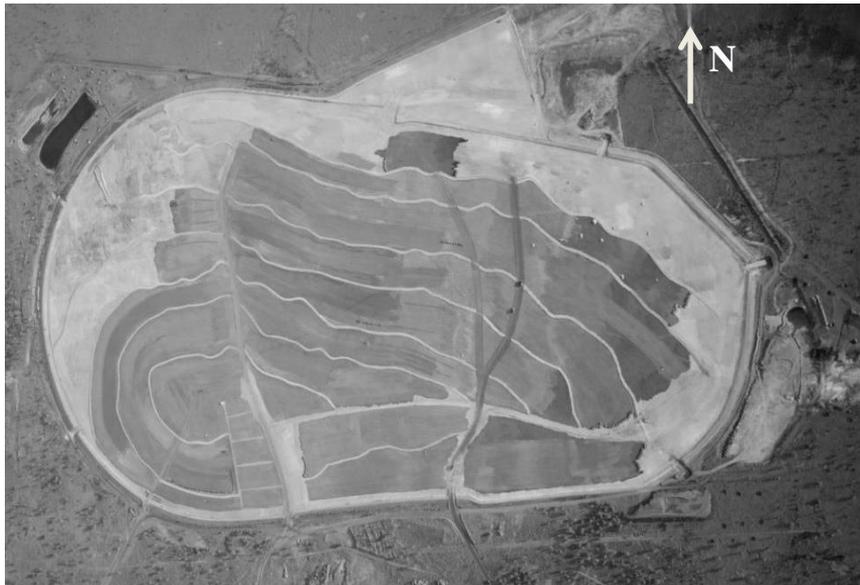
For the long term success of the TSF rehabilitation it is critical that the landform remains stable and is able to cope with the monsoonal rainfall events common to the area. To achieve this, the design criterion was based on a one-in-one hundred year rain event (1:100 ARI). A key aspect of the TSF design was the construction of drainage control breaks and erosion barriers. This was achieved by placing barriers of limestone waste rock along the TSF surface contours to direct water to appropriate drainage channels (Figure 2). The rock barriers were approximately five metres wide and nominally spaced every 100 m, they also served as temporary access tracks during the rehabilitation and monitoring process (Lennard Shelf Pty Ltd, 2009).

Figure 2 Aerial photo of Pillara TSF showing rock barrier contours
