Reclamation and remediation of the Tom Property, Macmillan Pass, Canada

Abstract

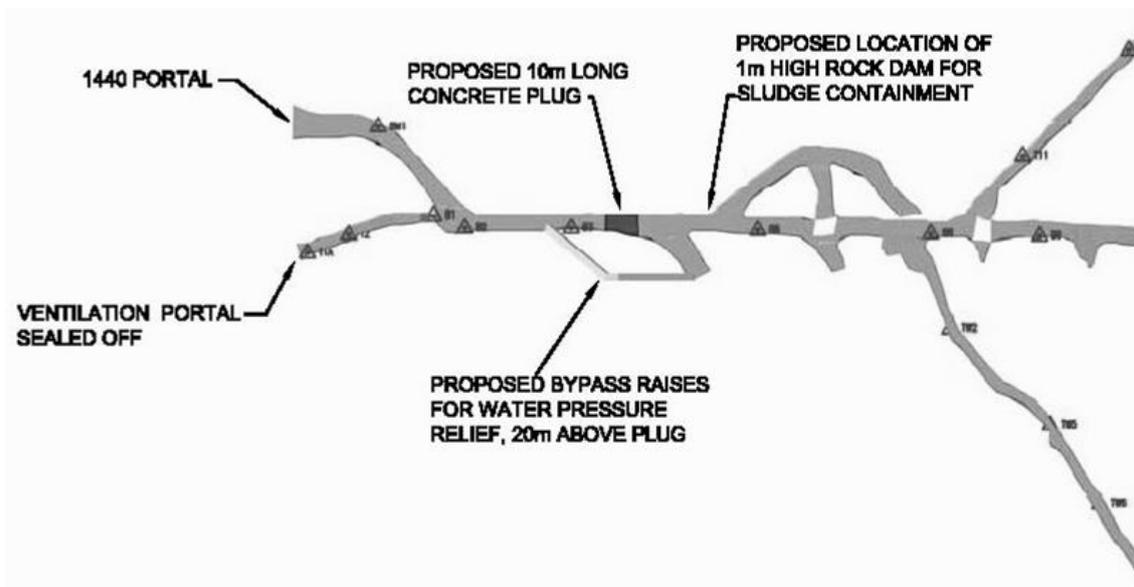
Figure 2 Tom Mine – plan view of underground workings and plug location

- To avoid having to construct multiple plugs to seal each branch of the underground workings, the plug location had to be in the main drift, downstream of the three branches of the underground workings and upstream of the junction between the two portal drifts (Figure 2).

- The favoured location for the plug based on geometric considerations was downstream of a service bay excavated into the south sidewall (Figure 2). At this location, the drift had a section that tapered slightly in a downstream direction, providing a favourable “cork” effect for the plug.

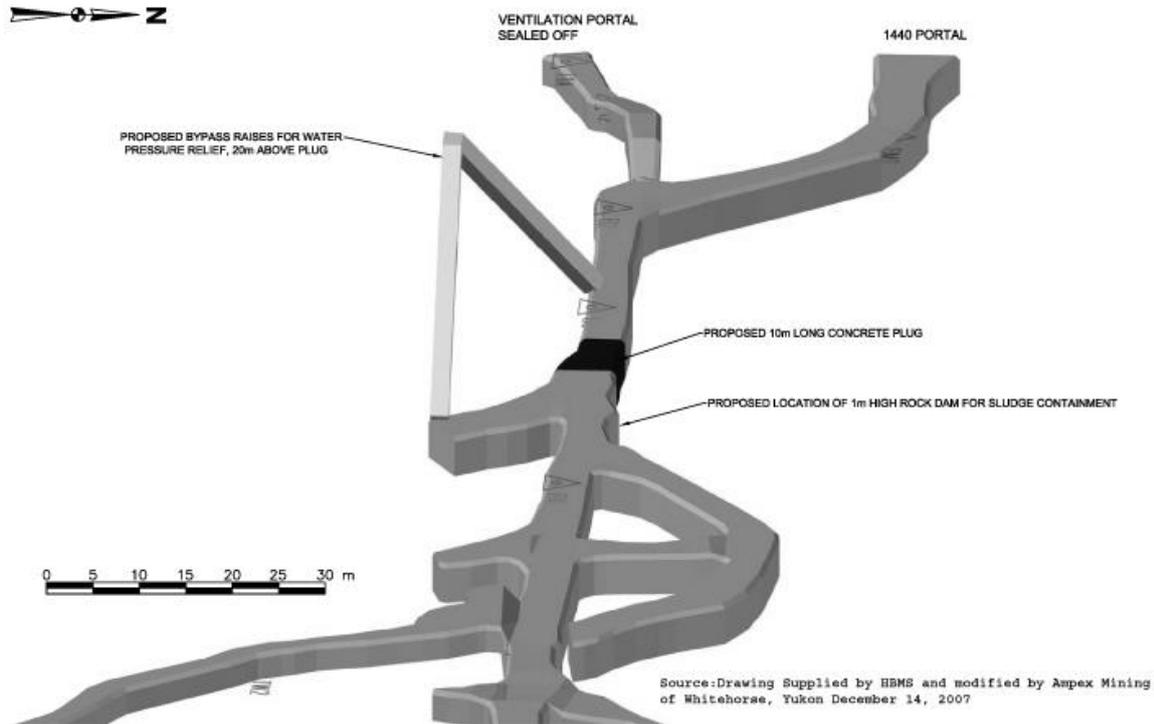
Figure 3 Tom Mine – 3D view of underground workings and plug location

- A bypass raise was provided to limit the head to a maximum of 20 m. The 2 m by 2 m raise was excavated into the south side of the main drift in the form of an inverted “V” (Figure 3). The upstream portion of the bypass raise was located at a vertical angle of 45° from the end of the service bay and was aligned parallel to the main drift. The downstream portion of the bypass raise was oriented at a vertical angle of 45° from a point about 15 m downstream of the plug, and aligned to intersect the upstream raise at a point 20 m above the top of the plug.

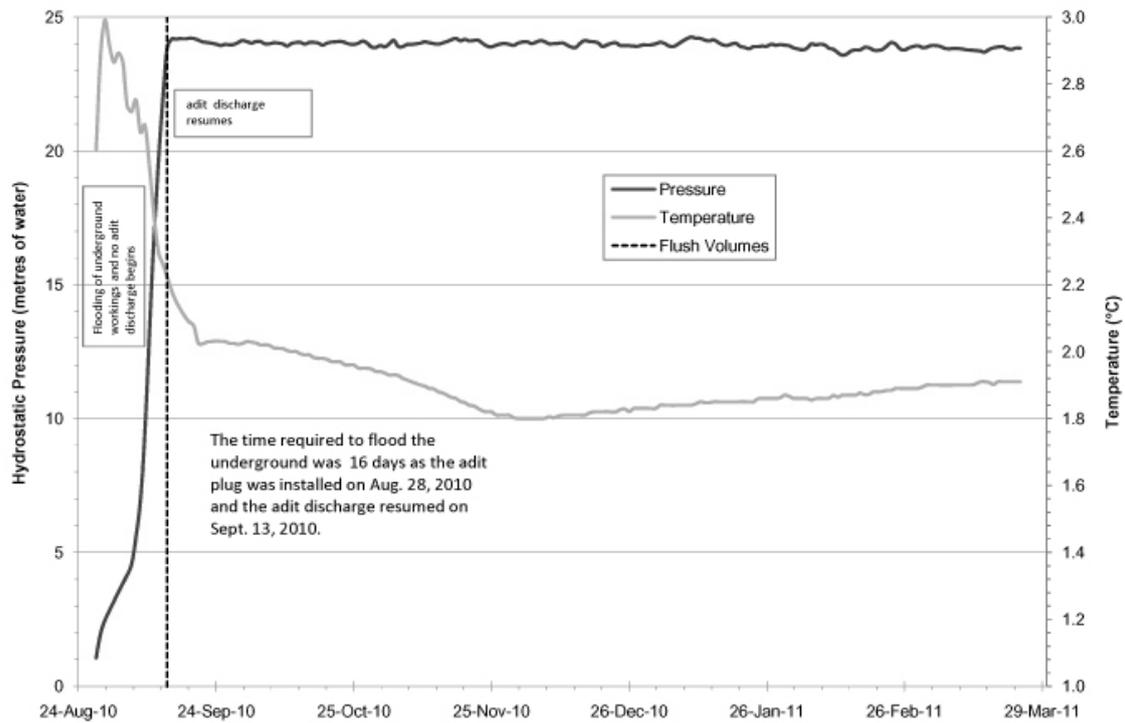
Figure 4 Hydrostatic pressure and water temperature behind the Tom adit plug

The plug pour of about 190 to 200 m³ was completed over a 10 hour period. Pre-mixed cement in 1 tonne bags were mixed on site with aggregate and other additives in a volumetric truck. Concrete cylinder samples were collected for strength testing every 50 m³. Void grouting was carried out 10 days later, using left over bulk concrete mix pumped through the pipes installed into the high points in the crown. A total of 2 m³ of additional concrete was placed under a pressure of 70 psi (483 kPa). Bedrock and contact grouting was carried out around the plug using microfine cement. Approximately 45 kg of grout was injected into the concrete-bedrock interface around the plug and 568 kg of grout was injected into the bedrock to seal the 2 m wide annulus of rock around the plug. The plug was commissioned 29 days after the pour was completed as water rose behind the plug. Upon completion of the grouting and plug commissioning, the bypass pipe through the plug was closed and sealed with grout backfill. Spill over the bypass raise occurred 16 days later when the water level reached 24 m above the adit floor. The hydrostatic pressure (water level) behind the plug is constantly being monitored by a vibrating wire piezometer connected to a data logger (Figure 4). To date, geotechnical performance of the adit plug has been deemed satisfactory.

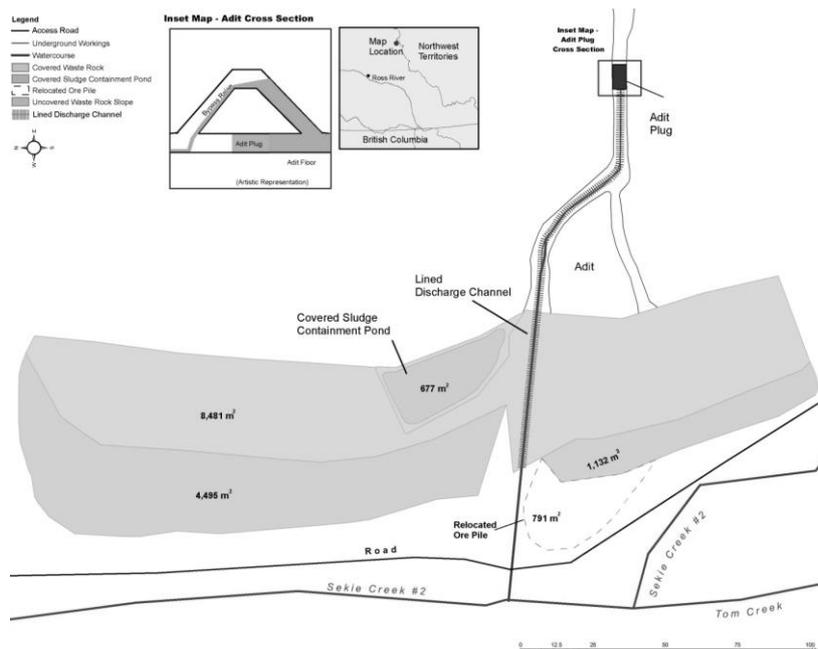
Figure 5 Waste rock cover and lined discharge channel plan view

A temporary lined discharge was installed in 2009 and was completed in early September 2010 when the underground workings were flooding and no discharge was present. The lined discharge channel as shown on Figure 5 begins at the bottom of downstream bypass raise and ends at the base of the waste rock dump. The lined discharge channel consists of a base geotextile layer with the 60 mm HDPE liner over top. The section of the lined discharge channel from the adit entrance to the crest of the top of the waste rock dump has been covered by a minimum thickness of 0.5 m of local talus material.
