# Performance of dynamic support system in highly burst-prone ground conditions at Vale' s Copper Cliff Mine - a case study

## Abstract

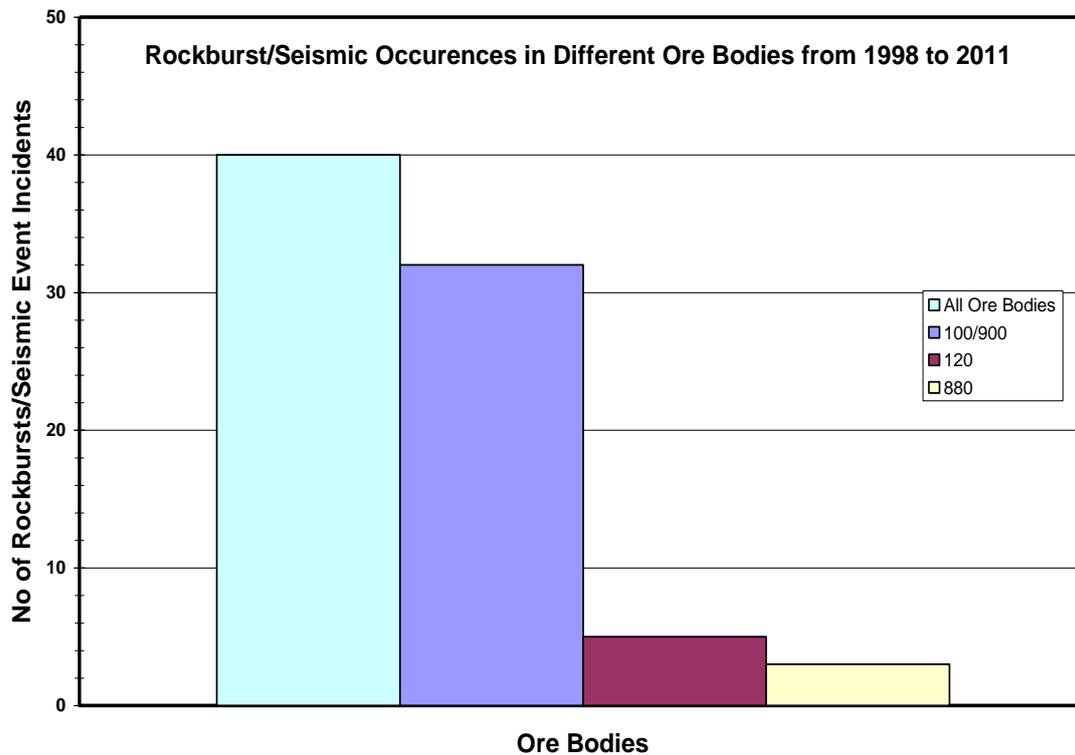
Of all the rockbursts, the 3.8 Mn event that occurred on 11 September 2008 in the 100/900 orebodies following a crown blast is considered to be significant as it caused considerable damage to underground excavations on multiple levels. Although the location of the major event was on 3050 L in the 100 orebody, the damage was extended across nearly a 300 m vertical block starting from 2700 L to 3710 L. Approximately, 3,000 t of material was displaced in total at five locations on different levels. The damage was mostly associated with either the Trap Dykes and/or 900 X-Fault. The support system at the damage locations mainly consisted of resin grouted rebars, and mechanically anchored bolts in the back, and anchored mechanical bolts on the walls to 1.5 m above the floor installed through #6 gauge welded wire mesh. At some locations, shotcrete and cable bolts were used as a secondary support system. Basically, the

installed ground support system was too stiff in nature and it did not provide much yielding capability. Accordingly, the support system that was employed at the damage locations was incapable of taking the impact of dynamic loading caused by the 3.8 Mn event.

Figure 4 Distribution of rockbursts/seismic events across different orebodies at Copper Cliff Mine

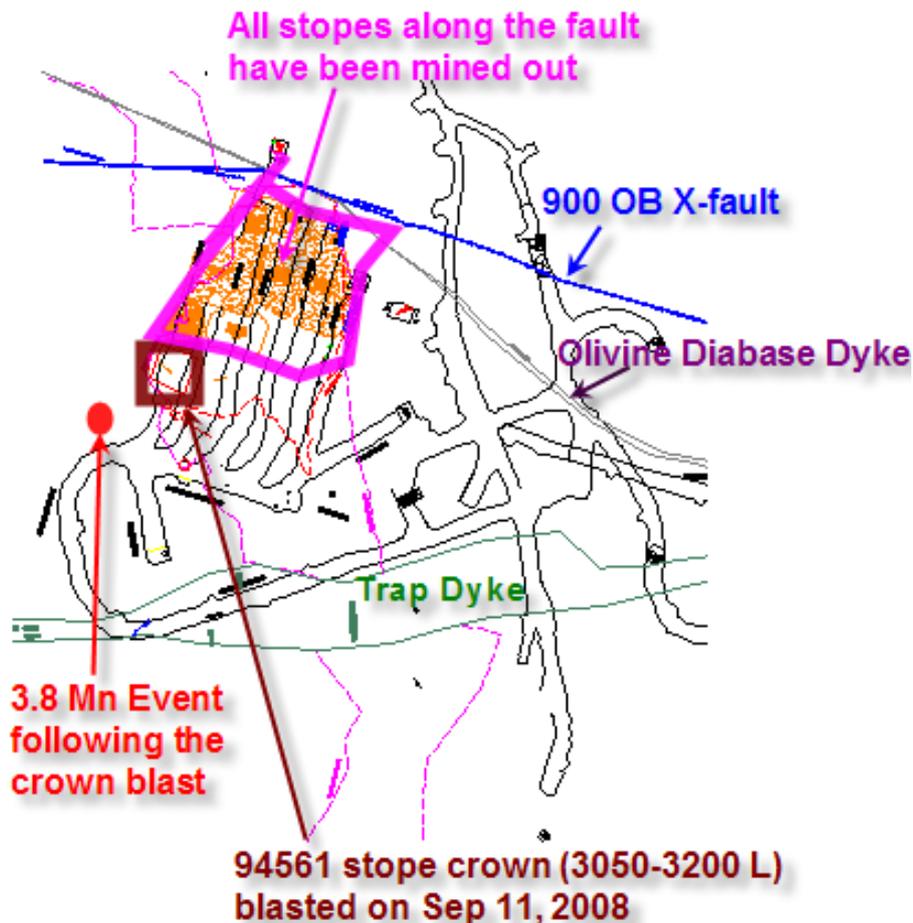
- Since all the stopes along the 900 OB X-fault were mined out on the mining front between 3500 and 3050 L, the natural confinement that the orebody provided to the fault plane was taken out. As a result of this, a major displacement might have occurred along the fault-plane and caused the 3.8 Mn event after taking the crown blast in the 94561 stope between 3050 L to 3200 L on 11 September 2008. By all means, the crown blast could have triggered the slip and caused the large magnitude event.
- As it can be seen in Figure 5, there is a Trap Dyke between 100 and 900 OB, which is very strong material and highly brittle in nature. As mining progressed in the 100 and 900 orebodies, the Trap Dyke is loaded up, which can then lead to significant seismic events/rockbursts.

The 3.8 Mn event on 11 September 2008 was considered to be a result of mining of the 94561 stope between 3050 and 3200 L. The location of the stope in relation to the major geological structures i.e. Trap Dyke and 900 X-fault is shown in Figure 5.

Figure 5 Layout showing the location of Trap Dyke and 900 X-fault in relation to mining on 3200 L

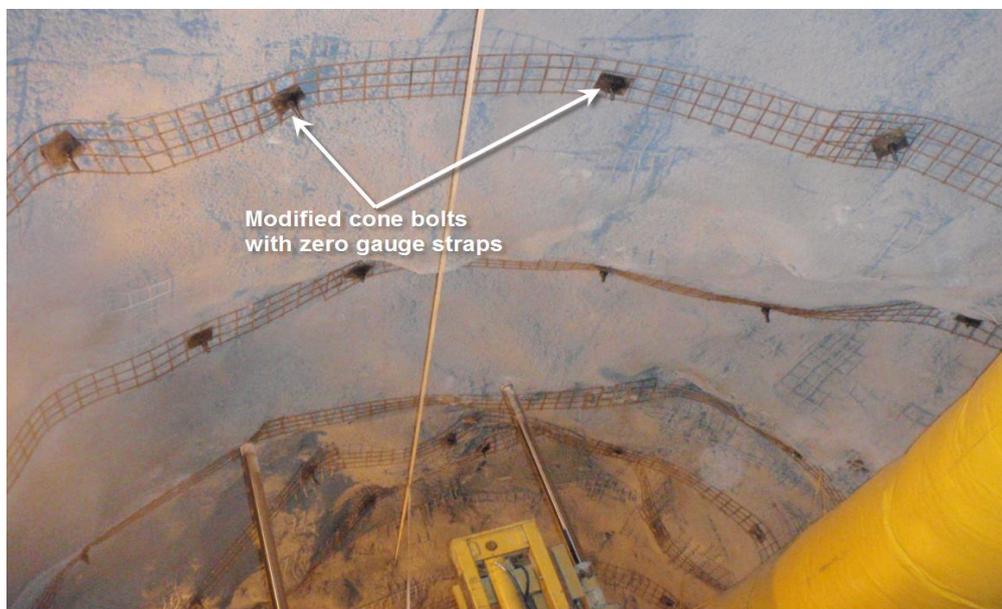
**Figure 7** Final product of burst-resistant (dynamic) support system used in one of the drill sills at Copper Cliff Mine

For walls: 1.95 m long FS-46 split sets on a 1.2 × 0.75 m pattern with #4 gauge welded-wire mesh followed by a minimum 76 mm thick pass of plain shotcrete, and then 2.3 m long modified cone bolts on a 1.2 × 1.8 m pattern with #0 gauge mesh straps. The wall bolting was usually extended to the floor level. For the back: 2.4 m resin rebars on a 1.2 × 0.75 m pattern with #4 gauge welded-wire mesh followed by a minimum 76 mm thick pass of plain shotcrete, and then 2.3 m long modified cone bolts on a 1.2 × 1.8 m pattern with #0 gauge mesh straps. In addition, 6.3 m long twin cable bolts were used in a ramp, where the depth of failure was almost 5.1 m from the seismic events. The purpose of the cable bolts was mainly to reinforce the rock mass as well as hold the broken rock mass by anchoring them in the solid ground.

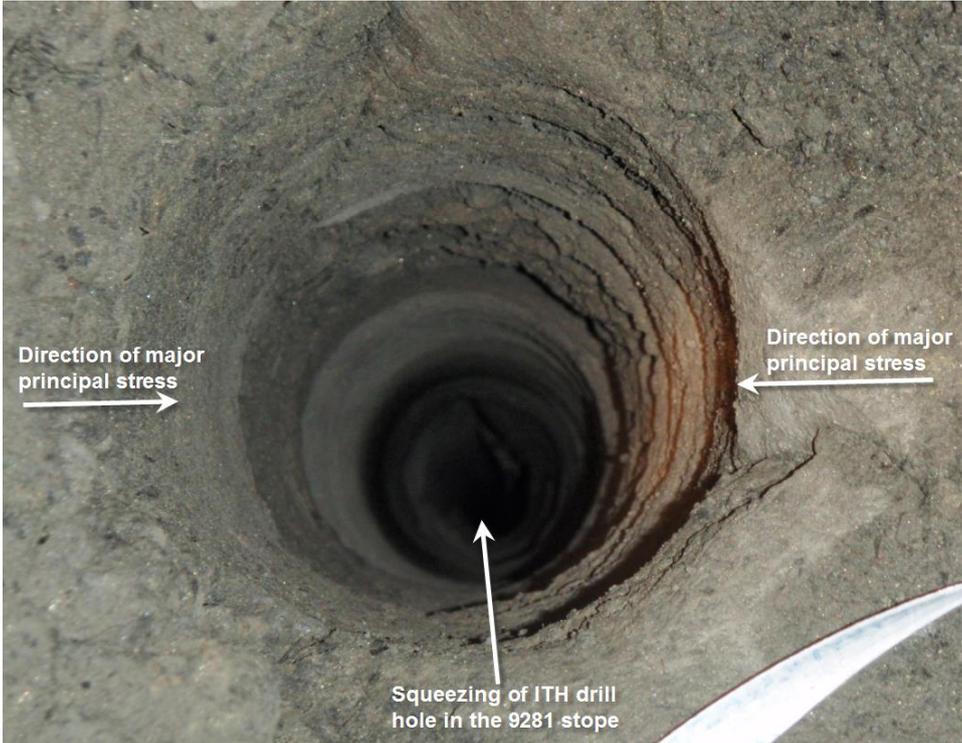
While mining the 9281 stope, the installed burst-resistant support system was repeatedly subjected to the impact of seismic events and as a result it showed some signs of negligible damage. Although it is difficult to assess the impact of previous seismic events in a quantitative manner in the field, the ground control engineer determines whether there are signs of support yielding based on their observations, and/or filed instrumentation monitoring if any. If so, it may be prudent to install extra support in an effort to compensate for any potential loss in safety margin (Kaiser et al., 1996). For instance, the induced stress level in the 9281 stope was observed to be relatively high when mining started in the stope. The reason could be due to fact that this stope was sandwiched between two limbs of Trap Dyke. The squeezing of an ‘in the hole’ (ITH) drill holes while mining was in progress in the 9281 stope can be seen in Figure 9.

**Figure 9** An ITH hole subjected to squeezing and shifting due to high induced stress level in the 9281 stope

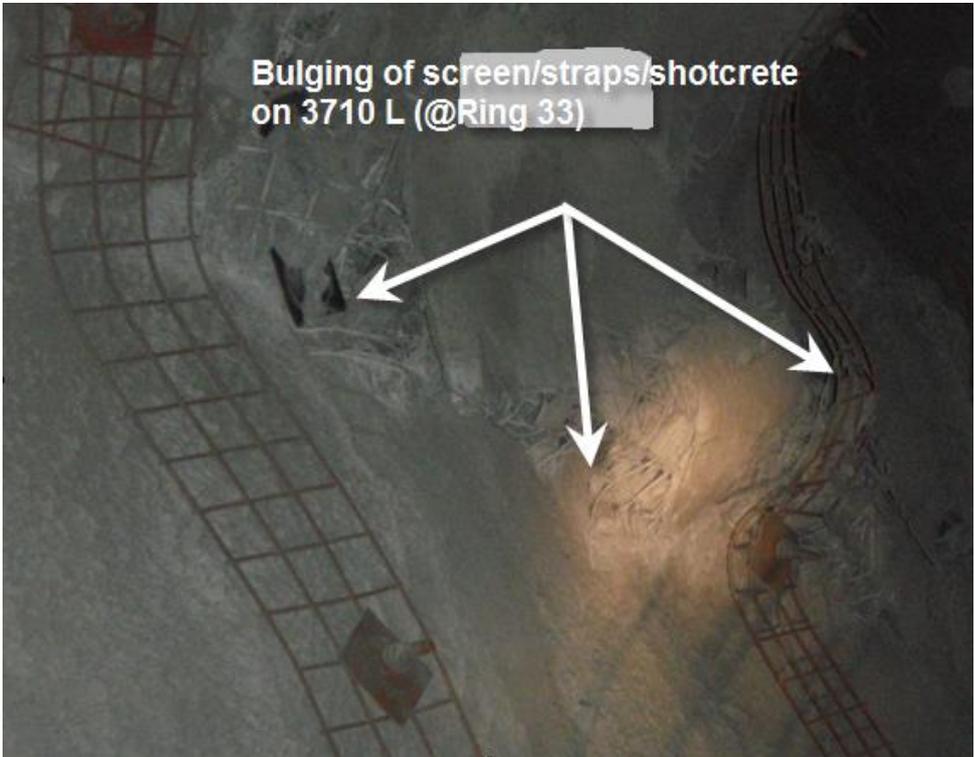
Although the support system was subjected to repeated seismic loading, the burst-resistant support system showed its first sign of damage only after the 2.3 Mn seismic event (see Table 3 for the order of events). However, the level of damage was very insignificant and it can be seen in Figure 10 and Figure 11 respectively.

**Figure 10** Minor cracking and bulging of the support system following a 2.3 Mn event in 9280 top sill

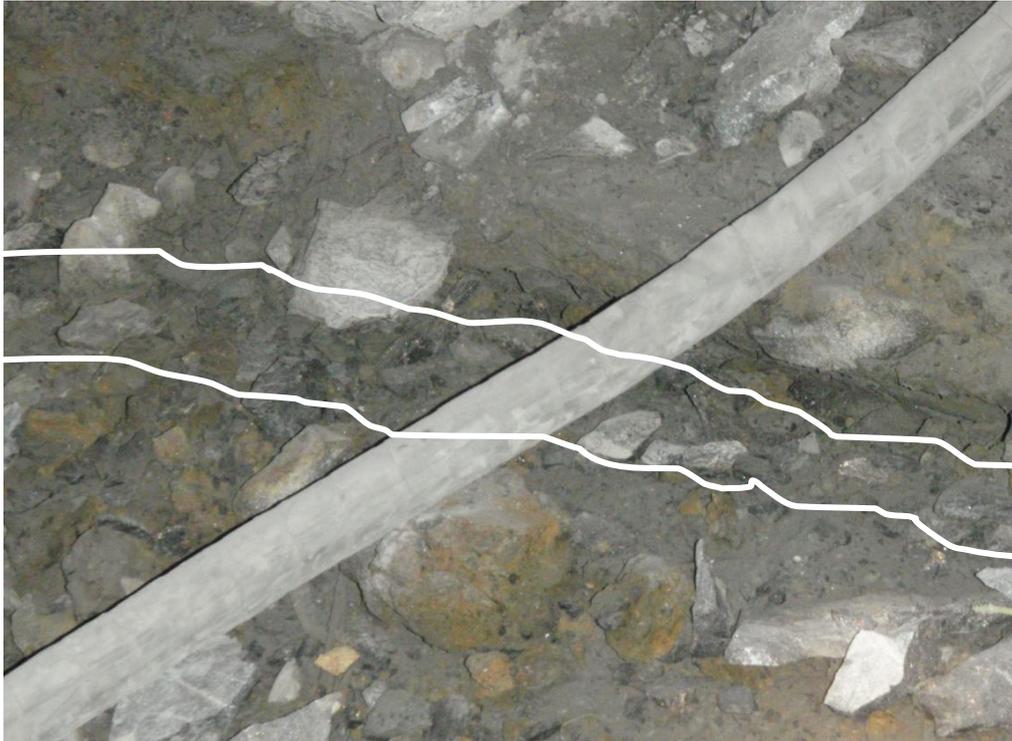
Figure 11 Floor heaving (5 cm) following a 2.3 Mn event in 9280 top sill

The “Canadian Rockburst Support Handbook” provides a reference (Figure 12) to the anticipated floor heave in a highly stressed ground caused by a remote seismic event. Since the conditions in the 9280 sill can be considered to be highly stressed due to presence of Trap Dyke on both sides of the stope, it would be worthwhile to compare the actual floor heave caused by the 2.3 Mn event. The source location of the 2.3 Mn event was found to be approximately 50 m away from the damage location. Based on the chart shown in Figure 12, the anticipated floor heaving could be more than 0.1 m for the 2.3 Mn event. However, in reality there was only about 0.05 m of floor heave, even though the floor was not supported. This could be attributed due to the fact that the dynamic loading caused by 2.3 Mn event was better managed by the burst-resistant support system and thereby reduction in the floor heaving due to impact of the 2.3 Mn event.
