Redevelopment support at Northparkes Mines

This paper looks at the strategies employed to safely re-open previously converged drawpoints and associated extraction drives that were subject to high abutment loading that was possibly associated with premature cave breakthrough.

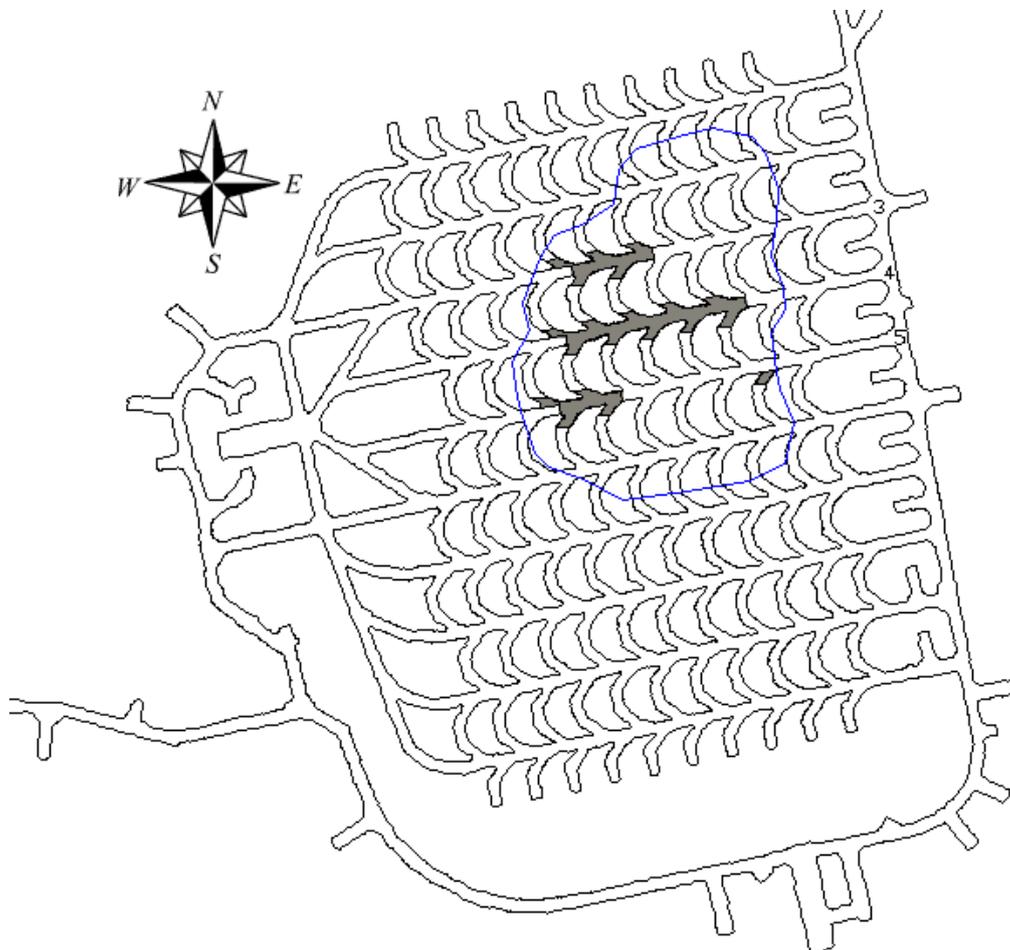
E48 was the first post-undercut block cave at Northparkes where significant stress loading conditions were experienced on the extraction level during undercutting in late 2010. This resulted in damage to some of the major pillars (Figure 1). Significant convergence (Figure 2) was experienced in the eastern region of the extraction level as active caving commenced in the west and abutment stresses increased along the undercut front which was being developed from west to east. The rapid cave breakthrough to surface occurred in early 2011, which is believed to be as a result of an intensive hydrofracturing programme undertaken in the E48 orebody. This early cave breakthrough, combined with the already weakened ground due to increased abutment stresses along the undercut front, resulted in elevated convergence and ground support damage as well as instability of drawpoints and their adjacent extraction drives 3, 4 and 5.

Figure 1 General layout of the E48 block cave showing concrete plugged drawpoints and outline of stress damage zone

In order to provide immediate support and prevent widespread instability, the affected drawpoints and extraction drives were plugged with low strength concrete. Resin injection and cable bolt installation in the surrounding areas was undertaken during 2011 prior to redevelopment, to control convergence before it caused significant damage to pillars in other drives. Resin injection provided consolidation of the ground to enable anchor holes to be drilled and remain open. Twenty drawpoints and their adjacent extraction drives were ultimately plugged.

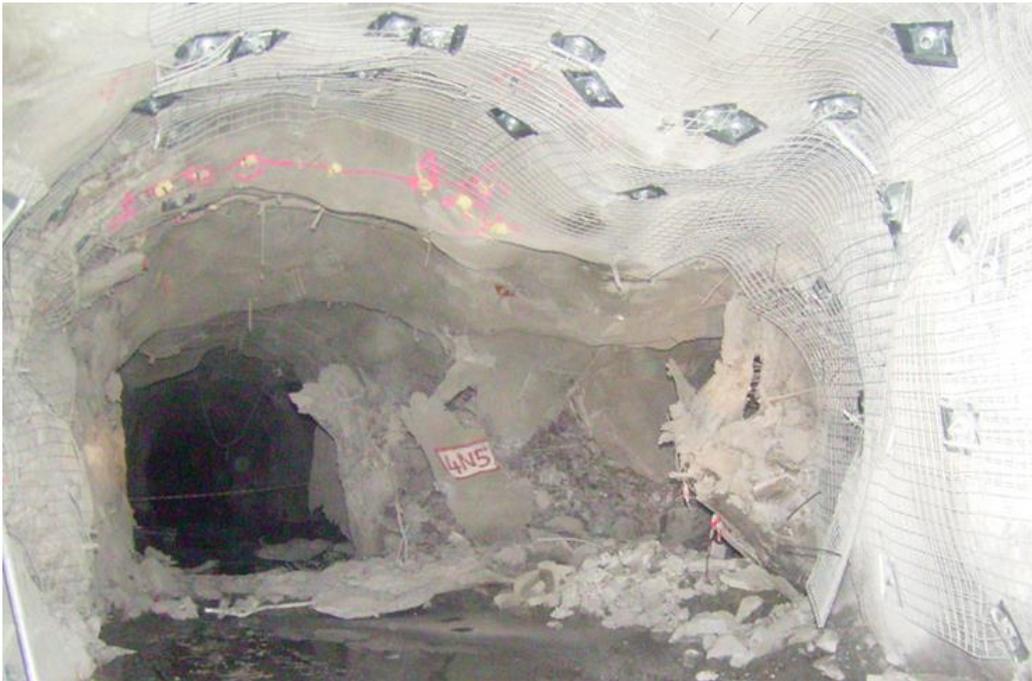
Figure 2 4N5 bullnose and camelback damage, looking down ED4 from east to west, prior to concrete plugging

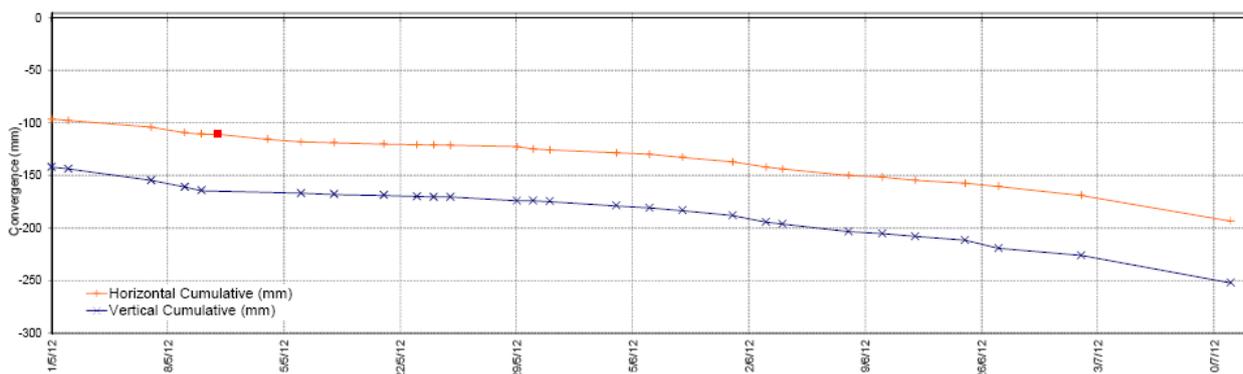
CED3_14

The drive in front of 3N5 was excavated with minimal convergence. However, poor ground was encountered when drilling around the fault zone in the backs and in the south sidewall across from the drawpoint. Once the turn out into the 3N5 drawpoint was commenced and the intersection with the extraction drive opened up, the convergence in both the backs and the sidewalls accelerated. Drilling was increasingly difficult as the zone of broken ground was found to extend further into the pillars than had been predicted. The single boom jumbo used for drilling struggled to drill in the conditions encountered. It also struggled to provide timely installation of ground support, making progress very slow. Over time the convergence in the backs and sidewalls continued (Figure 3), despite the re-opening of the drawpoint and continuous draw, use of resin injection and further ground support installation. A combination of failed reinforcement elements and increasing convergence made the drive unserviceable, which in turn resulted in the closure of the area and subsequent re-plugging with concrete 8 months after opening.

Figure 3 Convergence in 3N5 from May 2012 to July 2012

The depth of damage predicted was 1.5–2.5 m from the surface. However, subsequent monitoring data in the 3N5 area (MPBX extensometers) showed movement at depths of up to 6.7 m in the backs, and drilling condition records showed poor ground encountered in some areas ranging from approximately 0–2, 3–5.5 and 7–8 m in depth. It was concluded that based on these observations, the 6 m long cable bolts installed,

with 2 m debonded sections at the collar were not achieving adequate anchorage into competent ground. 9 m long cable bolts were then installed with 5 m debonded sections to allow for the greater depth of damage. However, by the time they were installed, the rock mass had further deteriorated with the ongoing convergence and their installation quality in broken ground was questionable. They failed to arrest the convergence in the backs and sidewalls. The learning was that depth of damage is impossible to be accurately estimated in the redevelopment area using probe hole information in surrounding areas. The depth of damage could vary significantly over a small distance, therefore future redevelopment should include preparatory drilling above the redevelopment zone for more accurate estimation. It was found that the depth of damage was not only shallow, but there were a number of intervals of damage separated by competent ground. Therefore future cable bolt designs would need to compensate for this with varying debonded lengths. An additional learning was that resin injection would be required prior to taking each cut and in-cycle with the first and second pass support regime, to target several horizons, not only the shallow rock mass.

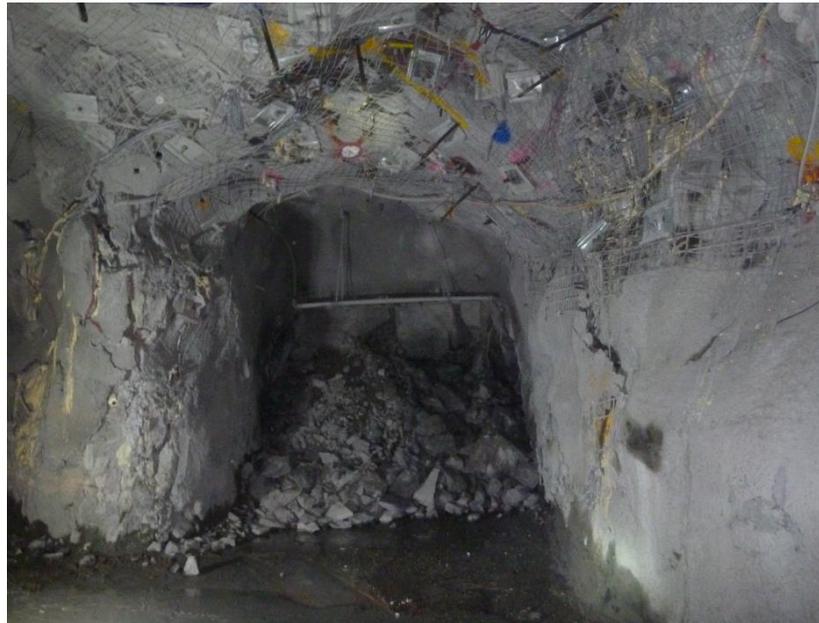
The extraction sequence coupled with the slow advance rate meant that the drive and the 3N5 intersection were opened three weeks prior to draw commencing from the 3N5 drawpoint. The convergence in the backs accelerated after opening the intersection to full span and it was observed that the loading above the major apex was pushing the backs down, creating crunching of the shoulders and bulging of the sidewall pillars (Figure 4). The first generation of cable bolts in the drive began to show loading on their plates and over a three week timespan, the shotcrete in the backs cracked up as they moved down around the cable plates. Without initiating cave draw there was no way of reducing loading. By the time the reinforcement of the area was complete and draw commenced, the rock mass had deteriorated so badly that any load removal through draw had little effect to slow down the convergence. It was therefore concluded that future redevelopment of drawpoints should use a reverse excavation sequence; redeveloping the turn-out to the drawpoint first, enabling draw to commence, before removing the plugged drive and opening up the intersection. This way the largest span would only be created after a consistent level of draw has been established to remove compacted material above the major apex, creating porosity in the caved material and therefore reducing loading.

Figure 4 Cracking of the 3N5 drawpoint shotcrete indicating loading

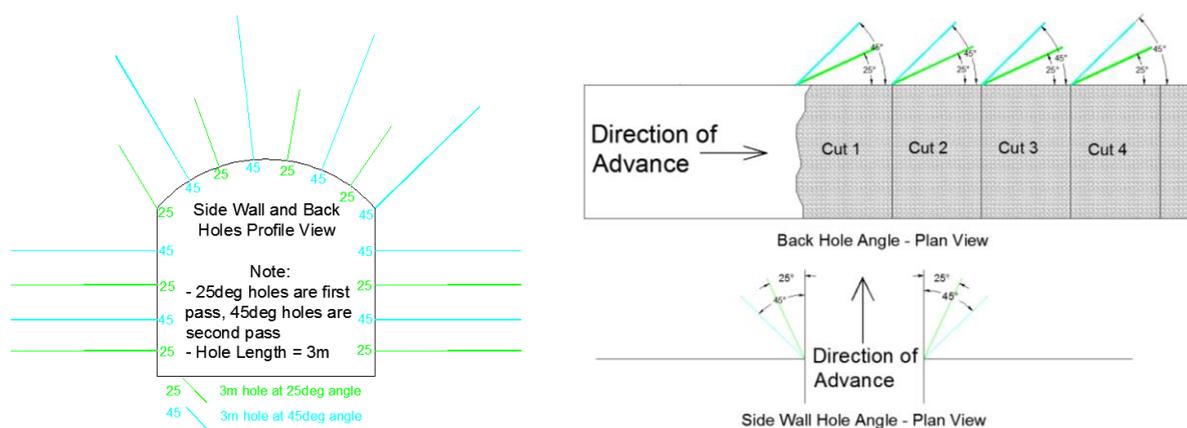
Figure 5 Advanced resin injection

A combination of various ground support elements was used to provide improved coverage and performance. Resin injection is done prior to blasting which is able to penetrate into the defects/voids, filling and re-consolidating broken ground. During the initial resin injection activities the injection drill holes are angled 25 and 45° relative to the concreted face (Figure 5). The face is then ready for blasting. After blasting, primary ground support is applied including 50 mm fibrecrete, 5.6 mm mesh from 0.5 m from the floor with minimum overlap of 200 mm, 2.4 m long rockbolts and further shallow resin injection (Figure 6). This primary ground support needs to be installed as soon as possible after blasting due to the assumption of broken rock mass conditions that will result in a reduced stand up time. Finally, 6 m long 21.8 mm diameter super strand cable bolts (590 kN capacity, with a 3 m long debonded section) are installed in the walls and 9 m long 21.8 mm diameter (5 m long debonded section) super strand cable bolts are installed in the shoulder and back of the opening (Figure 7).

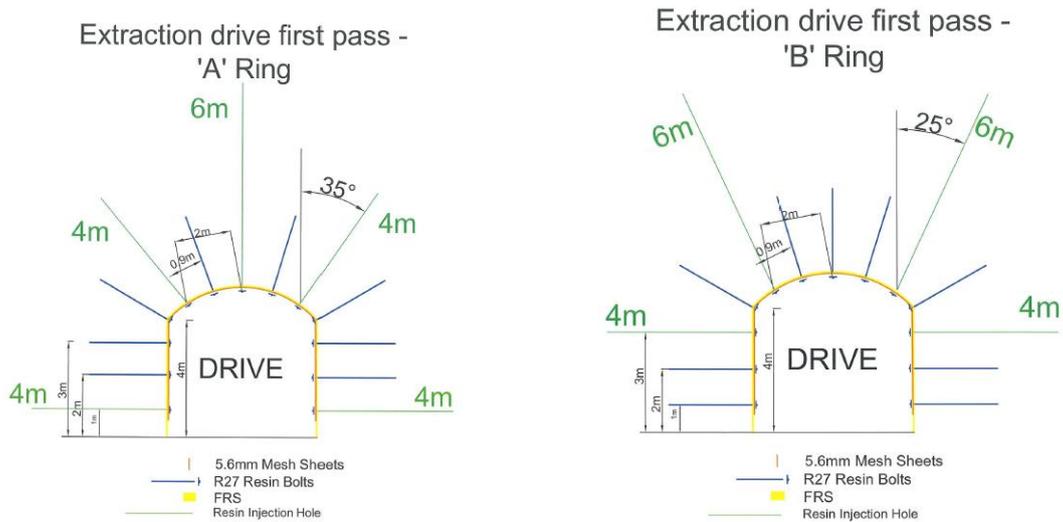
Figure 6 Extraction drive primary ground support and resin injection plan

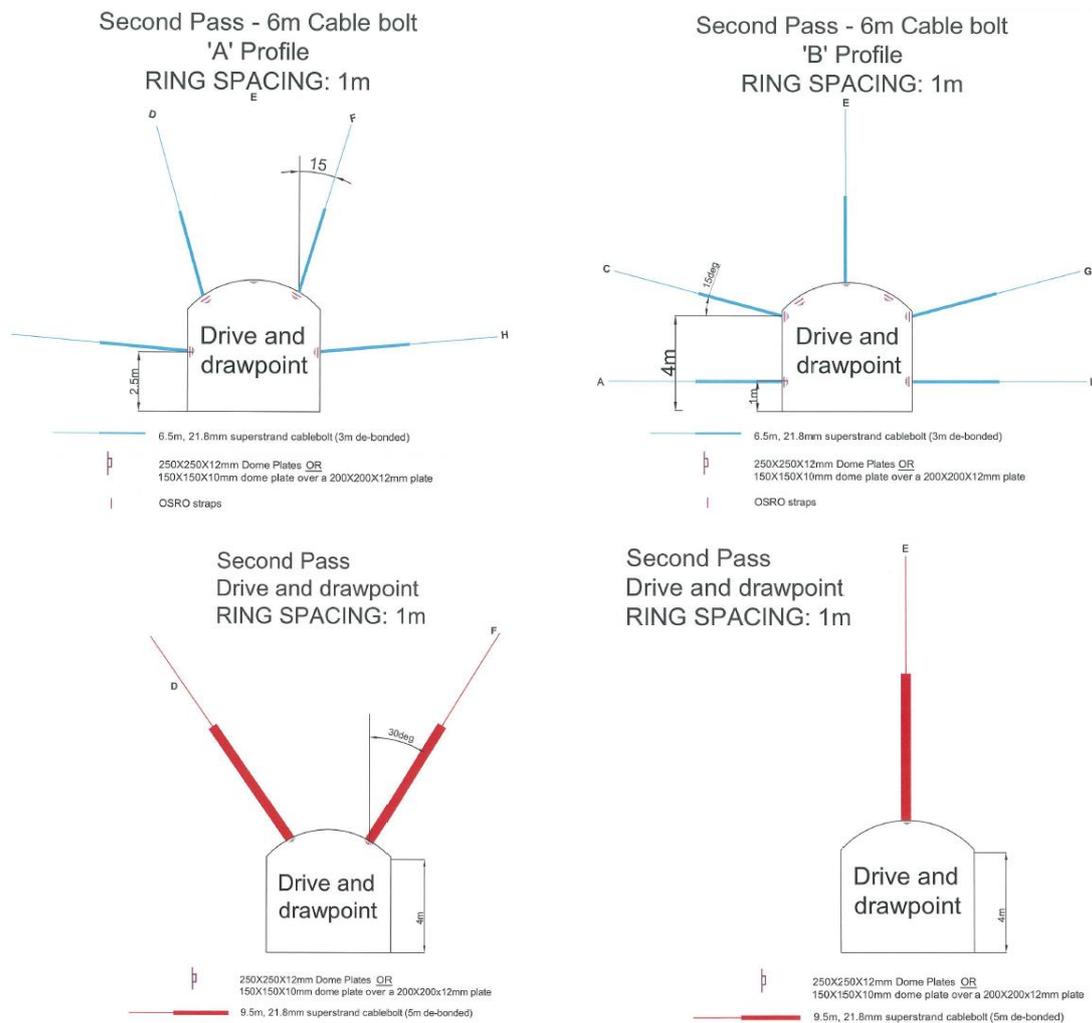
Figure 7 6 and 9 m cable bolt plans

From the drilling condition records, it was confirmed that the ground is fairly broken behind the brow of the draw point. The 6 m long cable bolts were installed to within 1.5 m from the drawpoint steel set, while all 2.4 m long rockbolts were installed to the drawpoint steel set.

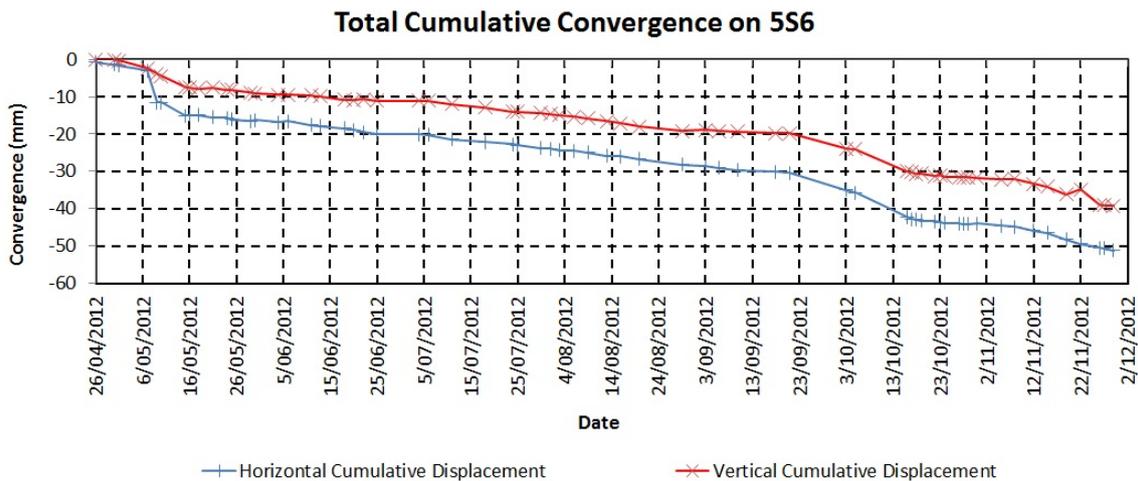
The same philosophy as described above was applied to the reopening of 5N8, with the same ground support system and bogging strategy applied. Based on the ground conditions observed prior to filling, these areas with concrete, as well as the experiences gained during the stage 1 trial and stage 2 execution, it is likely that a number of draw points will not be recovered in the long term, due to the inability to effectively re-support these areas. In such areas where the rock mass and pillars have experienced extreme deterioration, leaving draw points filled with concrete provide additional support to the weakened rock mass and are likely to provide sufficient assistance to allow the main extraction drive to be re-established. From start-up of re-development until production commenced in 5S6 (Figure 8) and 5N8 (Figure 9), convergence was maintained between 0.01 and 0.3 mm/day, except during blasting when there was an increase in convergence immediately after blasting. This was proven by visual observations that indicated no significant increasing level of damage to ground and ground support.

Figure 8 Cumulative convergence in 5S6

Once the 5S6 drawpoint was opened, the bogging strategy became priority. The tonnage called for was slowly increased (5 buckets/day, 10 buckets/day, 15 buckets/day, 20/24 buckets/day) to give the caved material time to 'fluff up'. From previous experience in E48, this has proven to be the best sequence for the initial draw point opening.

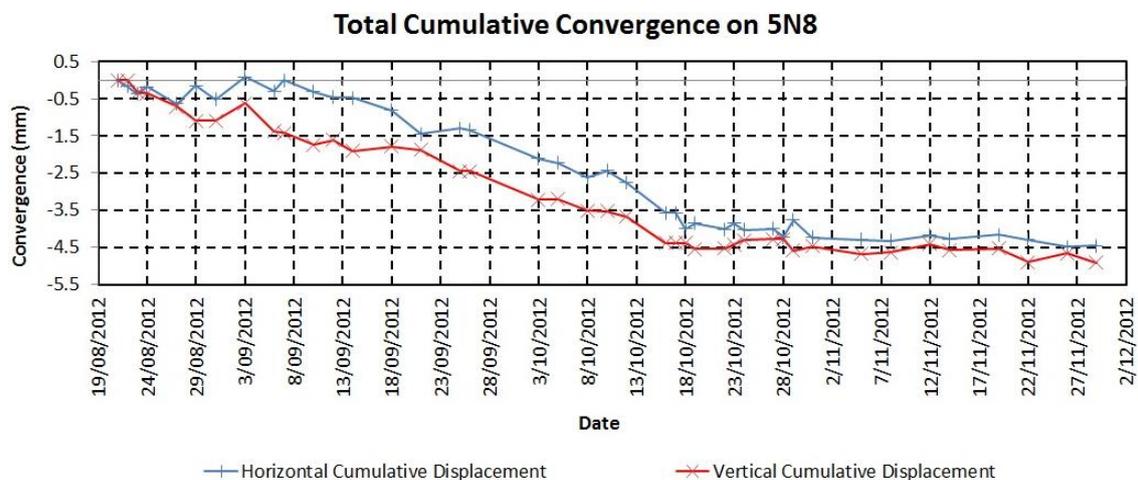
Figure 9 Cumulative convergence in 5N8
