Water management for slope stabilisation – an example from Peru

C. Pérez Schlumberger Water Services, Peru

V. Pérez Minera Yanacocha S.R.L, Peru

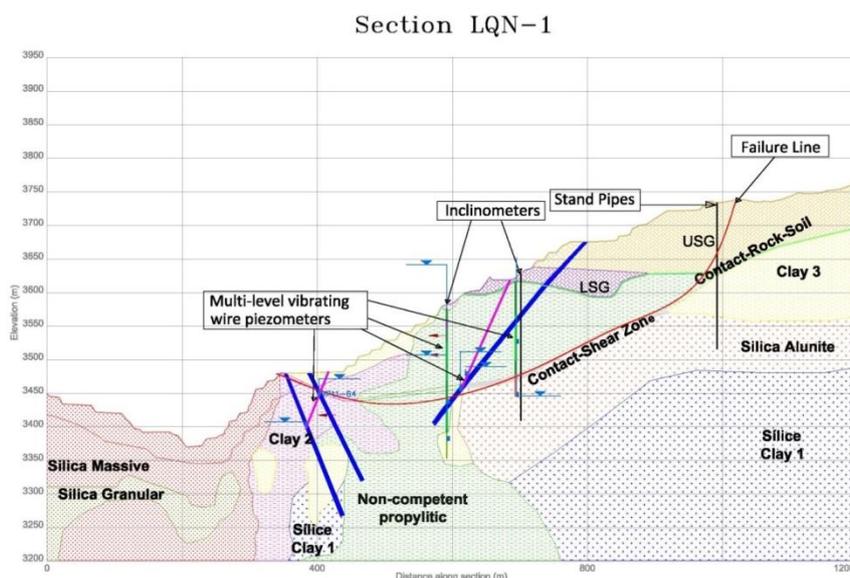
Figure 3 Cross section through the El Tapado north wall showing geology and instrumentation

The initial monitoring network comprised multi-level vibrating-wire piezometers and inclinometers. In addition, the slope was continuously monitored using a total station with prisms and by radar. The early monitoring results identified that depressurisation of the propylitic and clay materials in the slope would not be feasible without first depressurising the underlying permeable silica alunite (Figure 3).

Initial depressurisation efforts were therefore focused on reducing pore pressures in the silica alunite with the installation of four high yielding remediation wells (LQPW45 through 48). Each of the wells derived water only from the silica alunite unit and the total pumping rate was rapidly increased to above 150 l/s (in addition to the 255 l/s pumped from the general dewatering wells from the silica massive in the pit floor).

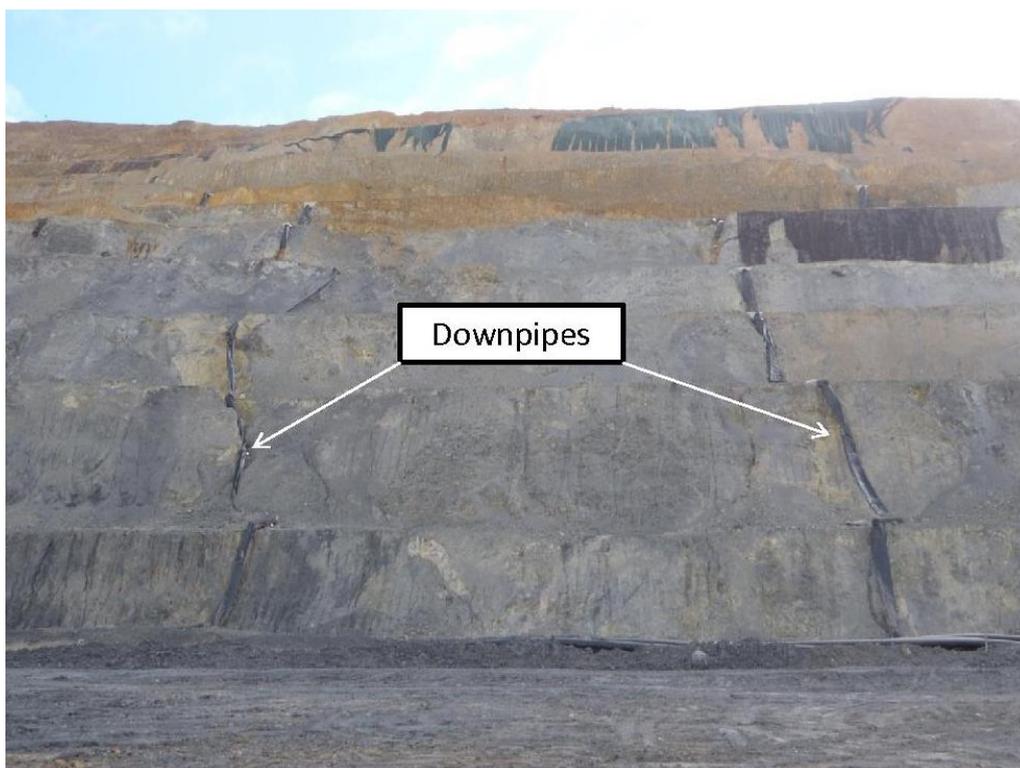
Figure 4 Downpipes installed to shed water rapidly from exposed weak materials in the slope. The downpipes connected into HDPE-lined trenches installed on each bench (visible in Figure 5)

- To minimise the potential for the surface water to enter tension cracks that had developed in the upper part of the slope.
- To shed water as rapidly as possible from the weak materials exposed in the slope and therefore reduce recharge to the weak (and low permeability) materials (Figures 4 and 5).
- To minimise the extent to which infiltration to the non-competent propylitic materials could create high transient pore pressure in the near surface materials.
- To minimise the extent to which erosion and back-cutting into the slope occurred due to surface water erosion.

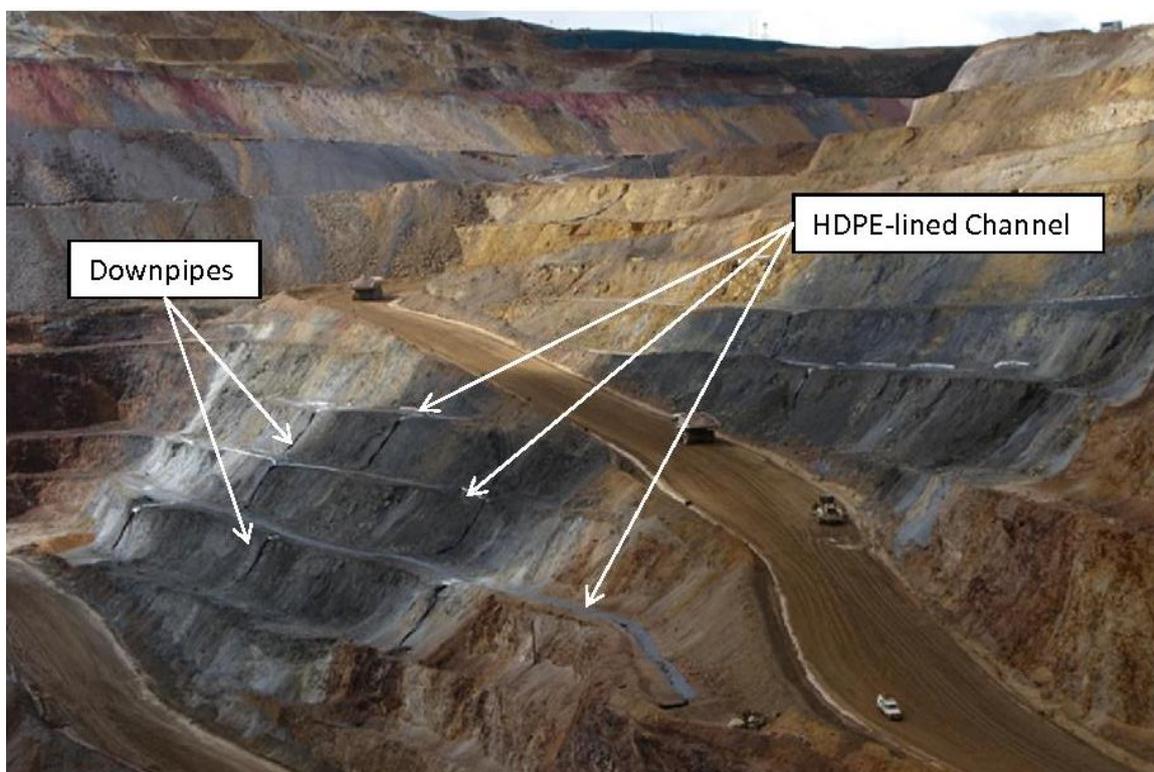
Figure 5 HDPE-lined trenches installed on each bench where weak materials are exposed in the slope (see also the downpipes between benches)

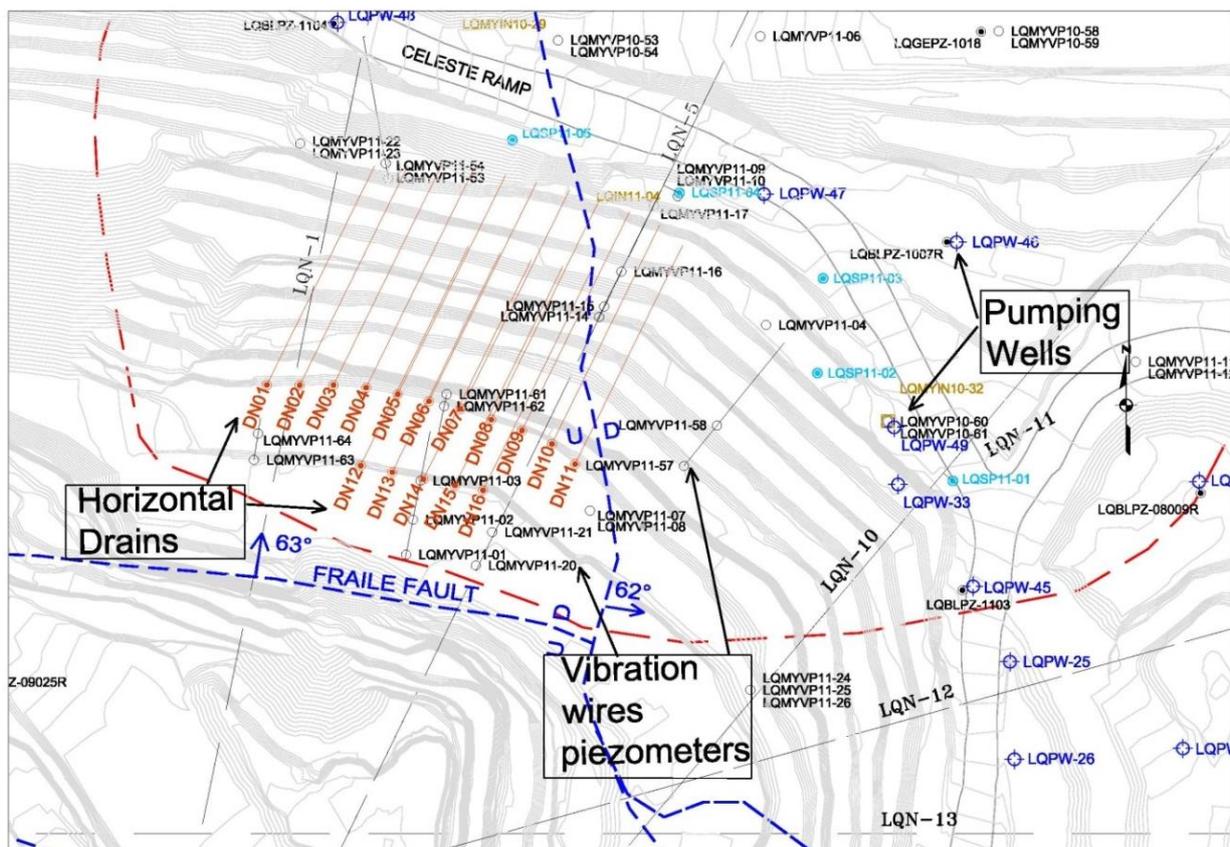
Figure 6 General map of the north wall showing the location of the horizontal drains

- The results of the first 15 drains and their effect on the groundwater levels confirmed the necessity to drill additional drains, as follows:
 - A total of 12 drains from the 3,480 bench and collared between the previously drilled drains.
 - These were the even-numbered drains (2 through 30) on Figure 6.
 - The total meterage in Phase 2 was 1,510 m.
 - Drilling of the Phase 2 drains is illustrated on Figure 7.

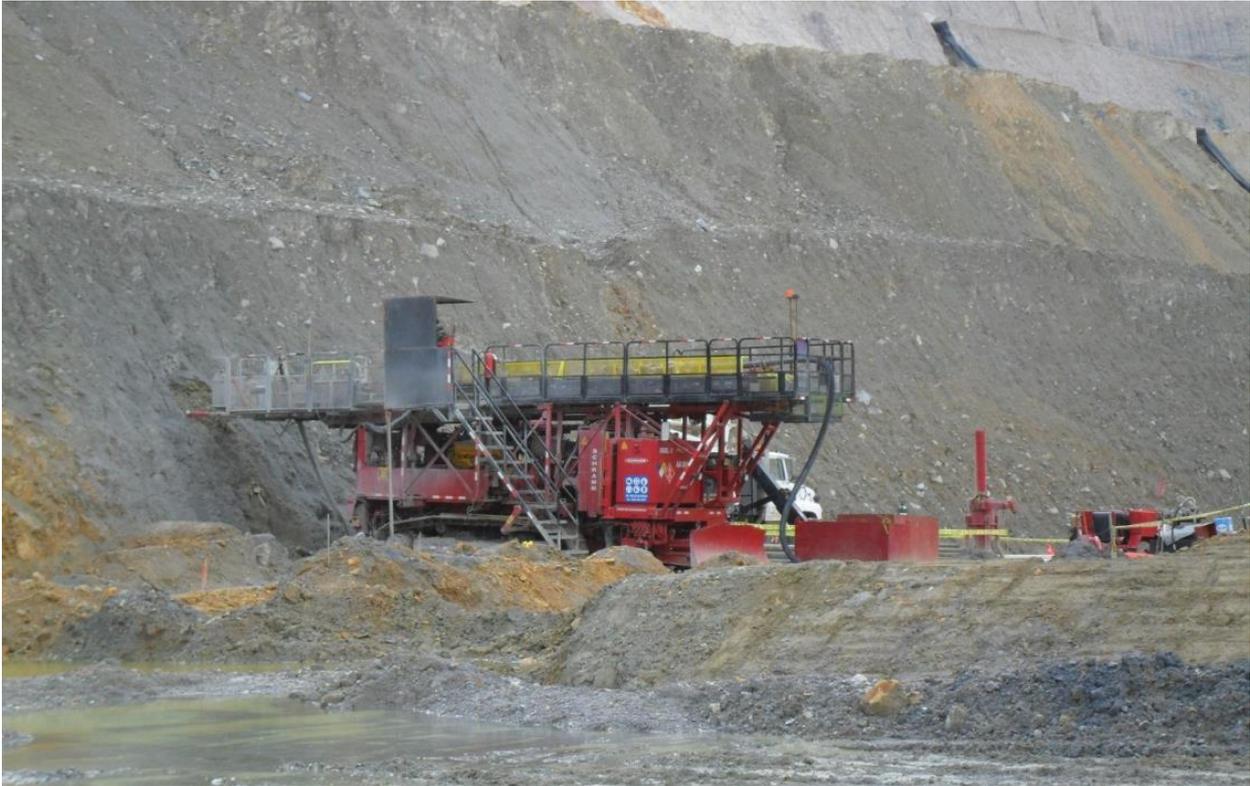
Figure 7 Drilling of the Phase 2 horizontal drains

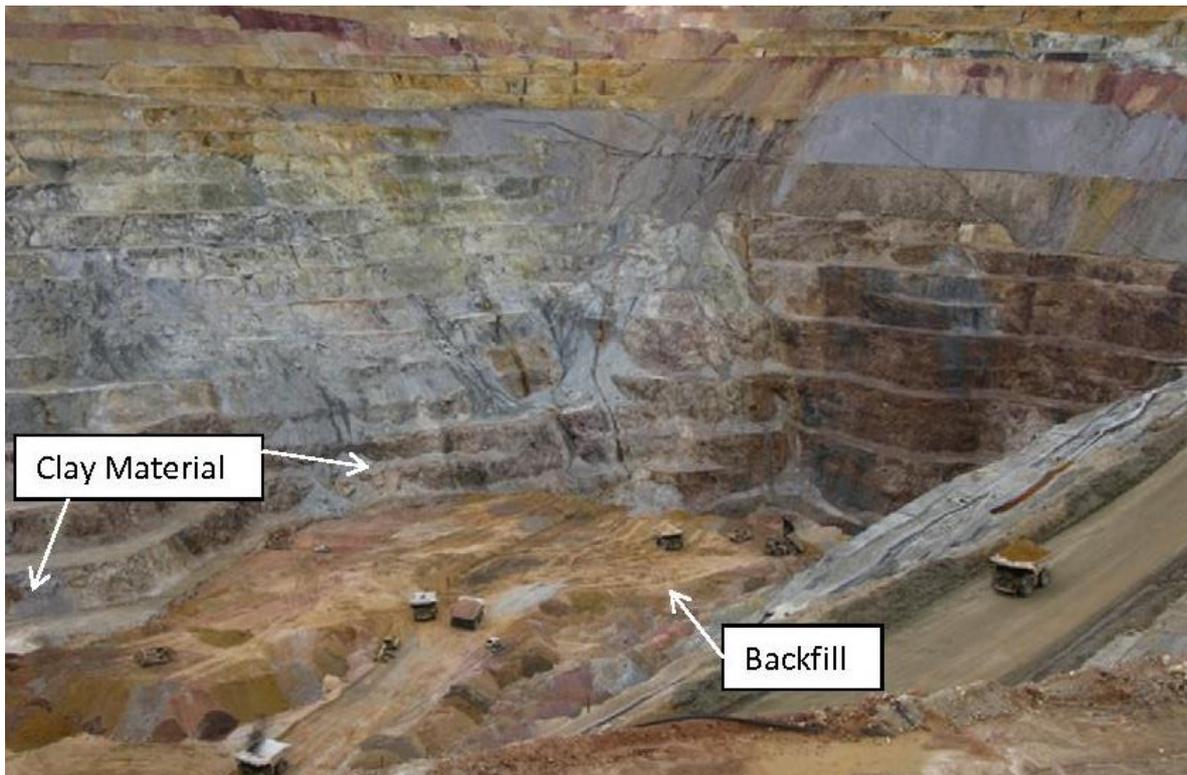
After a six month period in which mining of the slope had continued concurrently with a progressive lowering of pore pressures, it was determined that all pore pressure targets had been achieved and the slope could be mined to full depth, with the exception of a small zone of exposed clay material in the lower part of the slope which was below the influence of the pumping from the silica alunite wells and which could not be accessed for horizontal drain drilling (Figure 8).

Figure 8 Weak clay materials exposed in the lower part of the slope (note that the pit floor backfilling was carried out subsequent to completion of mining of the slope)

Depressurisation targets for the upper slope were successfully achieved (Table 2, Figures 9 and 10). However, for the lower slope, there was still about 20 m pressure above the target within the clay altered materials in the lower part of the wall (Figure 8).

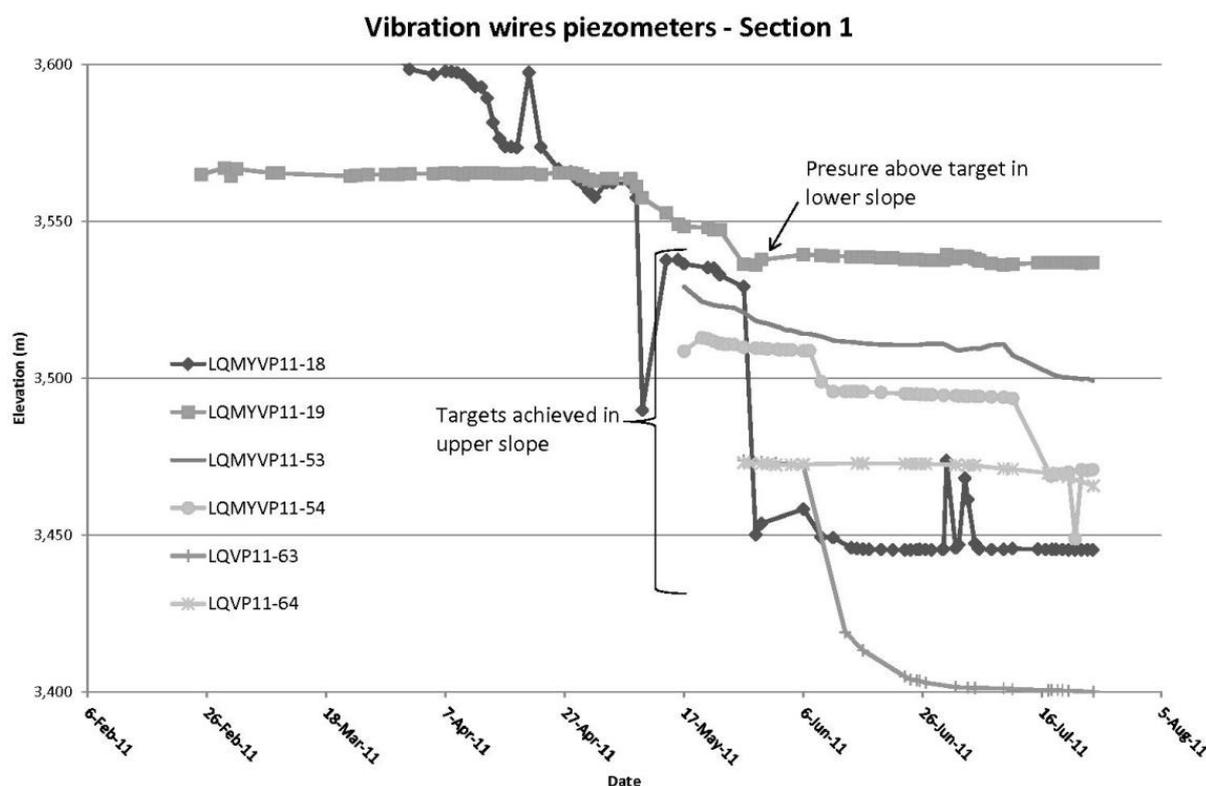
Figure 9 Vibrating wire piezometer hydrographs for Geotechnical Section 1

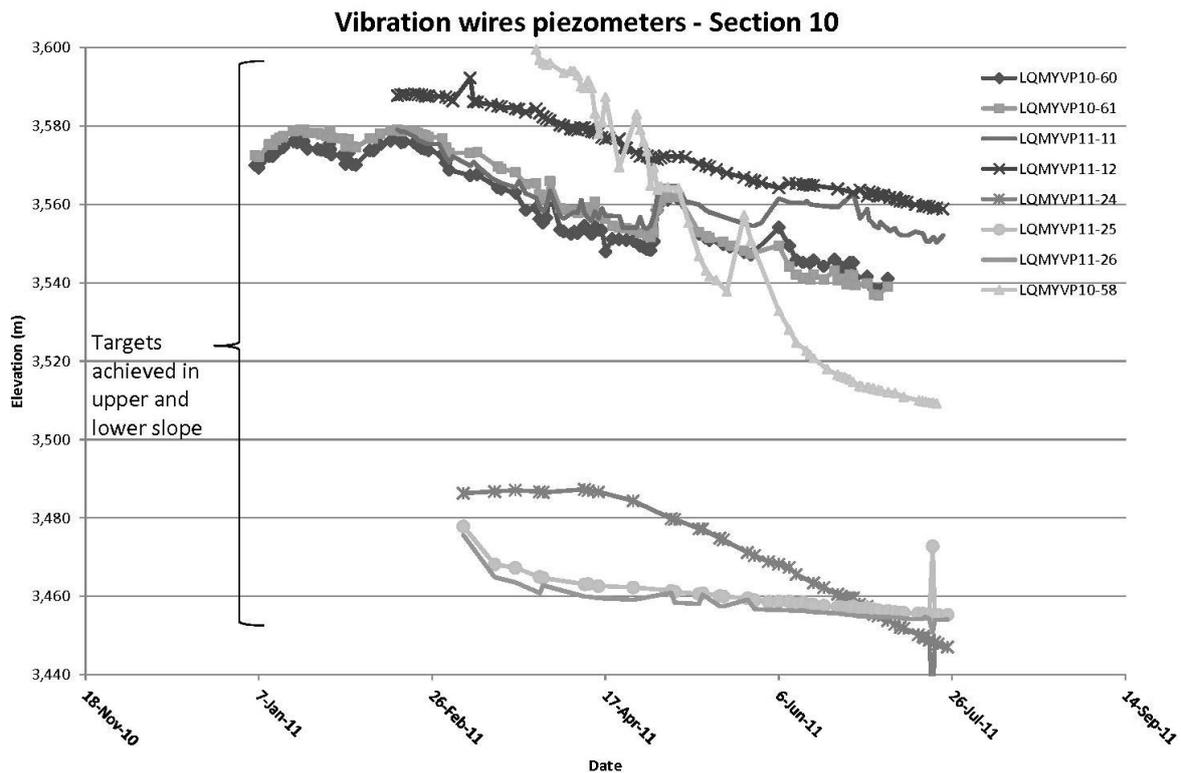
Figure 10 Vibrating wire piezometer hydrographs for Geotechnical Section 10
