Cockatoo Island stage 3: seawall failure and remediation

P.K. Wong *Coffey Geotechnics Pty Ltd, Australia*

Abstract

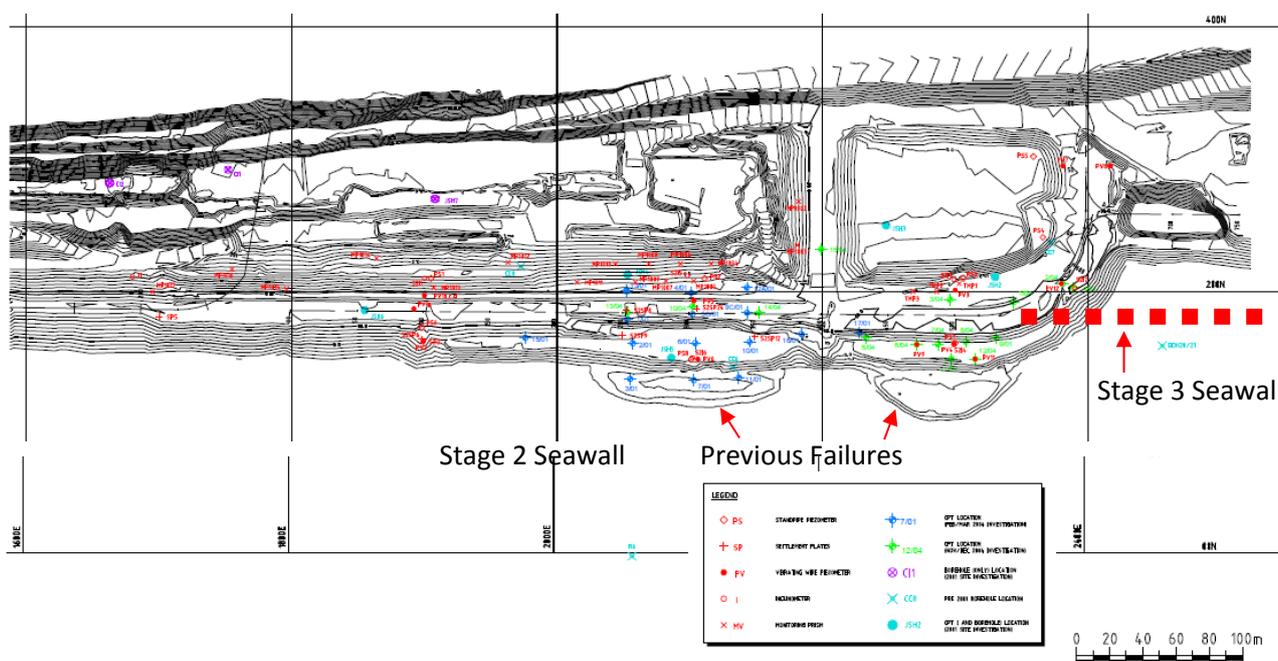
The design profile of the Stage 3 seawall was essentially the same as that for Stages 1 and 2. The construction methodology was also similar, comprising initial end dumping of rockfill to RL 4 m, excavation for the core trench and placement of core material during low tides. Time windows for construction during the low tides were typically restricted to two to four hours, and placement of core material in wet conditions often proved difficult. A description of the Stage 2 seawall construction was given by Phillips et al. (2004) who also reported that a deep seated rotational failure of about 100 m length occurred seawards during construction near the eastern end of the Stage 2 seawall (i.e. close to the western end of the Stage 3 seawall). In fact, there were two such failures during construction of the Stage 2 seawall, with the larger one being about 130 m long further to the west as shown in Figure 3.

Figure 3 Plan showing previous stage 2 seawall failures

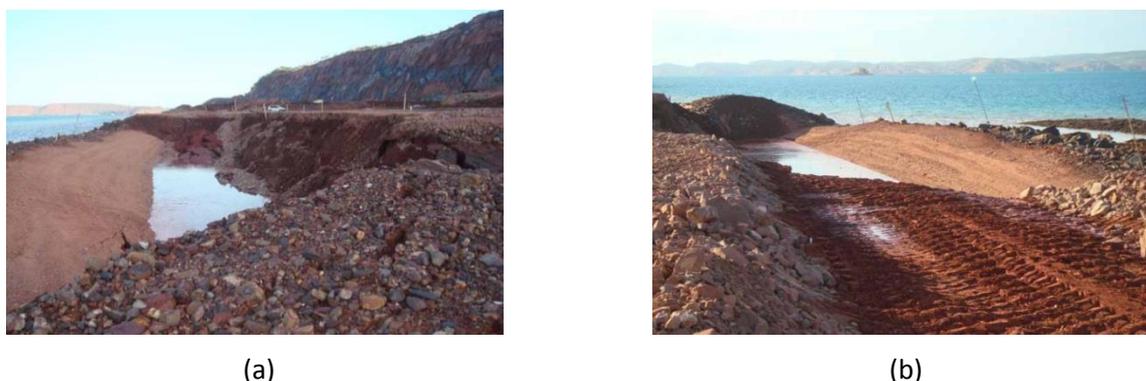
Figure 4 shows two photographs taken in the area of the failed embankment, both clearly showing a rear scarp almost 6 m deep, and rotation of the failed embankment surface.

Figure 4 (a) failed area looking west; (b) failed area looking east

The remedial works comprised construction of a 20 m wide berm to RL 2 m in the area west of the failed area, and utilising the failed debris to form a 35 m wide counterweight toe berm at RL 4 m within the failed area to increase stability. More importantly, it was recognised from the failure and back-analyses that the failure was caused by constructing the embankment too quickly which did not allow for sufficient consolidation and drainage, and the lack of appropriate instrumentation (particularly the ability to read inclinometers for signs of lateral movements and potential development of shear planes).

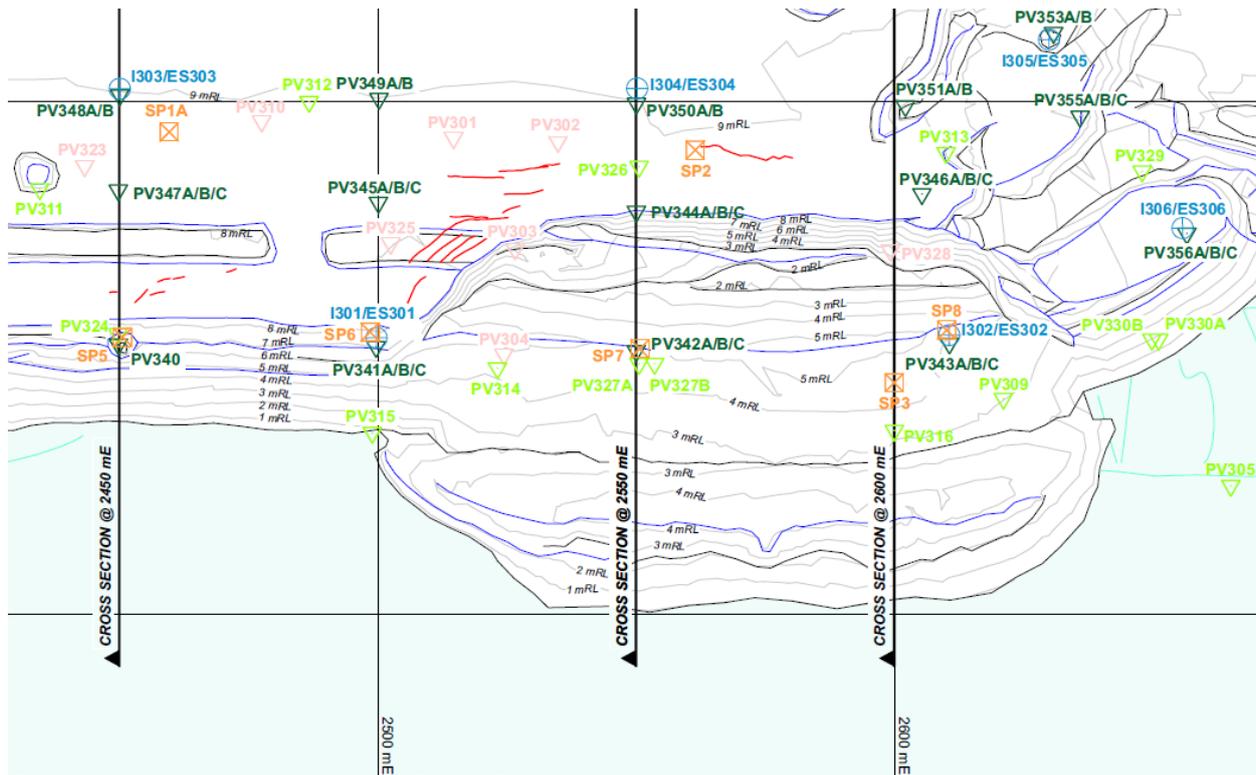
A plan of the failed Stage 3 seawall is shown in Figure 5, showing a seaward movement of about 30 m. Tension cracking was observed to the immediate north and west of the failure, extending in a pattern generally sympathetic to the orientation of the back scarp and western edge of the failure.

Examination of the failure geometry suggested that the failure surface was approximately circular and deep seated, extending to below RL -15 m (based on post-failure investigations). Subsequent examination of the monitoring data indicated that the embankment failure occurred between 04:00 and 05:00 on 24 April 2009. It is possible that some settlement and tension cracking could have developed over a period of minutes and perhaps hours, prior to the main failure event, but there is little monitoring data to substantiate this as discussed in Section 3.2.

Figure 5 Plan of failed section of the Stage 3 seawall together with instrumentation locations; SP = settlement plates; PV = piezometers; I = inclinometers; ES = downhole extensometers

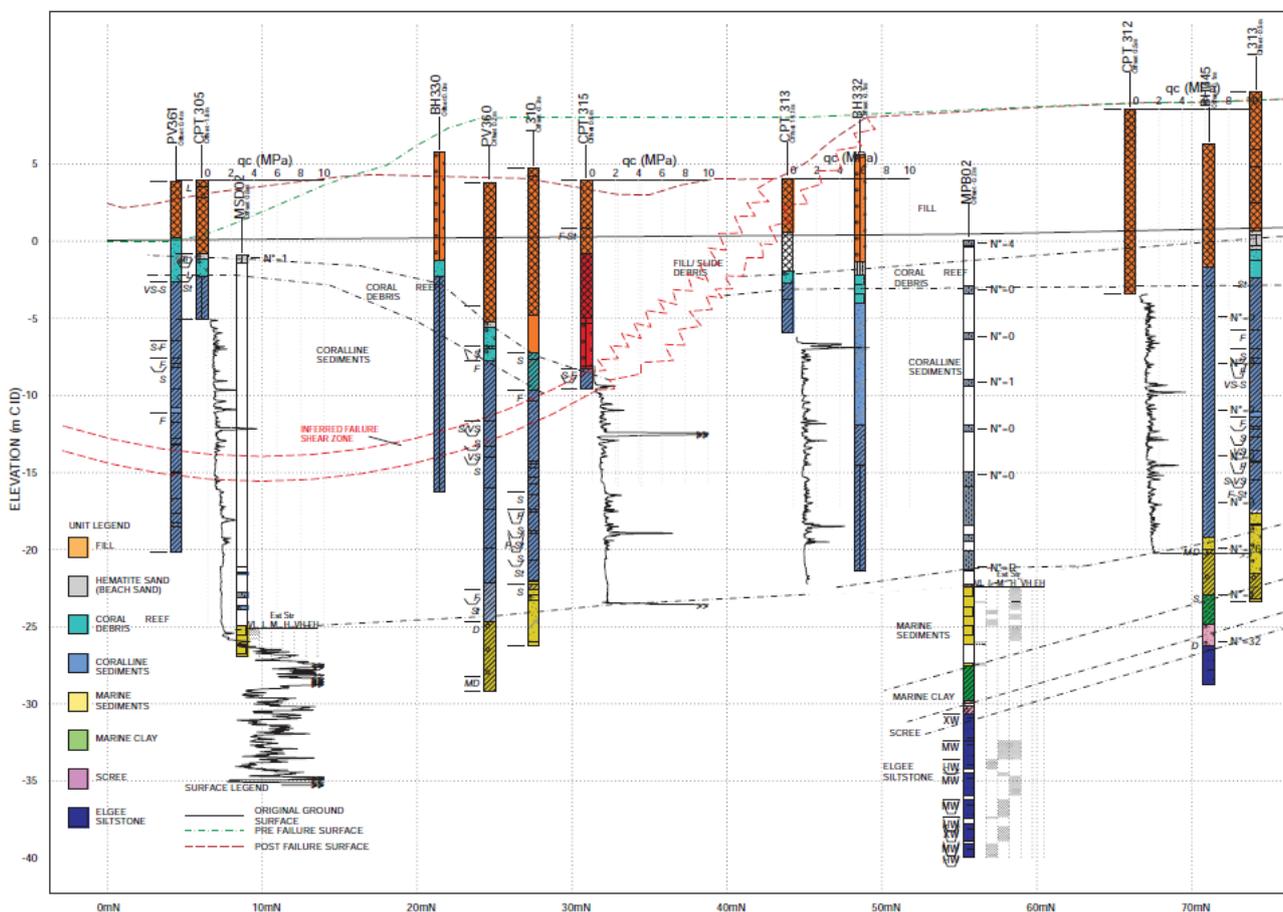
On 1 May 2009, seven days after the seawall failure, interim remediation was undertaken which comprised flattening of the failure back scarp and placement of rockfill protection over the core exposed at either end of the failure. A working platform was constructed at RL 4 m to facilitate post-failure investigations and allow additional instrumentation to be installed to replace damaged instrumentation. Post-failure site investigations included additional boreholes, cone penetration tests (CPT), dilatometer (DMT) and shear vane testing. The investigation results indicated that in the failed area, the total thickness of the beach sand and coral reef debris layer was relatively thin (1 to 2 m), and confirmed that the rotational slip surface extended down to about RL -15 m as shown in the inferred geological section presented in Figure 7.

Figure 7 Interpretation of the post-failure subsurface profile within the failed area

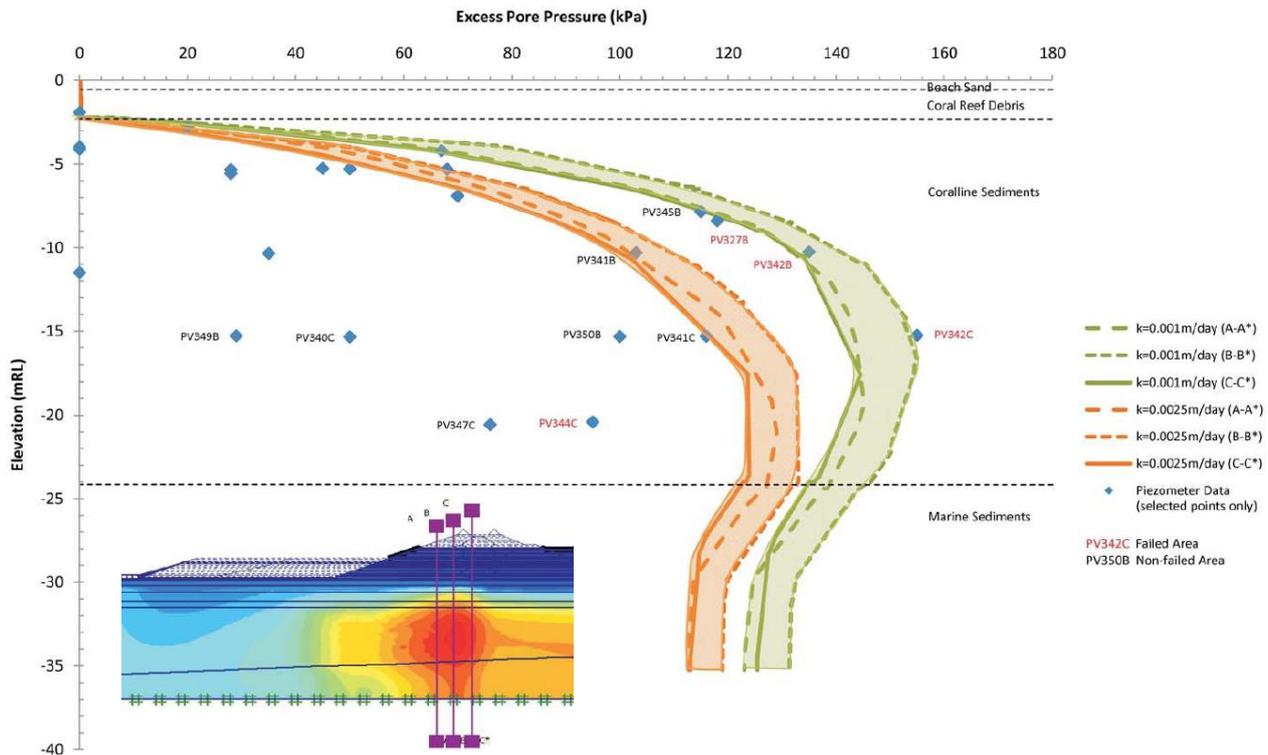
PLAXIS analyses were carried out for both the failed and non-failed areas, although discussions will focus on the failed area. Figure 10 shows the computed pore pressure distribution beneath the seawall in the failed area just prior to the failure on 24 April 2009. The embankment was raised to RL 8.7 m using the as-built construction sequence and the sea level was dropped to RL 1.3 m to simulate the spring low tide at the time of failure. A FS of one was back-analysed using the c' - ϕ' reduction method.

Figure 10 Computed excess pore pressure distribution within failed area

- Based on the relatively high excessive pore pressures measured at depth within and on the western edge of the failed area, there appeared to be a lack of basal drainage in the failed area compared to outside the failed area. To inhibit basal drainage in the modelling, a permeability $k_v = k_h = 0.002 \text{ m/day}$ was adopted for the marine sediments underlying the coralline sediment.

- An adopted permeability $k_v = k_h = 0.001 \text{ m/day}$ for the coralline sediment provided a reasonable match of excess pore pressures measured at depth in piezometer PV342 (located at the western third point of the failed area Ch2,550 mE). This section appeared to exhibit the highest excess pore pressures. PV344C, also located on the same section but on the landward side of the failure scarp, showed lower excess pore pressures.

- PV341, located at the western edge of the failed area, showed lower excess pore pressures which matched the back-analysis results for a higher coralline sediments permeability of $k_v = k_h = 0.0025 \text{ m/day}$.
