# Undrained behaviour in spoil piles

A. Duran *Pells Sullivan Meynink, Australia*

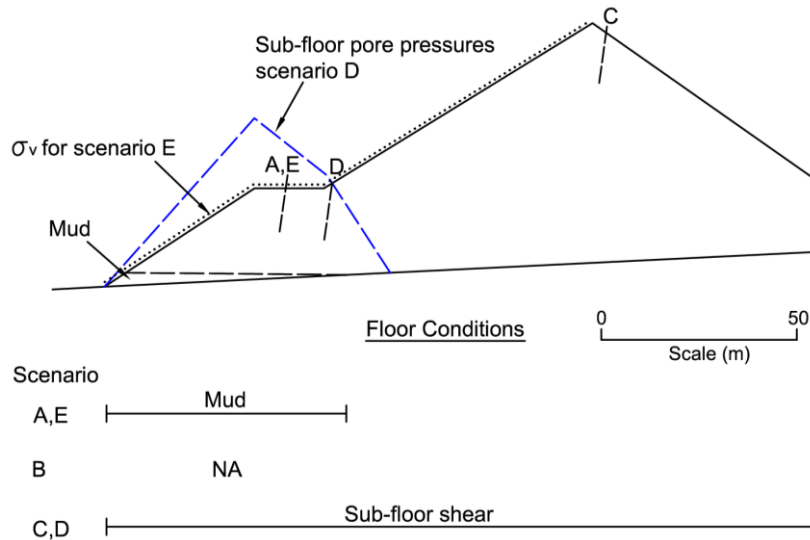
For Case 1 there was some uncertainty as to the extent of mud placed within historic 'mud cells' placed against the remnant coal toe. During development of the strip, failure of the lower bench occurred in the proximity of the operating dragline bench. The lateral extent of failure along the strip was relatively minor.

**Figure 5 Case 1: failure scarp observations in accord with results of analyses from scenario A, E and D**

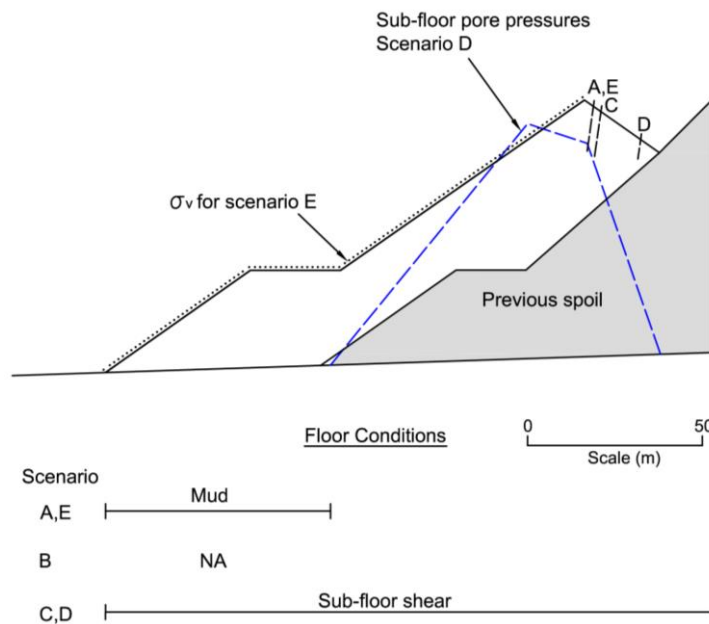
For Case 2 there had been flooding of the pit prior to spoiling being undertaken. The pit was largely dewatered prior to spoiling being undertaken. Failure occurred over a strike length of about 150 m of the pit and with the back scarp at the first spoil peak. There was evidence to suggest that Tertiary clay, locally thicker in the area of instability, may have been placed in the spoil base.

**Figure 6 Case 2: failure scarp observations in accord with results of analyses from scenario A, C and E**

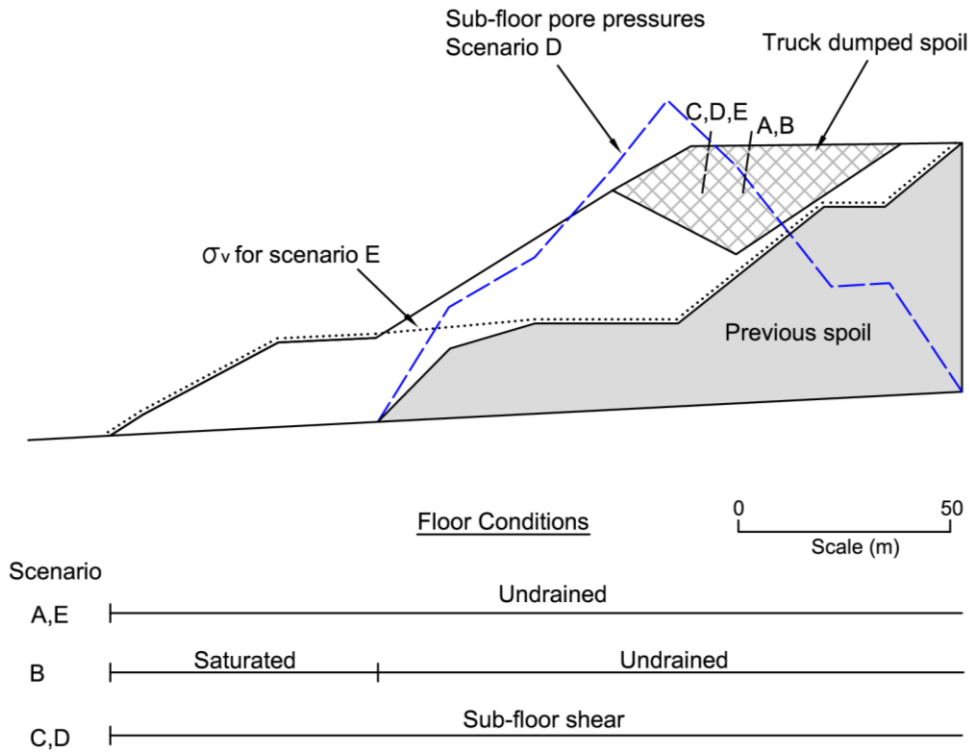
For Case 3, truck dumping was being carried out to the spoil peak in the current mining strip when failure occurred. Such dumping practice is typically avoided in most strip operations. However, of particular note in this case was the relatively low floor dips in addition to moderate overall spoil height. Two aspects were of particular note for the failure, the rear scarp was very steep and the lateral extent of the failure was significant, encompassing about 300 m strike length of pit.

Figure 7 Case 3: failure scarp observations in accord with results of analyses from scenario A and B. For scenario E, accepted that initial phase of current spoiling assisted in consolidation of floor material

For Case 3, the results of the back-analyses were also utilised to assess the stability of the initial dragline spoil prior to the truck dumping having taken place. For scenarios A, B, D and E the analyses indicated Factors of Safety (FS) of nominally of 1.14 and in accord with the observed performance of the spoil prior to the truck dumping taking place. However, for Scenario C a FS of 1.04 was indicated suggesting such a scenario was unlikely for Case 3.

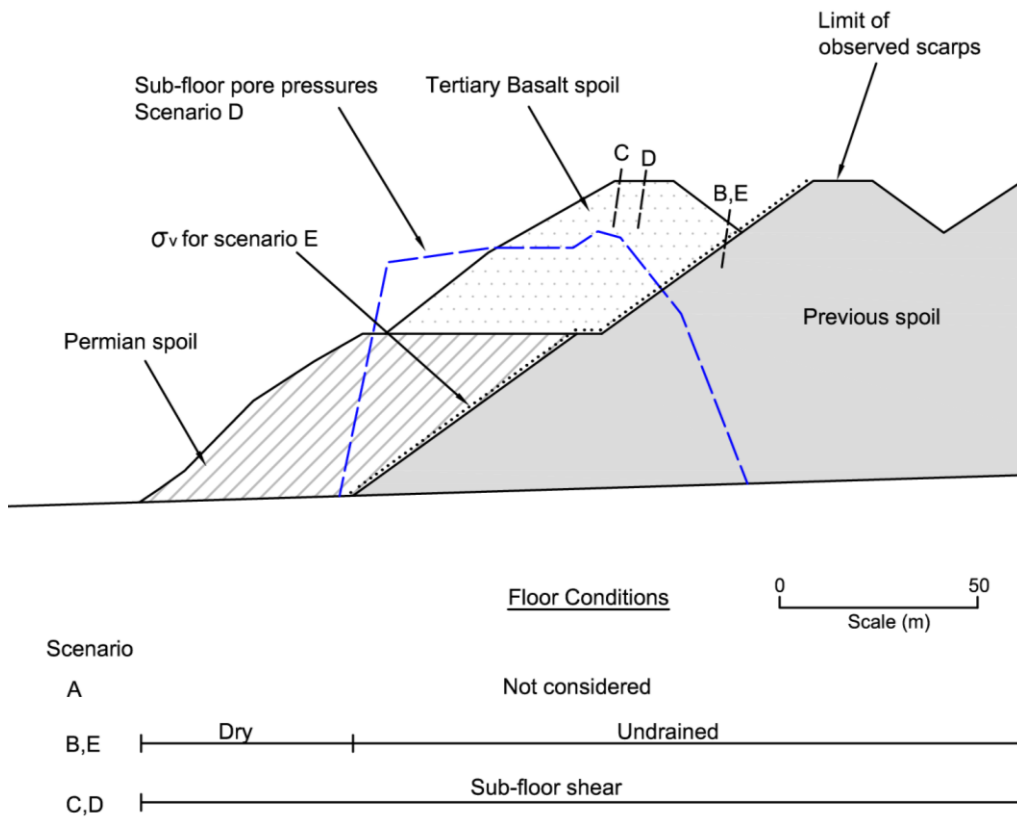
Case 4 presented a conundrum at the time. The operations personnel were well aware of the risk of spoil failure in the strip as the pit had been inundated. As such, an extensive effort was made to clean up the floor of all mud. In addition, the spoiling in the strip had been carried out during a relatively dry period and with cast blasting of fresh Permian material into the pit void. Although Tertiary materials are present these were double handled to ensure their placement in the upper part of the spoil. Even with the high degree of certainty in the spoil floor conditions, an extensive failure occurred in the strip. Elements of note of the failure were; an extensive lateral extent of 400 m along strike, a very steep rear scarp which had developed

in the second spoil peak and a pronounced lateral movement of the lower spoil pile, up to 30 m into the pit void, with thrusting both over and through the exposed coal seam.

Figure 8 Case 4: failure scarp observations in accord with results of analyses from scenario B and E

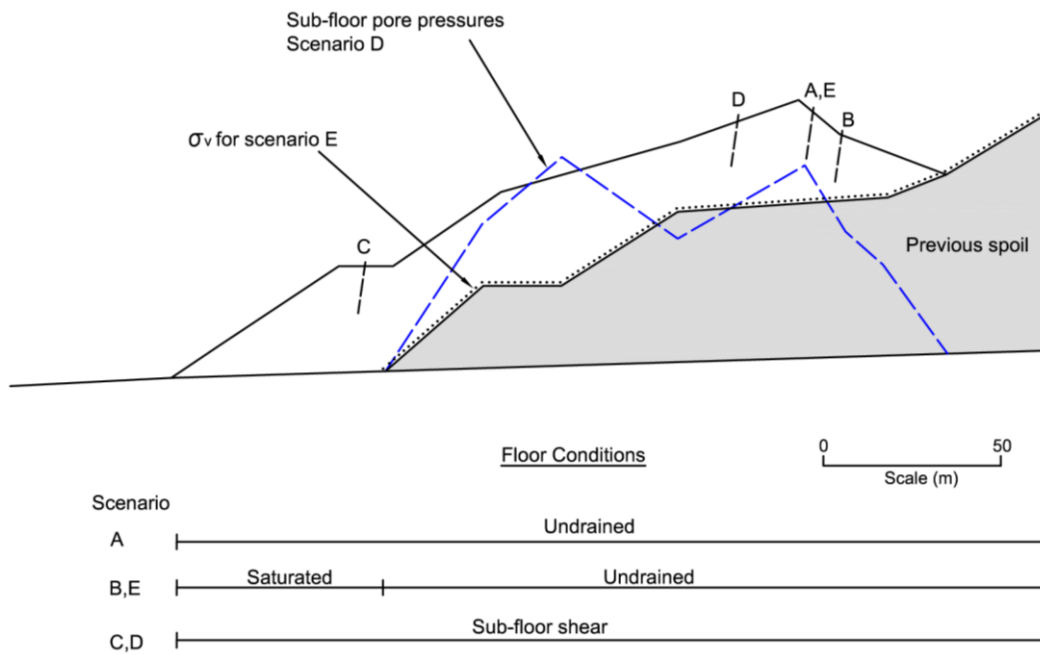
For Case 5 very difficult in-pit conditions were experienced. Tertiary clays, which had been placed at the spoil base, had become saturated/inundated during a significant wet season. Although a program of 'mud-replacement' had been utilised (the process involves progressively excavating the mud from the spoil base and replacing the mud with better quality Permian) the program was carried out during further heavy rain periods. Numerous failures occurred in the spoil within the strip, commonly with the back scarp at the first spoil peak but also with evidence of remobilisation of historic failures.

Figure 9 Case 5: failure scarp observations in accord with results of analyses from scenario A, B and E

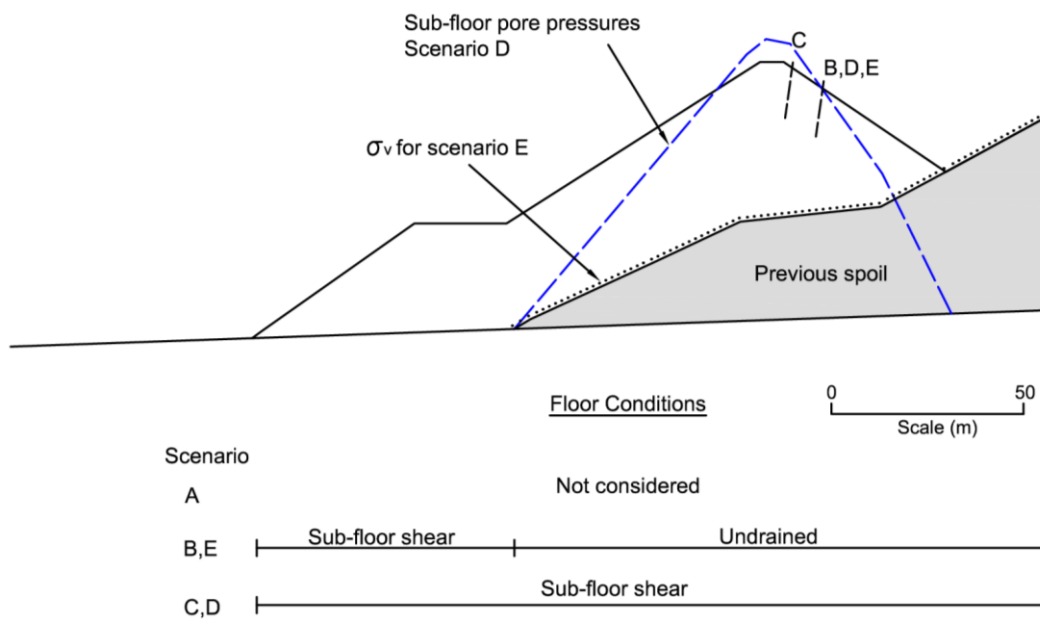
For Case 6 flooding of the pit had occurred prior to spoiling taking place. Pit dewatering had taken place and operations personnel ensured the base of the spoil was placed under ideal conditions. However, a significant failure occurred that encompassed about 200 m of strike length, with the failure scarp located up to 15 m behind the crest of the first spoil peak and partly affecting a low wall ramp into the strip.

Figure 10 Case 6: failure scarp observations in accord with results of analyses from scenario B, D and E

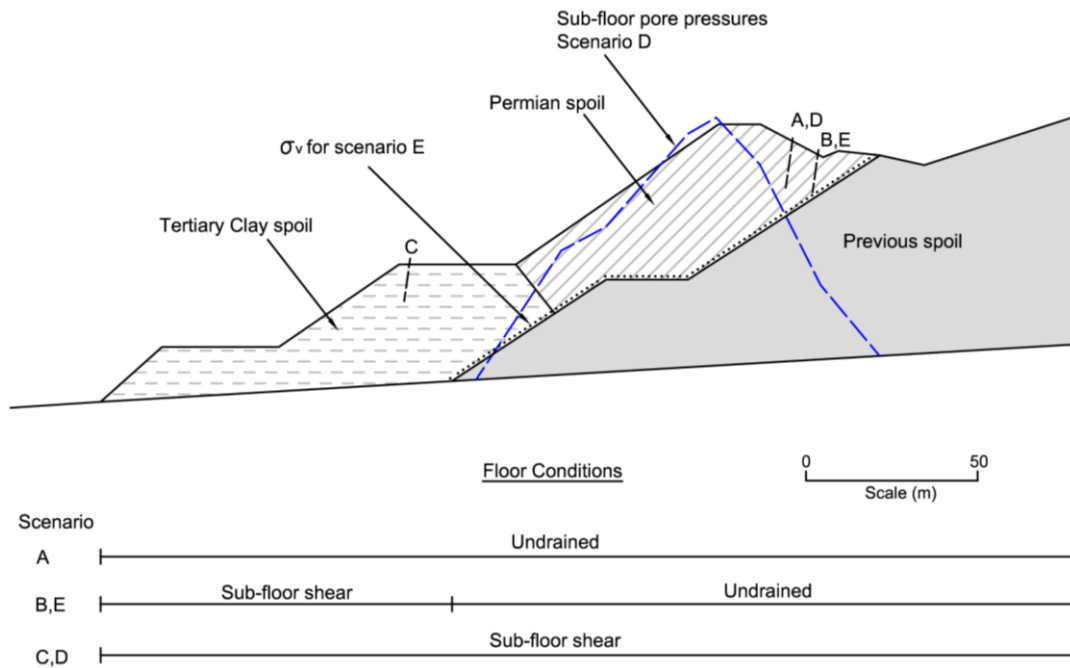
Case 7 represents the subsequent mining strip to Case 5. Parallels to Case 4 are present in that a concerted effort was made by operations personnel to ensure the base of the spoil was placed under ideal conditions. Even with the concerted effort, a significant failure occurred that encompassed about 450 m of strike length, with the failure scarp located up to 40 m behind the crest of the first spoil peak and affecting a lowwall ramp into the strip.

**Figure 11 Case 7: failure scarp observations in accord with results of analyses from scenario B and E**
