Risk management and remediation of the north wall slip, West Angelas Mine, Western Australia

Abstract

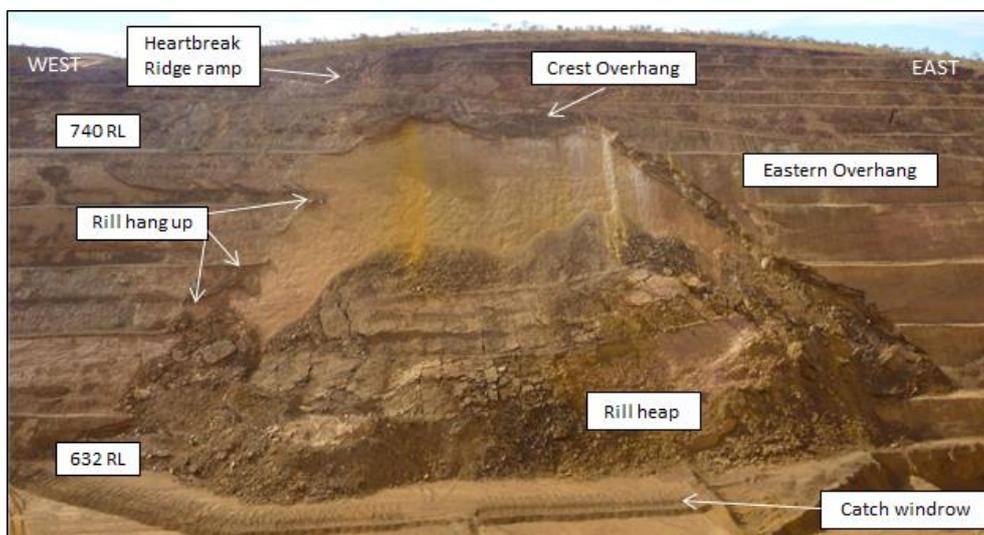
Figure 1 CEPN north wall failure and residual risks (taken 07 May 2010)

- Crest overhang: A 30 m high, 5 m thick band of BIF remained across the top of the failure surface, residing on the NS2 shale.
- Eastern overhang: The break out surface on the eastern limit of the slip was defined by a sub-vertical joint plane, dipping at approximately 70°/230°, creating a significant overhang between 8 to 16 m thick. The NS2 shale, which formed the failure surface, extends to the east of the joint surface. It does not daylight at the toe of the eastern overhang and no potential breakout surfaces are known. Minor movements were recorded on prisms and wireline extensometers on the eastern overhang at the time of failure, however no displacements were detected post failure. The risks posed by the overhang are twofold; there is a risk of rockfalls from the underside of the overhang, and the risk of planar failure on the NS2 shale.

- Shale bedding: The NS2 shale is comprised of two shale bands 30 to 40 cm thick, approximately 2 m apart. It was initially unclear whether the failure had occurred on the upper or lower shale band, however subsequent investigations indicated it was the upper shale band. This left a veneer of BIF sitting on the lower shale band. An additional shale band (NS1.5) is located approximately 15 m below the NS2 shale. Both shale bands are potential slip surfaces.

- Rockfalls and hang up: A number of large rocks and areas of rill remained perched on the slip surface, and ongoing creep in the rill heap left additional suspended material on the face.

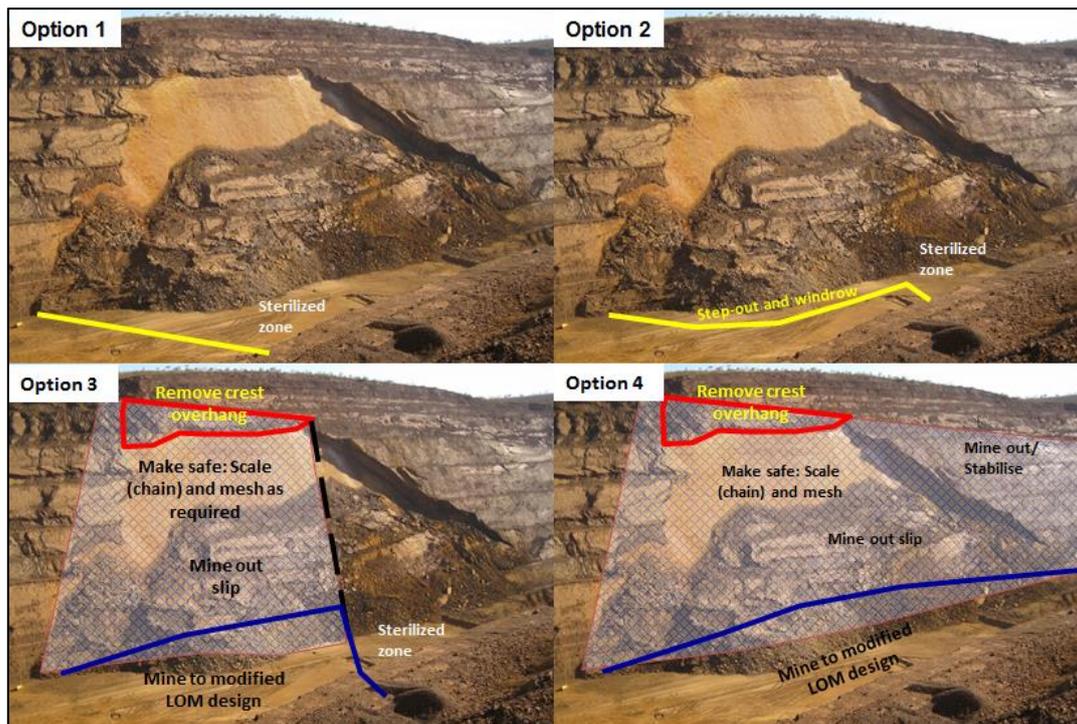
Figure 2 CEPN north wall remediation options

- No remediation of the failed material and a conservative standoff from the western margin of the slip. Lowest risk option, but would sterilise all ore in front of the slip.

- No remediation of the failed material, develop an appropriate stand-off from the toe of slip including a significant rockfall protection windrow, and an exclusion zone below the eastern overhang. This would sterilise ore beneath the eastern overhang.

- Mine out the slip debris from the west of the overhang, remediate remaining crest overhang and manage the rockfall hazard. Options for managing the rockfall hazard would involve scaling, meshing and development of catch fences. This option would sterilise ore immediately beneath the eastern overhang but would facilitate mining to a modified Life of Mine design to the east.

- Remediate the eastern overhang and mine out all of the slip material, allowing 100% ore recovery. Two options were provided for remediation of the eastern overhang:

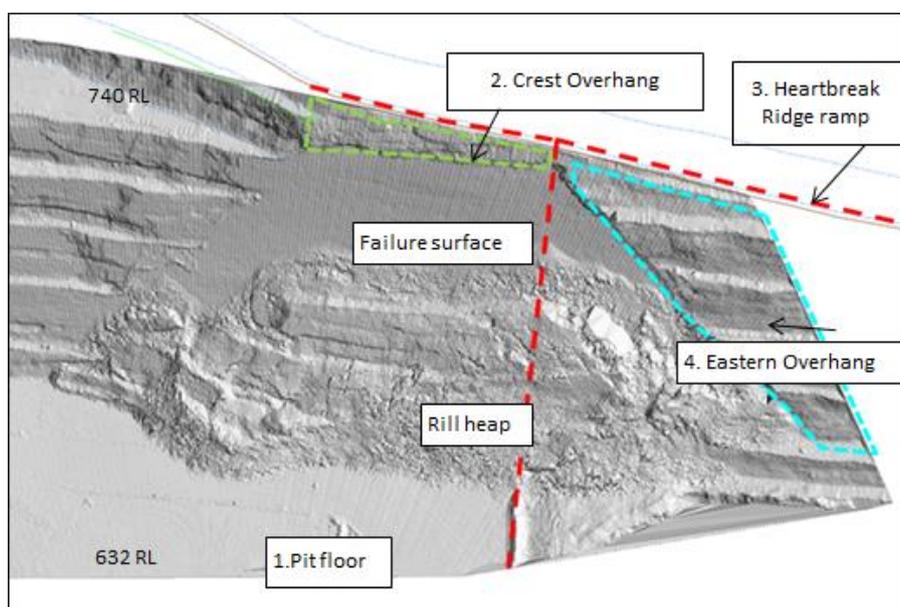
Figure 3 Laser scan of CEPN north wall failure with 'no go' lines denoted in dark red (oblique view), February 2010

Before work could commence, four exclusion or 'no go' lines needed to be defined, to limit access to high risk areas (Figure 3).

- Exclusion zone 1: Pit floor 632 RL. Shortly after the failure a catch windrow 2 m high was constructed 15 m from the toe of the rill heap as protection in the event of further falls of ground. Since blasting, scaling and sidecasting at the crest has the potential to generate rockfalls, the 632 RL bench below the slip was isolated prior to commencement of work on the face.

- Exclusion zone 2: Crest overhang. Defined as 5 m to the north of the NS2 shale band for heavy equipment and 2 m for light vehicles and unsecured personnel on foot. A small windrow was subsequently constructed along the 'no go' line at the crest.

- Exclusion zone 3: Heartbreak Ridge ramp. Defined as 5 m north of the shale line. A windrow was constructed along the 'no go' line as a physical barrier against access at the crest.

- Exclusion zone 4: The eastern overhang. Defined 2 m west of the top of the eastern overhang to be used as protection against potential rockfall hazards. It was not designed to provide protection against a failure of the overhang itself, as this was likely to have a lateral component, to the west. This line was subsequently painted on the face by the specialist contractor and downloaded into the Computer Aided Earthmoving System (CAES, an on board monitoring system) in all manned equipment used during mining operations.

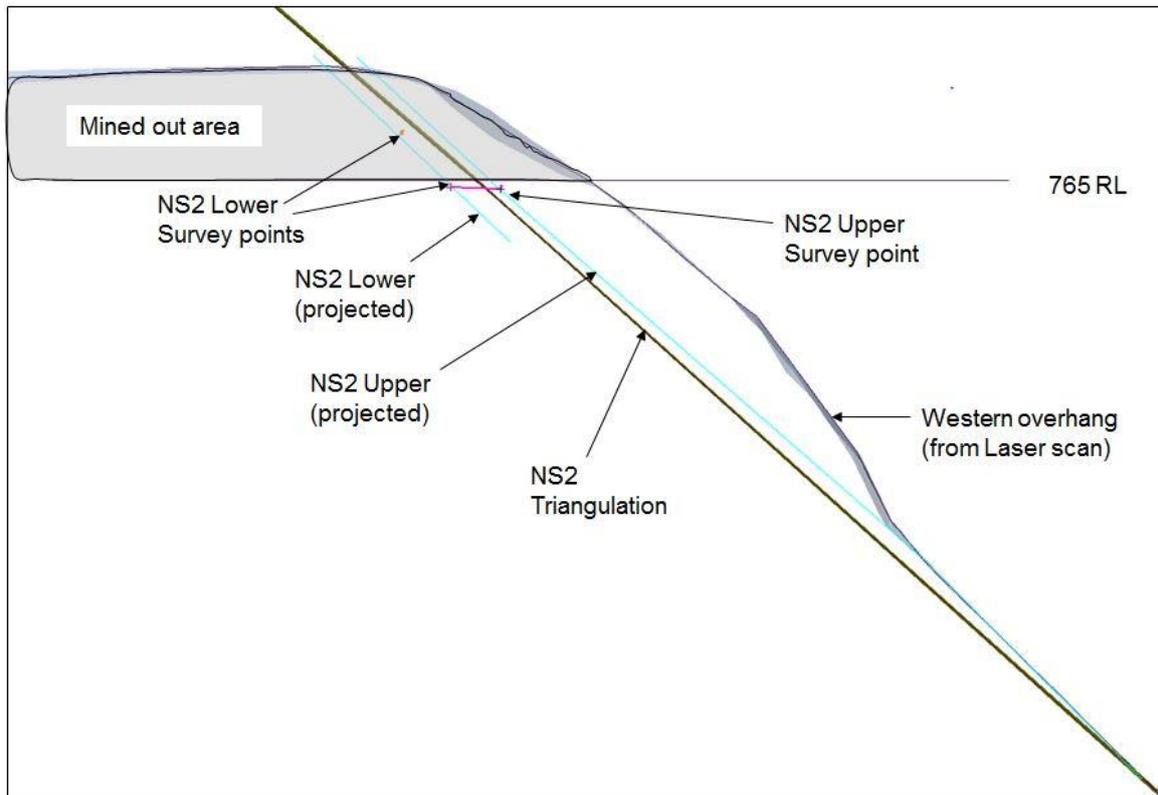
Access to the cutback for mapping was limited because of the limited size of the cutback and equipment operating in the area. A small number of points on the NS2 shale were identified, surveyed and used to further refine the NS2 shale location. They also supported the view that the failure had occurred on the

upper NS2 shale, and that the exposed failure surface was probably a veneer 2–3 m thick, sitting on the lower shale band.

Figure 4 NS2 shale interpretation, cross section of western end of crest overhang

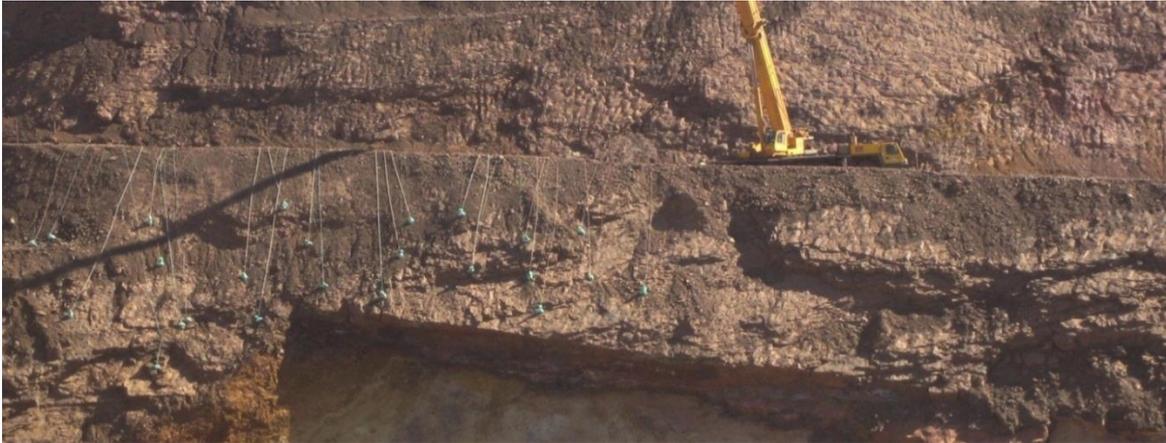
Figure 5(a) Placing explosives on crest overhang

- Air blasting: It was thought that the vibration caused by an air blast might shake the overhang loose. Bags of explosives were lowered on to the outside face of the overhang by crane and tied into position. A spotter on the south wall of the pit assisted with the positioning of the explosives (refer to Figure 5(a) and (b)). This was also unsuccessful.

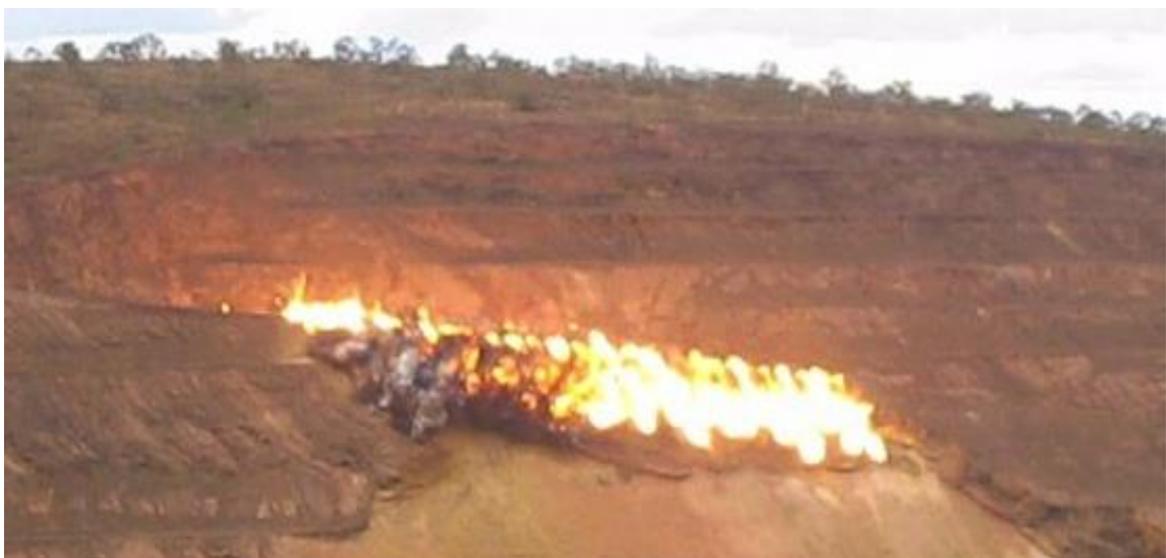
Figure 5(b) Air blast on the crest overhang

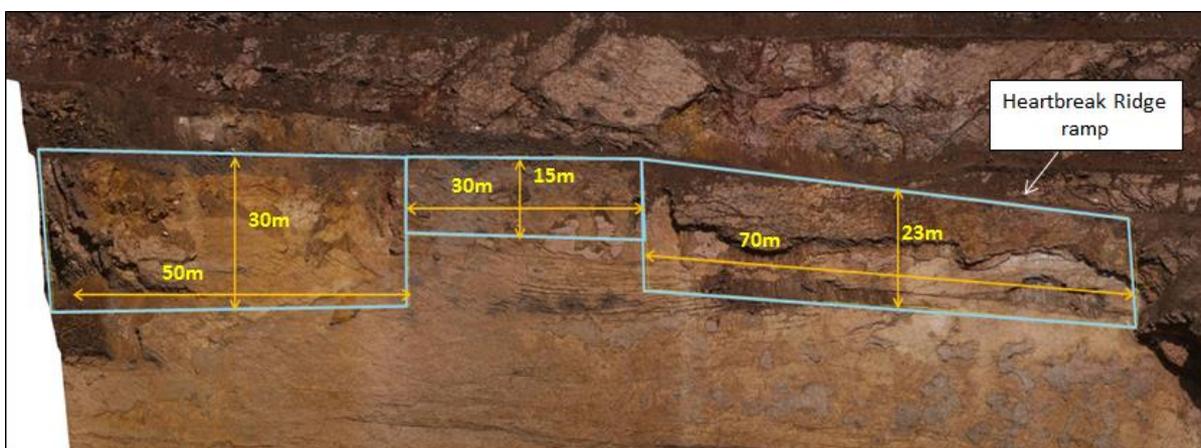
The remains of the crest overhang still posed a potential rockfall hazard, though on a much lesser scale. The remaining hazards were controlled by meshing and rock bolting by the contractor (Figure 6).

Figure 6 Remnant crest overhang and meshing requirements

The mesh was designed to restrain potential rock falls. Rockbolts were used to secure the mesh; they were not designed to be used as face support. The rockbolts were 3 m long to ensure penetration into the BIF below the lower NS2 shale bed. They were installed on a 2.5 by 2.5 m grid pattern covering an area of 3,560 m². All rockbolts were fully grouted; records of grout consumption by hole were kept to indicate areas of poor rock quality. Pull out tests were performed on a representative proportion of the rockbolts to

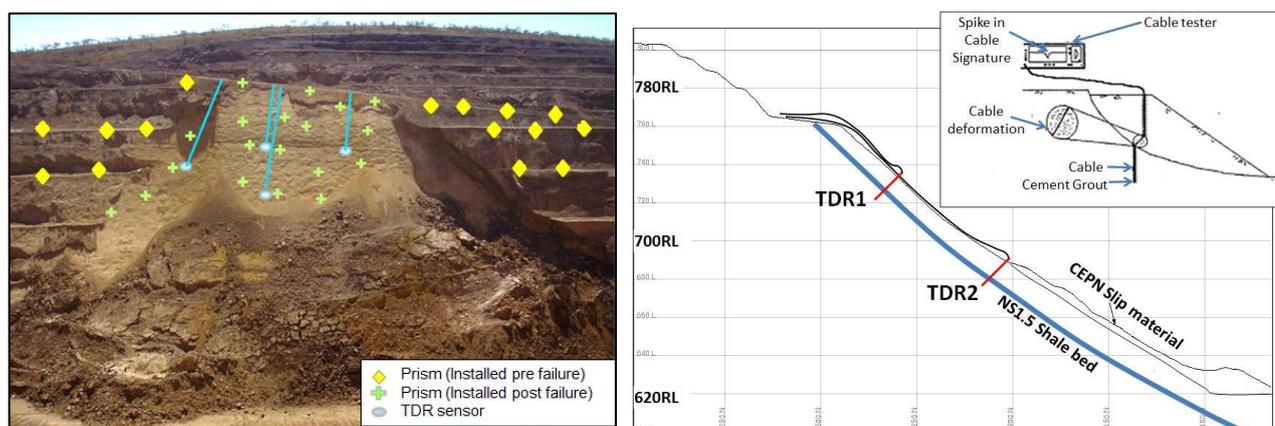
Figure 7 Slope monitoring installations on failure surface

Four TDR cables were installed on the face to provide sub-surface monitoring for the deeper NS1.5 shale band (Figure 7). All instruments were installed perpendicular to the face, to a depth of 30 m. special brackets were manufactured and mounted at the collar of the holes to prevent tight bends and damage to the cables which were extended up the face to a monitoring point on the crest. The TDRs were read manually, on a weekly basis.

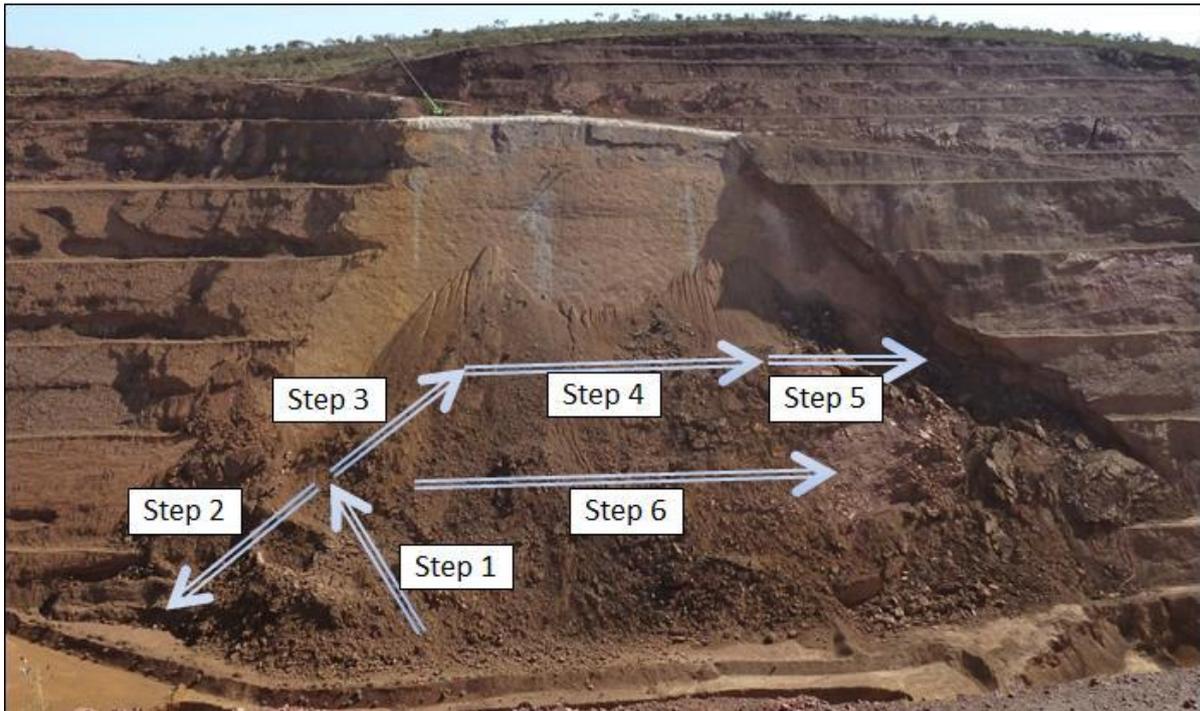
Figure 8 Proposed rill heap mining plan

1. Use an excavator to establish an access ramp, towards the western side of the rill heap, through its shallowest section.
2. Excavator or dozer to ramp down to the west and establish permanent ramp from the 632 RL.

3. Excavator to ramp from east, removing and sidecasting all the rill above the ramp in the process.
4. Excavator to level the ramp off at 692 RL and continue mining east to the 'no go' line.

5. Remotely operated dozers to sidecast material east of the eastern overhang 'no go' line down to the same level as the excavator pad. Mining west of the 'no go' line could not advance more than one flitch ahead of the remote dozing, otherwise access will be lost.

6. Use the excavator and dozer to sidecast the next flitch to the eastern overhang 'no go' line and widen the pad in the process.
7. Repeat steps 5 and 6 until mining completed.

8. Once the pad is sufficiently wide, start mining from the southern side on the 632 RL, taking care not to undermine where the excavator and dozer were working.

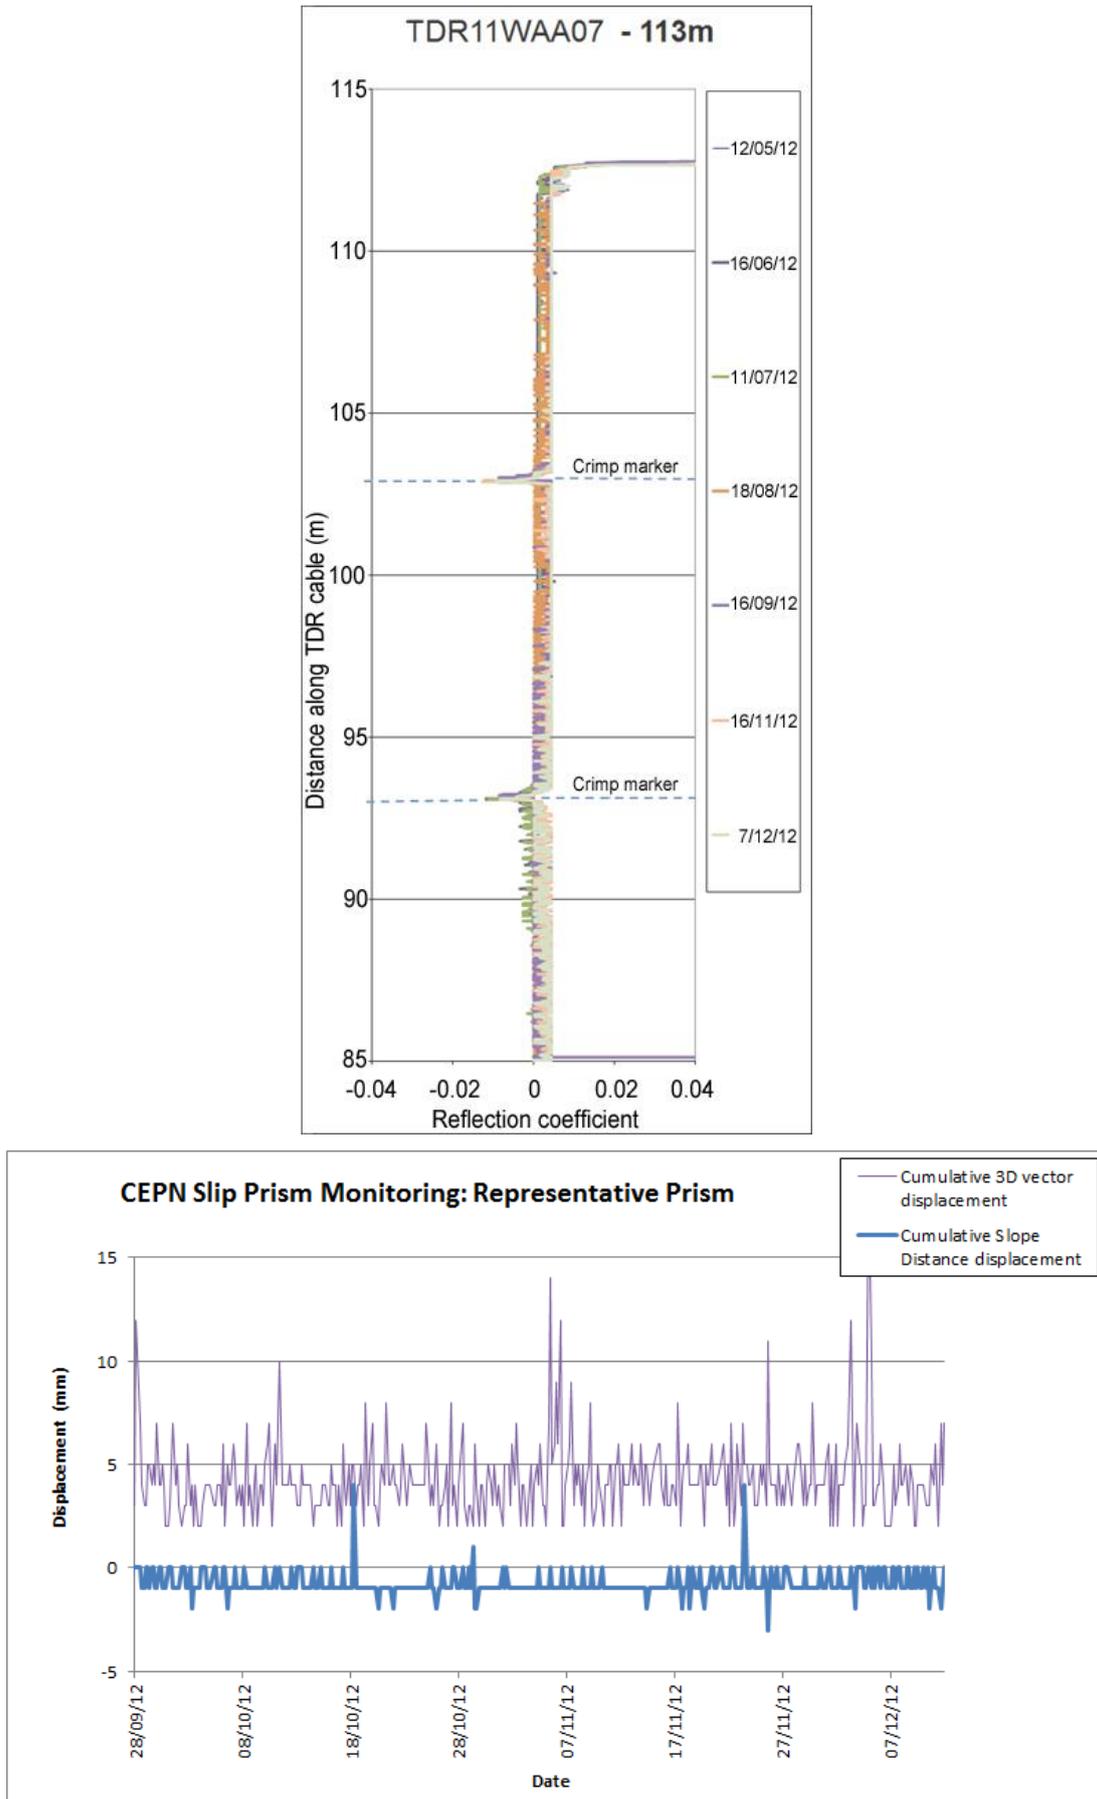
TDR data was compared against previous traces, confirming that no adverse displacement was occurring on the deeper NS1.5 shale band. An example of representative prism and TDR observations is presented in Figure 9.

Figure 9 Prism 3D vector and TDR data examples

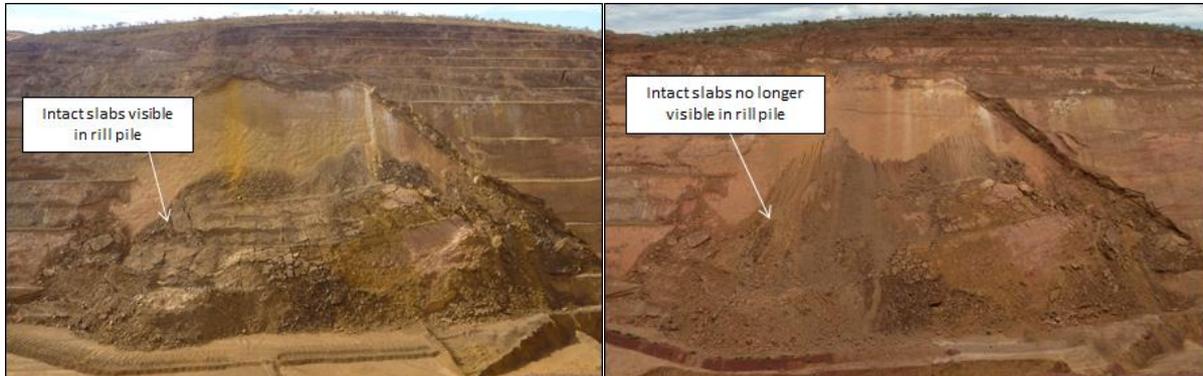
The removal of the crest overhang and subsequent scaling activities covered many of the large rock slabs originally visible in the rill heap post failure. Photographs taken prior to the crest work were used to compare with the daily photographs to identify the likely location of the large rock slabs and scale of potential problems (Figure 10).

Figure 10 Changes to rill heap over time. Shortly after failure (left); after completion of crest work (right)

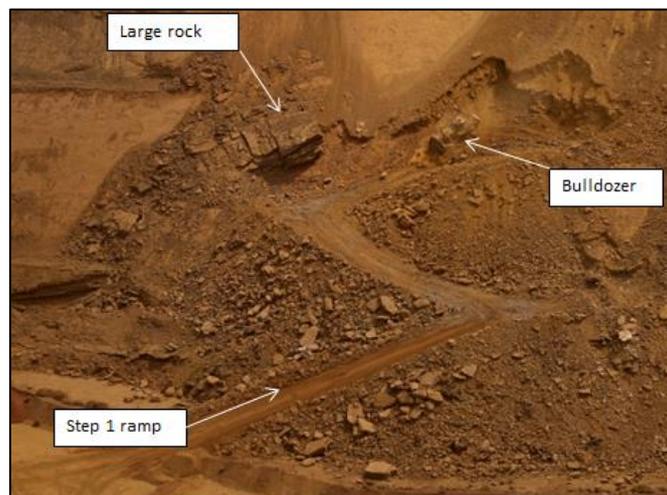
The first large rock was encountered towards the end of the step 1 ramp (Figure 11). In order to drill and blast the rock, it was necessary to move it to a flatter, more stable location. Attempts to dislodge it initially proved unsuccessful and left it undermined and a significant hazard to the development of the step 2 ramp to the west. It was therefore decided to bypass step 2 and start work on the step 3 ramp to the east, to allow the digger and dozer safer access to move it. This became unnecessary when the rock dislodged, before the pad could be constructed, and broke into smaller pieces in the process. No other large rocks were encountered while completing steps 2 and 3.

Figure 11 Large rock undercut by excavator. Dozer establishing digger pad for step 3 ramp

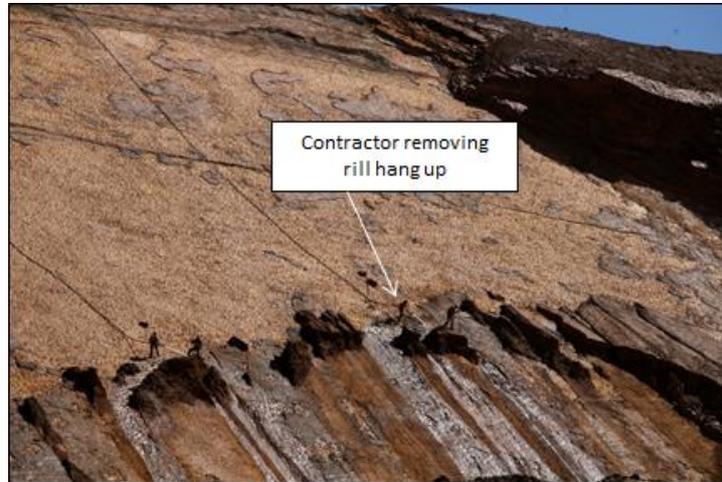
A considerable amount of rill remained on the face out of reach of the excavator, as predicted during the risk assessment. This would pose an increasing rockfall hazard as mining progressed and the height to the hang up increased. The hazard was removed by hydraulic sluicing by lowering a pipe down the face to provide a directed flow of water onto the top of the rill. Flow rates were low, thus erosion of the face was not deemed to be an issue. The rill heap was free draining and the groundwater level was several metres below the pit floor. Stability analyses indicated that the sluicing activity would not have a detrimental impact on wall stability. Though effective, with the low flow rate it was very slow and it was difficult to

Figure 12 Rope access personnel sluicing and scaling the rill hang up

Approximately 70% of the rill hang up was removed by sluicing, however in order to accelerate the process, the contractor was engaged to use rope access to scale the last of the hang up (Figure 12).

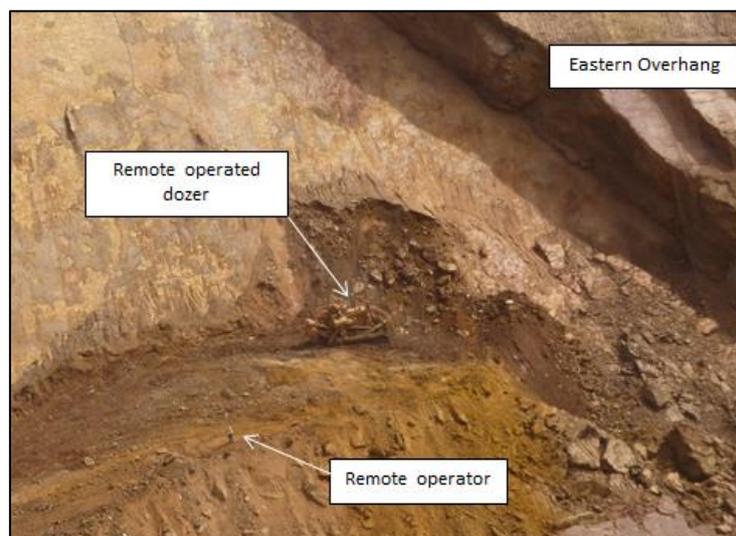
Figure 13 Remote dozer working below eastern overhang. Controller is stationed, outside 'no go' line

Control of the remote dozers was originally attempted from the south wall, opposite the slip. The operator found that this did not provide sufficient visibility for the level of control required, particularly when working near the wall. The optimal position was found to be on the excavator pad, just outside the eastern overhang 'no go' line (Figure 13).

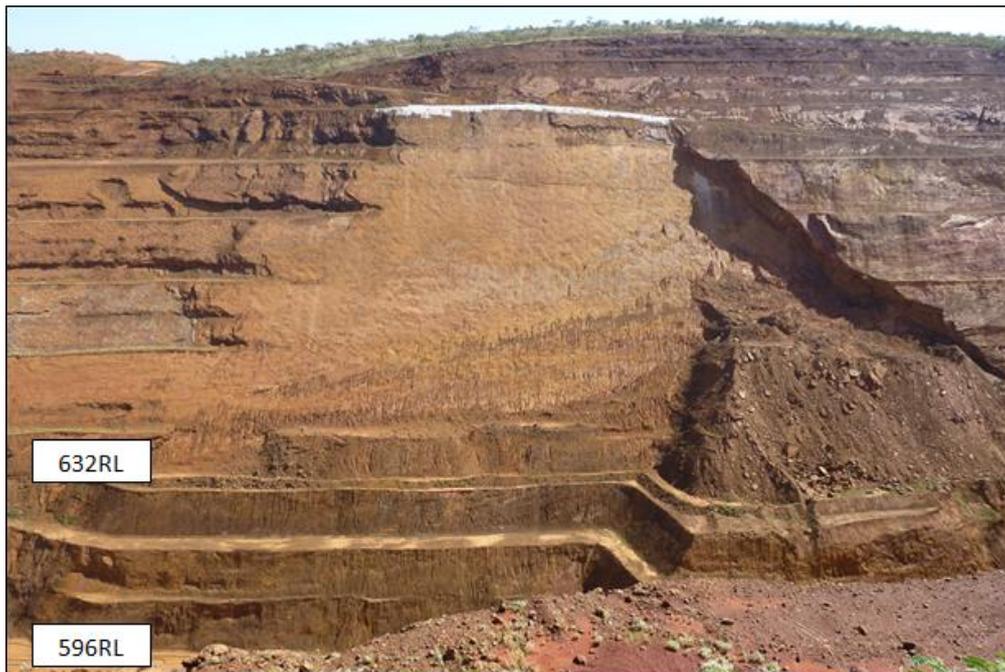
When mining reached the 644 RL it was found that much of the berm was still intact. The pit design required a 15 m wide berm at the base of the slip face, the 644 RL berm made up roughly half the required amount, the remainder of the 15 m was established on the 632 RL. A rockfall catch windrow was constructed behind the designed crest on the 632 RL, while mining of the high grade was underway (refer to Figure 14).

Figure 14 Slip remediation completed and high grade below 632 RL recovered
