Slope stabilisation program at West Gully, PT Freeport Indonesia

Abstract

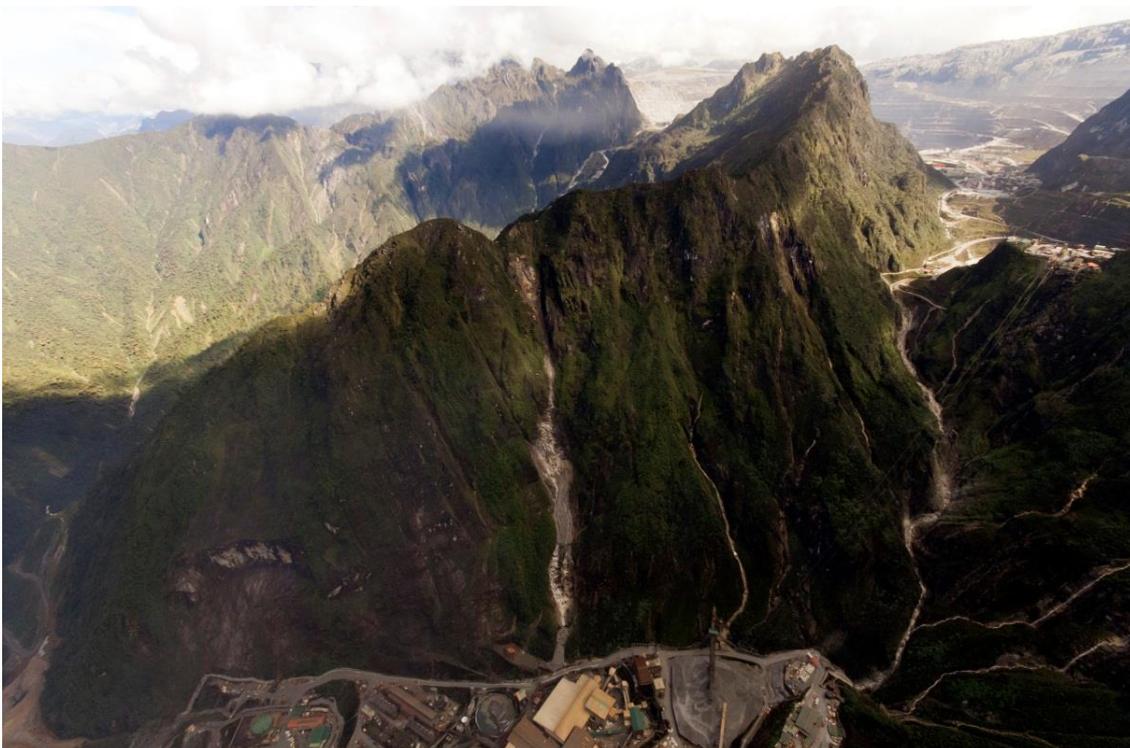
West Gully is one of the locations above the mill-processing area which requires extensive work to mitigate rockfall hazard (Figure 2). Several rockfall events occurred in the past and two rock fences were constructed. Since the end of July 2011, a number of major rock failures and rockfalls occurred that completely damaged the two existing fences located below the rockfall sources.

Figure 2 Panoramic view of West Gully slope and mill processing facilities area which is located approximately 700 m vertically below main rockfall source (Photo by P. Warren)

Field inspections and evaluations identified potential further instabilities which required immediate and comprehensive implementation of remediation measures. After a geotechnical evaluation it was agreed that the remediation would include: the stabilisation of the main rockfall source (scaling and meshing program for approximately 6,000 m²), debris flow barrier construction, creation of a rock fence with higher capacity compared with previously constructed fences, a corrugated steel structure tunnel to secure the road, and also roof strengthening for critical buildings.

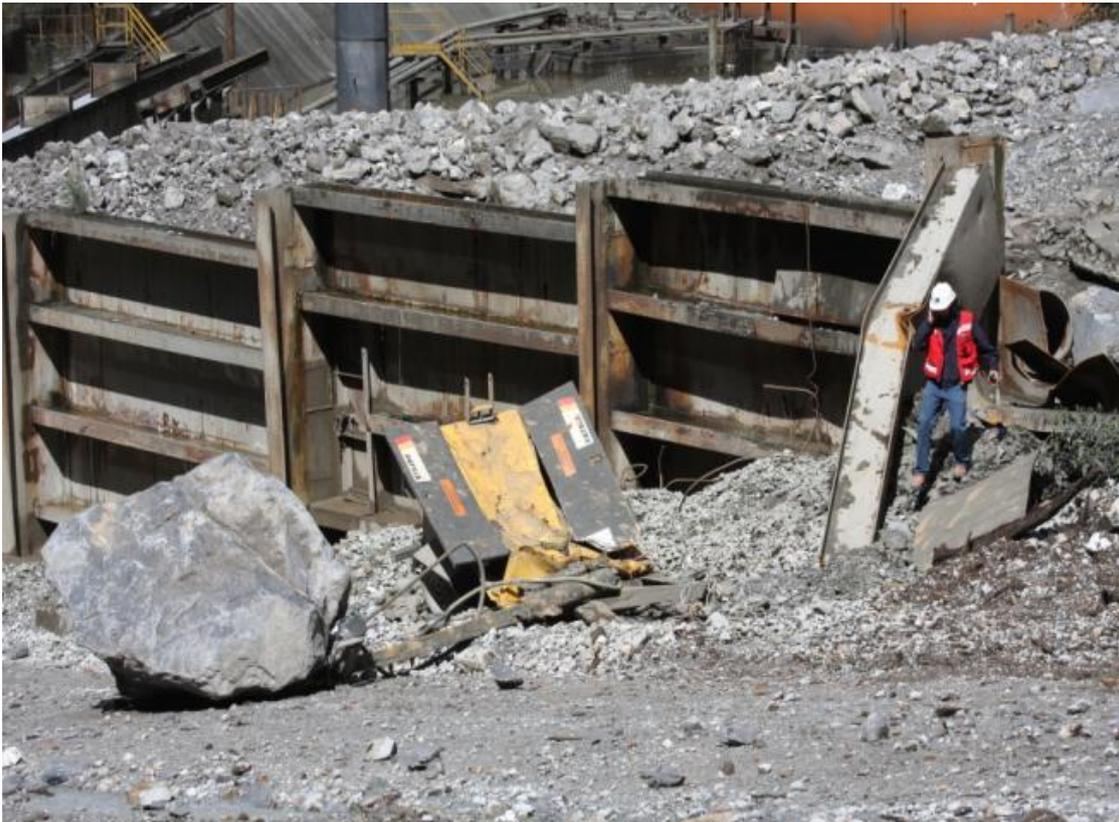
The number of major rockfalls over a short period of time caused serious interruptions to the operation of mill processing facilities, i.e. some rock fragments hit the flocculent and concentrator building; also some hit the main road causing its closure (Figure 3).

Figure 3 One of the rockfalls which hit the main road (originated approximately from 500 m above), September 2011

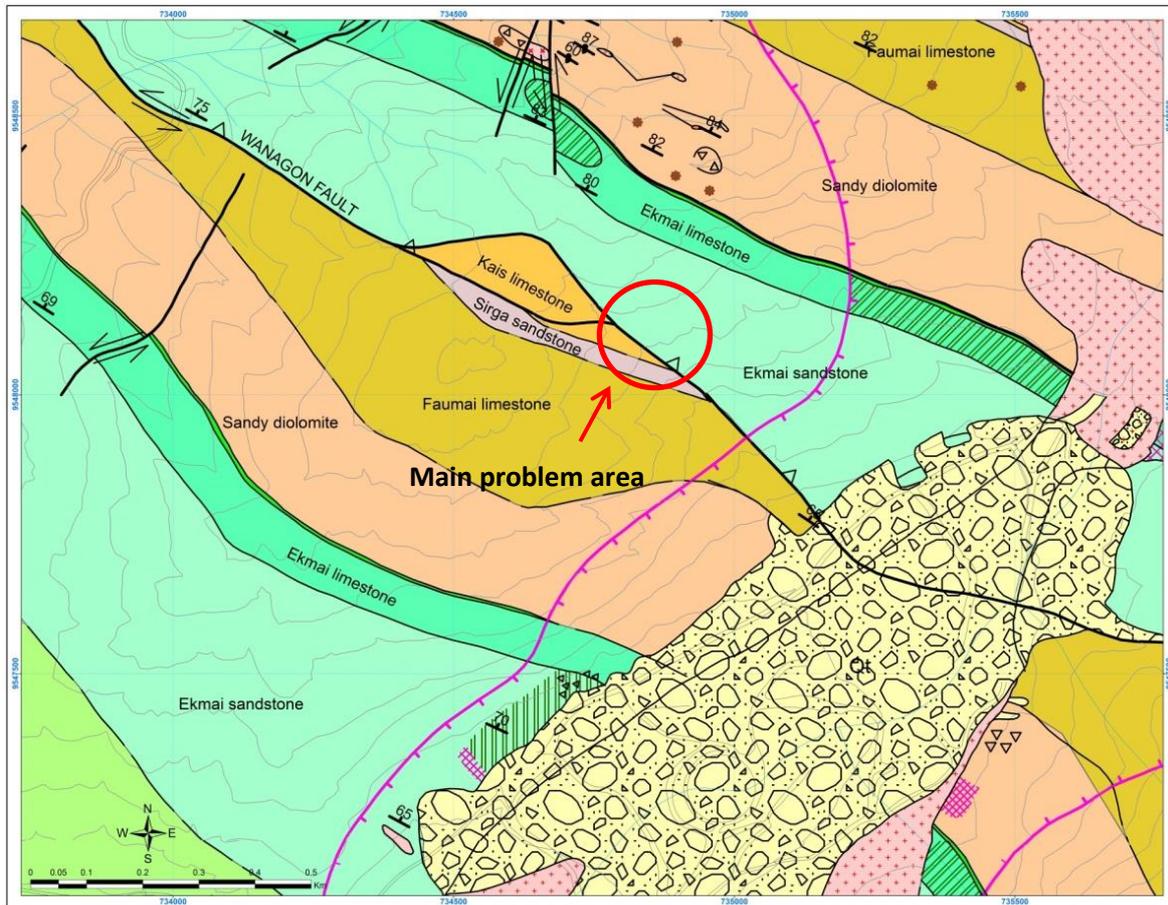
into the slope with the Wanagon Fault intersecting this area, and with a combination of intense jointing which creates mechanisms for potential slides and toppling failures (Figure 4).

Figure 4 Regional geological map – the West Gully area consists of Kais limestone (Tk₁); Sirga sandstone and shale (Ts); and Faumai limestone (Tf); the main structure is a Wanagon Fault with intense jointing and bedding

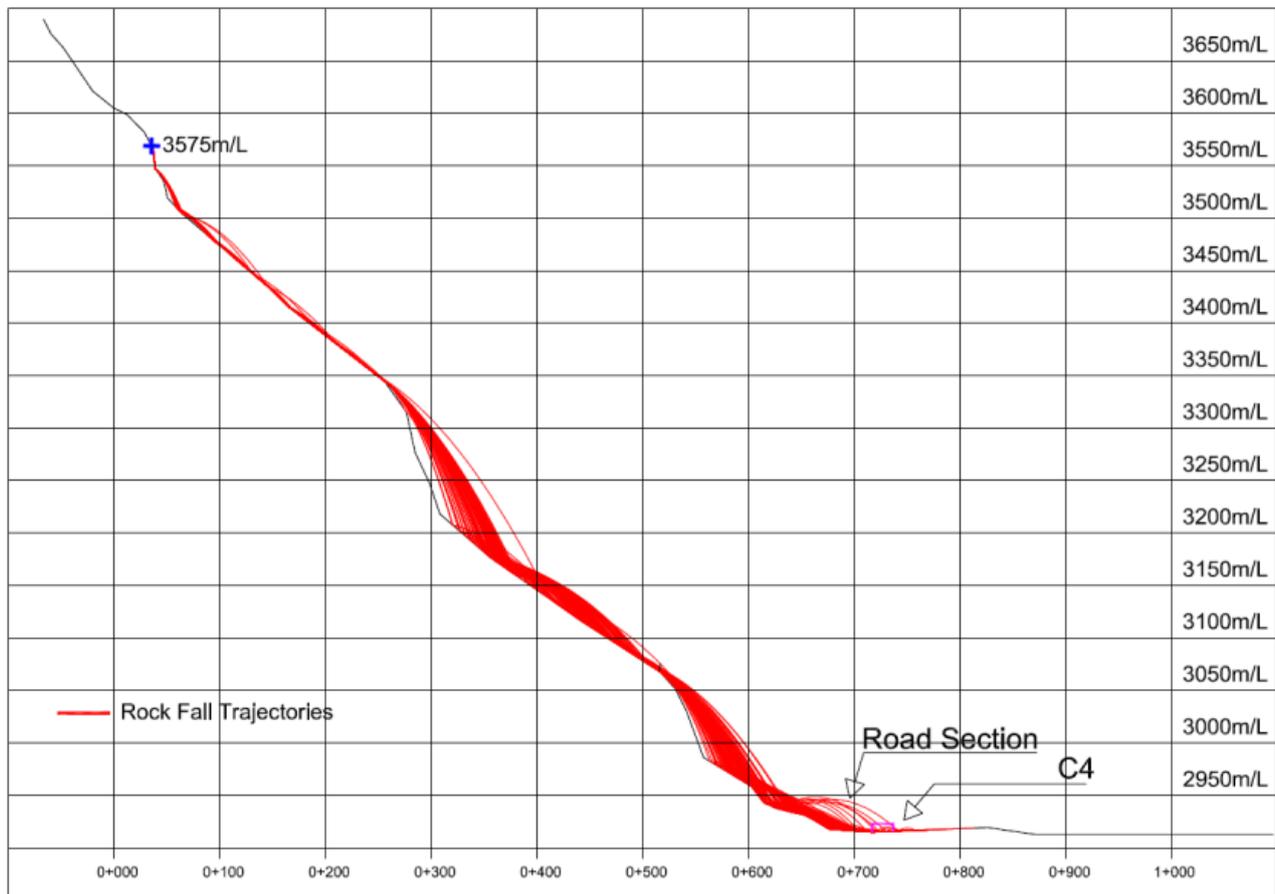
Figure 5 Two-dimensional rockfall analysis results without any protection (Rocscience Inc., 2013)

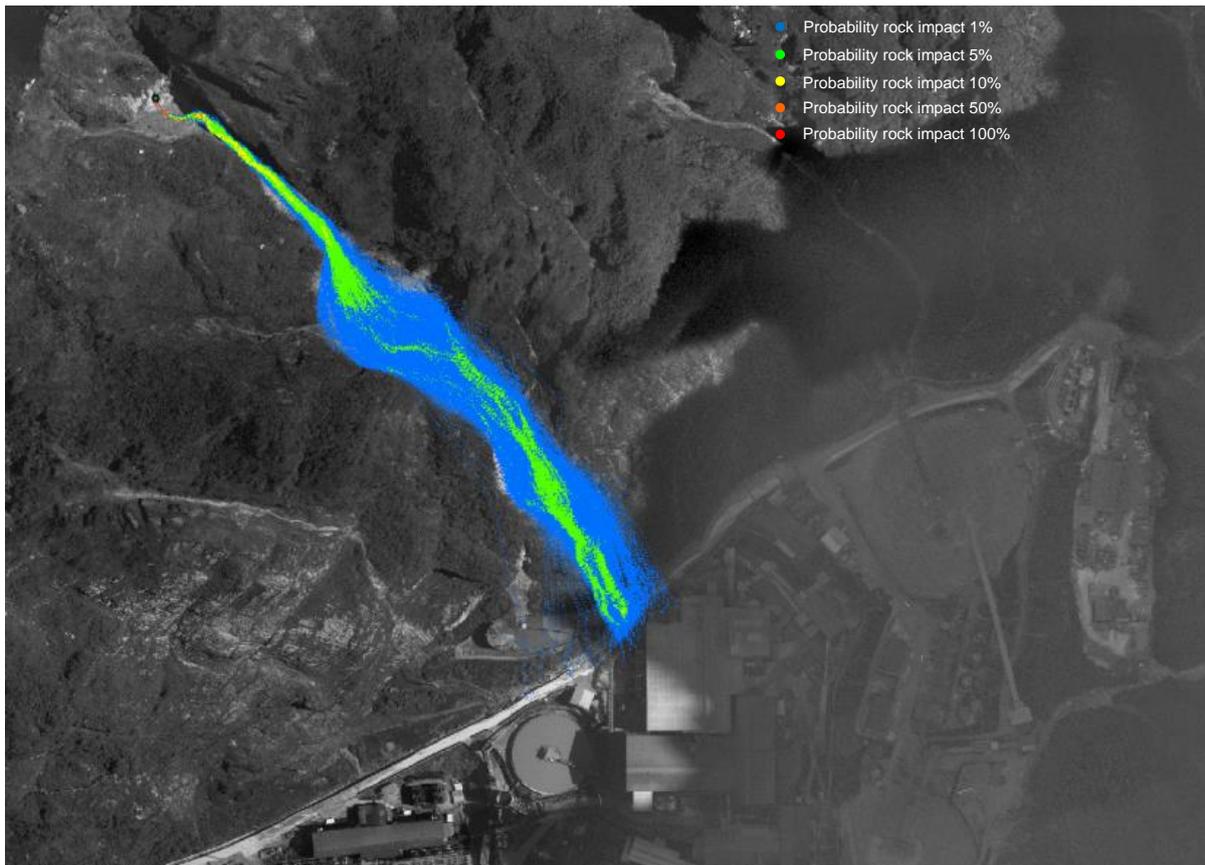
Figure 6 Three-dimensional rockfall analysis results without any protection (FEAT, 2013)

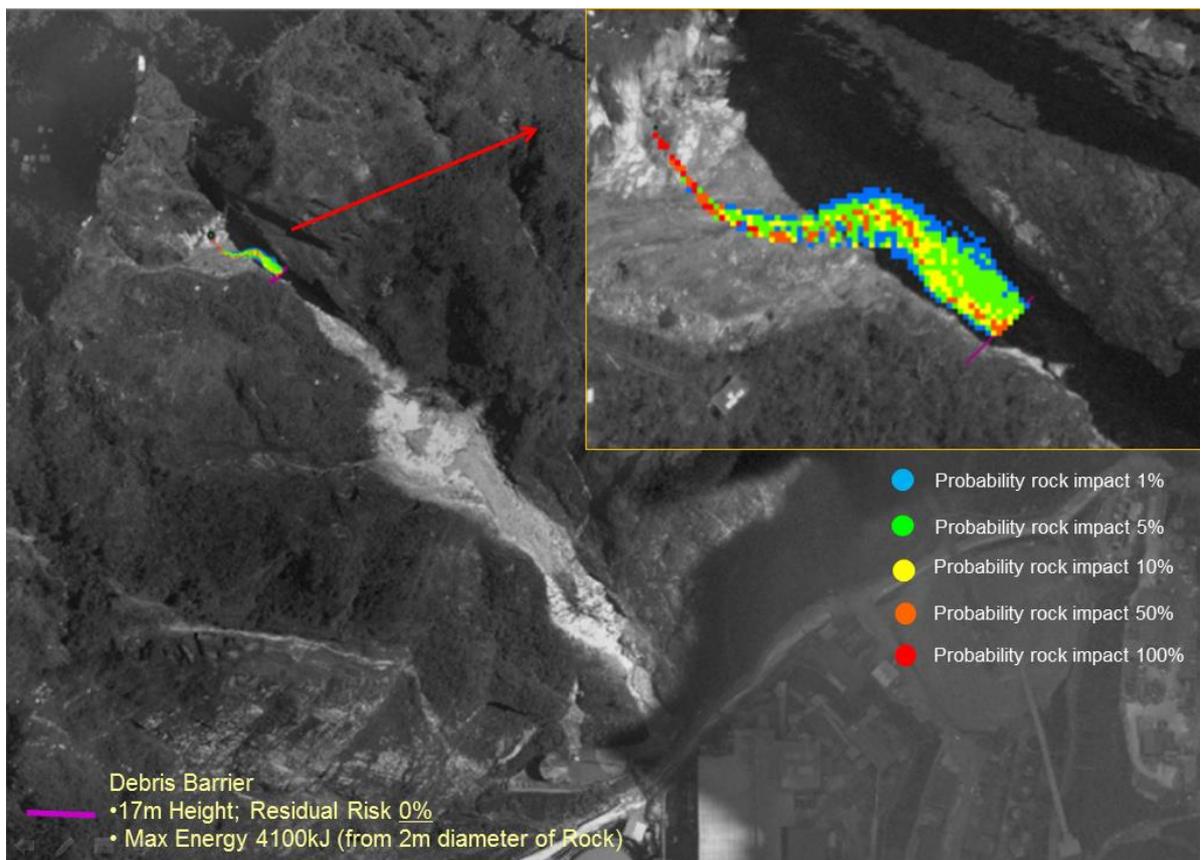
Figure 7 Analysis on debris flow structure effectiveness to capture material (FEAT, 2013)

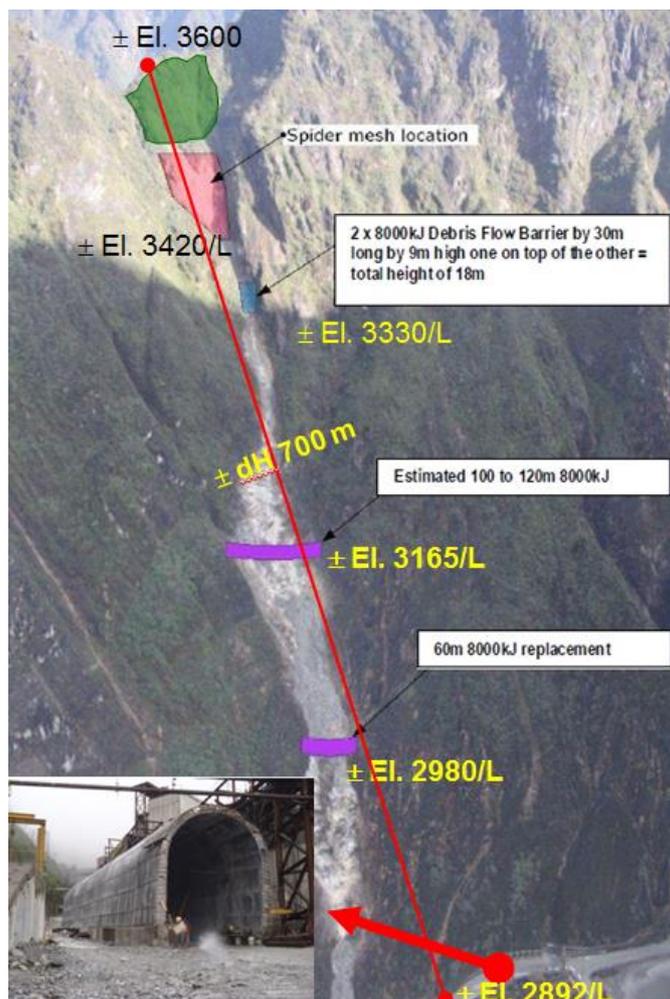
Figure 8 The original proposed rockfall protection and remediation at the West Gully area

- Scaling and spider meshing installation at main source area which was approximately 6,000 m².
- Debris flow barrier (17 m height with 8,000 kJ capacity).
- Rock fence at the upper section (9 m height with 8,000 kJ capacity).
- Rock fence at the lower section (9 m height with 8,000 kJ capacity).
- Corrugated steel/concrete tunnel (9,000 kJ capacity).

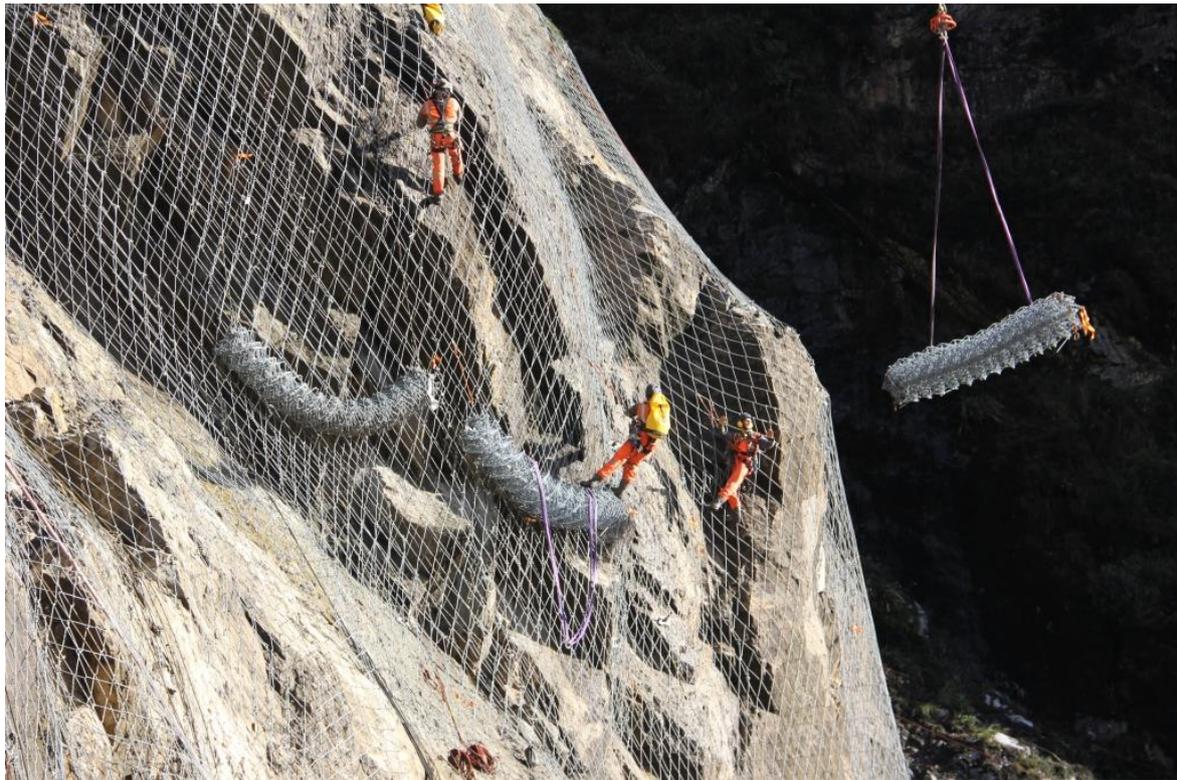
Figure 13 Meshing activities at the main problem area (December 2012)

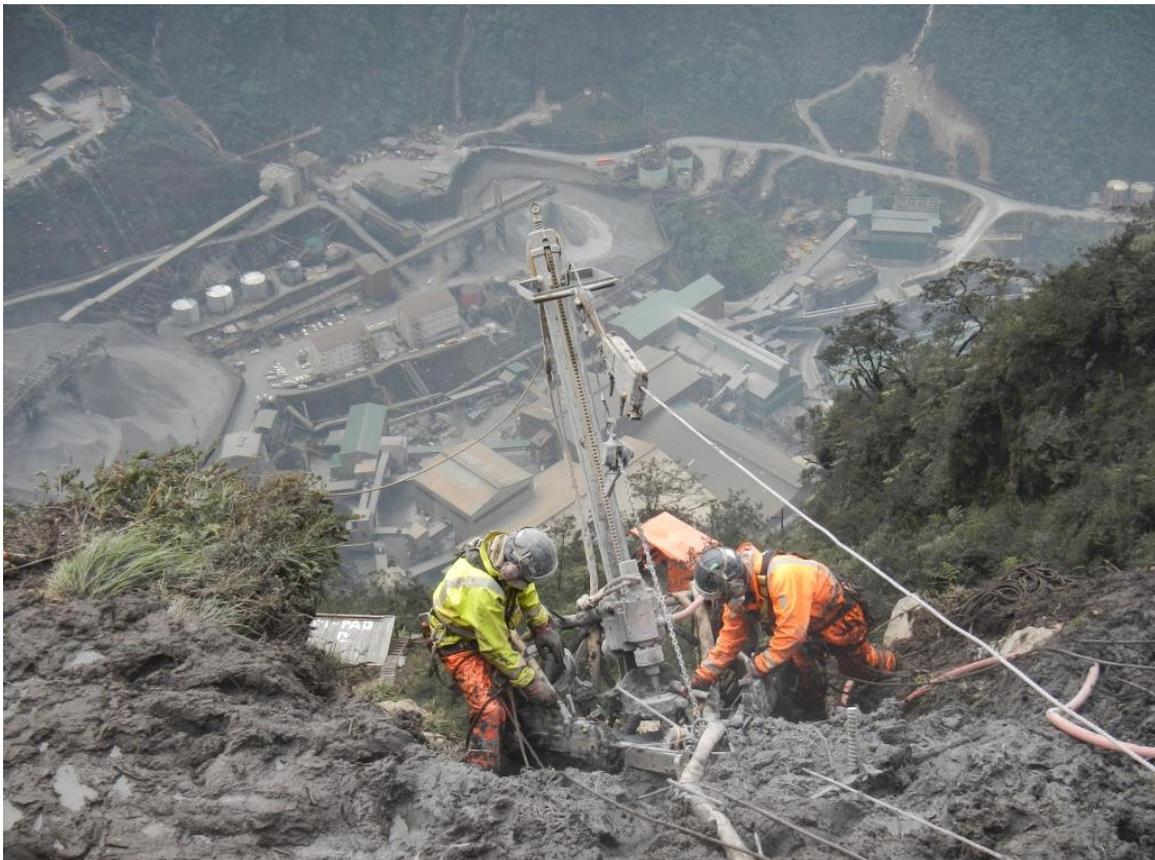
Figure 14 Drilling activities at the main problem area
