# Short-term solutions to squeezing ground at Agnew Gold Mine, Western Australia

## Abstract

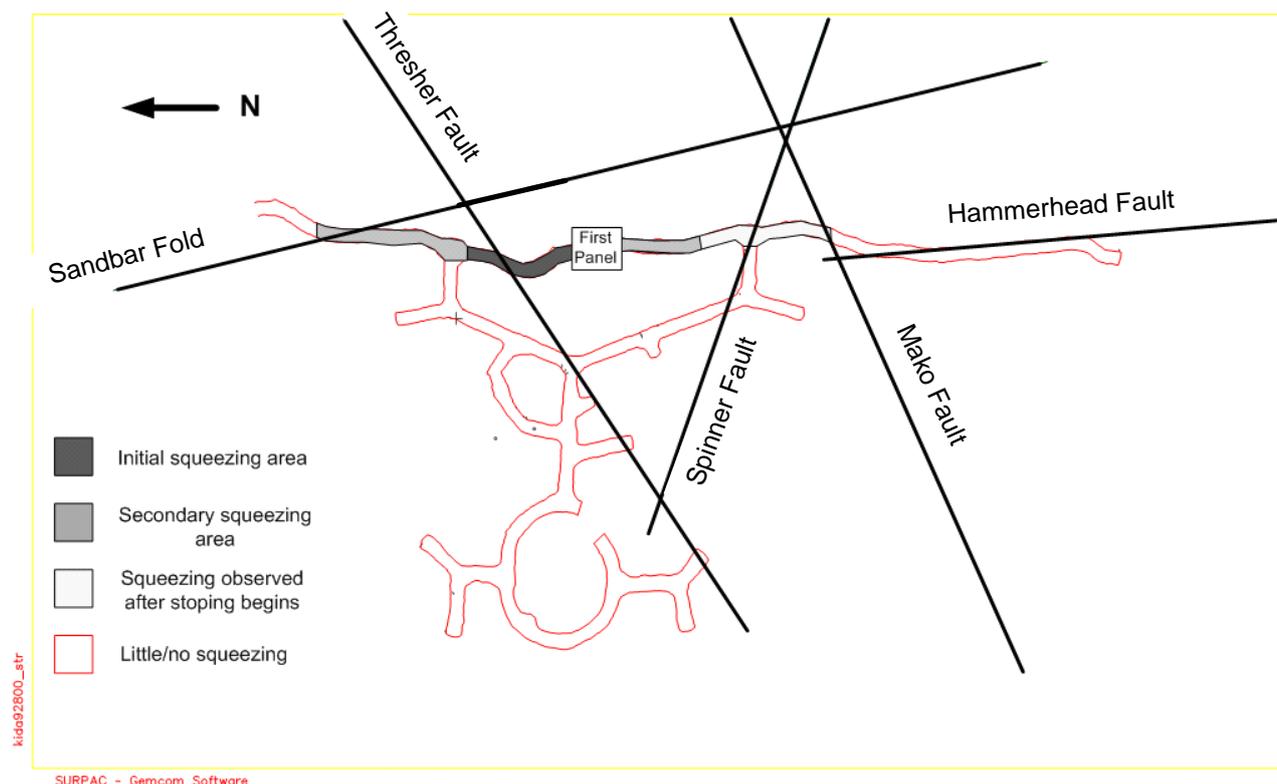
Figure 4 Squeezing areas in Lode 1 ore drives

Where squeezing conditions were observed in ore drives prior to stoping (Levels 2, 3, 4 and 5), the progression of squeezing/deteriorating ground appears to follow a noticeable pattern (Figure 4):

Deterioration occurs first in the central ore drive around the Thresher fault zone. On the FW cracking is observed in FC, with rockbolt plates taking load in this area. Initial signs of deformation in the HW shoulder may also be observed; noticeable deterioration to HW shoulder at this stage has predominantly been seen in lower ore drives (Levels 4 and 5).

Deterioration continues around the Thresher fault zone; FW bulging becomes noticeable and rockbolt plates may fail in this area; initial indicators of floor heave are observed. Bulging will also become noticeable in the HW shoulder; bolts begin to fail in backs.

Significant floor heave and FW bulging is seen around Thresher fault zone, and more than 20% of ground support in area is compromised; failing rockbolts, significant FC cracking and failure. HW shoulder/back may fail if not meshed, and slabbing is observed on the sidewall. Stage 2 style deformation is observed in the north and remainder of central ore drive.

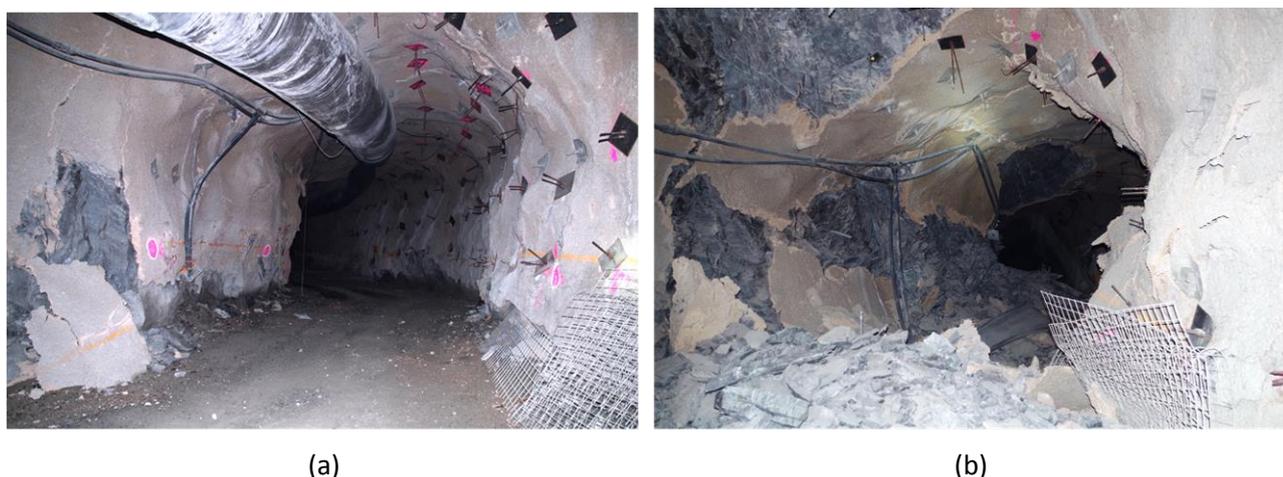
Figure 5 Initial squeezing and final profile before signing off in Level 4: (a) initial deterioration; and (b) final profile

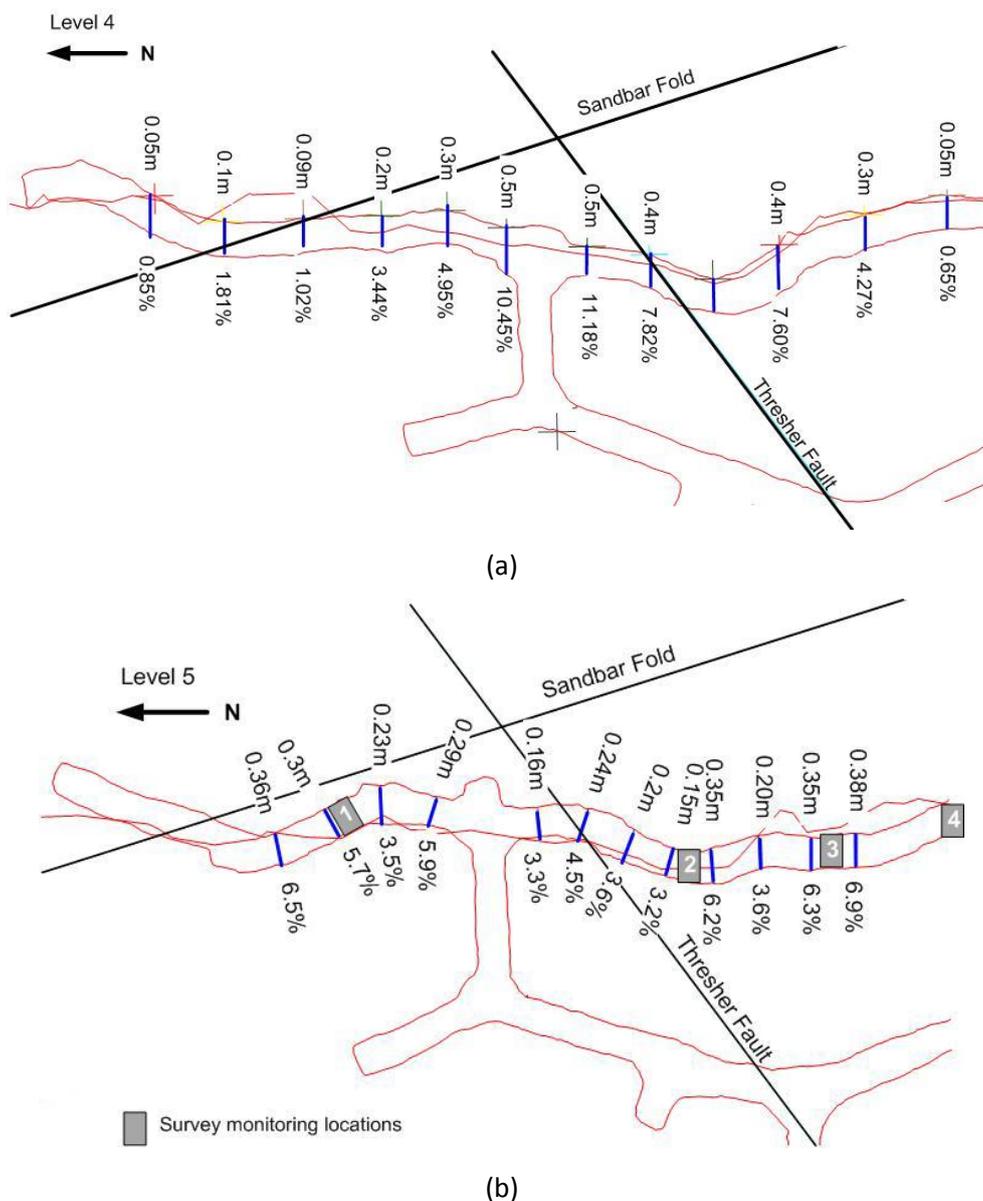
Measurements in Level 4 were taken over a three month period before area became too damaged to enter without rehabilitation. During this time, the stoping front progressed to Level 3 and significant deformations were recorded around the Sandbar fold and Thresher fault zone, with the largest deformation of 0.5 m recorded at the north intersection between these two structures (Figure 6(a)). It is estimated that final deformation in this area was around 0.9 m.

Figure 6 (a) extensometer locations, measured deformations and calculated strains, Level 4; and (b) extensometer and survey monitoring locations, measured deformations and calculated strain, Level 5

Measurements in Level 5 have been taken over a 6-month period. As with Level 4, this drive showed significant deformation between the Sandbar fold and Thresher fault zone. However, the largest measured deformation is approximately 50 m from the Thresher zone (Figure 6(b)).

The highest percentage strain in Level 4 was measured at Pin 7, and at 11.17% places this area in the extreme squeezing category of the hard rock squeezing ground index (Mercier-Langevin & Hadjigeorgiou 2011; Mercier-Langevin & Wilson 2013). The largest strain calculated so far in Level 5 is 6.88% at Pin 12 (Figure 6) placing this area in the very severe squeezing category; it should be noted that further deformation is expected in Level 5 as has already occurred in Level 4.

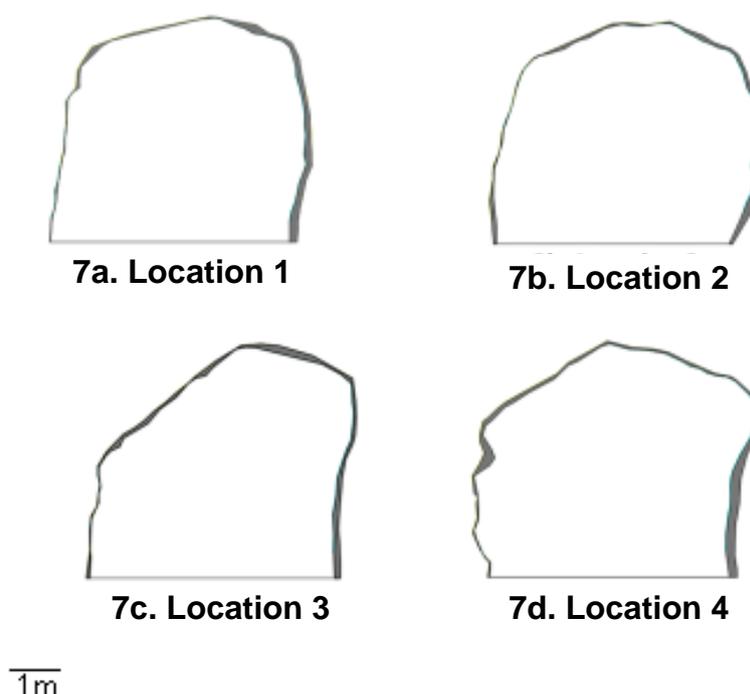
Measured deformation from survey monitoring (Figure 7) is  $\approx 120$  mm, this is considerably less than that measured using the extensometer, although, it should be noted that extensometer measurements began more than two months before survey monitoring and that deformation was on-going during this time span. Survey monitoring shows clear squeezing of the FW, corroborating extensometer measurements and observations, it also shows closure in backs and HW.

It has highlighted that adherence to design profile in Level 5 was poor. Intriguingly locations 3 and 4, those with the most accurate profiles, appear to show more HW movement than locations 1 and 2. Very slightly more FW movement has also been recorded in location 4 compared to other locations. However, it is impossible to definitively say if the profile is affecting squeezing behaviour based on four monitoring locations. This may be an interesting area of further study.

Figure 7 Survey profile monitoring, Level 5

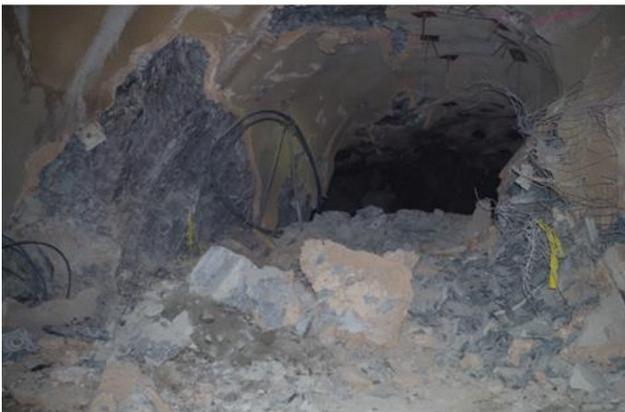
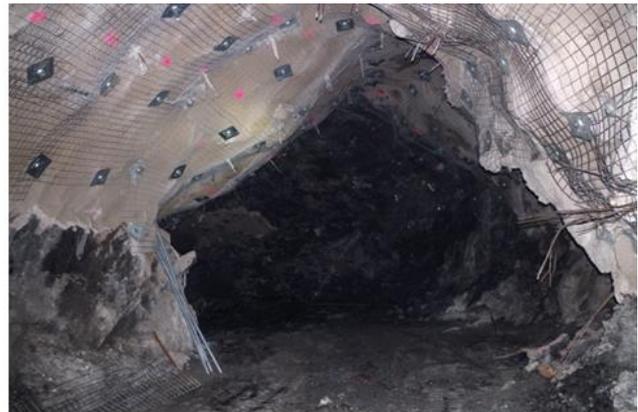
Figure 9 Level 3 north ore drive at peak deformation and after rehabilitation: (a) peak deformation; and (b) after rehabilitation

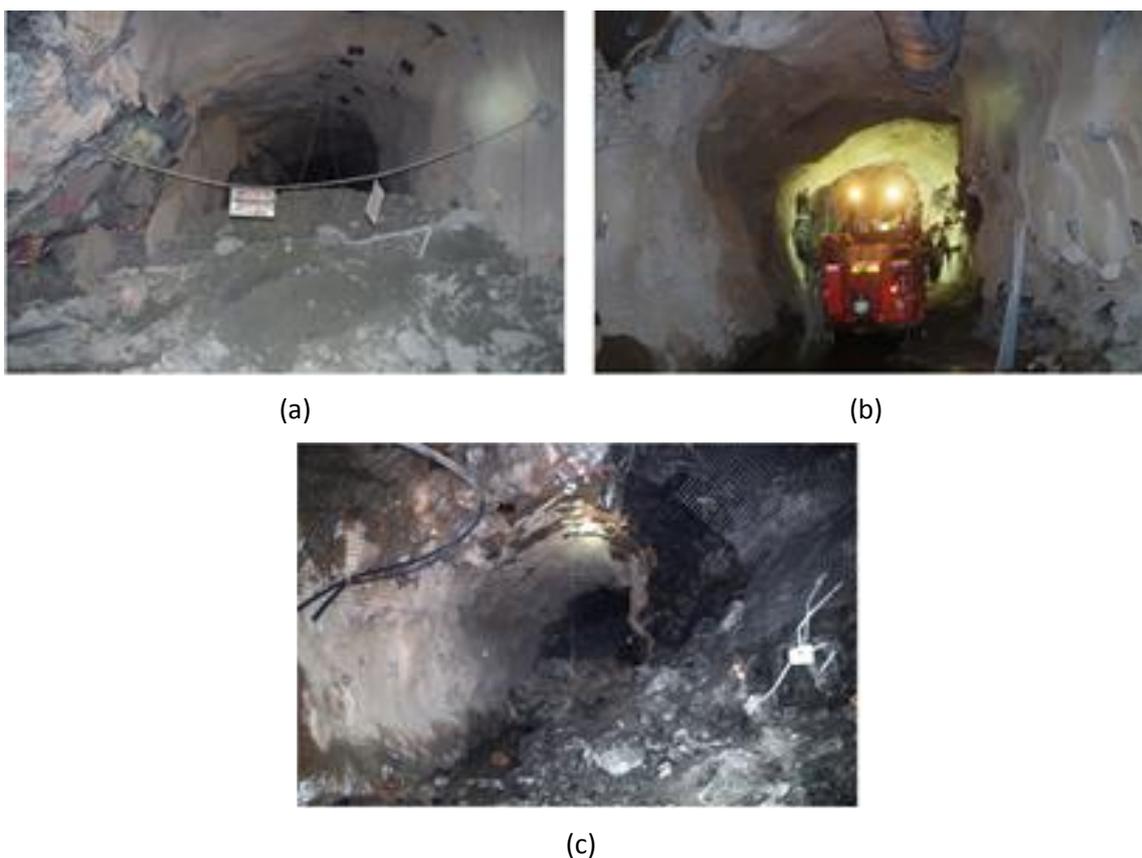
Figure 10 Level 3 deformation, first and second rehabilitation cycles: (a) stage 2 deformation; (b) first rehabilitation cycle; and (c) second rehabilitation cycle

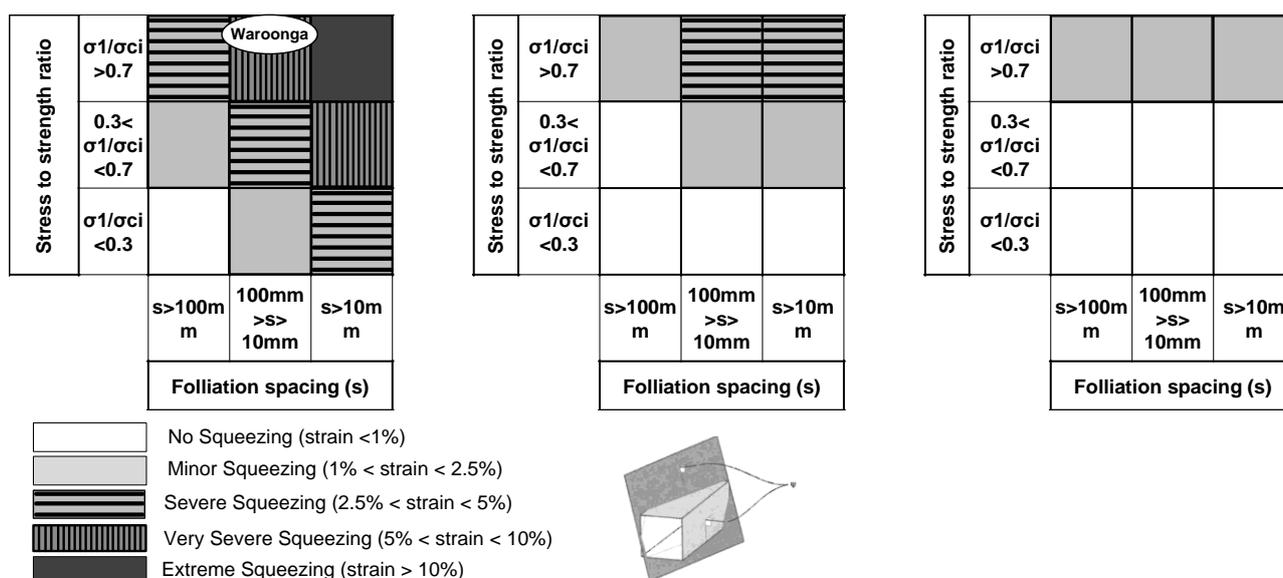
When lower bound ultramafic strength (SkU3) was used and taking into account increased stress with depth Levels 1-5 were all predicted to experience severe to very severe squeezing conditions (Figure 11); all parameters (Table 2) remained constant across levels except principal stress which increased by  $\approx 1$  MPa per level. This can be directly correlated to percentage strain, calculated after Hadjigeorgiou et al. (2013), which showed that Levels 4 and 5 were experiencing, on average, very severe levels of squeezing, with two locations in Level 4 falling into the extreme category.

Figure 11 Squeezing matrices for different angles of interception, after Mercier-Langevin and Hadjigeorgiou (2011) and Mercier-Langevin and Wilson (2013), with squeezing prediction for Waroonga Lode 1

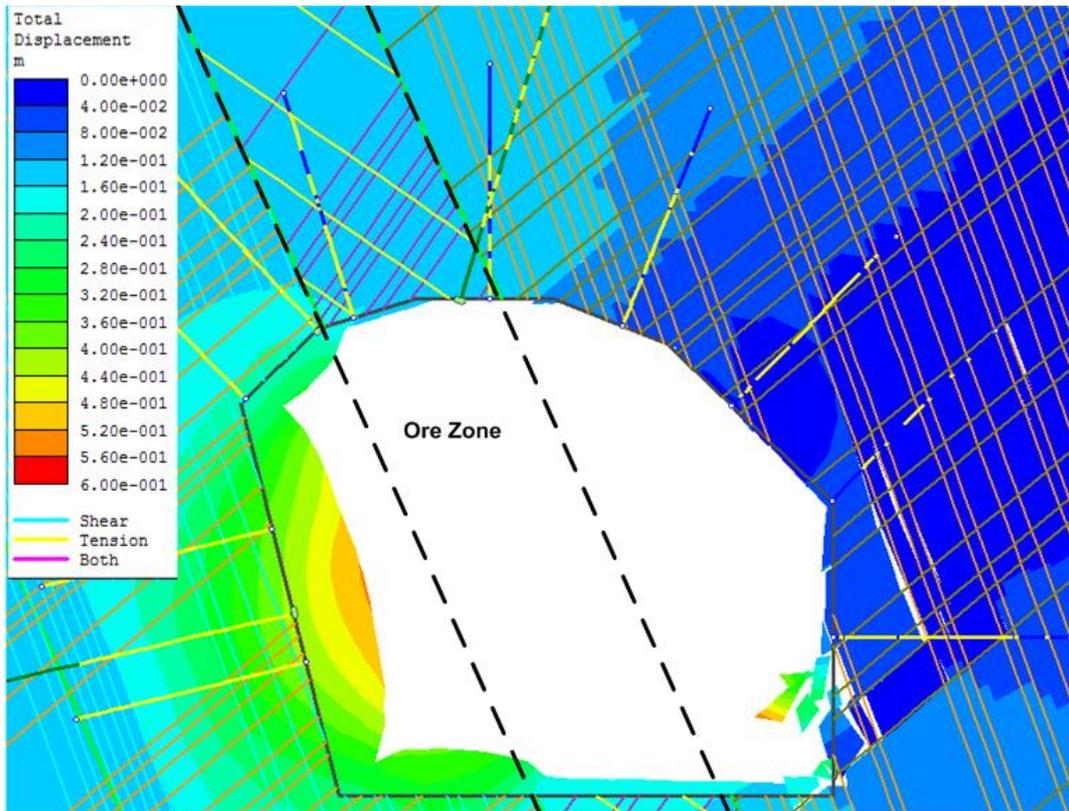
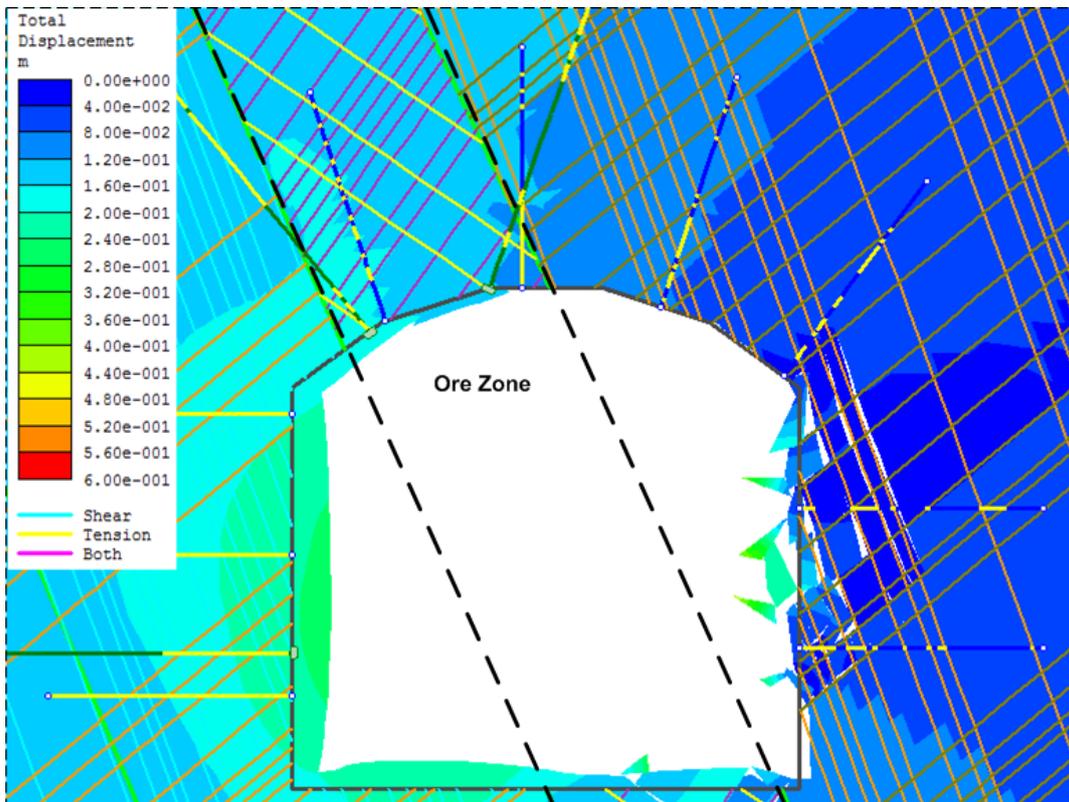
Results of shanty profile modelling (Figure 12(a)) show potential for up to 600 mm of squeezing, which corresponds well with observed conditions in Levels 4 and 5, this model also showed potential for sliding from HW joints; also observed underground. The model did not capture significant deformation in HW shoulder and backs. Interestingly results of arched profile modelling (Figure 12(b)) shows less deformation in FW, with just 300 mm predicted with this profile; this appears to corroborate initial analysis of survey profile monitoring.

Figure 12 Total deformation predictions from 2D finite element modelling of Level 5: (a) shanty drive profile; and (b) arched drive profile

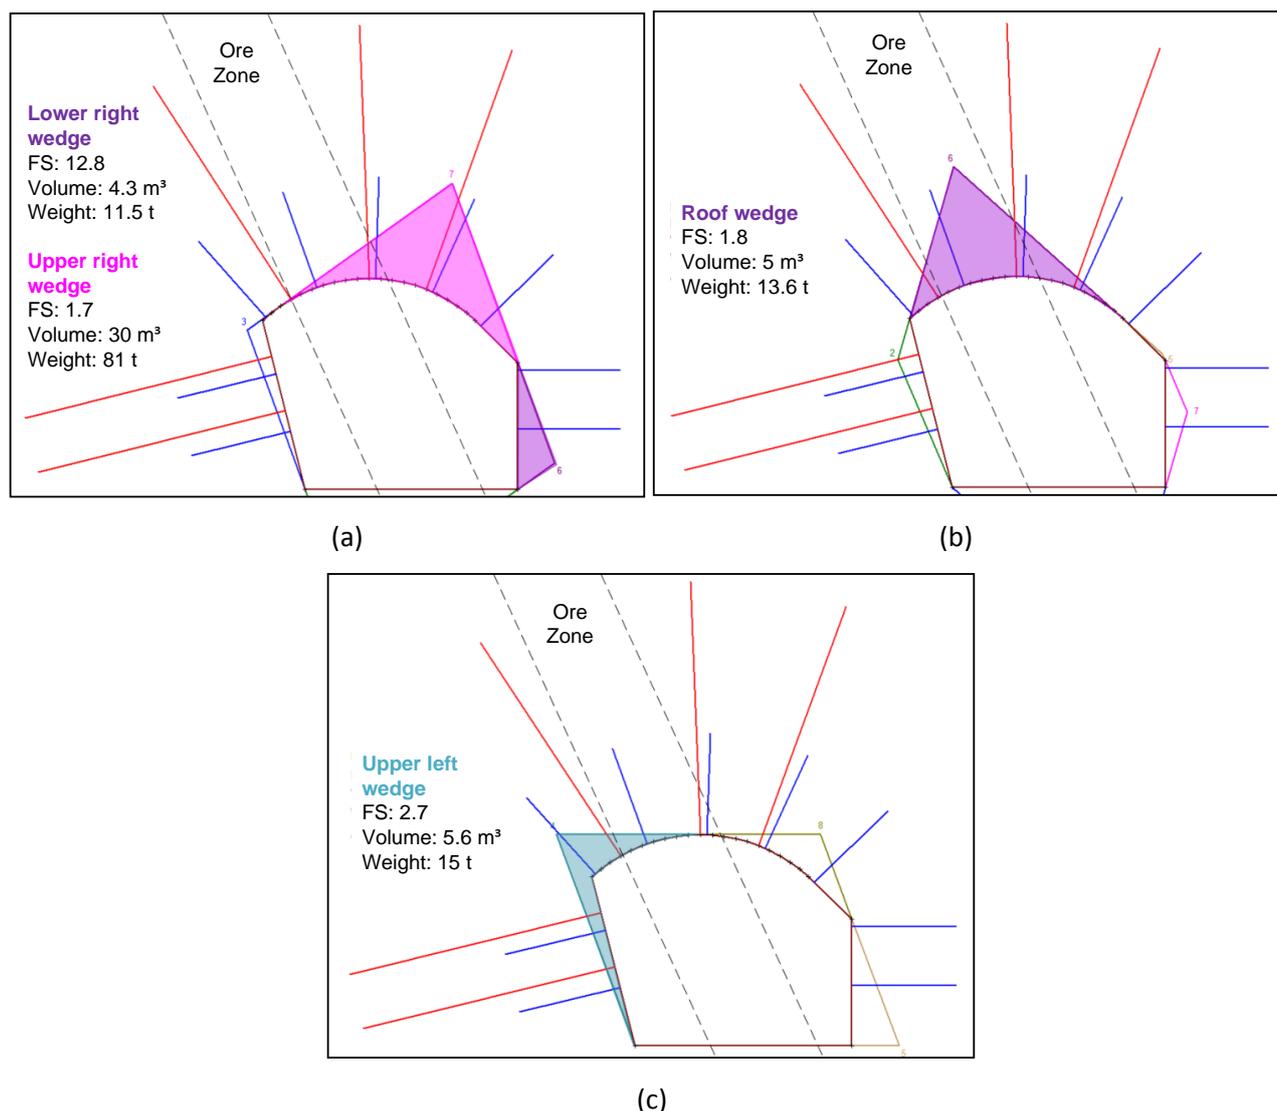
Kinematic analysis, using Unwedge, of joint sets present in HW, ore zone and FW showed that 2.4 m friction stabilisers, combined with cable bolts, would provide a FS of 1.8 and 1.7, in the ore zone and HW respectively, for wedges most likely to cause failure (Figure 13). FS is likely higher in actuality since interface between HW and ore zone will truncate the maximum size of wedges formed. Given this, and given that the site required FS for ground support is 1.5, the calculated FS of 1.7 and 1.8 were considered as acceptable.

Figure 13 Kinematic analysis of possible HW, FW and ore zone wedges with planned rehabilitation support elements: (a) HW joint sets; (b) ore zone joint sets; and (c) FW joint sets
