# Pit slope evaluation based on the historical failure database at Batu Hijau mine

**HD Lelono** *PT. Newmont Nusa Tenggara, Indonesia*

## Abstract

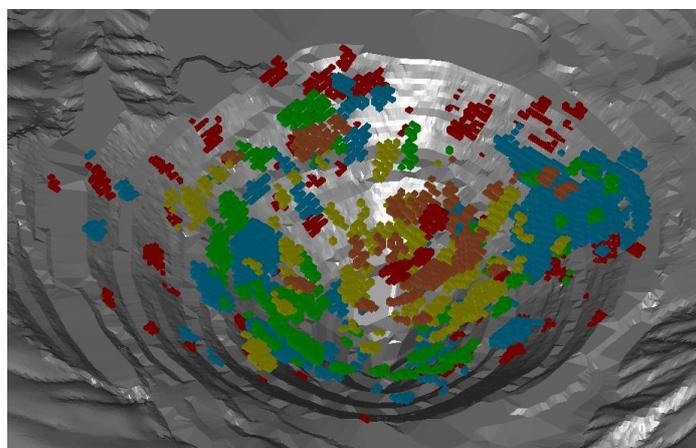
To visualise the failures collectively, a failure block model has been generated as shown in Figure 7. Using the topographic survey of the failure area and the interpreted failure surface underneath, solids of failed material were generated. With Minesight Mining software, 3D blocks were generated that capture the main characteristics of each failure, such as date of failure, slope aspect, orientation of the structures involved, interpreted failure mechanism, geotechnical domain, lithology, alteration, volume, mining phase etc.

Figure 7 Geotechnical failure block model based on the failure model updated at the end of 2015

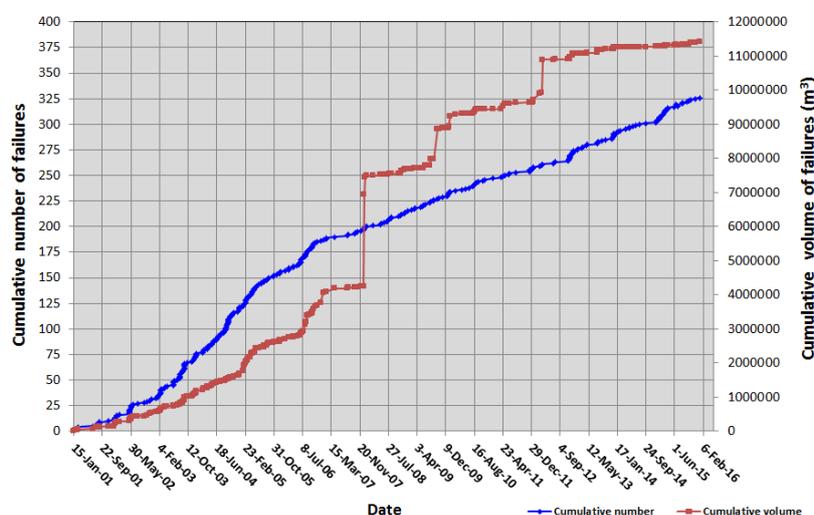
During the period considered, Batu Hijau mine has experienced 325 failure events, which include the propagation, extension and reactivation of existing failures. The total volume calculated from the failure solids is about 11,3 Mm<sup>3</sup> or 29.35 Mton. See Figure 8 for a summary of the cumulative volume of failure and number of failures.

Figure 8 Graph shows comparison between cumulative and total volume of failure

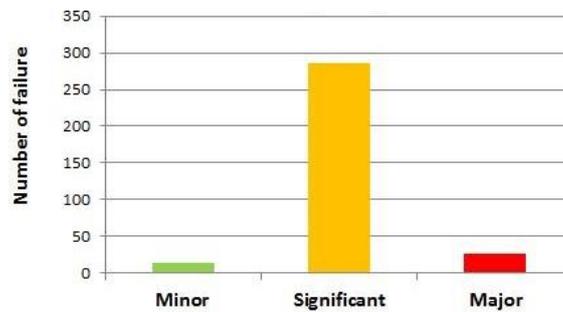
Based on the size of the slope failure, they were categorised into minor, significant and major failure events. Failure less than 1.5 Kmt was categorised as minor failure, significant failure was ranging from 1.5–150 Kmt, and major failure was more than 150 Kmt. The distribution of each failure category as follows:

- Minor is approximately 4% (13 events).
- Significant is approximately 88% (286 events).
- Major is approximately 8% (26 events).

Figure 9 The distribution of failures based on the open pit slope reporting criteria

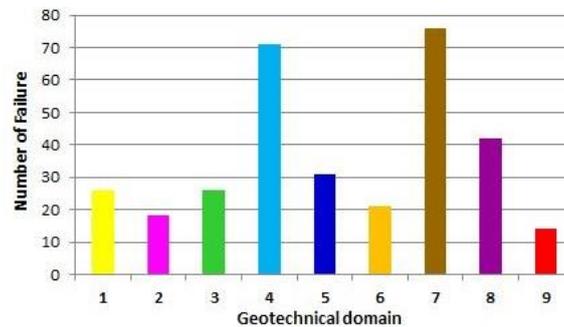
Based on the failure number, the largest number of failures occurred in the volcanic rock type of domain 7 (Tambora hanging block) with 76 events (23.4 %). Second was the diorite rock mass of domain 4 (east wall lower block) with a total of 71 failures (21.9 %), and third was the volcanic rock of domain 8 (northwest block) with 42 failures (12.9 %). A detailed summary of the total number failures per geotechnical domain is shown in Figure 10.

Figure 10 Number of failures per geotechnical domain

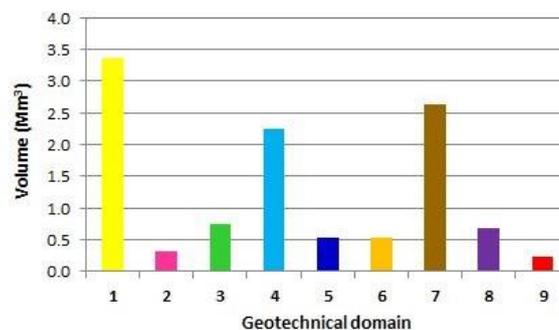
Based on the total volume, the largest failure volume occurred in domain 1 (north upper block) with 3.37 Mm<sup>3</sup> (29.6%) that was largely contributed by failures 17 and 19. The failure volume in domain 7 was 2.67 Mm<sup>3</sup> and came largely from failure 55. The failure volume in domain 4 was 2.24 Mm<sup>3</sup> and largely from failure 53. Figures 10 and 11 show the detail for the total number and volume of failure based on geotechnical domains.

Figure 11 Total volume of failures per geotechnical domain

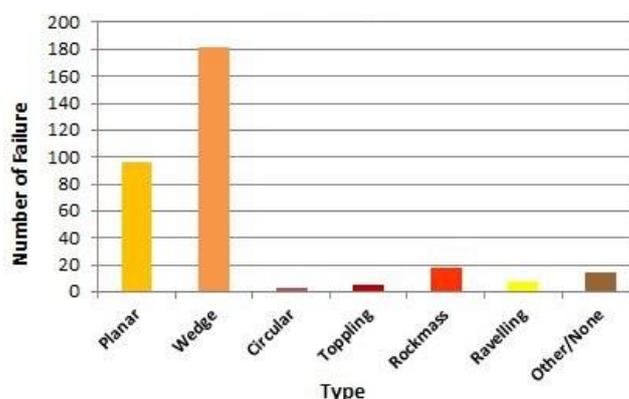
The failure database indicated that wedge type failure is the most common with 181 (55.7%) failure events. Planar failure was less common with 96 (29.5%) failure events. Other failure mechanisms occurred only occasionally as shown in Figure 12.

Figure 12 Number of failures by failure type

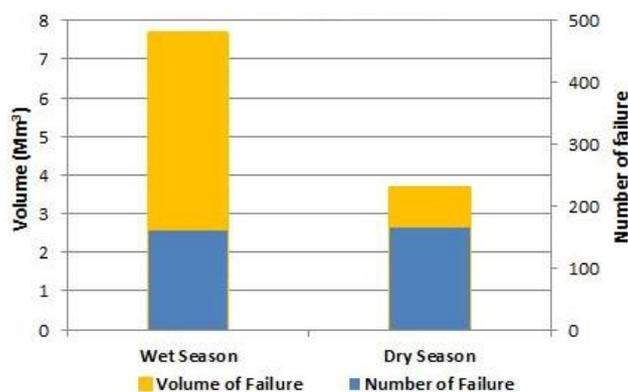
Historically at Batu Hijau, the wet season (rainy season) occurs from November to April, and the dry season from May to October. Based on failure occurrence, there was no significant difference between the wet and dry seasons in terms of failure number; 159 failures occurred during the wet season and 166 failures occurred during the dry season. This indicates that the slope failures most likely occur due to internal factors, namely the geological structures as described in the previous section. However, the total volume of failure is bigger during the wet season compared to the dry season, with 67.7% of the total failure volume. The rain fall thus contributes as an external factor that triggered and impacted to the size of the slope failure. Figure 13 shows the total number and volume of failures for the different seasons.

Figure 13 Failures based on season

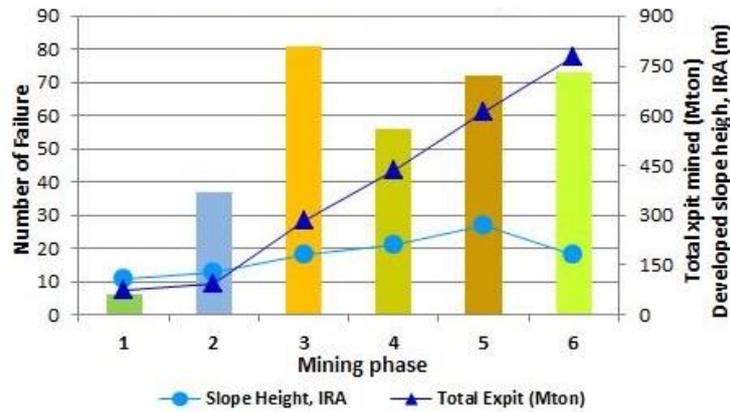
Phase 3 showed a significant number of failure events with a total number of 81 failures (24.9%). Even though the phase 3 mining dimensions were small compared to the current mine shape of phase 6, phase 3 mining was aggressive by applying ‘scram cut’ mining. Furthermore, 72 failures occurred during phase 5, and 73 occurred to date in the current phase 6. The comparison of the total number of failures for each mining phase is shown in Figure 14.

Figure 14 Number of failures based on mining phase

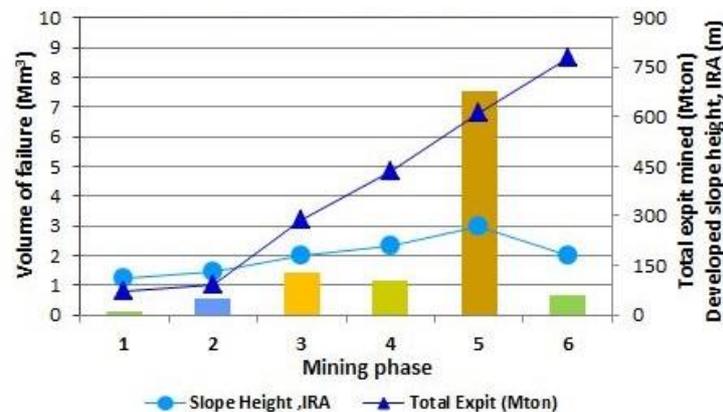
The highest total volume of failure occurred during phase 5 mining with around 7.53 Mm<sup>3</sup> (65.7%). The total failure volume for the current phase 6 mining is low and around 0.66 Mm<sup>3</sup>. The comparison of total number and volume of failure for each mining phase is shown in Figures 14 and 15.

Figure 15 Total volume of failures based on each mining phase

The failure size during phase 6 was controlled by the slope dimension as the highwall slope height was limited less than 150 m. In terms of rock mass quality, there was not a significant change from phase 5 and phase 6, except in the upper portion of the slope at the west wall.

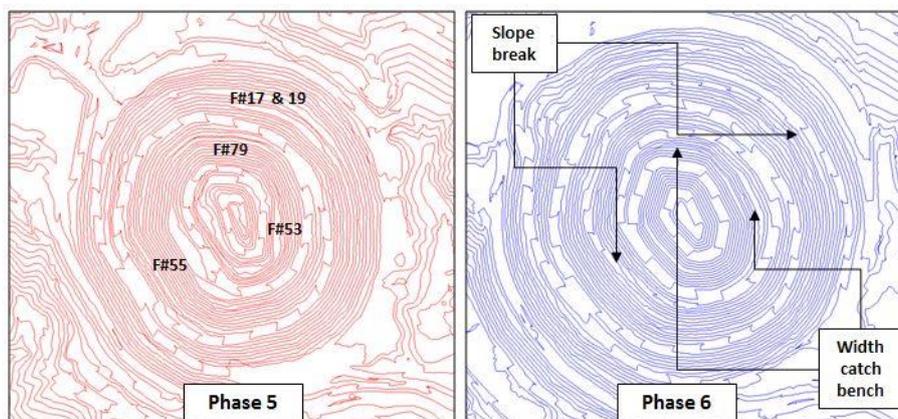
Figure 16 Implementation of slope breaks and wide catch benches in phase 6

Slope breaks and wide catch benches were designed for the areas that experienced major slope failures during previous phases, and the maximum inter ramp height was limited to 150 m. Allowance was made during slope design for these areas to provide 'flexibility room' for in-case instabilities develop. In addition, the slope breaks and wide catch benches can be utilised for infrastructure such as power poles, alternative accesses, surface drainage and geotechnical instrumentation. The decoupling of the highwall is shown in Figure 16.

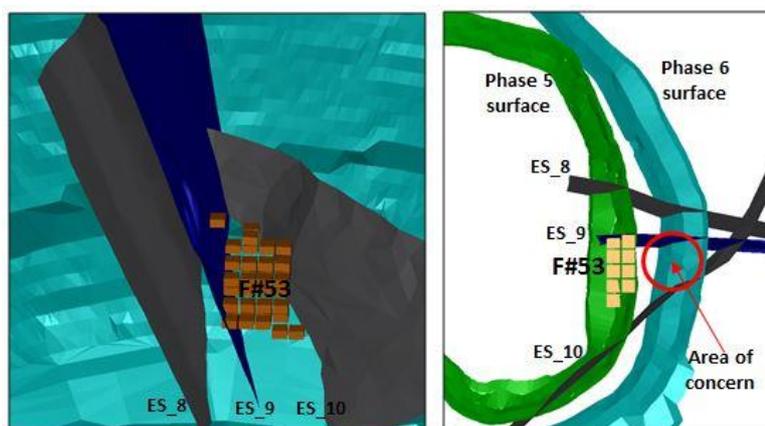
Most of multiple bench scale failures at Batu Hijau were structurally controlled by major and intermediate faults, joint sets and rock fabric. Therefore, understanding the faults and defect set orientations are critical to anticipate potential instabilities. A mapping program has been developed to increase the reliability of the structural model, and the model was used to investigate the role of these structures during past instabilities. The major and intermediate fault triangulations can be overlaid onto the failure model to seek potential instability issues on the current or future mine design. An example is shown in Figure 17.

Figure 17 Interpretation of instability issues based on the structural and failure models

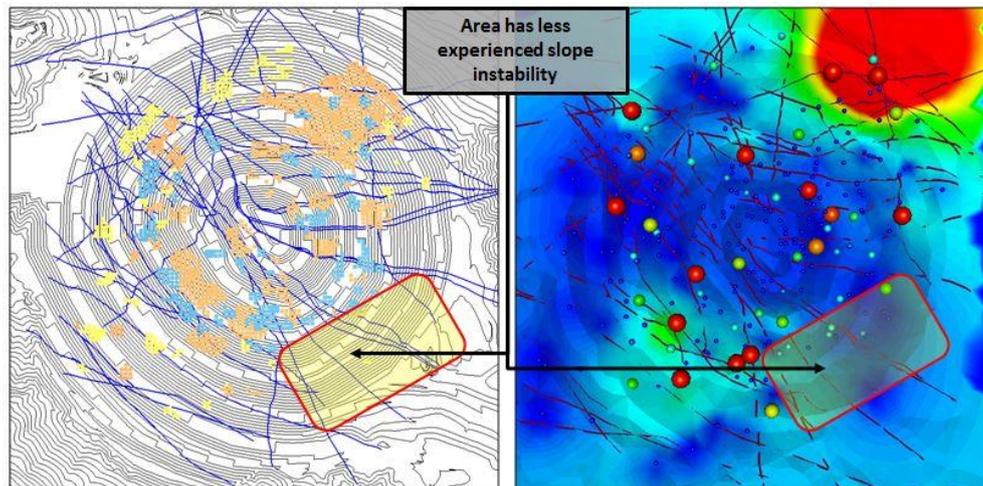
The failure database can be used during back-analysis of previous events, and the learnings can assist with predictions for the next mining phase. For example, using the failure data showed that the failure distribution on the southeast sector of Batu Hijau pit is low. Furthermore, the structural model shows that the major structures are perpendicular to the slope face. As a result, an opportunity could be explored to steepen this southeast sector of the next cut back of phase 7 mining. The simple example of the interpretation process is shown in the Figure 18, but future geotechnical studies and assessments will be conducted.

Figure 18 Interpretation failure histories and major faults
