# Geotechnical challenges in development of El Soldado open pit

EO Bermedo *AngloAmerican Chile, Chile*

## Abstract

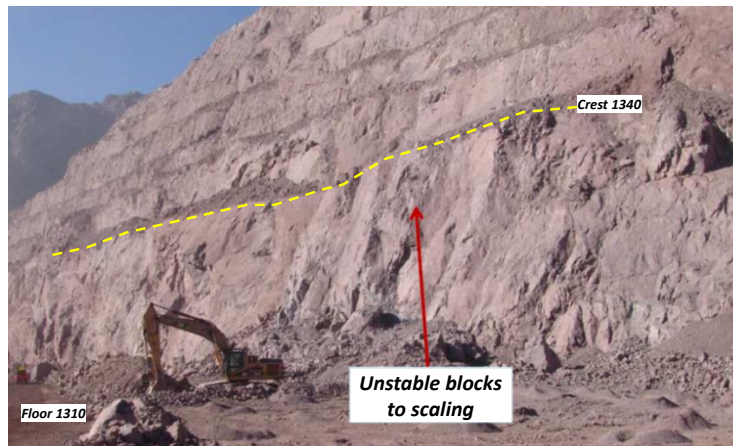
During the development of the first benches of Phase 3, structurally controlled instabilities were observed at the bench level (Figure 3), they were scaling with mechanised equipment as they emerged. It was not possible to generate a predictive analysis of potential instability that would compromise the development of Phase 3 because bench mapping and structural modelling had not been performed nor updated since 2006. From the operational point-of-view, the wall control blasting techniques were deficient because design lines in the foot of the bench were not achieved and generated excessive damage on the crest (Figure 4). Typically, the losses were between 4 to 6 m in the foot and 2 to 5 m on the crests, this meant a reduction of the width of the berm. On the other hand, there were no operational practices to clean benches with preformed blocks located on the crests of benches.

Figure 3 Initial observed condition in the development of Phase 3

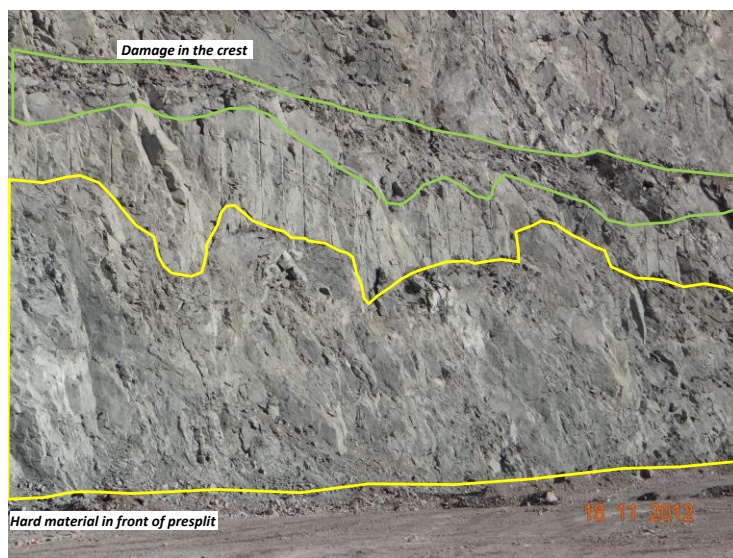
Figure 4 Final wall condition in 2012

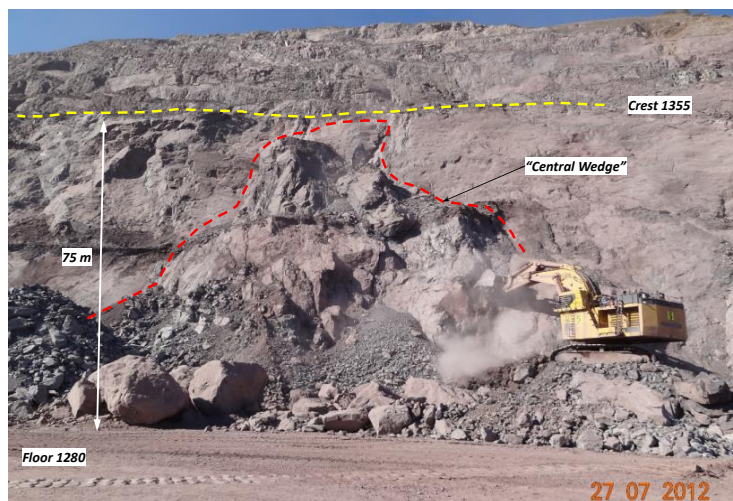
The development of Phase 3 continued to bench 1280, as it had been assumed that the observed instability could be caused by its proximity to the California Fault. However, in bench 1280, a non-daylighting wedge type instability was observed in the central part of Phase 3 between the coordinates N-300 and N-500, named Central Wedge (Figure 5).

Figure 5 Central Wedge in bench 1280

In parallel with the update of the major structures and proposals for alternative designs, the wedge was mined out and the wall cleaned between elevation 1280 and 1355 (Figure 5), the final condition achieved in March 2013 (Figure 7).

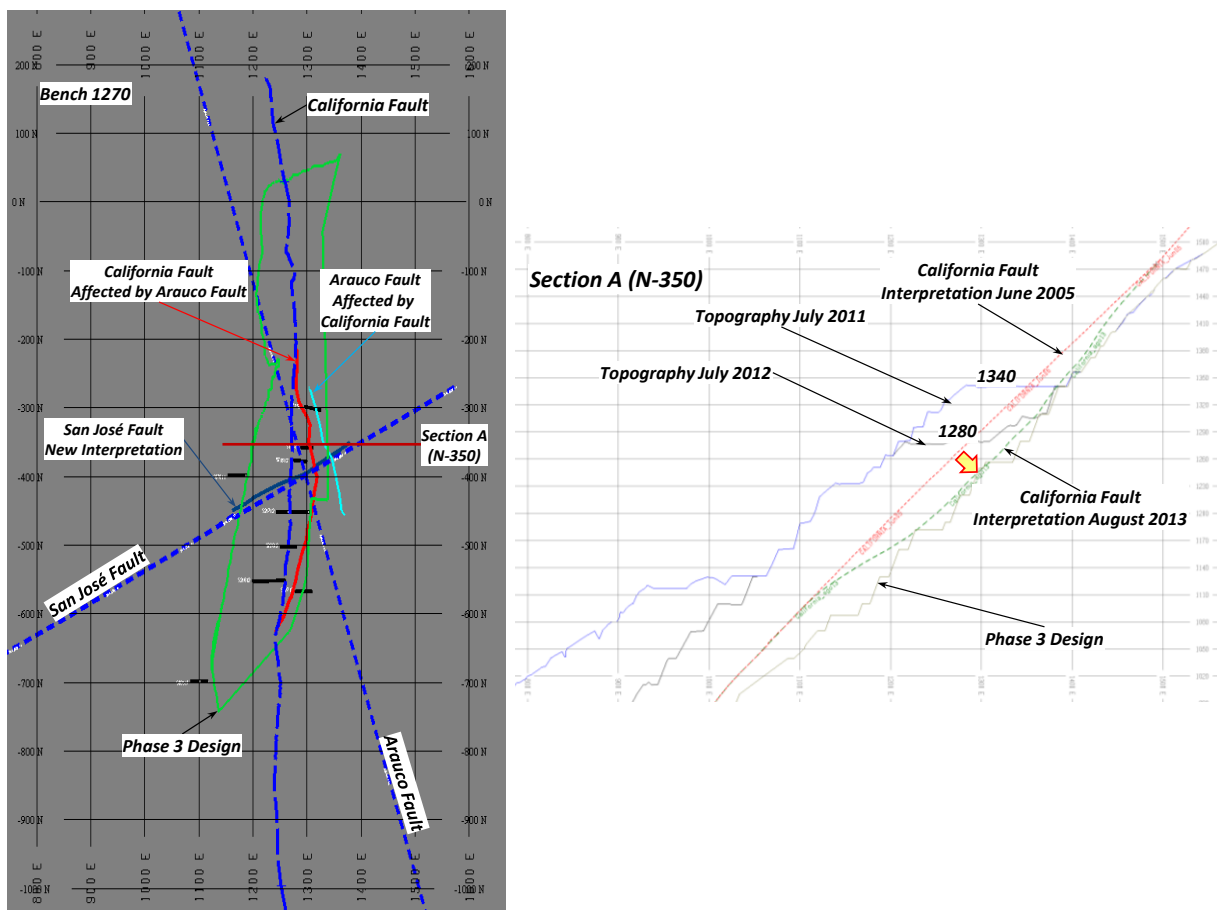
In addition, the models indicated that in the north sector of the Central Wedge the convergence of California and Arauco Fault occurs. This convergence creates an area of greater damage to the environment, which locally modifies the trace of the California Fault, bringing it closer to the wall design Phase 3 (Figure 6).

Figure 6 California, Arauco and San José Faults updated (Gonzalez 2013)

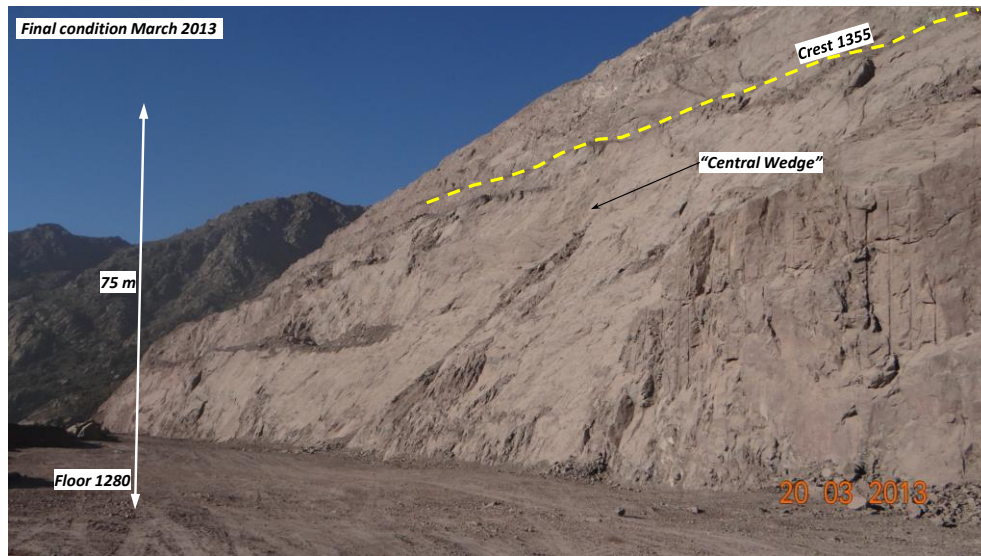
Figure 7 Final condition achieved March 2013

This was achieved by defining a strategy for scaling by shovel excavator PC-5500 (operated by remote control to prevent human exposure to falling material), with continued support of geomechanics onsite. The support radar was focused on monitoring the deformation and deformation rates. When, during works, the monitoring shows an acceleration of this sector, people and equipment were evacuated from the affected area. An example is shown in Figure 8, wherein point 1 indicates an increase in the sector monitored deformations, point 2 marks the evacuation and point 3 indicates the collapse of block deformation.

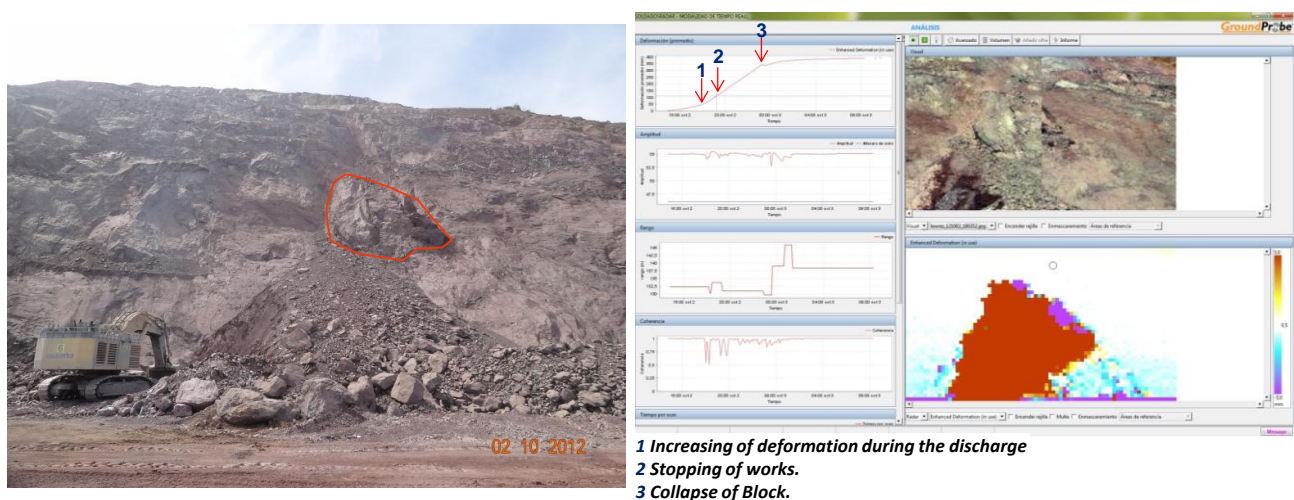
Figure 8 Activation of geomechanics monitoring during discharge

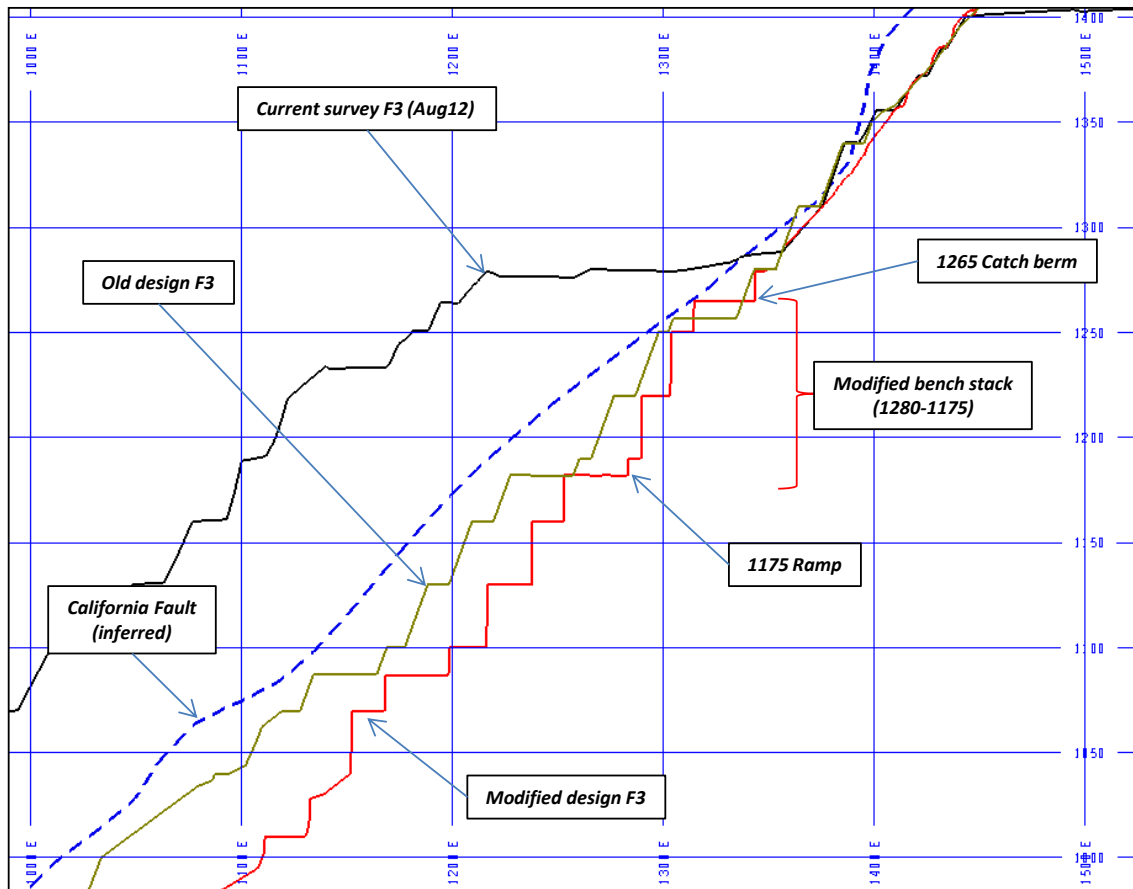
Figure 9 Phase 3 modified design

After evaluating different design alternatives to increase/decrease the inter-ramp angle, including: a platform, developing a new phase behind the current design etc., it was decided to adopt an aggressive design from the geomechanical point-of-view, considering the increased inter-ramp angle in the first stack

of benches from 55 to 65° between the coordinates N-100 to N-500 and between elevations 1280 to 1175. This meant that the width of the berm design would decrease from 21 to 14 m but would guarantee development of the wall behind of the California Fault (Figure 9).

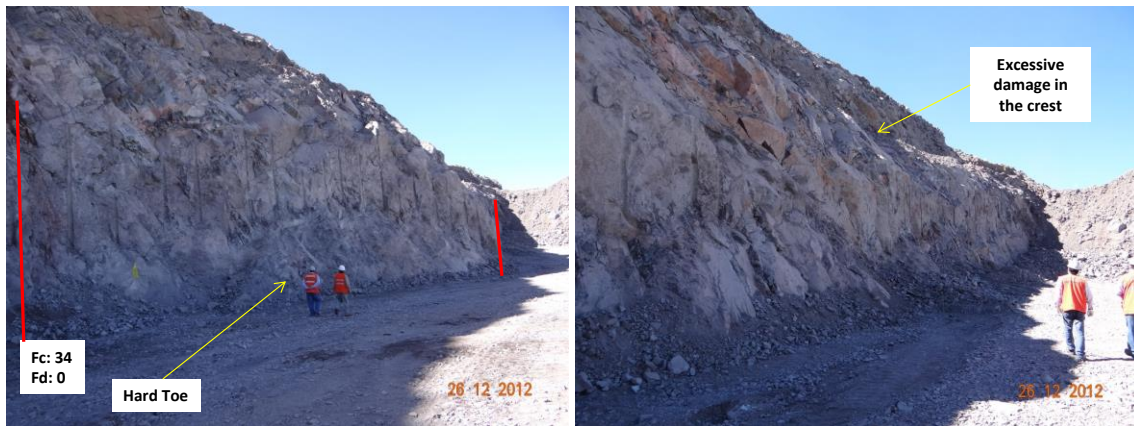
Test 1 was the baseline and the authors used current wall-control blasting geometries for drill pattern (burden and spacing) and loading holes (charging). Post-blasting observed that the foot had not been achieved and there was excessive damage at the crest of the wall. The Fc and Fd are 34 and 0, respectively, indicating a bad condition of the final wall (Figure 10). Modifications continued with the tests until optimised blasting, which allowed achievement of the design lines of the foot and minimised damage in the crest. The final results are shown in Figure 11, including the Fc and Fd.

Figure 10 Results of contour blasting test 1

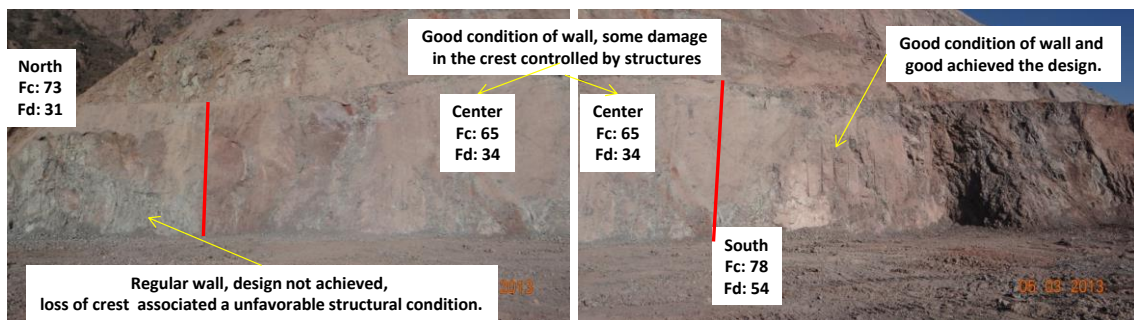
Figure 11 Results of contour blasting test 10

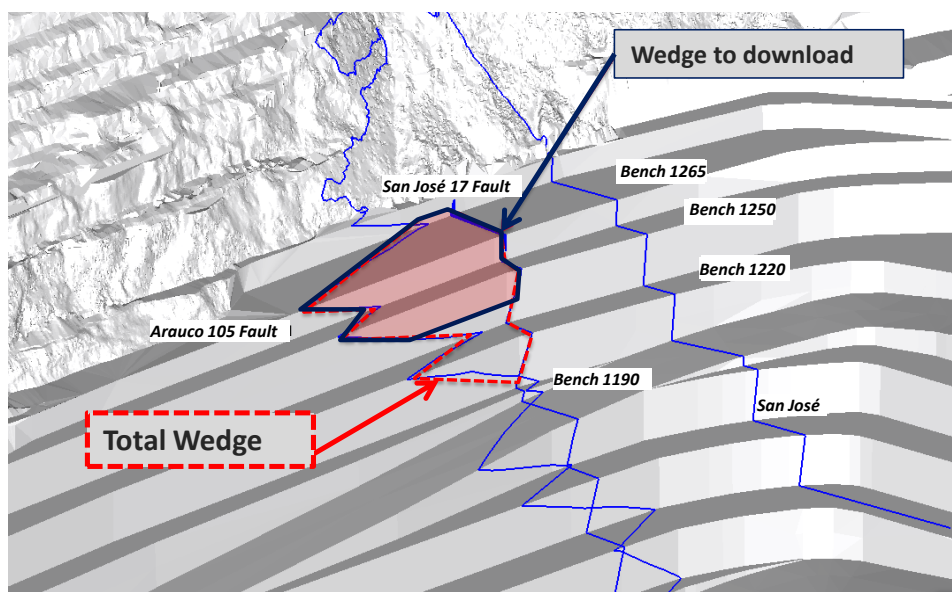
One example was the detection of a potential daylighting wedge between benches 1190 and 1265, controlled by Arauco 105 Fault and San José 17 Fault. After geomechanical analysis, it was determined that, to reduce the risk of this wedge, it should be removed in higher benches. This would download the 1265 and 1220 benches between the faults planes controlling this wedge, this is shown in Figure 14.

Figure 14 Potential wedge to discharge

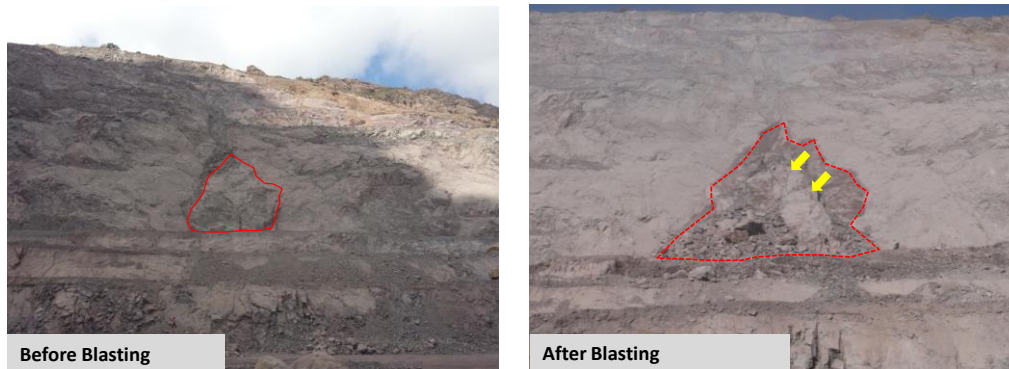
After the first blasting to discharge instability, identified in Figure 14 under the Central Wedge, the sector was reactivated due to the presence of another San José subparallel fault system south of the first (Figure 15).

Figure 15 Comparison before and after discharge blasting

The behaviour after the blast activated the south Central Wedge, limited by another San José system, (SJ\_S3\_Ajust) this involved changing the original strategy stopping development under the Central Wedge.

In order to be able to resume development, stabilisation of the upper section was required (ensuring the collapse of the unstable zone). For this, a strategy was defined including:

- Water discharge from upper benches and by helicopter.
- Blasting sub-horizontal at the base to accelerate collapse.
- Scale down the material in the foot wedge with autonomous equipment (remote control shovel).

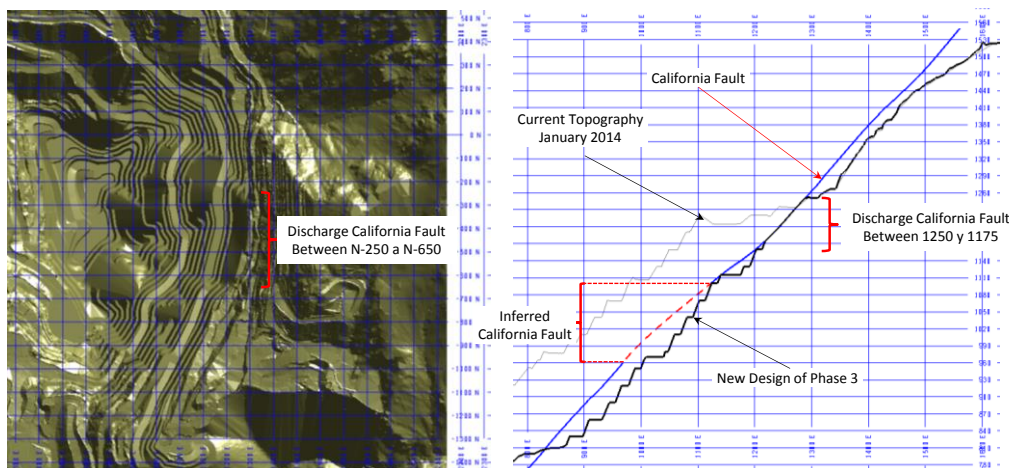
Figure 16 Phase 3 new design considering clean-up of the California Fault

Therefore, to ensure operational continuity of El Soldado, an alternative design was made to unload the California Fault between the coordinates N-250 and N-650 and between 1235-1175 levels, leaving the clean-up on the slope (Figure 16). Under the 1175 elevation, bench berm design began in order to begin movement behind the California Fault.

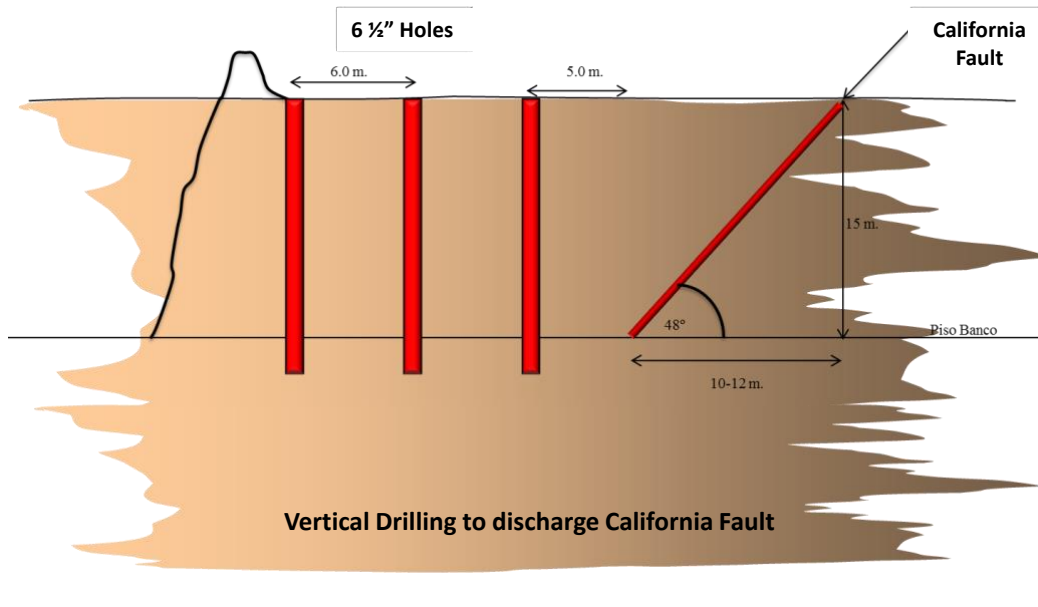
Figure 17 Drilling diagram showing contour blasting in California Fault discharge area

The strategy for the mitigation of the California Fault plane hazard considered blasting controlled vertical drilling, while maintaining a minimum of 5 m offset from the plane of the California Fault (Figure 17).

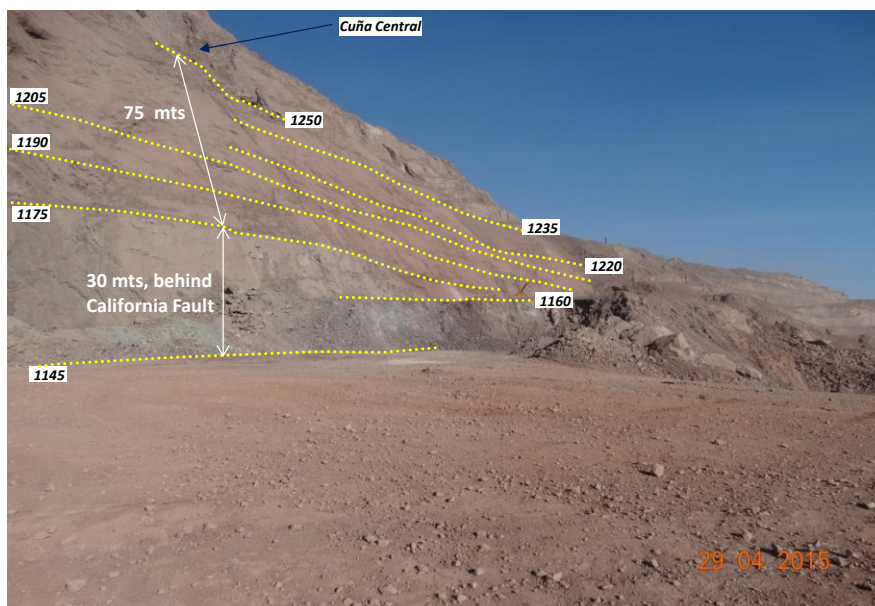
During the month of April 2014, the mining of California Fault plane between elevations 1250 and 1175 was completed, and the first double bench was developed behind the fault plane. The results of this are shown in Figure 18.

Figure 18 Final results of discharge in California Fault Plane, April 2014
