# Capping of a surface slurried coal tailings storage facility

DJ Williams *The University of Queensland, Australia*

G King *New Acland Operations, Australia*

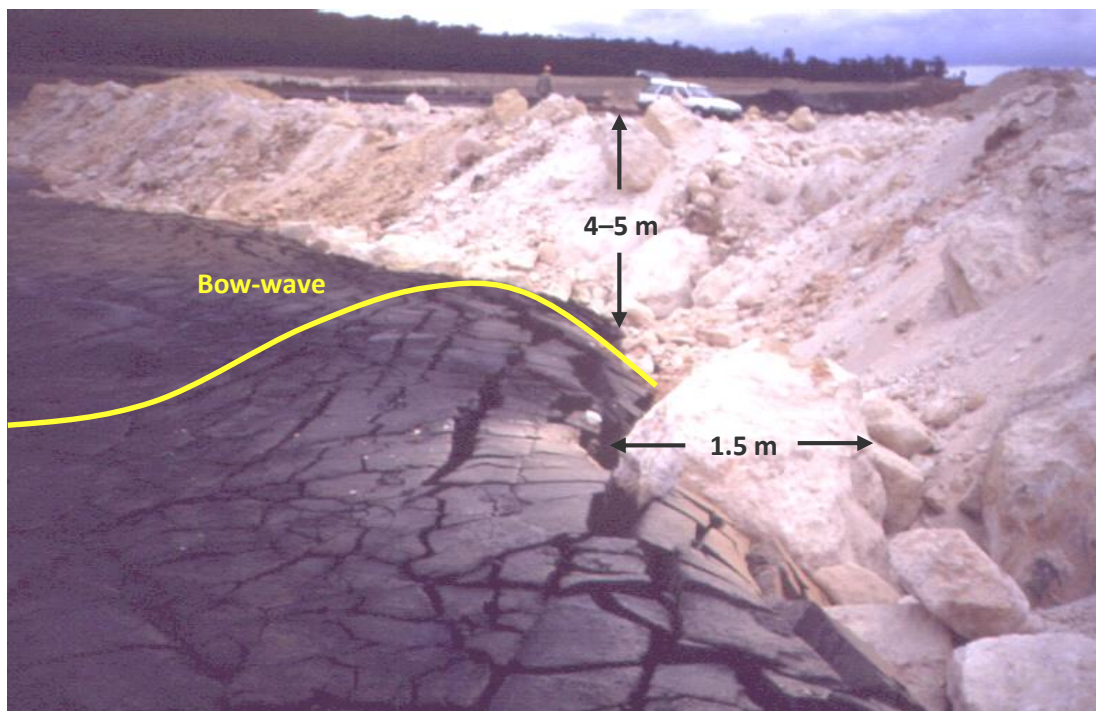
The loaded-initially profile was measured within 12 hours of a 4 to 5 m high layer of spoil being placed on the desiccated tailings (Figure 4), which caused remoulding of the tailings accompanied by the formation of a bow-wave, and a drop in vane shear strength towards the previous remoulded profile. The loaded-drained profile was measured about one week after spoil placement, and shows a dramatic increase in the peak vane shear strength to an average about 30 kPa, twice the desiccated profile and over four times the remoulded profile. In the loaded-drained profile, the drop in shear strength towards the surface is due to the desiccated near-surface tailings having a much-reduced (unsaturated) hydraulic conductivity than the near-saturated and less consolidated tailings at depth. Hence, the near-surface tailings are incapable of draining the excess pore water pressures from the more permeable tailings at depth, and they wet-up and soften somewhat (Figure 3).

Figure 4 Bow-waving on filling over desiccated coal tailings at Ulan Coal Mine

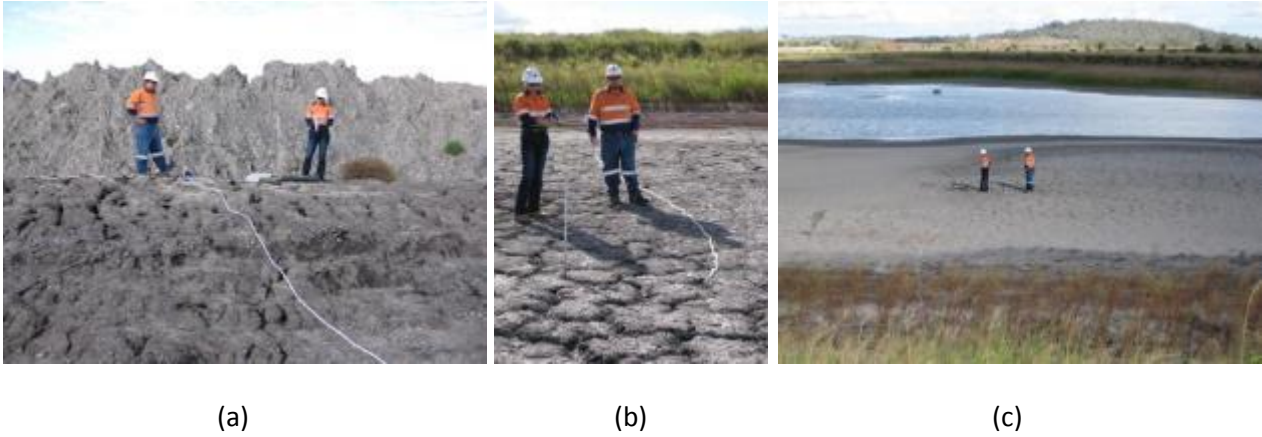
The locations of the initial vane shear tests carried out in early May 2012 are shown in Figure 6, with the locations of all vane shear tests carried out in three stages from May to October 2012 shown in Figure 7, which are mainly confined to the more accessible parts of TSF1 Extension. Figure 6 shows the raised crest of the old bow-wave, which was induced by the previous capping using spoil dumped from haul trucks, the nearby southern reeds, and the northern reeds and pond. The peak and remoulded vane shear strength profiles with depth corresponding to the locations shown in Figure 6 are presented in Figure 8.

Figure 6 Vane shear testing at: (a) crest of old bow-wave, (b) southern reeds, and (c) northern reeds

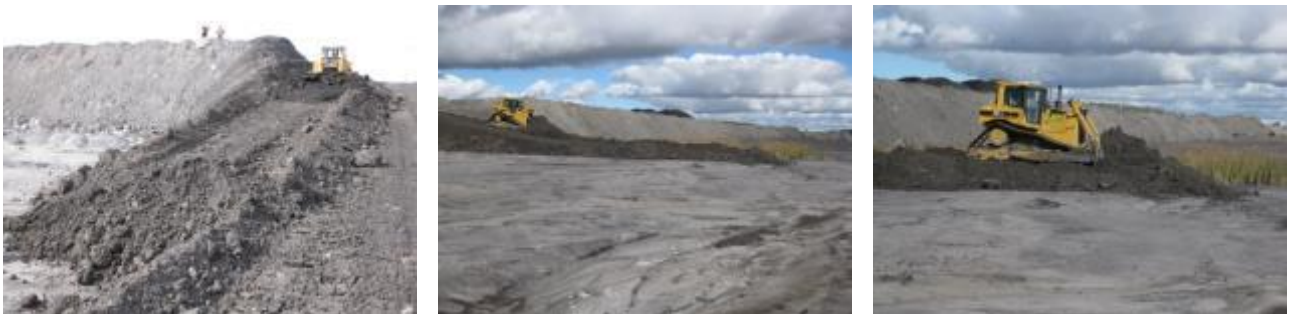
Photographs of the early pushing of the initial capping of coarse reject over the raised crest of the old bow-wave of the surface TSF at New Acland are shown in Figure 13.

Figure 13 Early pushing of a capping of coarse reject over old bow-wave of surface TSF

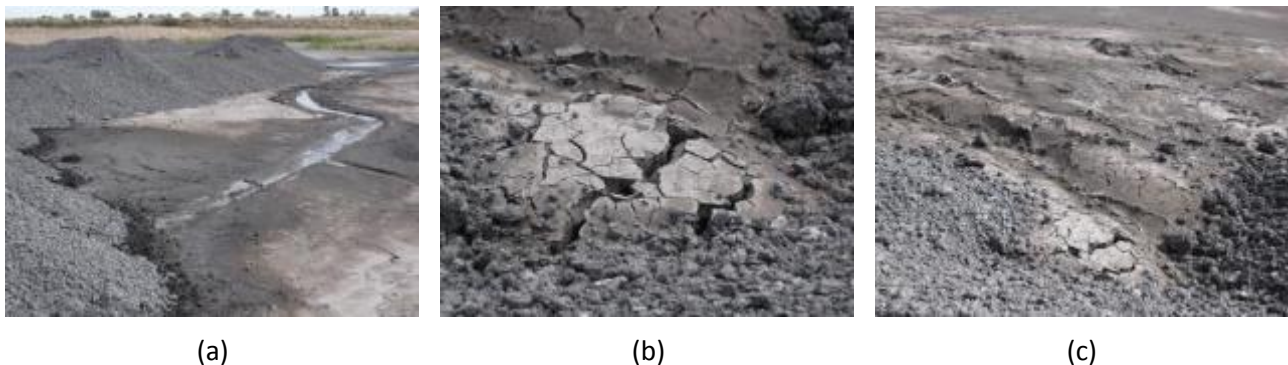
Fill placement caused the tailings to drain, often raising the water table to the surface of the tailings as seen in Figure 14(a). The first sign of imminent bow-waving was the appearance of hydraulic fractures radiating out from the toe of the fill, as seen in Figure 15(b), with continued dozing leading to the formation of a bow-wave (Figure 14(c)).

Figure 14 Fill placement causing: (a) water table rise to tailings surface, (b) hydraulic fractures radiating out from toe of fill, and (c) formation of a bow-wave on continued dozing

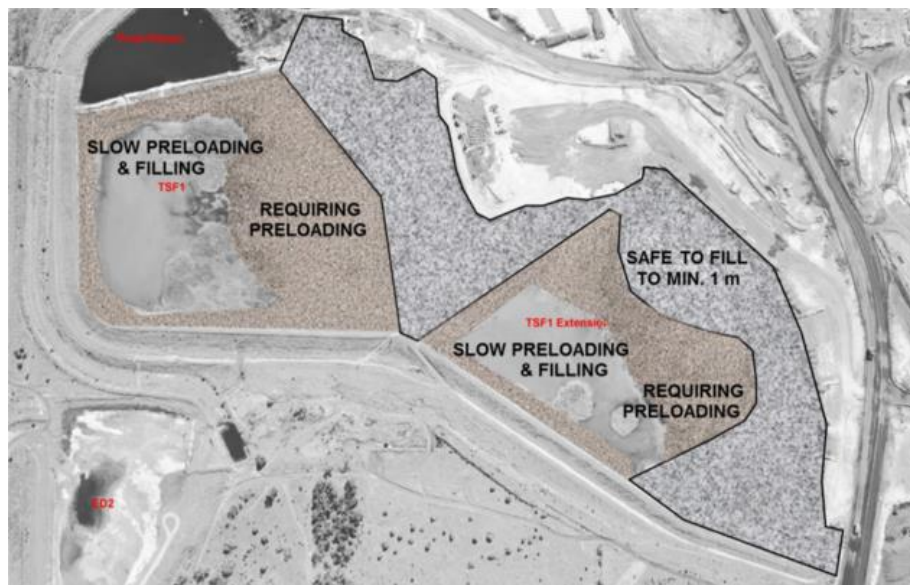
Figure 15 Schematic of identified zones over surface TSF

Three zones were identified over the area of the New Acland surface TSF (Figure 15), with the following recommended capping procedures:

1. *Old bow-wave areas* (along northern side of TSF1 and eastern side of TSF1 Extension):
  - Safe to place an initial capping to a minimum 1 m high:
    - 2+ m at the crest of the old bow-wave.
    - 1+ m between the old bow-waves and to the start of the reeds.
2. *Desiccated areas beyond the bow-waves*:
  - Place 1 to 2 m of fill preload along the edge.
  - Leave for one to four weeks (the timing to be confirmed by further testing), to enable the underlying tailings time to drain and strengthen.
  - Gradually push out the preload along a broad front using a D6 Swamp Dozer, to allow progressive drainage and strength gain in the tailings.

### 3. Poorly-desiccated and ponded areas:

- Remove water to enable further desiccation.
- Slowly preload the edge, limiting the fill height to avoid bow-wave initiation, which would more than halve the shear strength and safe fill height.
- Leave for one to four weeks, the timing to be confirmed by further testing, to enable the underlying tailings time to drain and strengthen.
- Gradually push out the preload along a broad front using a D6 Swamp Dozer, to allow drainage and strength gain in the tailings, limiting the fill height and rate of filling to avoid bow-wave initiation.

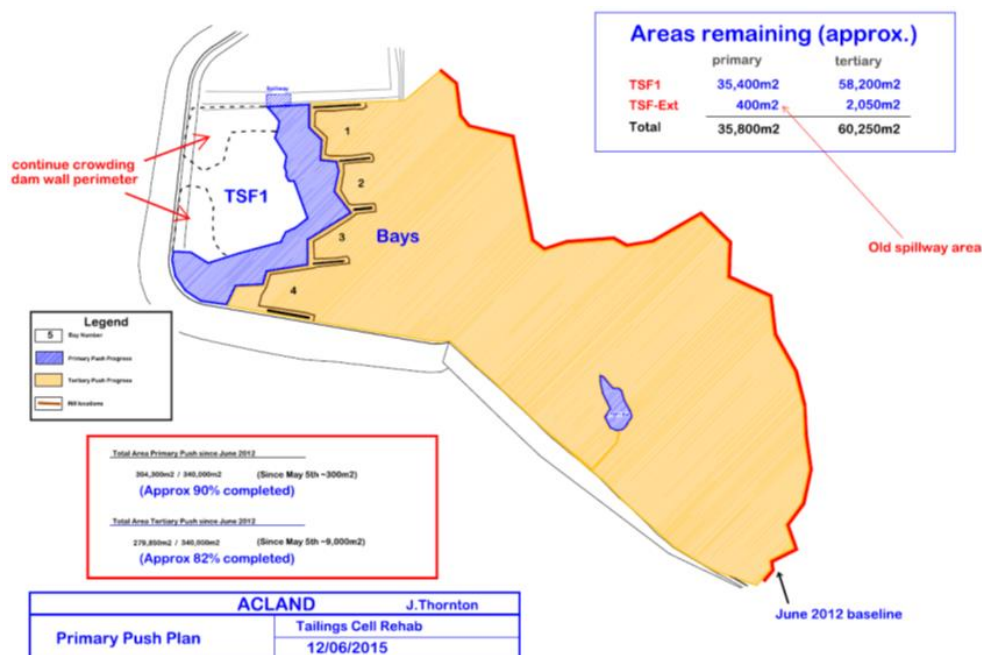
The progress of the capping of the New Acland surface TSF to mid-2015 is depicted in Figures 16 to 21. By mid-2015, the initial capping was nearing completion and the secondary capping layer was following closely behind, being placed by D9 Dozer to save cost and time. It was proposed to complete the initial capping by progressively moving in from the south and the north along the outer western wall of the surface TSF to confine any bow-waving of the soft tailings present. Surcharging the leading edge and allowing time for drainage and strength gain in the tailings will limit bow-waving and scarp formation, and facilitate the safe and effective closure of the initial capping.

Figure 16 Progress of capping of surface TSF as at 12 June 2015

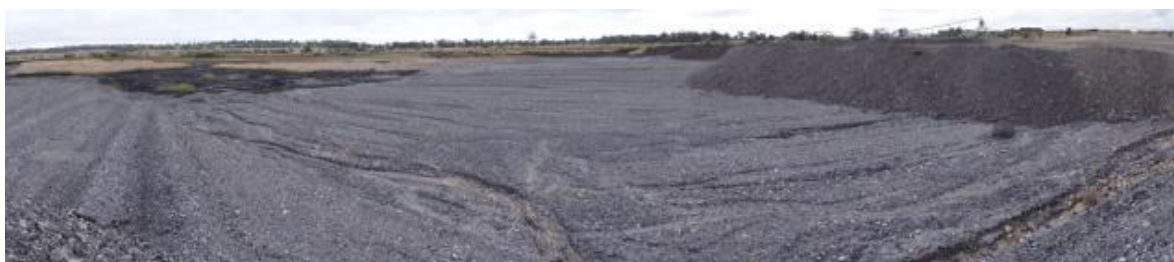
Figure 17 Progress of capping of surface TSF as at 25 June 2015, with all but the northwestern corner of TSF1 capped

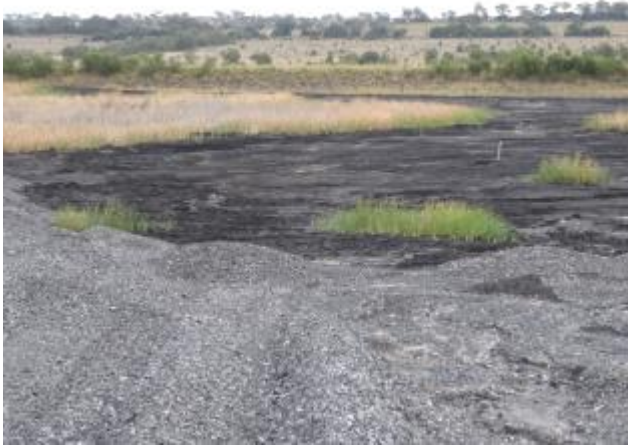
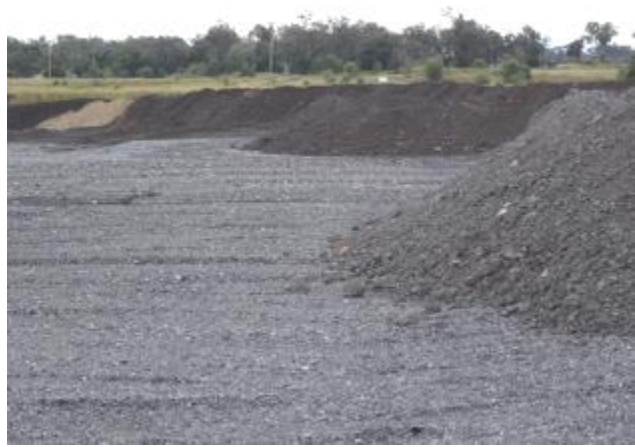
Figure 18 Detail of: (a) leading edge, and (b) toe of secondary capping

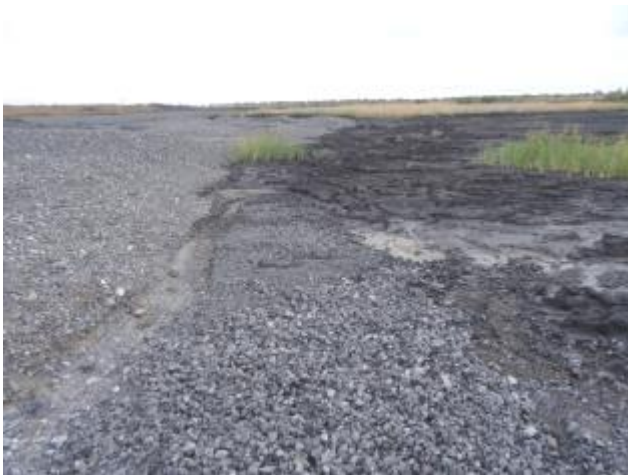
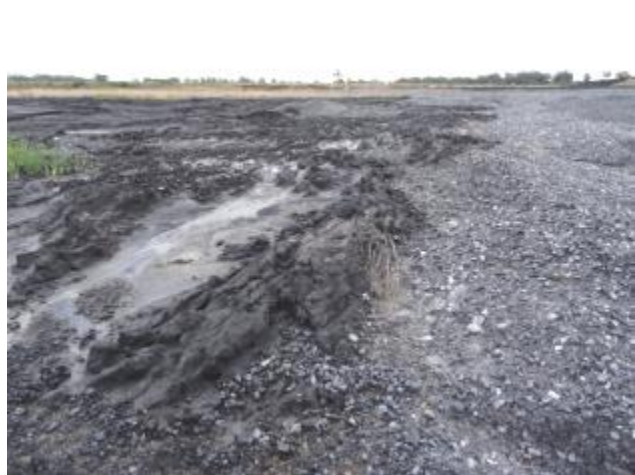
Figure 19 Minor bow-waving of leading edge

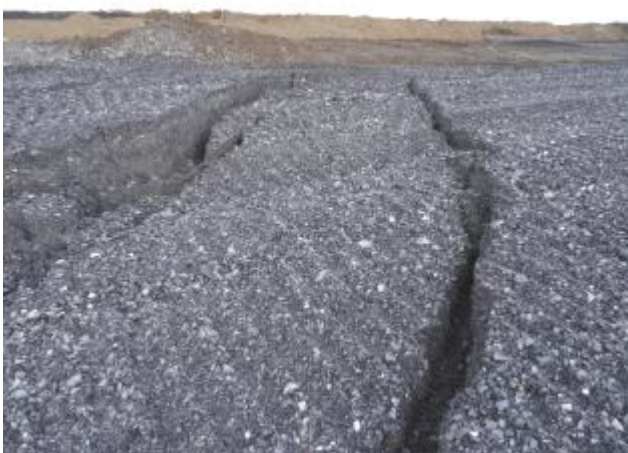
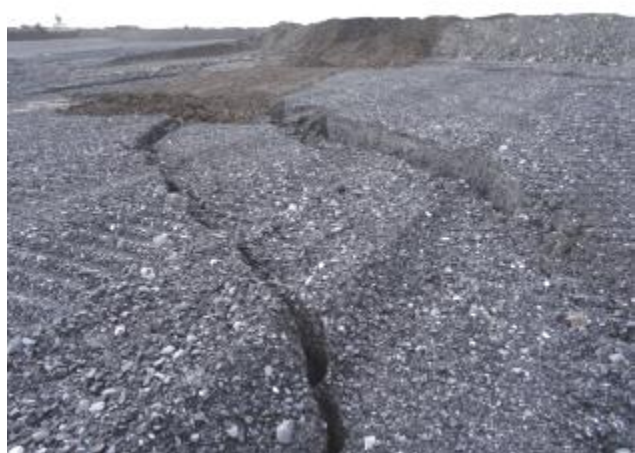
Figure 20 Up to 0.5 m high scarps in capping over soft tailings

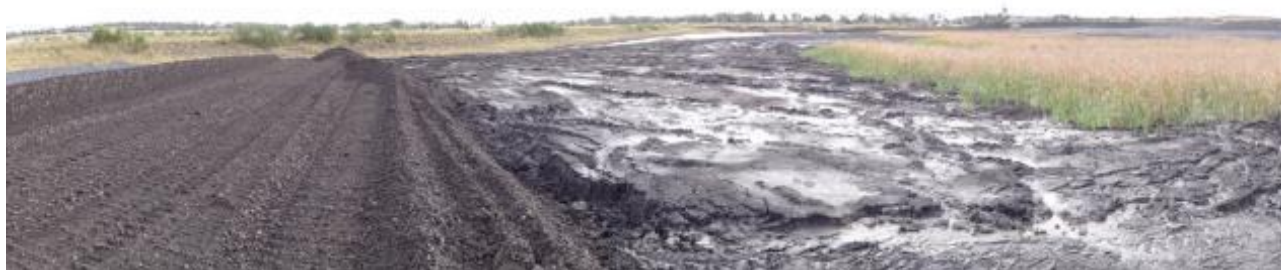
Figure 21 Significant bow-waving beyond latest dozer push onto soft tailings

The secondary capping layer will be completed using a D9 Dozer to save cost and time. Localised tension cracks that appear in places in the secondary capping layer are confined and of little consequence. The completed cap will later be topsoiled and seeded with pasture grasses.
