# Managing the onset of accelerated deformation in capital development at Agnew Gold Mine

**CR Moulding** *Gold Fields Australia Pty Ltd, Australia*

**RM Stephenson** *AMC Consultants Pty Ltd, Australia*

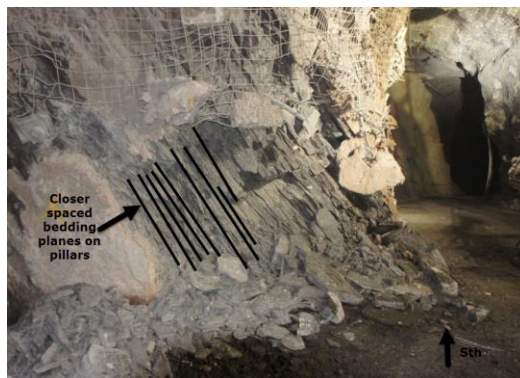
The spacing of the dominant bedding planes of the Skg unit within the capital development is variable, ranging between 0.05 and 0.5 m. The thinly spaced bedding, along with deep-seated shearing, have been observed in the south access pillars at the ore front (cross cuts) as presented in Figure 4. This, combined with fault interactions, leads to the pillars becoming predisposed to deterioration and deformation if they are not supported adequately.

Figure 4 Closely spaced bedding on footwall (FW) pillars

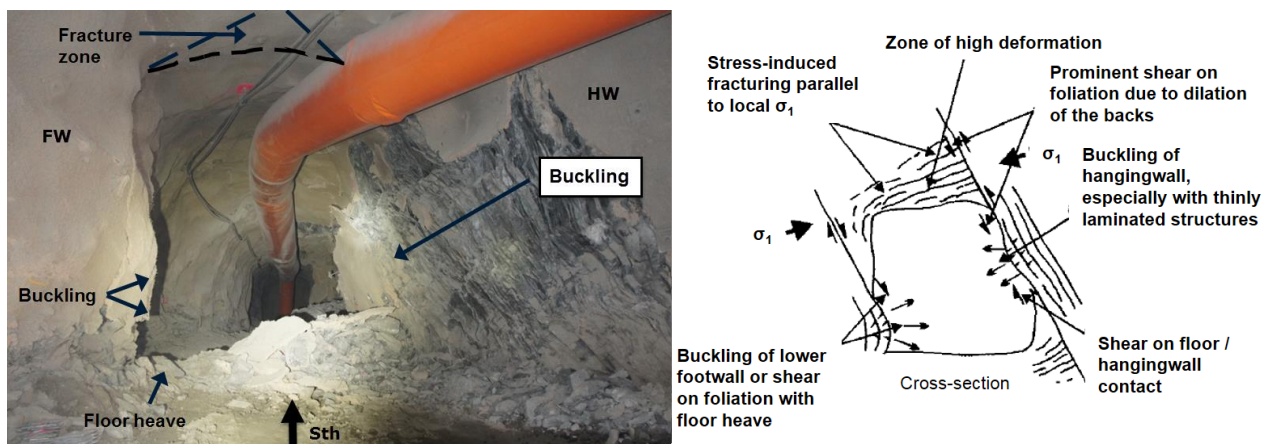
The majority of rock mass damage was observed in the shoulders, lower walls and floor of the southern accesses (Figure 6). The depth of fracturing observed when probing and scaling these areas was up to 2 m in the backs and walls, and was broken up into 'shards' or thin planar slabs (spalling).

Figure 6 Southern access deformation at 1,200 m depth, relative to a diagram (Sandy et al. 2007)

The majority of the deformation was occurring with the southern access drives and appeared to be accentuated between Thresher and Spinner Faults.

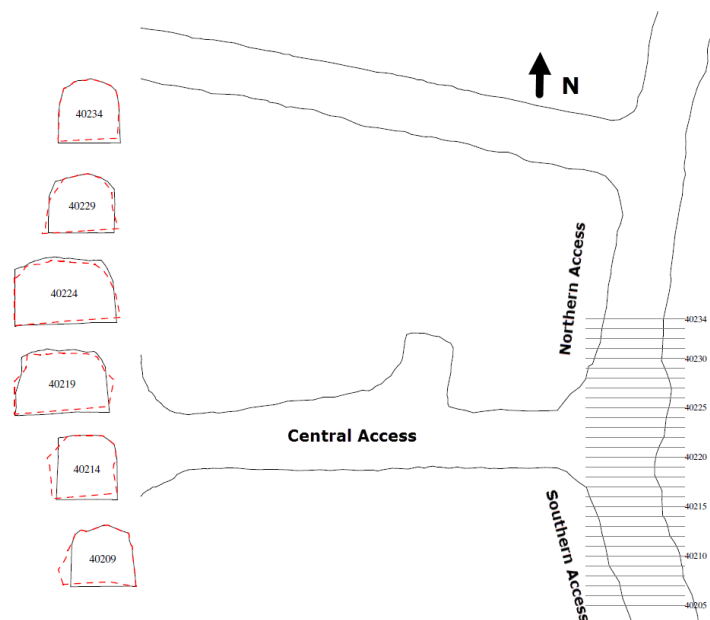
Survey monitoring is regularly used to quantify the extent of floor heave within the levels. Previous measurements have shown over 1.2 m heave in the eastern floor of the access drives (Figure 7). Stripping of the floor for machinery access encourages buckling in the lower eastern wall. This buckling material either falls out or is struck by a bopper, which leads to undercut walls and increases the span of the drive. Thereby, increasing loading to the support of the overhanging rock mass in the upper wall.

Figure 7 Example of floor heave monitoring in the capital accesses; original development represented by solid line and post deformation survey represented by dashed line

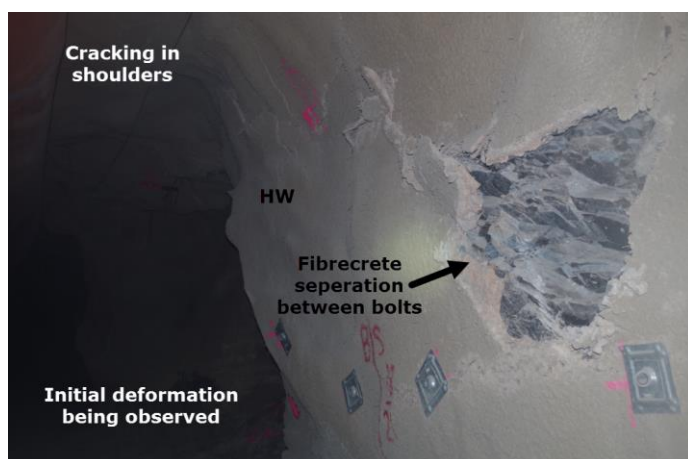
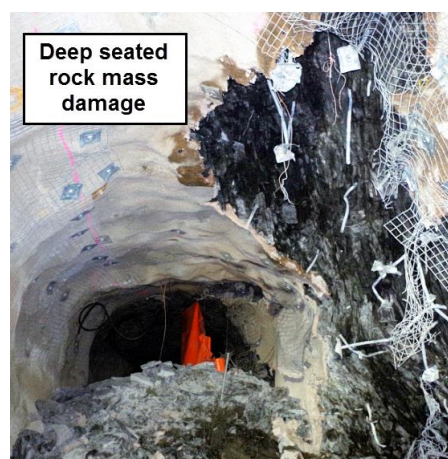
Support damage was observed in lower wall buckling below the fibrecrete, cracking and separation of fibrecrete that occurred between bolts, and shearing of split sets and plates being inverted into the rock mass (Figure 8).

Figure 8 Example of initial deformation occurring and the increased rock mass damage after stope firings

The split sets were compromised by the shearing of the hanging wall and the excessive loading due to drive convergence. The fibrecrete alone was too brittle and was unable to respond to the amount of deformation. With the surface support separating between the split sets, the spacing of reinforcement in the backs was too great for long-term stability.

The ground support damage was also identified to be, in part, compromised due to equipment damage. This included damaged or removed support around pillars and at approximately 1.5 m above the floor from bogger bucket scraping. This essentially removes one of the bolts confining the rock mass on the walls and weakens or wears down the fibrecrete support.

Based on the Levkovitch Reusch (elasto-plastic) model conducted by Beck Engineering Pty Ltd (Jones 2016), it was determined the initial ground support designs within capital development will not be able to withstand the additional stress re-distributions that will occur as stoping progresses. It is recommended the support system should be upgraded to withstand and delay the onset of deformation.

It has been recommended to use a two stage support system. This system will provide initial confinement (for minor rock mass damage) during the development stage, and will allow for high deformational capacity (extensive rock mass damage/convergence) when stoping begins.

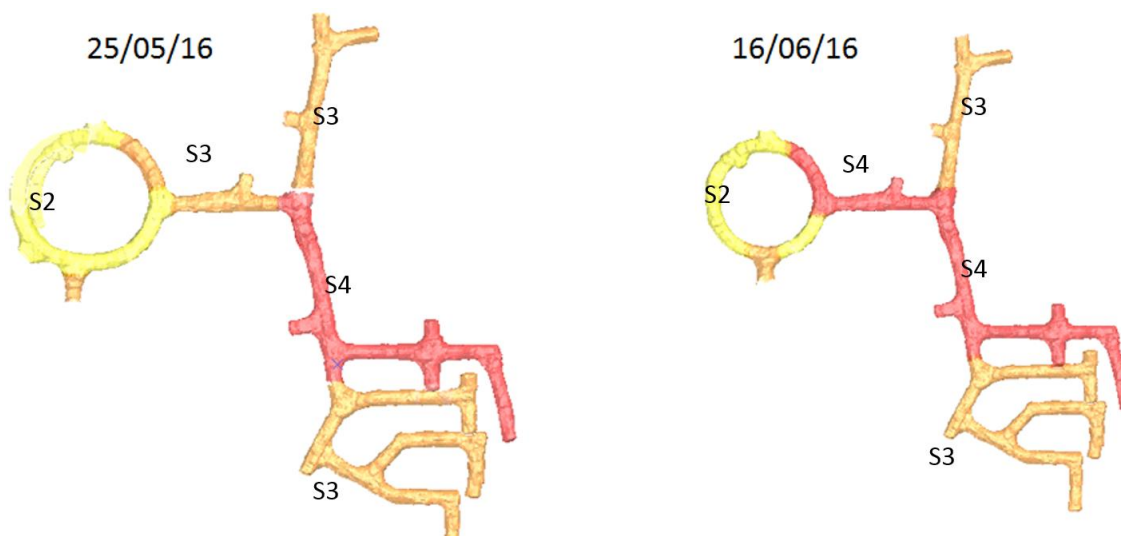
Damage mapping is conducted periodically, whenever changes to damage in development are observed (Figure 10). The mapping is digitised using the mine asbuilts, which can be spatially compared with faults and numerical modelling results. The intention is to relate increases of damage to the response to stoping and forecast rates of damage and rehabilitation requirements.

Figure 10 Progression of damage mapping of 260 Level across two different months

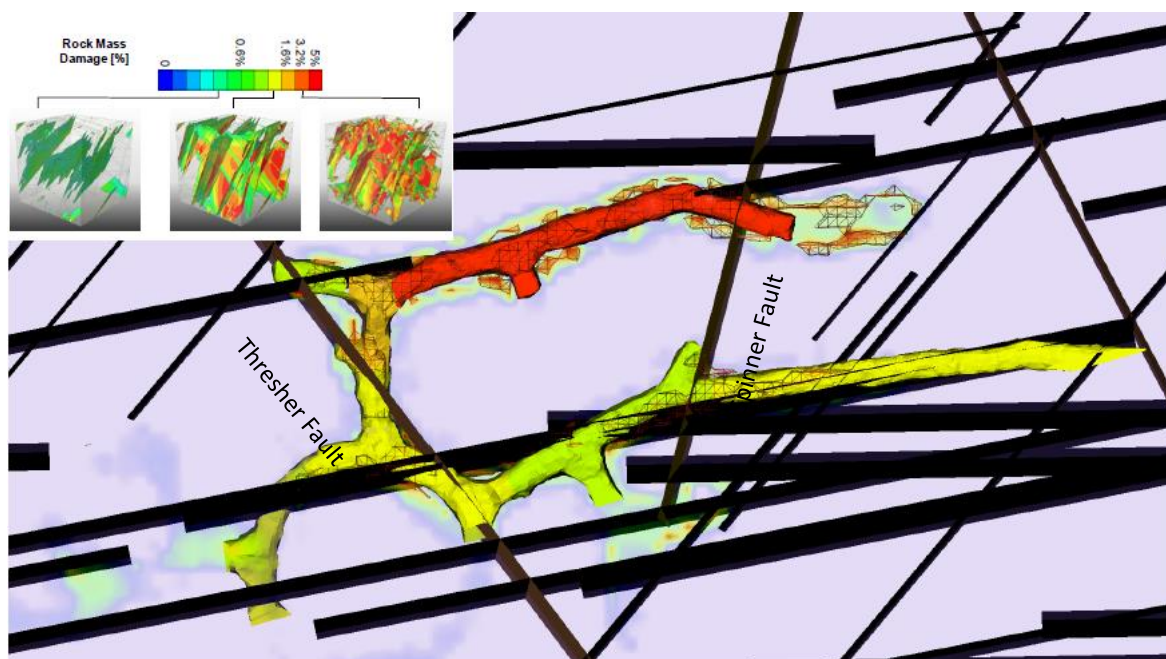
Following several iterations, the modelled damage for the 260, 240, and 200 Levels showed a reasonable correlation between simulated and modelled damage (Jones 2016), an example of this is shown in Figure 11. The damage mapping is indicated by the coloured development wireframes while the simulated damage is shown by the contours and meshes on the development. This model was used to assess the severity of rock mass damage in the proposed mine design below the 200L, specifically in the capital development.

Figure 11 Simulated damage and observed damage on the 200L for the calibrated model (Jones 2016)

Using the rock mass damage, a rate of 3.5 % plastic strain was determined to correlate to approximately 1.5–2.0 m of yielded rock in the backs of hanging wall access development. This required significant rehabilitation including removing the yielded rock mass and re-installing an upgraded ground support system. This will be discussed further in Section 6.1. While moderate rehabilitation in the decline was indicated on rock mass damage scale by a plastic strain of 1.2 %. This has proved useful in predicting areas for rehabilitation prior to full-scale deformation resulting in significant rehabilitation.

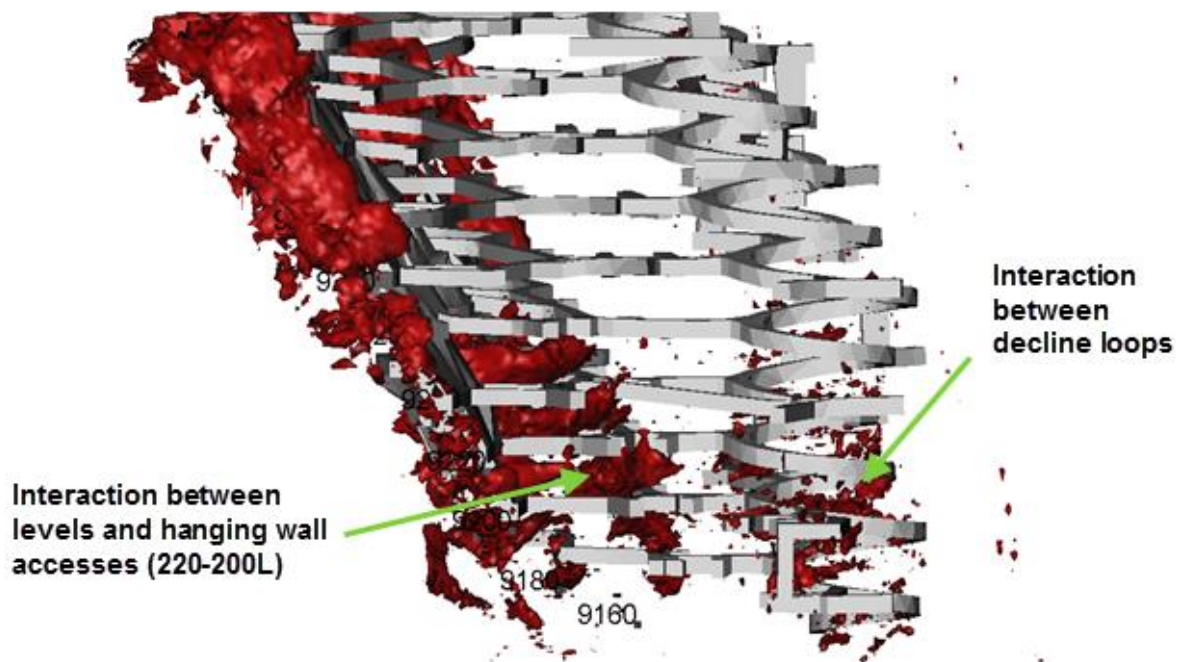
Deterioration of Kim Decline below the 380 Level has gradually increased, but accelerated specifically around the 240 to 180 Levels (1,160 to 1,220 m depth below surface). The closure pillar forming between the 260 and 220 Levels concentrates stress through the adjacent rock mass where the decline is located. This increased stress field induces interaction between the loops of the decline and level accesses (Figure 12). Regions shown in red are areas exceeding a  $\sigma_1$  of 120 MPa, which is approximately the yield limit for an unconfined laboratory sample (Jones 2016).

Figure 12 Looking south, showing stress concentration (exceeding  $\sigma_1$  of 120 MPa) in between levels and the decline

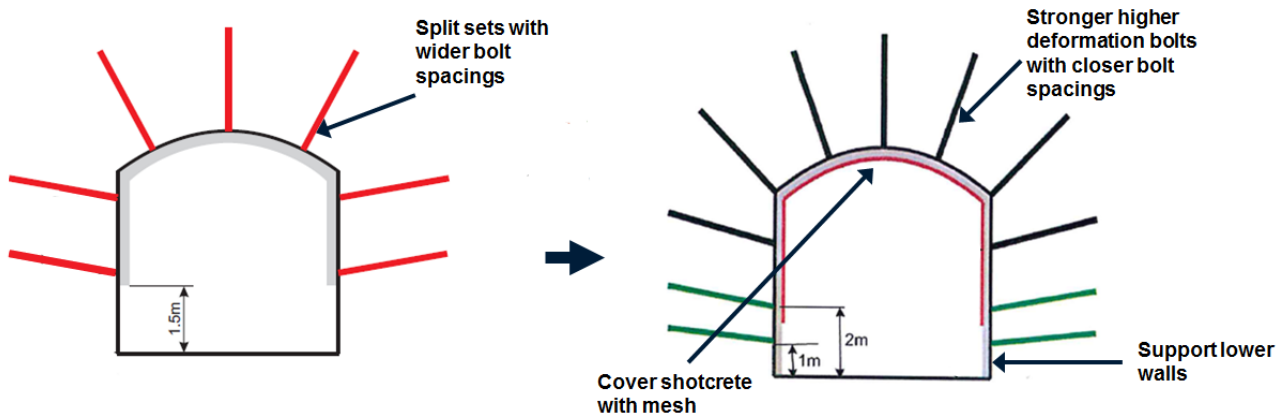
Figure 14 Premise behind ground support upgrades: (left) initial versus (right) new

The use of 2.4 m 47 mm ungrouted hybrid bolts was determined to be beneficial within the support system. These bolts allow for significant displacement (up to 200 mm) of the plate before the mechanism locks up. This ground support element combines high deformational capacity with typical pull-out resistance. The installation of 6 m twin strand 50 t fully grouted cable bolts along with the hybrid bolts, become the preferred component of the primary ground support in high deformation conditions where large displacements are expected.

The use of 2.4 m spiro bolts (modified split set with 20 t capacity) in the lower walls will be installed to pin larger slabs in place and reduce the loading that could occur on the hybrid bolts further up the walls. Both these rock reinforcement types will be in addition to fibrecrete floor to floor and mesh to 1.8 m above the floor (to avoid bogger damage). The previous and upgraded ground support scheme is presented in Figure 14.

The upgraded primary support system in high deformation areas comprises of: 32 MPa 500 J fibrecrete sprayed from floor to floor at 50 mm thickness, mesh overlain across the backs and walls down to 2.0 m above the floor, 2.4 m 47 mm hybrid bolts installed across the backs and upper walls, and 2.4 mm 47 mm spiro bolts installed in the lower walls (below 2.0 m). The cable bolts are installed in addition during a second pass of installation.

Depending on the orientation of the drive relative to the bedding and the deformation expectations from modelling results, ground support will also be complimented with 6 m cable bolts in the backs and walls. This is to ensure that the support is anchored into competent ground as deformation begins to take effect.
