Lessons learnt from egress drift excavation through a minor pillar in an extraction level, Deep Ore Zone mine, Freeport Indonesia, Papua

SA Firmanulhaq *PT Freeport Indonesia, Indonesia*

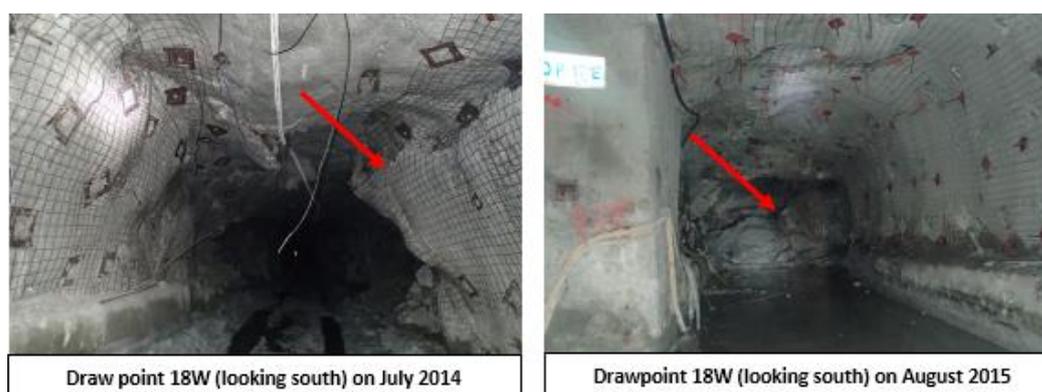
The collapsed ground at panel O2 between drawpoint 17 west into drawpoint 21 west (90 m length) is located in the lithology of diorite (based on drilling data). The drift had experienced damage since July 2014, with the damage classified as heavy damage (displacement > 300 mm), and then completely collapsed in the middle of 2015. Damage progress was evaluated by stress distribution due to no mucking and less mucking activity which caused increasing load static stress around the area.

Damage progression was monitored visually due to geotechnical crews not being allowed to perform manual tape extensometer measurements below the damaged ground. Based on visual observation, ground displacement was estimated at 0.5–1.0 m at shoulder and rib (observed in July 2014) and completely ejected (collapsed) in August 2015, as indicated in Figure 3.

Figure 3 Damage progress at drawpoint 18W (looking south)

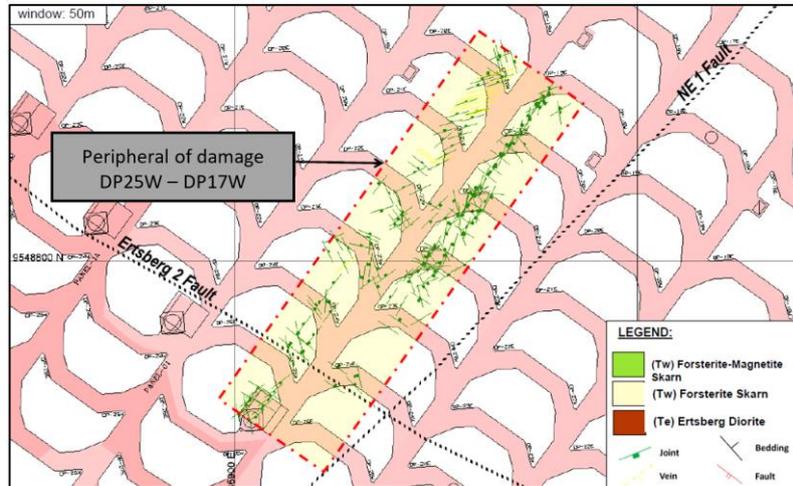
Rehabilitation works had been conducted through the south side (from drawpoint 25 west until drawpoint 21 west), but then stopped due to damage severity, damage peripheral and geology condition as indicated in Figure 4. Considering the severity of the damage, the length of the damage, remaining mineable

Figure 4 Peripheral of damage overlaid with geological condition

reserves, liabilities due to government regulations, rehabilitation rates, cost, and the panel being situated at a potential wet muck spill/mud rush location, excavation of a secondary egress through a minor pillar of panel 02 to 01 has been decided as a reasonable alternative.

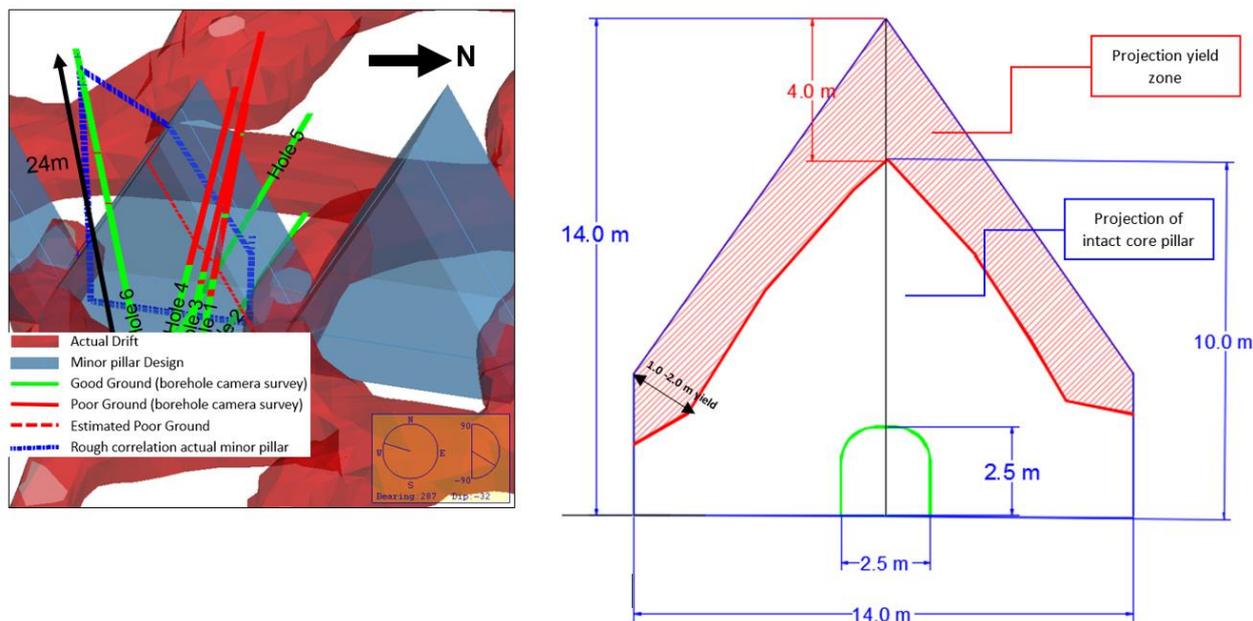
In the first stage, four borehole cameras have been drilled into the core of the pillar and two additional borehole cameras were drilled in the second stage. The first stage (holes 1–4) of observation indicated that the first 7–8 m of hole was good ground, and the rest of the hole (8–26 m) was broken zone. It means that 10–12 m from the floor was still relatively good ground. Two additional borehole camera surveys (holes 5–6) had been undertaken at the same pillar oriented to the southwest side. The observation result indicated that 24 m of hole 6 was in good ground condition. The pillar area oriented to southwest was not well defined due to drilling accuracy. Figure 6 shows detailed borehole camera results and core pillar (rough) estimation.

Figure 6 Borehole camera survey result and core pillar estimation

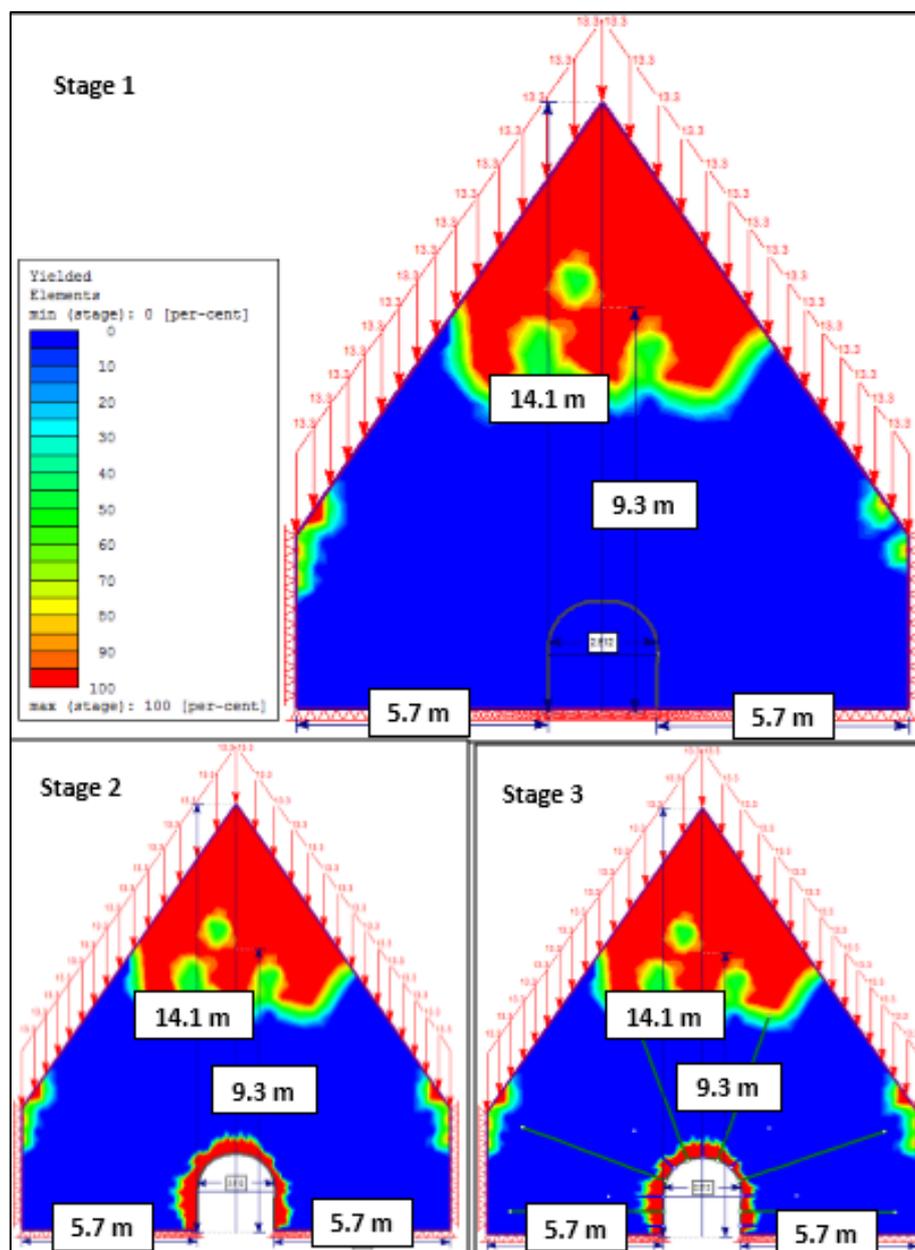
- First stage: Yielding zones mostly occur at about 4–5 m above the crinkle of the pillar which means 10 m high of the pillar remains intact. This result is similar to borehole camera survey results.
- Second stage: At this stage, the drift has been excavated, the zone of yielding is significantly higher at the boundary of the pillar, while at the tunnel boundary, about 0.2–0.2 m is 100% yield.
- Third stage: There is no significant change to the tunnel condition after ground support installation. However, there is no yielding bolt, and ground support is calculated as adequate in this environment.
- Total solid displacement is calculated as 1.8 cm along the drift boundary. The resulting model is shown in Figure 8.

Figure 8 Modelling result showing the mining stage over pillar condition

- Primary support: 1.8 m long of resin bar at a spacing of 1.0 × 1.0 m + 5.6 mm weld-mesh. Minimum installation is 0.3 m from lower rib up to back.
- Secondary support: 4.0 m long of cable bolt at a spacing of 1.0 × 1.0 m is installed when drifting to achieve two rounds (4 m) of the excavation. Minimum installation is 0.8 m from lower rib to back.

Evaluation of the ground condition is planned to be performed during and post-excitation in order to calibrate the model. A manual air leg is employed during the excavation process, and blasting and ground support installation is installed in a short round sequence (2 meter advance per round). Prior to starting the excavation, two drawpoints (drawpoint 13 west and drawpoint 14 west) were permanently closed using high-pressure concrete to create an additional artificial pillar.

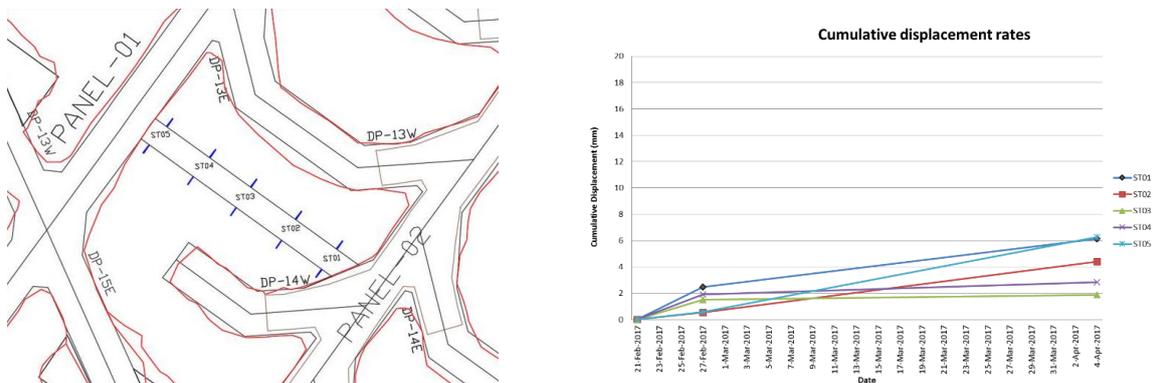
Tape extensometers are designed to monitor ground deformation/displacement (Rachmad & Widijanto 2000), 1 m of convergence station is installed inside rib of the tunnel oriented horizontally at five locations along the tunnel. Convergence measurement is scheduled to be conducted on a weekly basis, but due to operational reasons, it is measured when panel 02 is opened. An initial measurement was undertaken on 22 February 2017, and the latest measurement was undertaken on 4 April 2017. The highest deformation is observed at stations number 1 and 5 (Figure 10) with a cumulative value of 6.0 mm. Both stations are located at the portal of the tunnel.

Figure 10 Convergence monitoring result

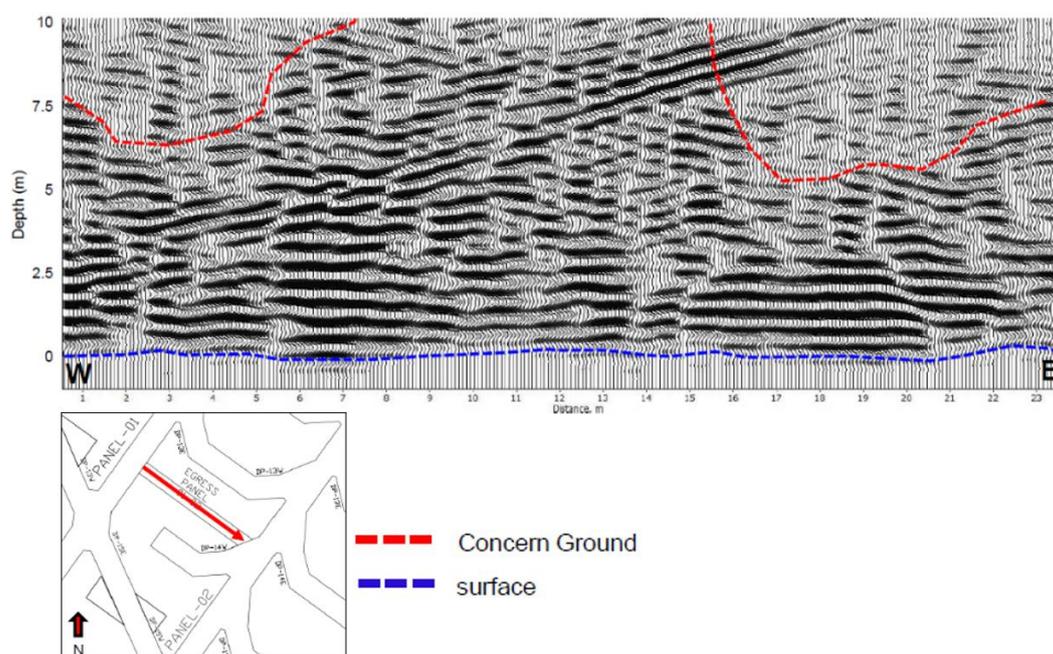
On the GPR profile shown in Figure 11, the intensity of low reflectivity is represented as a light grey tone, and high reflectivity is shown as a black tone, ground of concern (predicted ground damage) along the back/roof of the pillar is estimated to be 6.25 up to 10 m of the back surface. This means 8.25 m of pillar height is still in relatively good condition.

Figure 11 Ground penetrating radar result of the back/roof of egress drift
