Digital imaging and laser measurement of paste pipe wear

Michael Santarossa *James Cook University, Australia*

Ross Marchant *James Cook University, Australia*

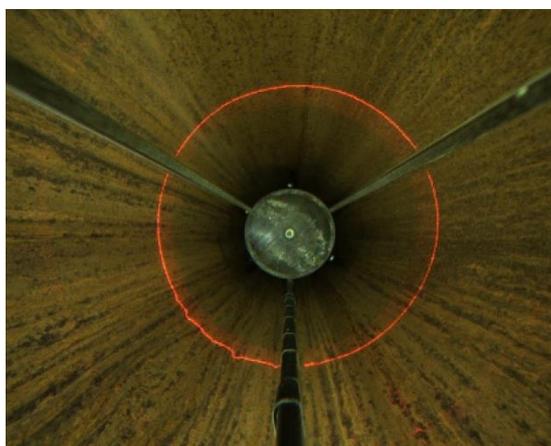
The dimensions of image of the ring can be used to infer the internal diameter of the pipe and determine the size of any anomalies from the average internal diameter. A typical image is shown in Figure 4 from which can be seen the laser light ring which is slightly out-of-round due to wear in the pipe. The three metal rods which secure the light source below the camera can be seen projecting radially from the center of the image.

Figure 4 Laser ring projected on the wall of a pipe showing wear at bottom left

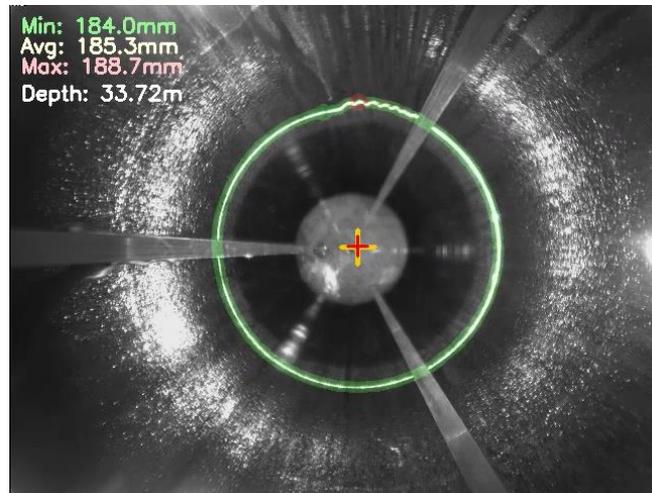
One thing to note is that wear tends to be highly asymmetrical. The typical wear pattern consists of longitudinal gouges approximately 0.5~1 m long concentrated on one side of the pipe. This gouging out of the pipe wall begins with the formation of small grooves as seen in Figure 6 which continue to deepen with use and eventually lead to pipe failure as shown in Figure 8.

Figure 6 Early signs of wear

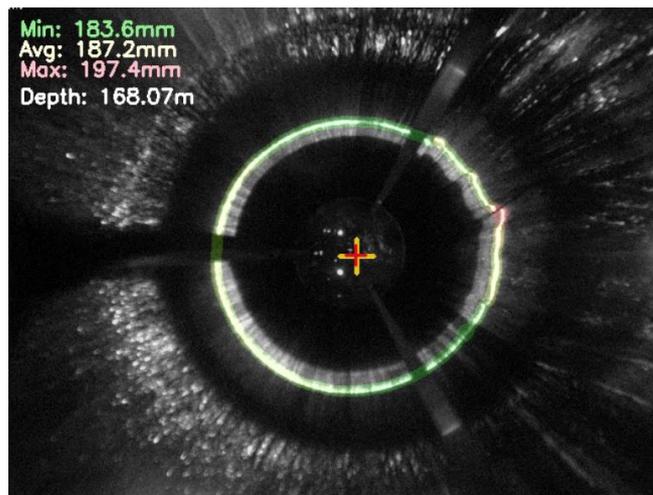
Figure 7 Progression of wear in paste pipe

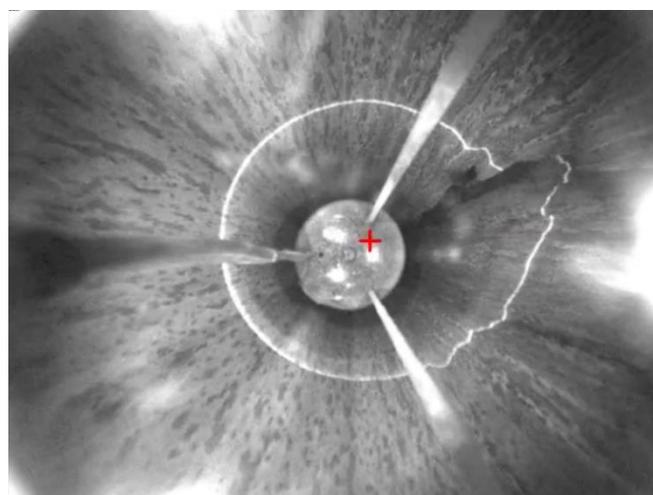
Figure 8 Failure of borehole pipe

The pipe has failed at 169 m (see Figure 8) and six other major areas of wear were identified at depths of 83 m, 179 m, 203 m, 239 m, 263 m and 287 m. A number of smaller areas of wear were also noted.

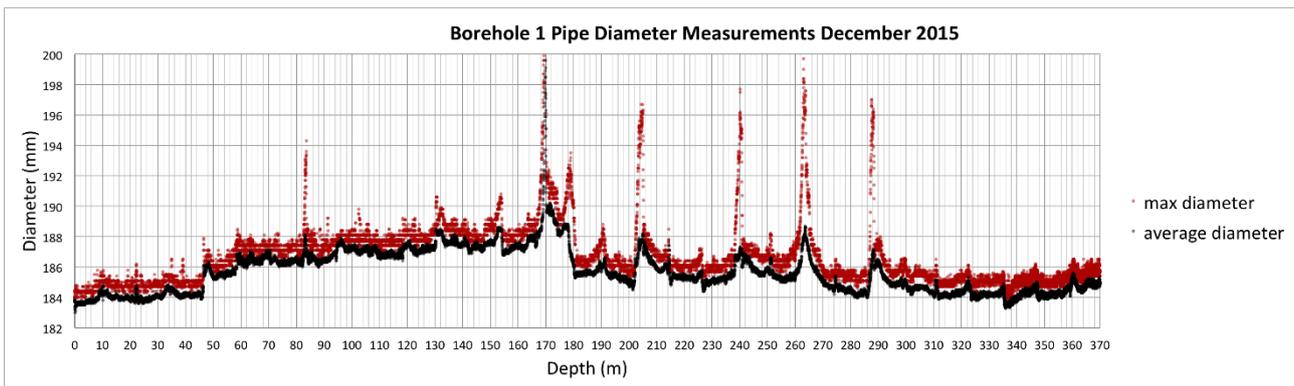
Figure 9 shows diameter measurements taken for Borehole Pipe 1 during the first inspection in December 2015. Red data points represent the maximum diameter recorded for a given depth while black data points represent the average diameter. In general the maximum diameter is roughly 2 mm greater than the average diameter. In areas of high wear however, the maximum diameter may be as much as 12 mm greater than the average.

Figure 9 Wear in borehole pipe 1

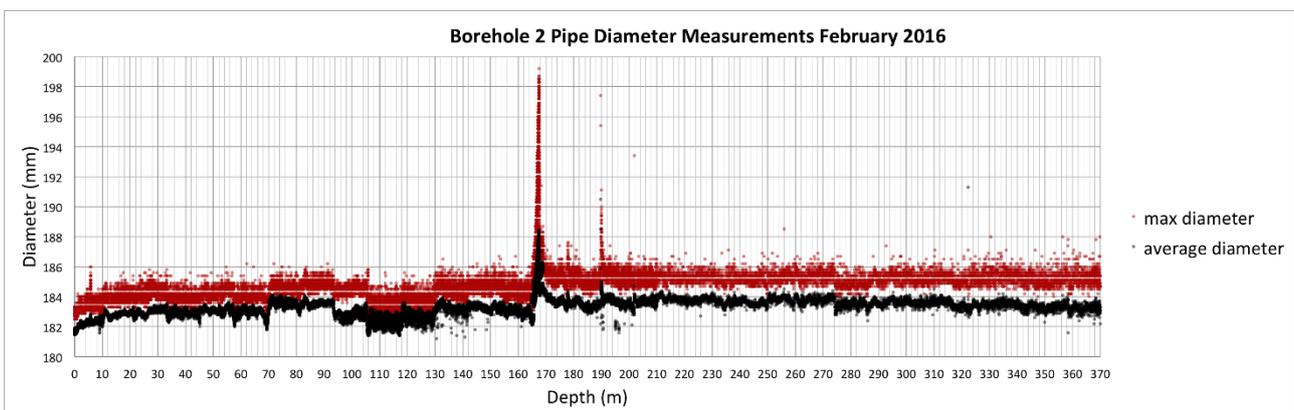
The pipe in borehole 2 (Figure 10) shows similar localized wear patterns as borehole 1. At one location, 168 m below the surface, the wall of the pipe in some spots was worn down to a thickness of approximately 5 mm from the nominal thickness of 18.26 mm. As a result of the very high wear measured the entire borehole pipe was subsequently replaced.

Figure 10 Wear in borehole pipe 2 measured in February 2016

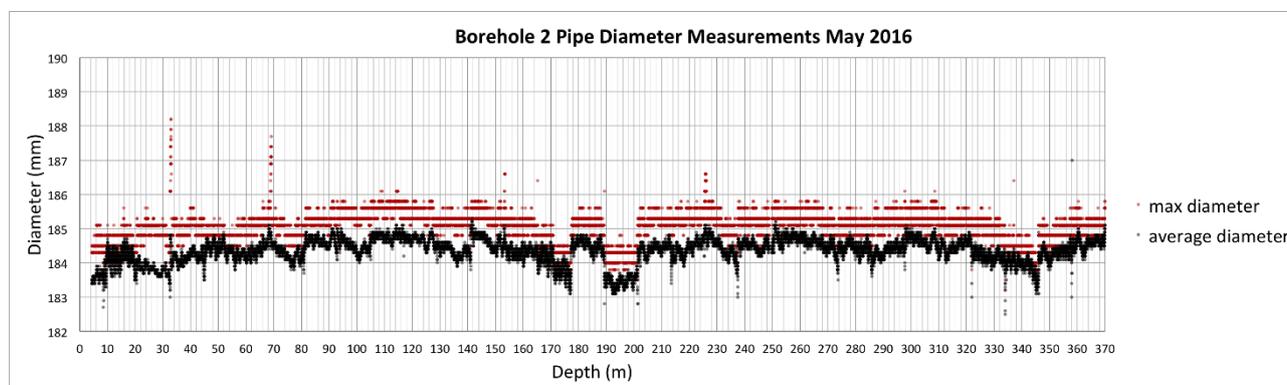
Figures 11 and 12 show average and maximum diameter measurements of borehole pipe 2 taken in May and July of 2016, respectively. The diameter measurements remained quite stable during this period. According to Tanami Operations this may have been a result of an altered paste mix and prudent plant operation in that period. The striping seen in these plots represents the maximum resolution for a single reading. When these values are averaged over the entire circumference of the pipe a much higher effective resolution is achieved.

Figure 11 Wear in borehole pipe 2 measured May 2016

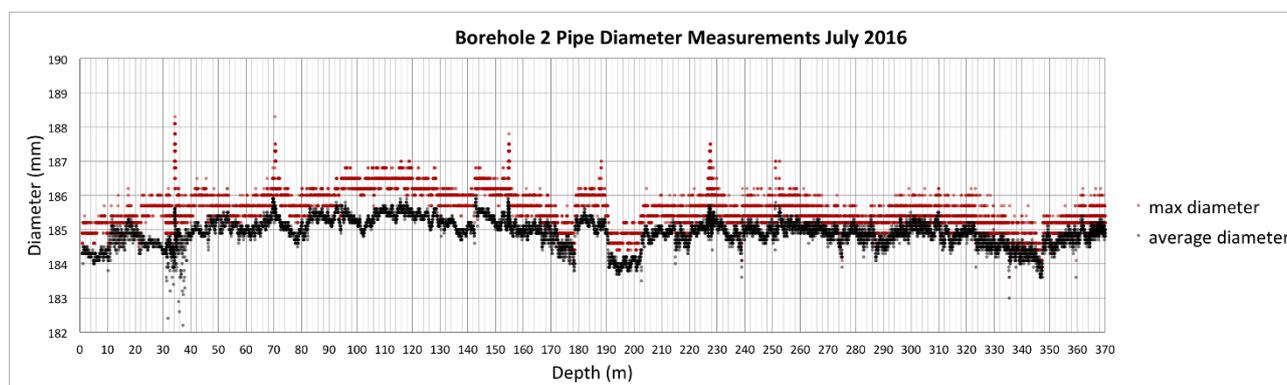
Figure 12 Wear in borehole pipe 2 measured July 2016

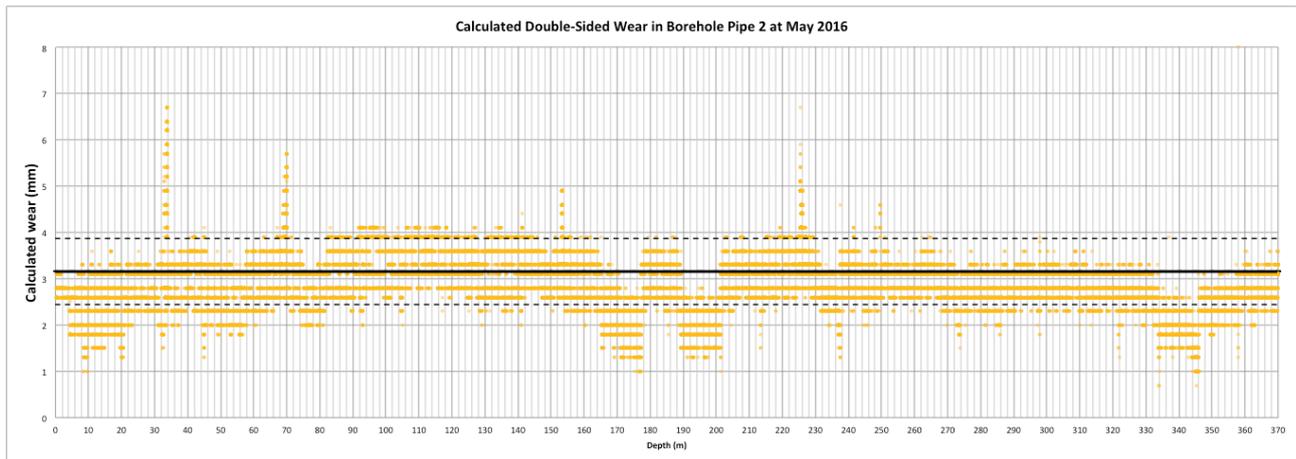
- The nominal diameter may change slightly between pipe sections.
- The wear is assumed to be one sided. If there has been some wear on the opposite side, then the wear measurement will be inflated by this amount. Figure 13 shows the calculated double-sided wear for borehole pipe 2 as measured in May 2016. The mean wear and standard deviations of the data-set are also marked on the plot.

Figure 13 Calculated double-sided wear in borehole pipe 2 at May 2016 – full black line represents the mean wear for the entire pipe and dotted black lines represent \pm one standard deviation from the mean

The first thing to note from the inspection results in the previous section is that the wear of steel paste pipes at Tanami is localized. Looking at Figure 13 for example, it is clear that the areas of high wear cover just a few meters of the entire 370 m length of pipe. It is not desirable to replace hundreds of meters of good steel pipe for the sake a few meters of worn pipe. By developing a greater understanding of how this wear is caused, it is possible that measures may be taken to minimize it either by modifying the pipe design, changing the paste recipe, or alternatively by early intervention.

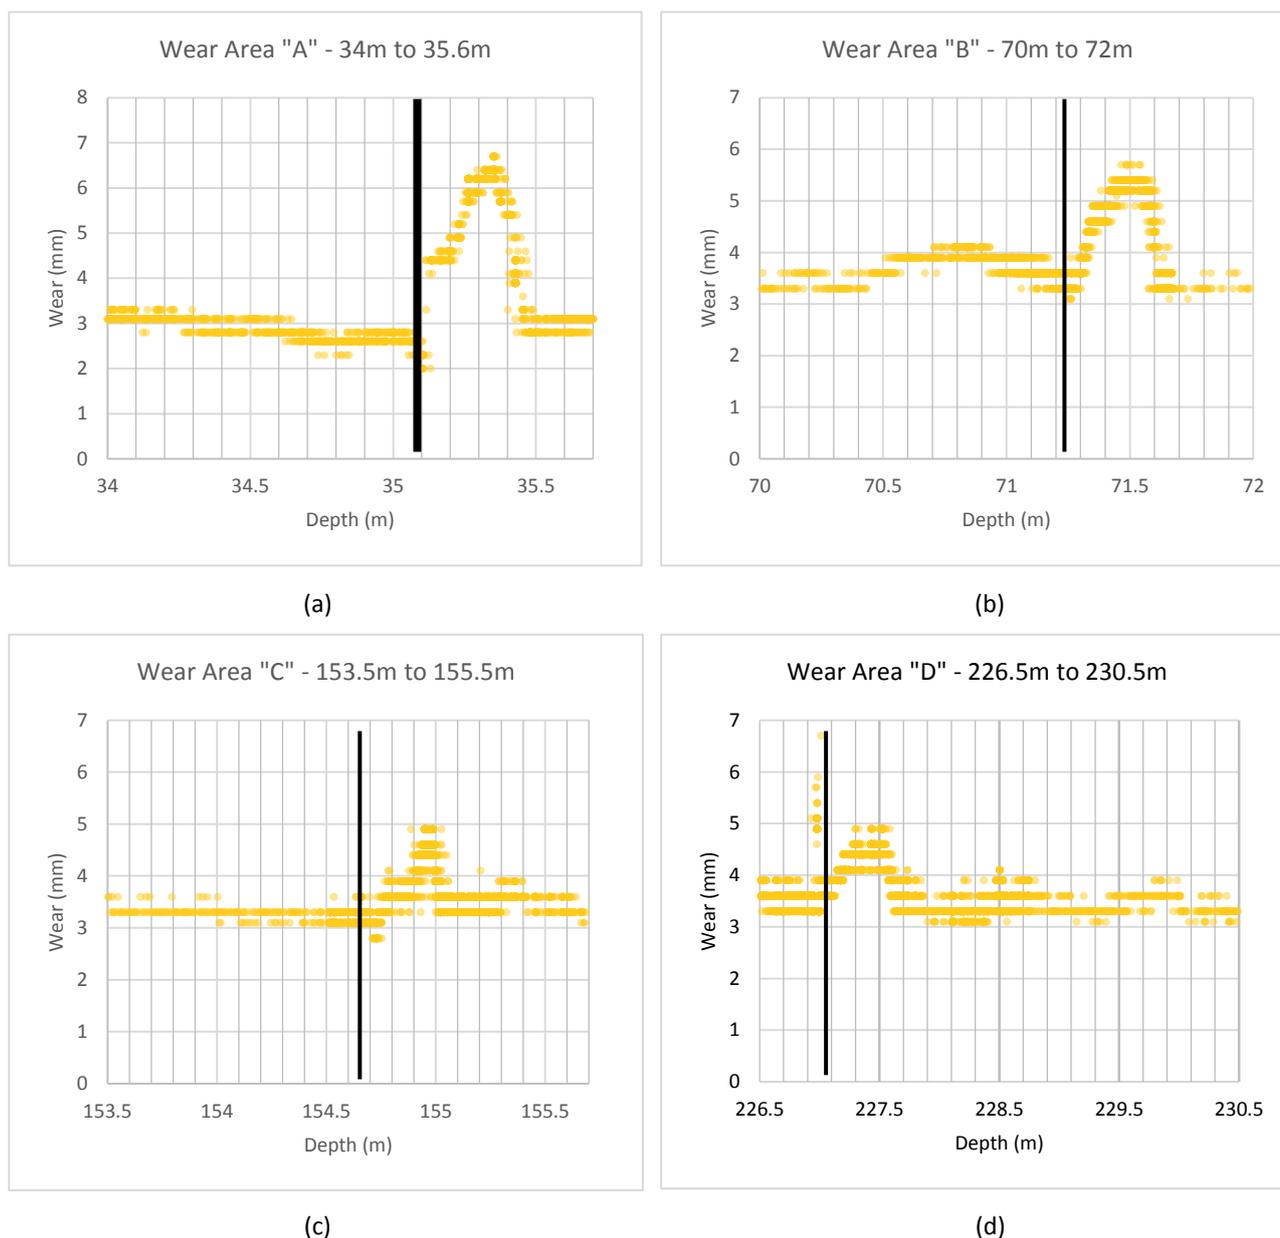
Of particular interest is the proximity of areas of high wear to the welded joints. Almost exclusively, the typical one-sided gouging out of the steel pipe occurs immediately below welded joints. Figure 14(a), (b), (c) and (d) show wear in mm calculated using Equation 1, against depth for four areas of increased wear in borehole pipe 2 as identified during the May 2016 site visit. A vertical line on the plot marks the location of the welded joint. At present it is not known why wear concentrates in these regions but if conditions under which the wear occurs could be understood better, it is possible that modified operation of the paste pipe could be implemented thus extending the effective life.

Figure 14 Localized wear in borehole pipe 2
