Safely re-opening a collapsed extraction level drive in a resource-limited environment

Abstract

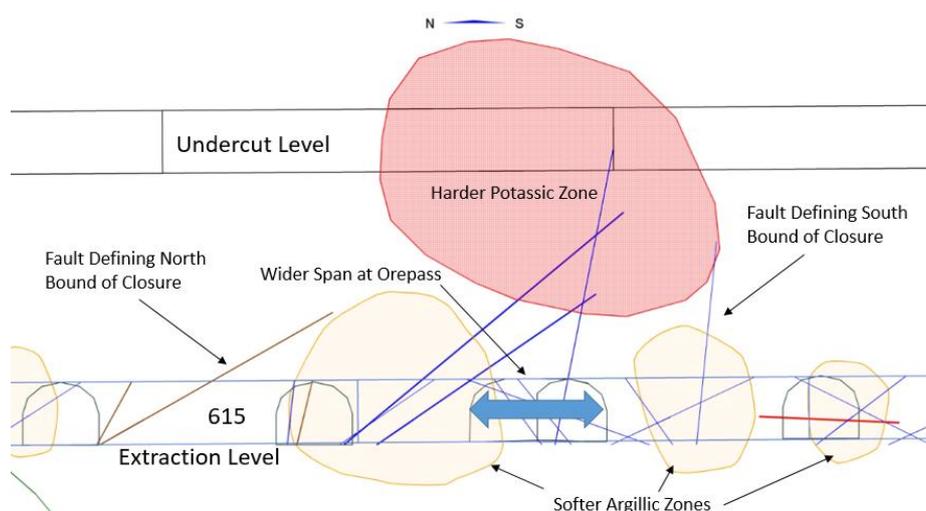
As the failure was notably defined by faulting on the north and south, geologic factors were considered next. In reviewing mapping data, these faults were found to be potentially continuous to adjacent extraction level drifts and the undercut. Molybdenum faults are ubiquitous at Henderson, and while they are a weak structure, they rarely present stability problems in isolation. Alteration was then also considered. On the extraction level, moderate argillic alteration was seen around the faulting which would result in some reduction in strength. This would be compounded by the high extraction ratio created by the orepass opening. On the undercut level, high potassic alteration was seen resulting in higher strength relative to the surrounding area (Figure 1).

Figure 1 Geologic cross-section along 615 through the collapsed area. Initial failure was defined by the vein-fault between 705 and 707, and the fault between 709 and 711. Secondary closure occurred in the 711 intersection. The potassic zone seen on the undercut level is higher strength material relative to the surrounding area

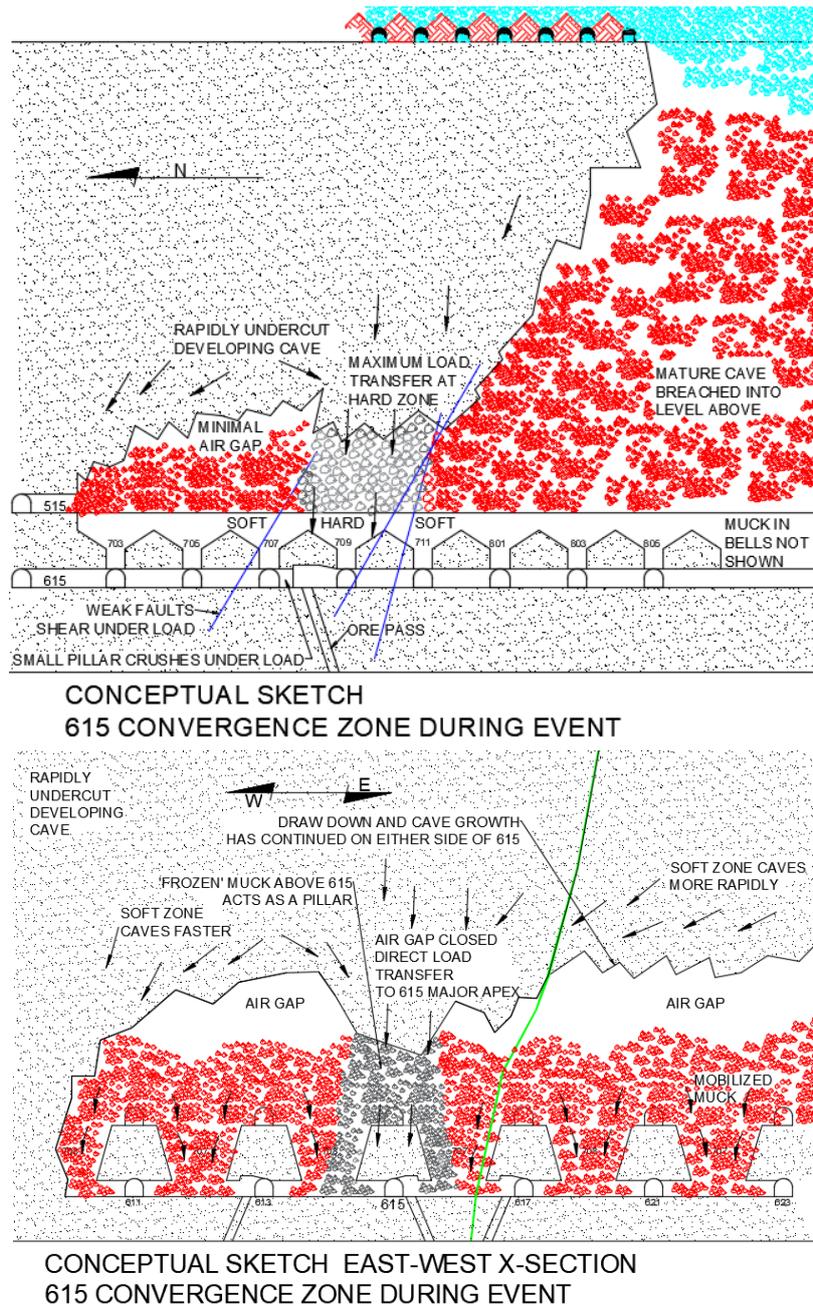
With these factors considered, a conceptual model of the failure was developed as follows: After rapid undercutting, a low cave back was present over the northern third of the production panel. Low draw rates across the panel meant that this low cave back was still present several months after undercutting. In 615, above the orepass, a hard zone likely resulted in slower caving activity and a cave back even lower than the surrounding area. Assumed cave back geometry is shown in concept in Figure 2. When draw was stopped for repair in 615, this lower cave back was able to sit down, either on muck above the apex pillar, or directly on the pillar itself, transmitting load from the large undercut area. As shown in Figure 2, the more developed cave in the surrounding softer areas does not transmit stress, resulting in a concentration of load directly above the 615 orepass. This loading quickly overcame the strength of the pillar, which was less than normal in this location due to the high extraction ratio of the orepass opening. The pillar was then able to fail in isolation due to the faults to the north and south.

Figure 2 Conceptual sketches of the suspected failure mechanism developed following closure. Harder material above 615 allows load transmission from the cave back to the pillars around the orepass opening

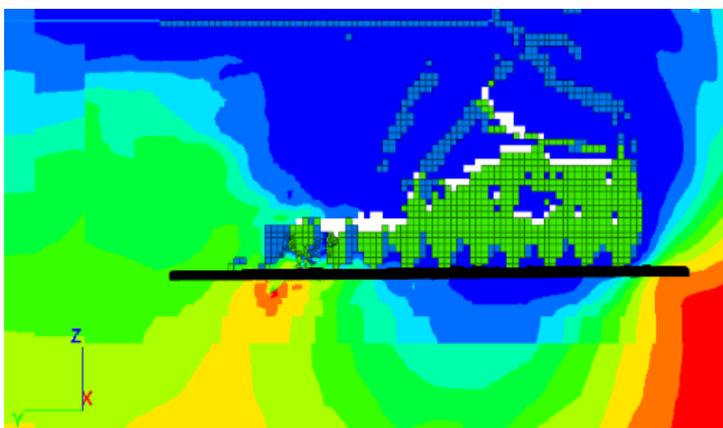
Figure 3 Numerical model results in a north-south section along 615 coloured by maximum principle stress. The mature cave area can be seen to the south, with mobilised muck shown in green. The low cave back can be seen to the north in the rapidly undercut area (Fuenzalida et al. 2017)

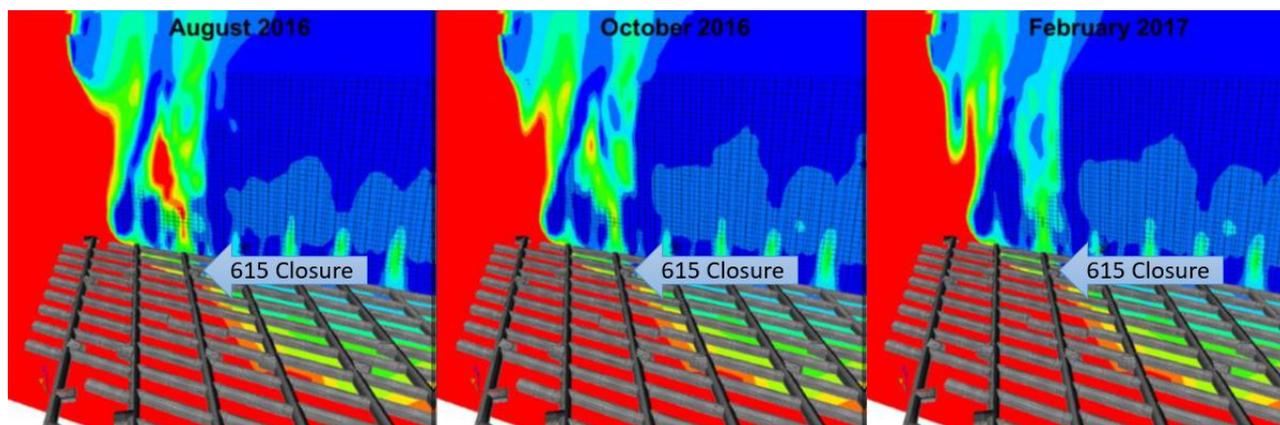
Using an innovative technique combining REBOP flow models (Itasca International, Inc. 2018a) and FLAC3D stress models (Itasca International, Inc. 2018b), the effects of undercutting and draw were able to be combined, showing the development of a low cave back area (Figure 3) and transmission of stress to the extraction level in the 615 drift (Figure 4).

Figure 4 Oblique sections looking north of numerical modelling results coloured by vertical stress. Elevated vertical stresses can be seen transmitted through 615, and reducing as the cave matures (Fuenzalida et al. 2017)

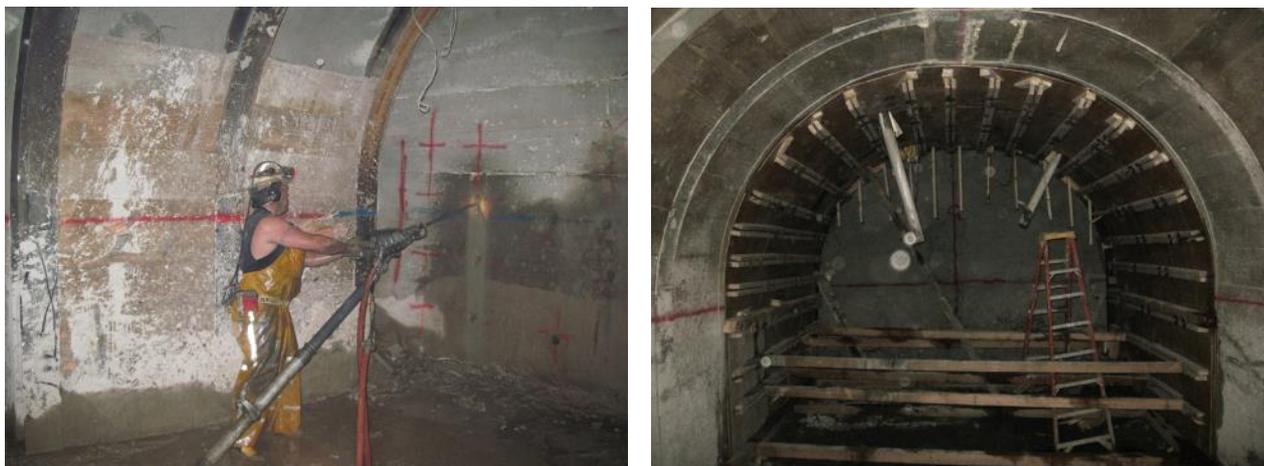
Figure 5 Re-mining through a collapsed extraction drift at Henderson in 2010. Cast concrete and steel arches were placed with each advance (from Carlson et al. 2012)

With each advance, steel sets were stood, formed, and backfilled with concrete, prior to spiling and grouting ahead for the next round (Figure 5). While effective, this method involved large amounts of high-exposure, labour-intensive work, and significant cost. This approach was no longer attractive in Henderson's operating environment and the resources were not in place for it.

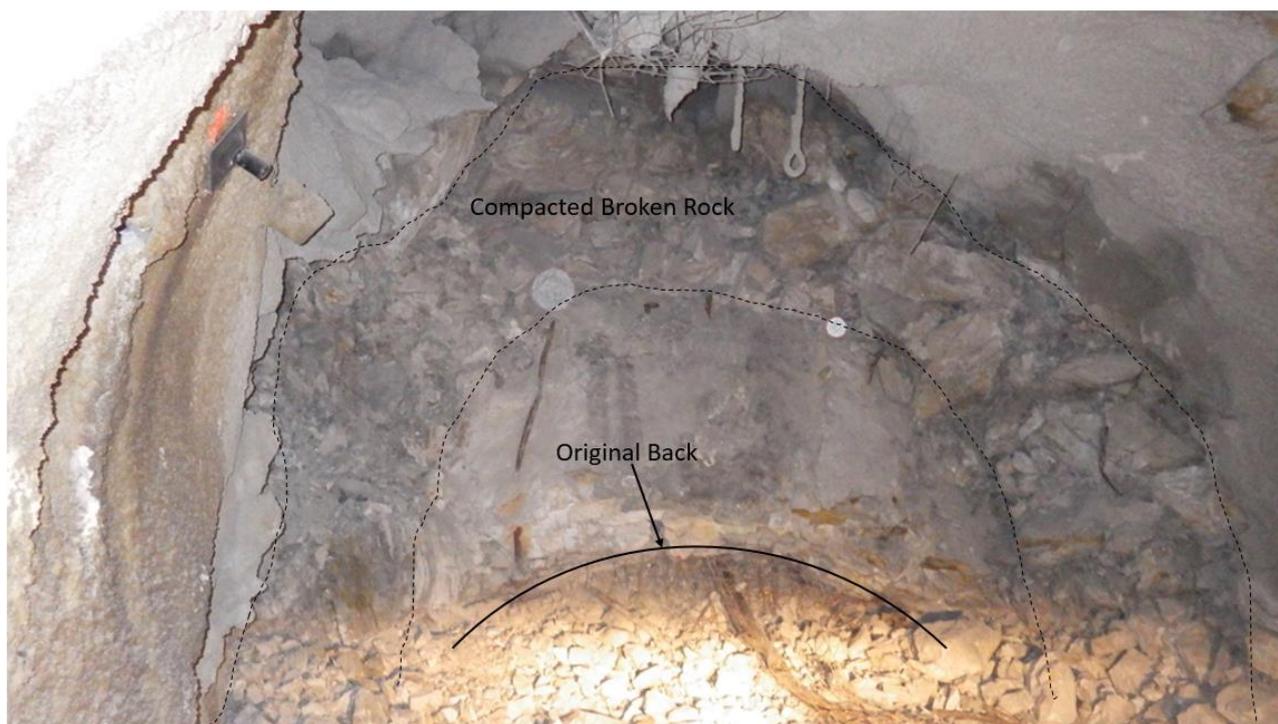
In this first advance, the fault structure that defined the northern extent of the failure was clearly seen, with the original back about half a metre from the floor of the drift sitting on broken rock. Perhaps the most striking feature in this first advance was the degree of compaction and interlock seen in the broken rock exposed (Figure 6). This was readily stabilised by the initial shotcrete and friction bolt support, and inflatable bolts were installed in all but the most broken portion (upper left in Figure 6). In this area, grout tubes were placed in the inflatable bolt holes and grout injected to locally improve the ground. Following grouting, the inflatables were installed successfully and advance could proceed.

Figure 6 First exposure of the collapsed zone in 2017, prior to support installation. The original back can be seen sitting on broken rock just above the floor. Broken rock in the back and ribs of the new excavation is highly compacted

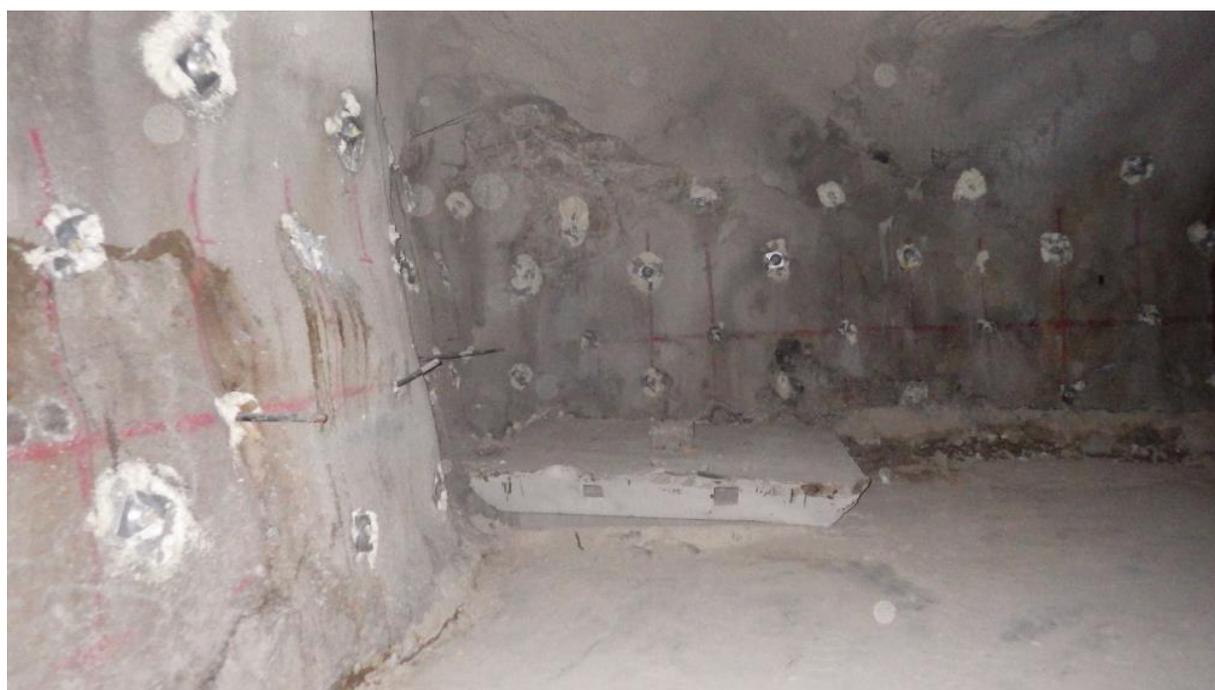
Using this method, the orepass was opened and returned to service for the re-mining work. When the excavation was approaching its final span, cracking and damage began to be seen in the ribs on the far side of the orepass excavation. Cracking began on both ribs just inside the wider span of the orepass opening and continued back to the north for five to eight metres. This was the first evidence of any damage to the support system encountered in the mining process to date. Upon observation, this damage was not progressing continuously, but was increasing with each new advance.

Through the course of excavation, the ground in the ribs had been the most damaged. Additionally, support in the lower ribs was typically limited to friction bolts and surface support. It was determined that the lower ribs were not effectively carrying the load from the span in the orepass, and were deforming plastically each time the span increased. Before this resulted in greater stability problems, excavation was halted and a plan developed to reinforce the lower ribs.

Figure 7 Friction bolts and hollow bar installed through the re-opened orepass for lower rib grouting

A closely spaced pattern of 2.1 m friction bolts and 3 m hollow bar was installed in the lower ribs from the orepass opening back to the drawpoint intersection (Figure 7). Grout tubes were placed in the friction bolts and sealed, and the entire pattern was systematically grouted. Cementitious grout was placed through each bolt, proceeding row by row, from bottom to top. The grout through the friction bolts provided ground improvement near the surface with the hollow bar tying this into the deeper rock mass.

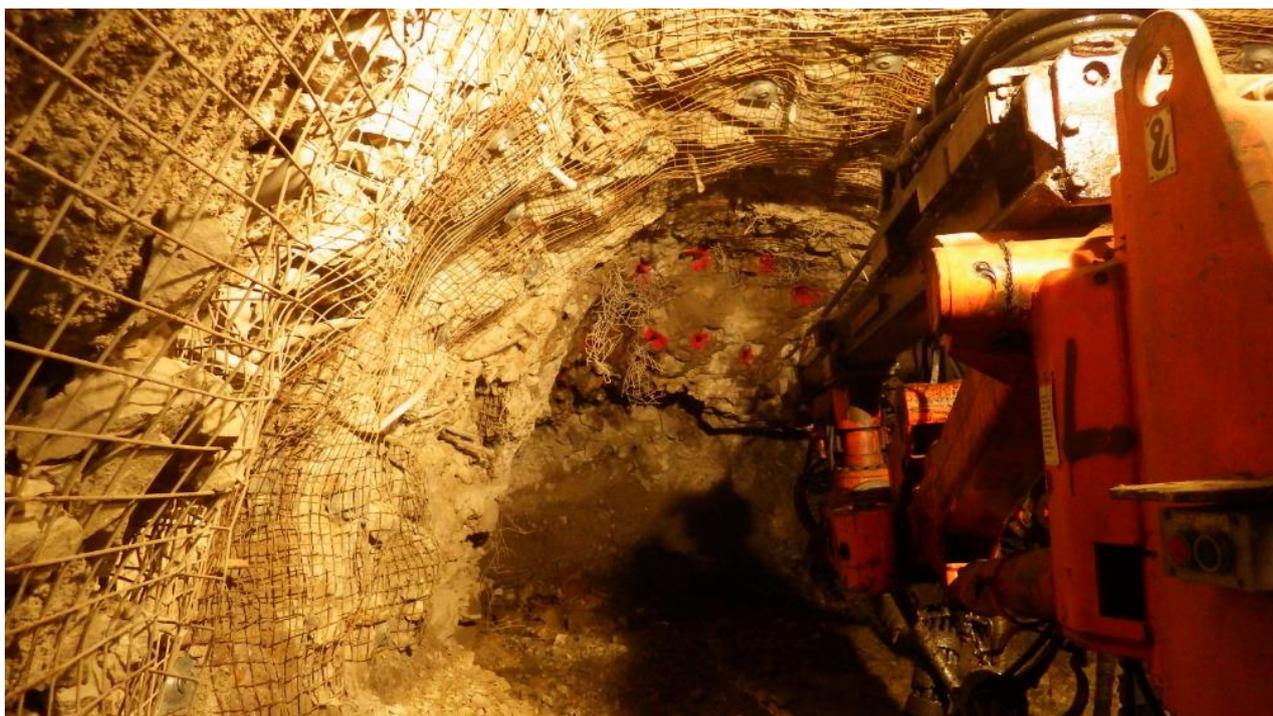
Once the backfilled zone was reached, anticipation was high to see the performance of the stacked muck and pumped concrete placed 18 months previous. The results were better than anticipated. The drift profile was preserved and intact, although about 1 m lower than the original height. The backfill itself was impressively robust, especially considering the minimalist placement method. The bottom portion of the drift was able to be excavated with a loader, but the upper portion of the backfill formed a solid cemented rock bridge, tight to the back.

Figure 8 Excavation through the backfilled zone. A backfilled drawpoint is to the left. The lower portion of the backfill was excavated by LHD, prior to drilling and blasting the upper portion

Advance through this area proceeded relatively rapidly by digging the bottom as far as could be reached safely, and then drilling and blasting the cemented portion away from the back (Figure 8). The original back was then secured with mesh and friction bolts and advance continued. The backfilled drawpoints were passed by, securing the surface of the backfill with friction bolts and mesh. Once breakthrough was completed, shotcrete was applied to complete repair of the surface support.
