Managing decline deformation in an active sublevel caving operation

Abstract

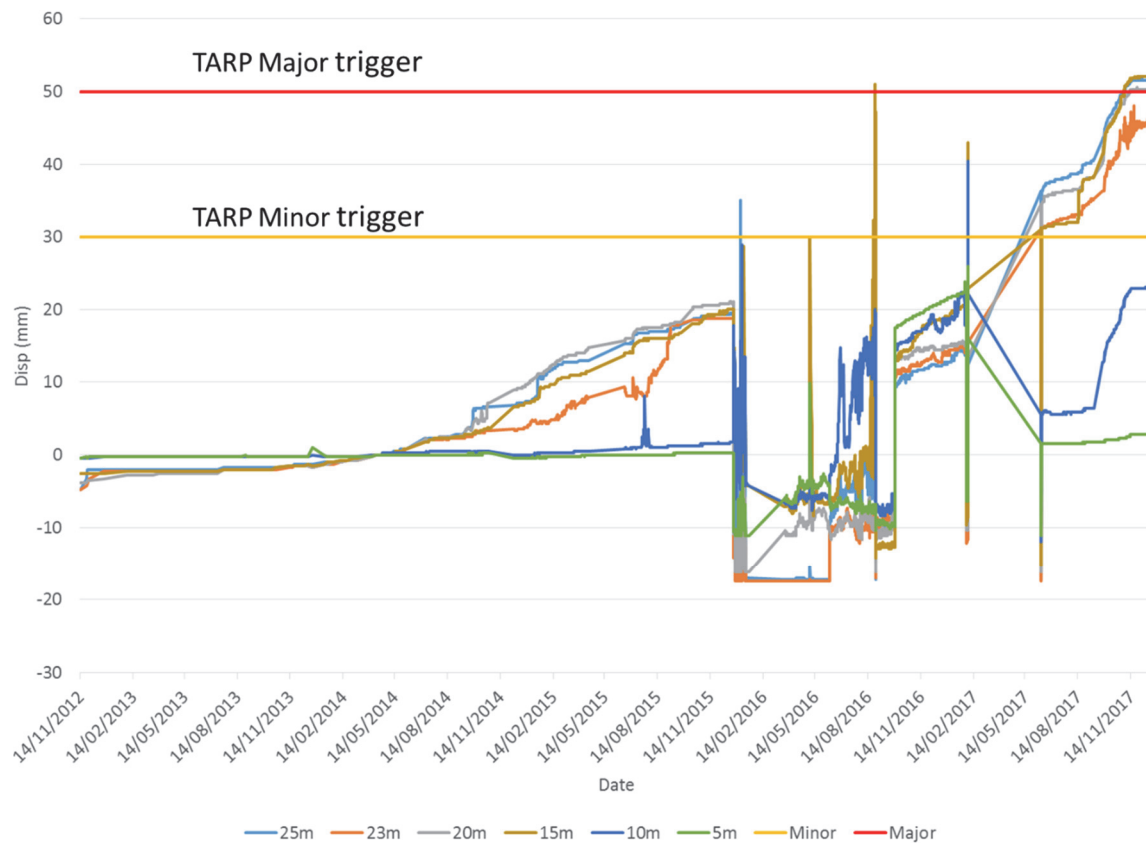
Monitoring remained ongoing during cave production and in mid-2017 one of the MPBX within the 4650 to 4600 Decline breached the TARP major trigger (Figure 6). The associated TARP response was to rehabilitate the area and commence designing a decline bypass, which was to commence development at breach of the critical trigger. The bulk of SLC production at that stage was coming from the 4500, 4475 and 4440 Levels, with development of the 4410 Level suspended, as mentioned in Section 3.2.

Figure 6 MPBX data from the 4650 Decline area with cave major hazard management plan (CMHMP) and TARP triggers used to implement support upgraded and bypass

With damage manifesting faster-than-expected, a 540 m long decline bypass was designed before the critical trigger was reached and commenced in November 2017 (Figure 7). Development throughout November to March was significantly hampered due to excessive heat and humidity issues, a challenge frequently encountered for lateral development at Telfer during the summer months. To ensure timely completion of the bypass post-summer, a rapid development plan was implemented which realised lateral development rates of up to 188 m per month, with over 100 m from a single heading alone. Decline bypass breakthrough was achieved in mid-June 2018, with the entire bypass project being completed free of injury and incident.

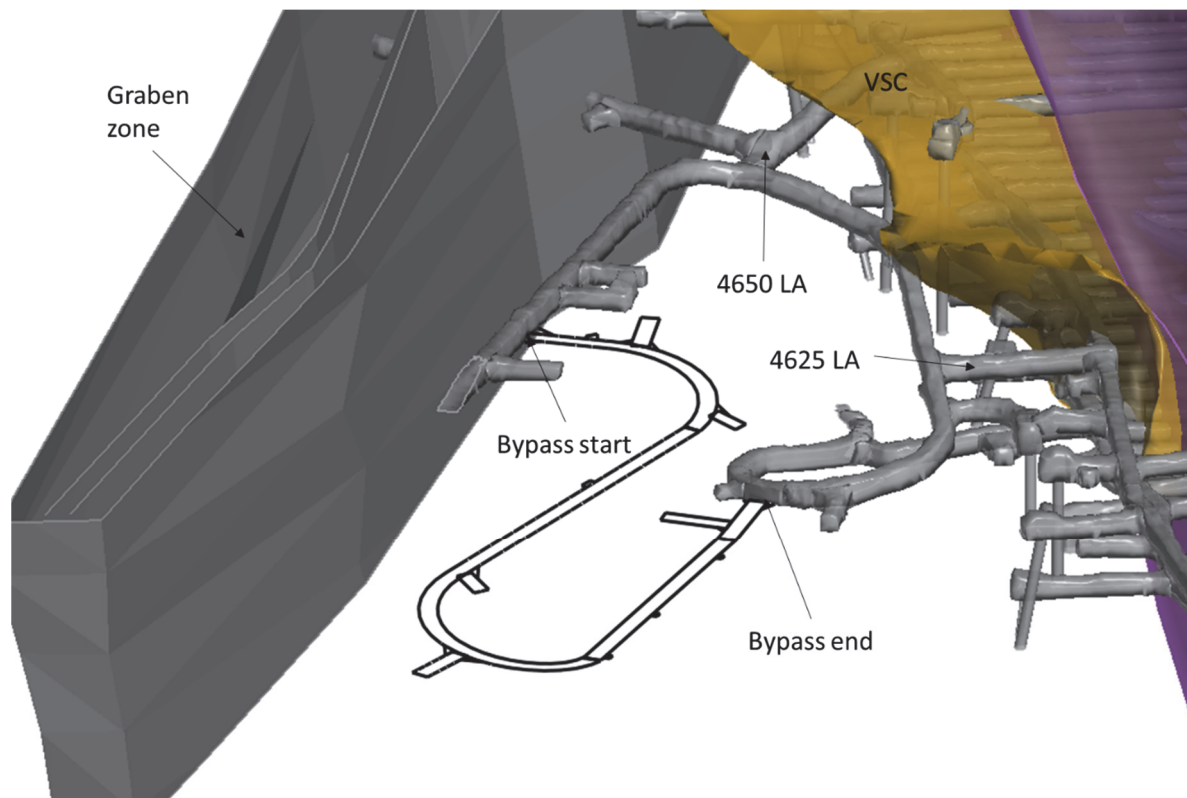
Figure 7 Decline bypass excluding the section of decline nearest the cave and VSC, A Reef and monocline contacts

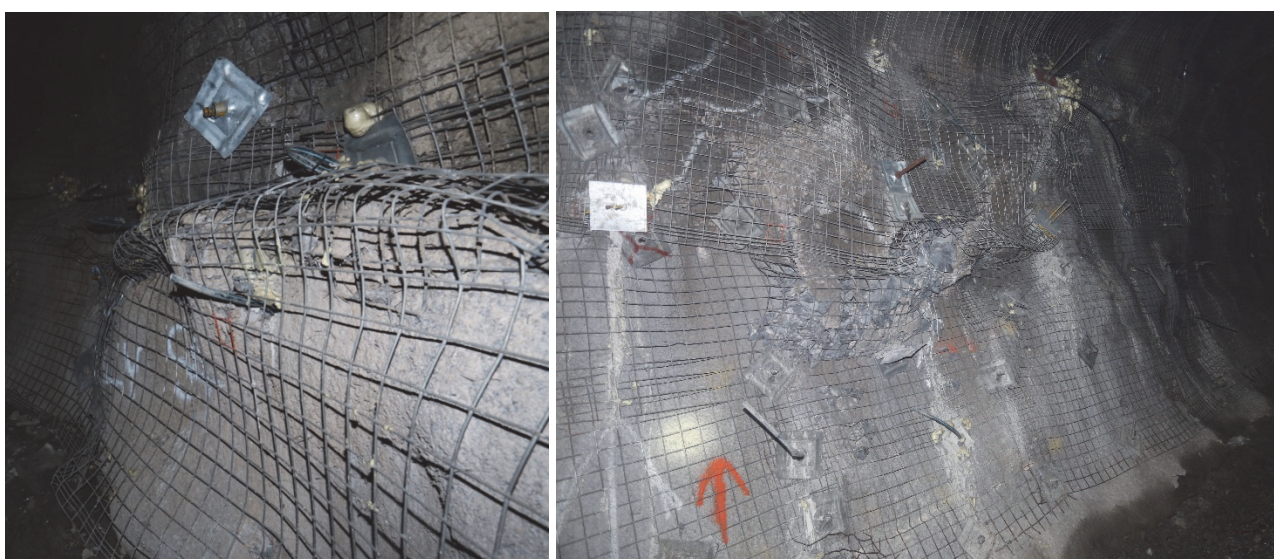
As the additional sublevels were mined, the increased cave influence zone and rock mass strain resulted in buckling of the bedded strata around the decline due to floor to back convergence, dilation and shearing of structures resulting in the clamping and rupturing of support elements. This is typical of the damage mechanisms described by Beck and Sandy (2003).

Floor to back convergence was evident with mesh doubling up on itself as shearing occurred (Figure 8), however, the backs of the drive generally showed minimal signs of deformation or ground support loading. This suggested that backs movement recorded by LiDAR scanning (Figure 9) occurred as walls sheared past each other and the lower side walls kicking out, rather than bulking of the backs. There was also potential for global deformation of the drive towards the cave, which could not be monitored with the SMART cables and LiDAR scans.

Figure 8 Damage within the decline showing shearing of the side walls, bulking between reinforcement elements and mesh folding over on itself

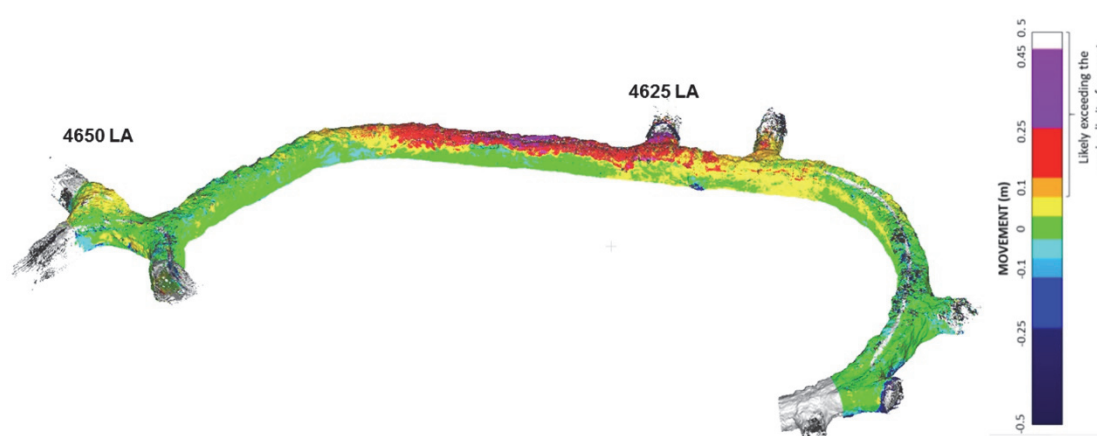
Figure 9 4650-4600 LiDAR scan comparing January 2018 to April 2018 looking east

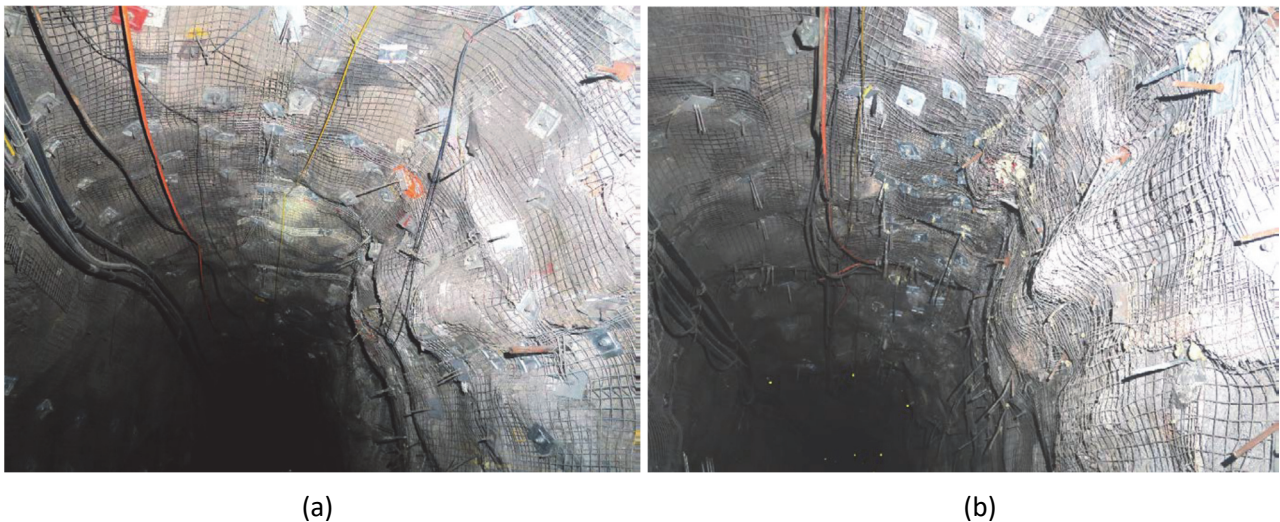
As noted earlier, deformation occurred at a faster rate than anticipated, with bulking particularly evident between reinforcement elements. Figure 10 shows the change in conditions over a three-month period.

Figure 10 Increase in deformation and buckling of side walls due to floor-to-backs convergence in (a) March 2018; (b) June 2018

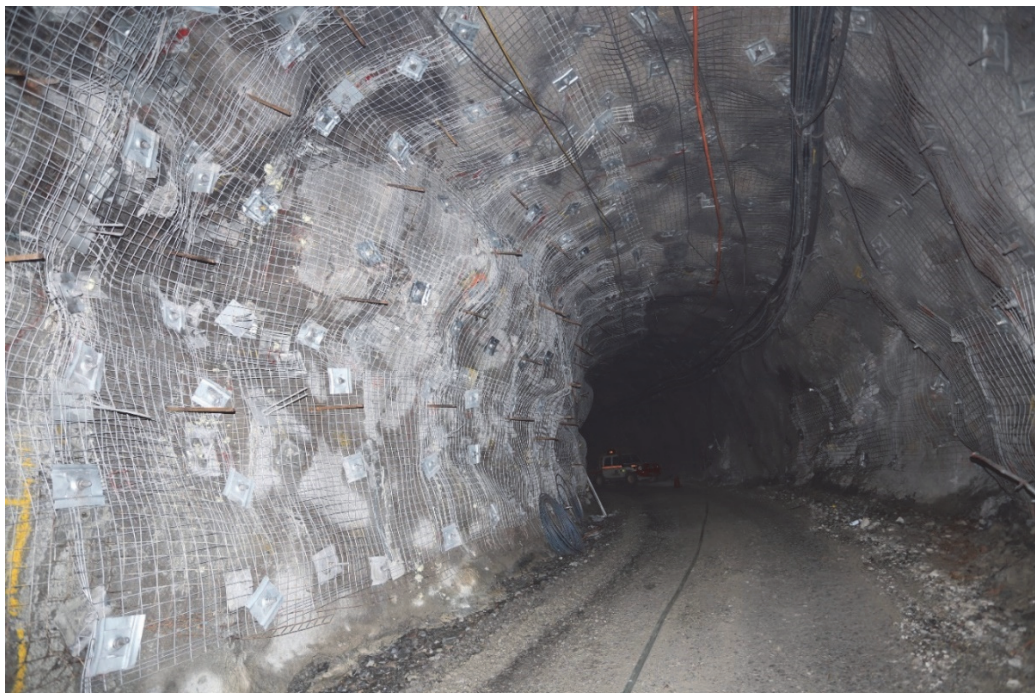
Figure 11 Decline upgrade with strengthened overlap mesh to floor, 2.4 m MD bolts and self-drilling anchors waiting to be plated

The support upgrade program commenced using a combination of either strengthened overlap mesh or Osro straps with 6 m cable bolts and 2.4 m Mechanical Dynamic® (MD) bolts. Due to difficulty keeping cable bolt holes open for installation, the decision was made to use 6 m self-drilling anchors with cement grout in the side walls and 6 m cable bolts in the backs where the depth of damage was less, allowing for installation (Figure 11). During upgrade depth of damage up to 2 m was recorded in the drive side walls.

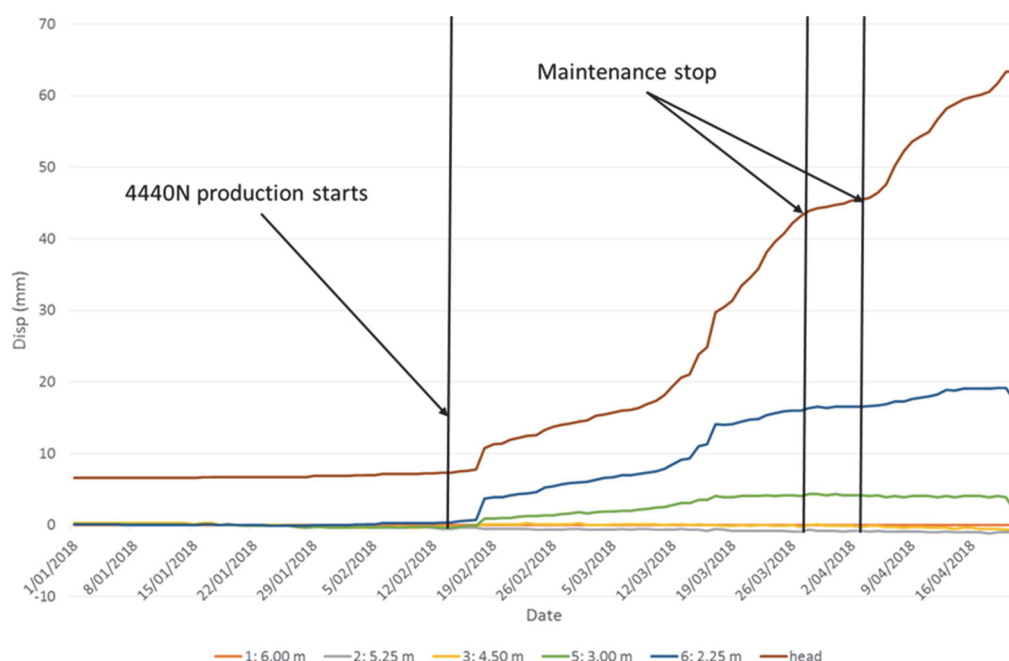
A number of the SMART cables within intersections showed a displacement trend related to SLC production (Figure 12). The increased rate of deformation is exhibited following restart of the 4440 N production area and reduction in deformation during an underground production hold for material handling maintenance. This is a trend also displayed in seismic monitoring.

Figure 12 4620 intersection SMART cable plotting displacement, also showing a strong correlation with production

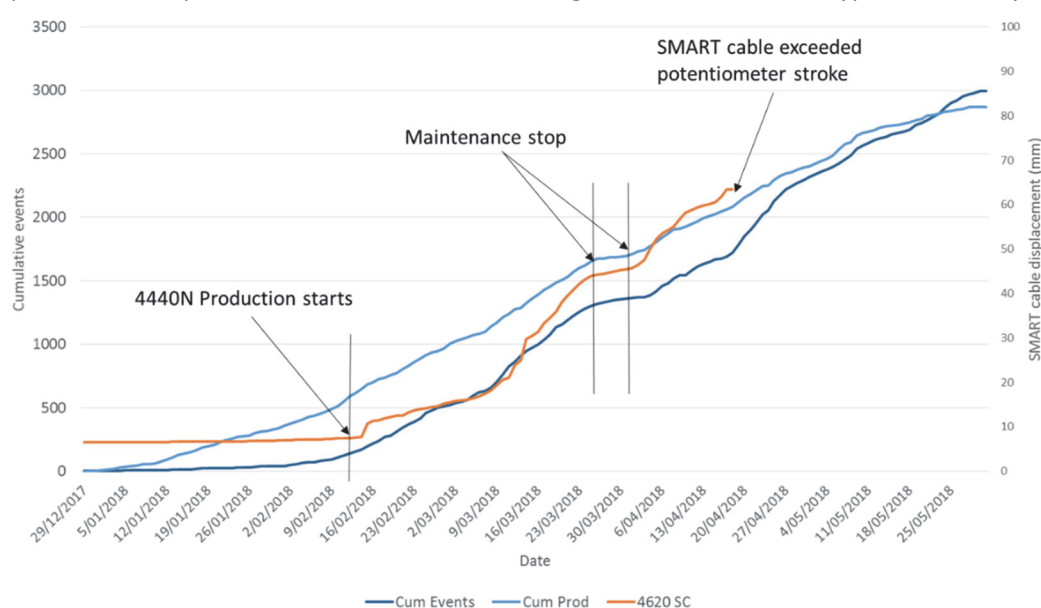
Combining both the seismic activity rate and SMART cable data, Figure 16 confirms that SLC production was the major driver of deformation in the 4650 to 4600 decline area. This clear cause and effect allowed management to use SLC production suspension as an effective risk management tool until the bypass was completed.

Figure 16 Clear correlation between SLC production, seismic activity rate and deformation monitoring around the 4650 Decline area

With the strong cause and effect observed between monitoring data, seismic activity rate and SLC production, SLC production holds were used to slow deformation in the 4650 to 4600 Decline from one month prior to bypass completion and ultimately a full SLC production stop used to reduce the likelihood of a potential seismic trigger 10 days before bypass completion.
