The Pardoo mine: closure planning, implementation and five years of performance monitoring data

S Gregory *Mine Earth Pty Ltd, Australia*

B Bow *Atlas Iron Pty Ltd, Australia*

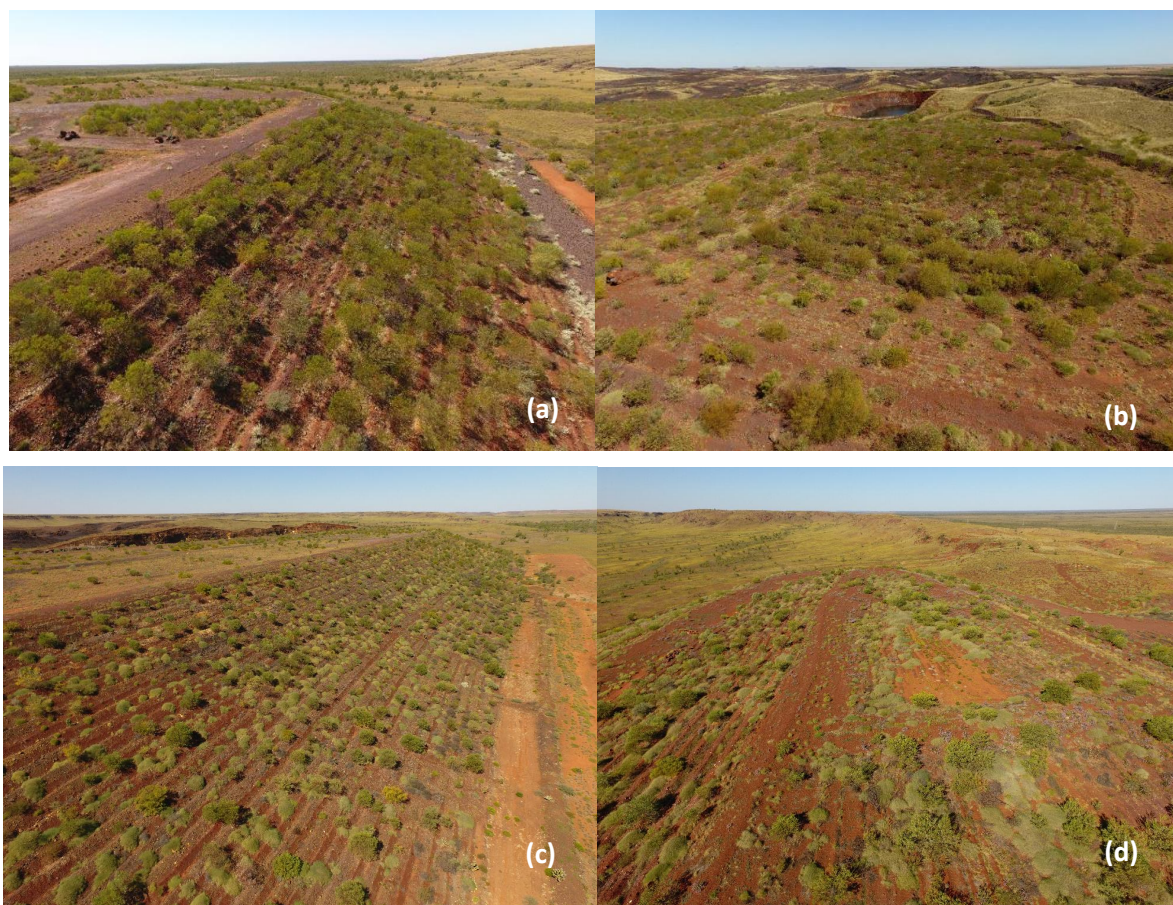
During 2018, the standards for perennial plant cover were met at 10 of the 23 transects (Table 5). However, transects not meeting plant cover standards were still showing an increasing trend over time. Those areas which were not performing well, were typically impacted by grazing activities. At the Bobby WRL, poorly performing transects were identified in areas that had to be reworked to improve the accuracy of the initial contour ripping, to avoid future erosion issues. A consequence of reworking these discrete WRL panels was that the topsoil and seed that was initially applied was reworked and buried.

Figure 2 Plant growth on the (a) Bobby, (b) Chloe, (c) Emma and (d) South Limb WRLs

The criterion that key taxa (*Acacia* and *Triodia*) are producing seed, has been achieved at all transects except for two on the Bobby WRL (slope transect PDO07 and top surface transect PDO05) and one on the Emma hardstand area (PDO17). These transects reported little to no plant cover and it is likely that they were devoid of the key taxa, most likely as a result of grazing (Table 5).

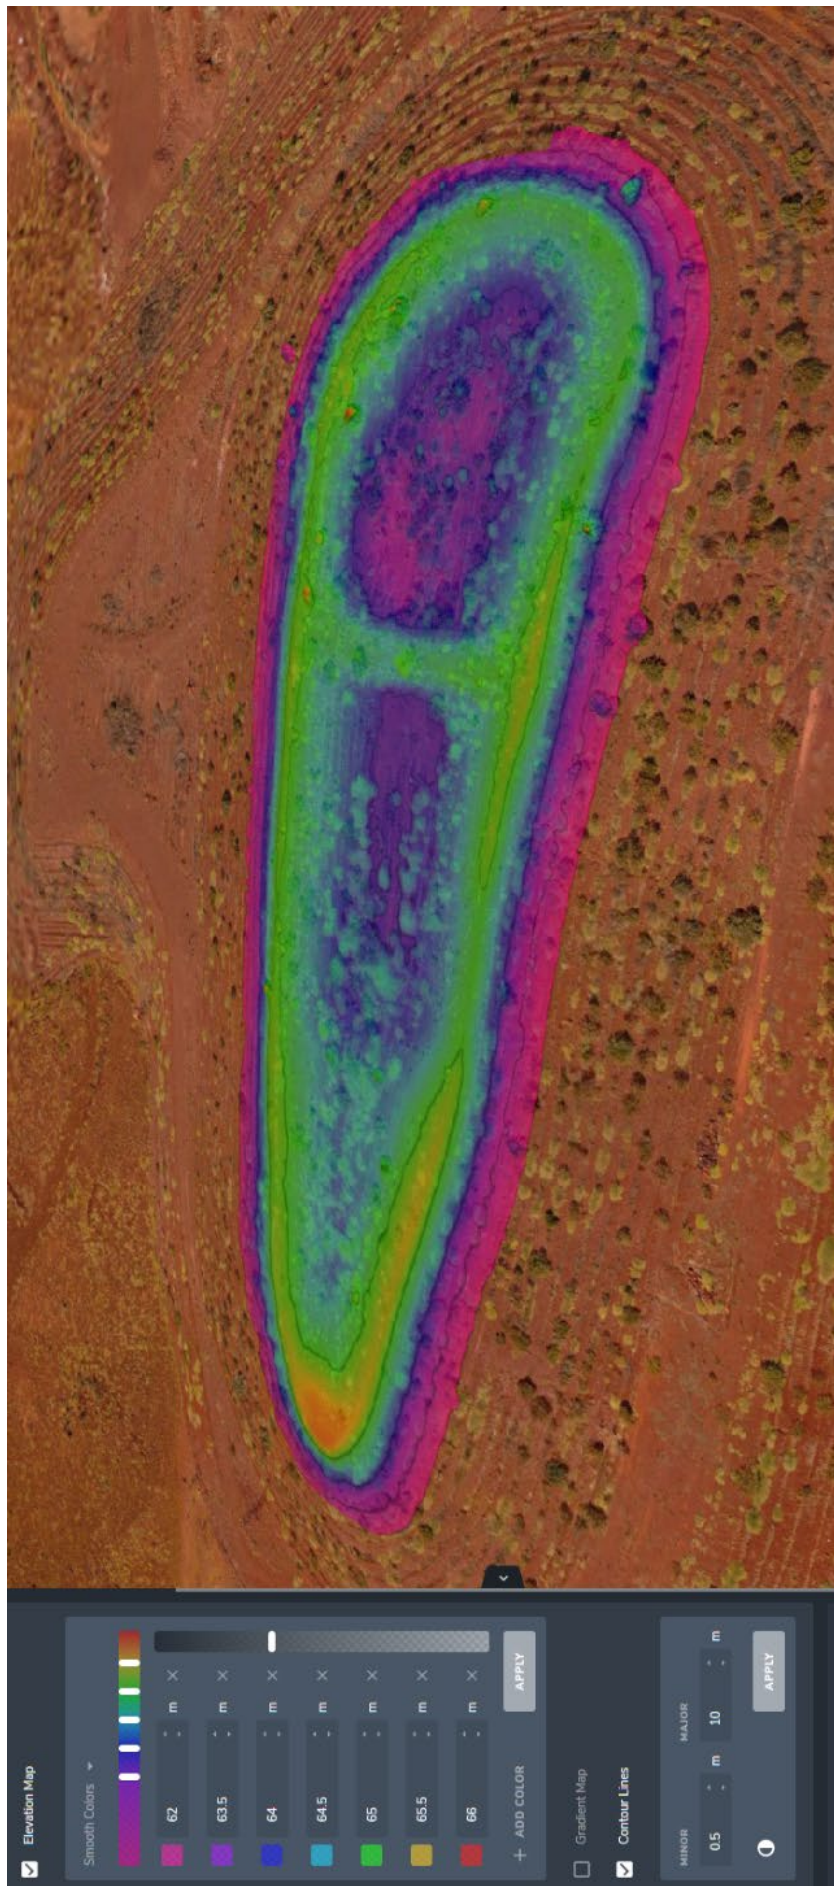
The UAV survey undertaken during November 2018 captured orthophoto data from each WRL. DEM data and elevation heatmaps were generated and analysed to determine if WRL surface water control features, including top surface catchment cells, crest bunds, berms and perimeter flood and drainage controls, were functioning as-designed (Figure 3).

The assessment identified that the top surfaces of the South Limb, South Limb West, Bobby, Chloe and Alice WRLs are relatively flat, with crest and internal bunds sufficiently elevated above the top surface level, to prevent overtopping onto the batters. No low-lying areas adjacent to the crest bunds were identified as high-risk areas for potential future erosion.

Figure 2 Example of waste rock landforms (WRL) upper surface elevation heat map for the South Limb WRL

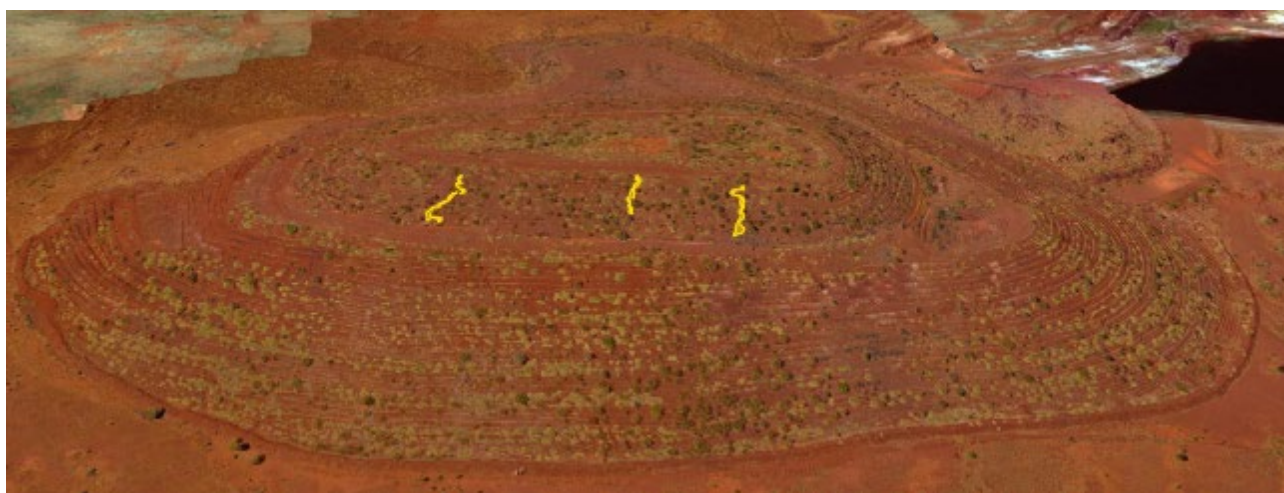
Each gully identified from the orthophotos and DEM was classified according to its severity, based on several features such as gully length, gully volume, sediment movement and the catchment size contributing to the gully. Most erosion features identified on the WRLs were relatively minor and were classified as *‘Green: Minor gully, no immediate threat to erosion stability and/or surface drainage control, to be monitored over time’*. Eleven gullies were classified as *‘Amber: Substantial gully to be closely monitored over time, potential threat to erosion stability and/or surface drainage control’*. None of the gullies were classified as *‘Red: Severe gully, current threat to landform erosion stability and/or surface drainage control, remediation required’*. This method identified far more erosion features than the traditional erosion transect method.

Most of the ‘Amber’ gullies at the Project were classified due to factors such as gully length, rather than high volume or sediment movement beyond the toe of the landform. Three ‘Amber’ gullies were identified on South Limb WRL (Figure 4), three on South Limb West WRL and five on the Bobby WRL. There were no amber gullies identified on the Chloe or Alice WRLs.

Figure 4 Identified erosion gullies on the South Limb WRL

Annual UAV surveys and associated landform scale erosion assessments will be undertaken to revisit each of the gullies identified from the 2018 ‘baseline’ assessment. The results from landform scale assessments of erosion will generate a robust erosion rate of change value, which will be applied as a standard for the erosion closure criteria.
