# Three case studies: mechanisms other than spillage and leaks that change groundwater quality and inhibit closure certification

## Abstract

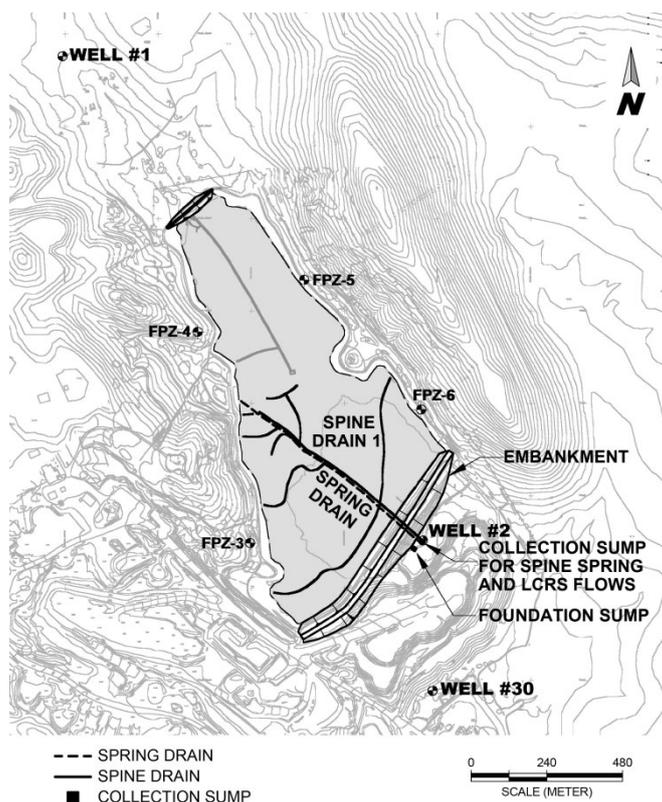
Figure 1 Flotation tailings impoundment and monitoring locations

The locations of monitoring wells #1 and #2 are shown in Figure 1. These wells were installed during the baseline period before the impoundment was constructed. There was also limited testing of the spring during the baseline period. Monitoring data were evaluated during the operations and closure periods as required by the environmental permits by comparison to site-specific water quality protection standards (WQPSs) (statistical control limits determined from the baseline dataset). If a WQPS is exceeded, evaluation and corrective action is triggered. The TDS and sulphate concentrations versus time at Well #2 are plotted in Figure 2. As shown in the figure, both TDS and sulphate began rising early in mine operations (which began in 1989). The concentrations exceeded WQPSs during operations in 1992, which triggered initial evaluation.

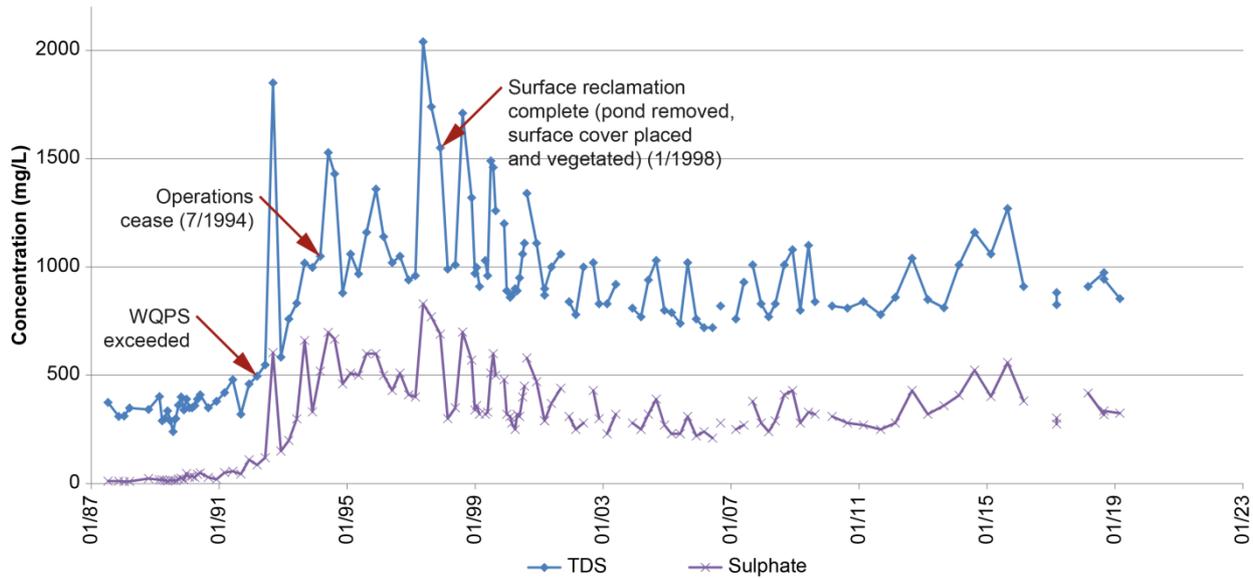
**Figure 2 Total dissolved solids (TDS) and sulphate versus time at Well #2**

The initial evaluation, completed in 1993, concluded that the change was due to excess seepage of tailings water through the liner into groundwater. The initial corrective actions developed included reducing the volume of water stored in the unit and closure. The storage volume was addressed within a year, and the mine ceased operating and initiated closure beginning in July 1994. By the end of 1998, the pond on the impoundment had been drained, the surface graded to slope towards a breach in the embankment, and a 15 cm thick soil cover was constructed and vegetated. As shown in Figure 2, the TDS and sulphate concentrations dropped somewhat after reclamation and seasonal peaks in concentrations were smaller, but the water quality stopped improving by about 2004. Concentrations were still above the WQPSs, thus evaluation of conditions was ongoing throughout and following this period.

In approximately 2002, an alternative hypothesis was being formulated as the cause of water quality changes at Well #2. The alternative hypothesis had two elements: (1) construction of the impoundment had cut off groundwater recharge within the valley, eliminating the supply of a thin layer of good-quality groundwater near the ground surface; and (2) the embankment, which was constructed with rock mined from the pits, was a primary source of TDS and sulphate. This alternative hypothesis was developed based on observations at Well #1 and also comparison of the chemistry of drain water with Well #2 groundwater.

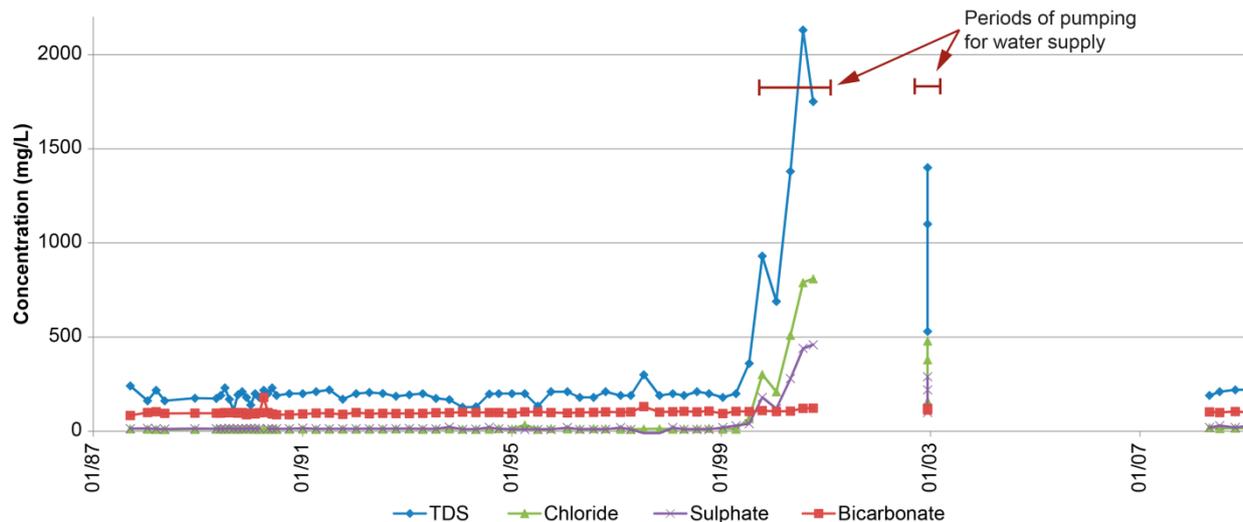
Well #1 served intermittently as a water supply well for a local rancher in addition to a baseline monitoring well for the mine. The water quality of Well #1, located upgradient of the flotation tailings impoundment, was good with low TDS and sulphate concentrations. The water quality had remained constant throughout the baseline and operations period. However, the rancher contacted the mine and asked if a new well could be installed because the water quality at Well #1 had become degraded. Figure 3 presents the concentration trends of several constituents in Well #1. As shown in the figure, the concentrations increased abruptly in mid-1999. The rancher stopped using the well and the water quality rapidly returned to baseline conditions. He started using the well again and the water quality again became degraded.

Figure 3 Water quality response in Well #1

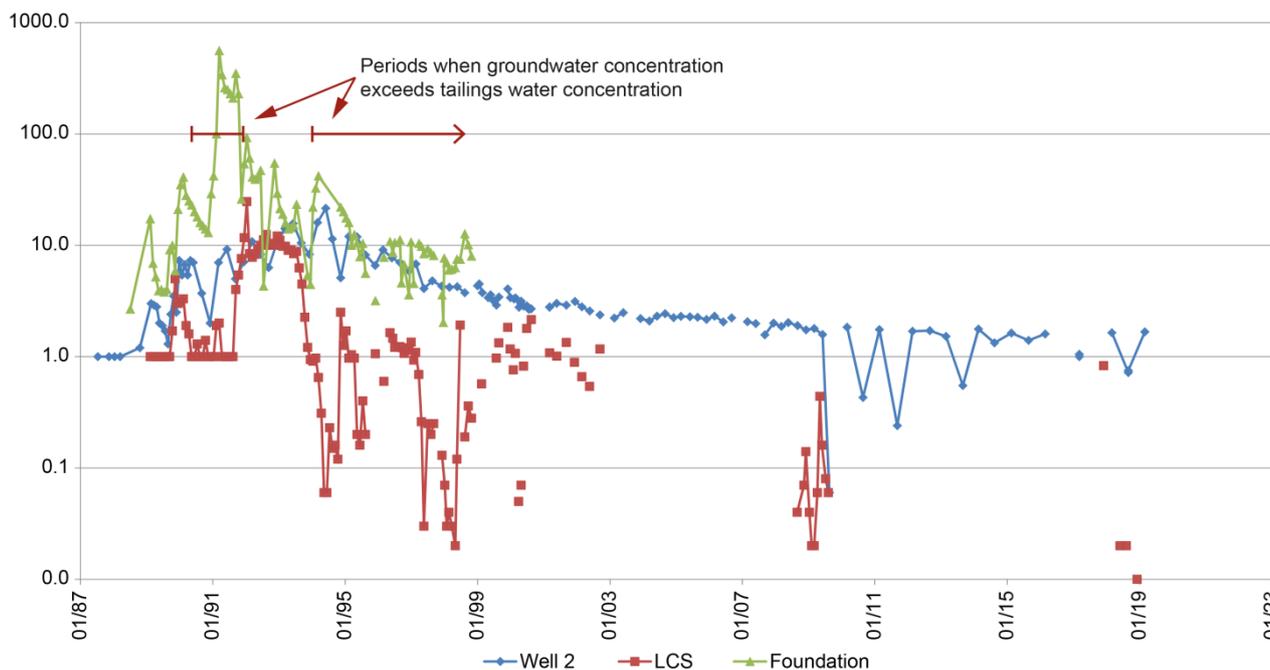
The approach to demonstrating the source was not the tailings impoundment was principally evaluation of water quality data. Figure 4 shows concentration of nitrate over time in Well #2, the LCS, and the foundation drain (note the log scale of the vertical axis). The nitrate concentration was high in Well #2 and often higher than nitrate in the tailings water (as indicated by the LCS). In fact, the only location being monitored at this mine with nitrate concentrations higher than Well #2 was the foundation drain. As mentioned previously, the foundation drain drained the foundation of the embankment for the tailings impoundment, which is located just upgradient of Well #2 (Figure 1).

Figure 4 Nitrate versus time at Well #2 and select drains

The embankment rock was screened of fine material so that it would be free-draining. The very high nitrate concentrations observed in the foundation drain occurred during the wet season (Figure 4) and are presumed to be a result of infiltrating precipitation rapidly rinsing the nitrate out of the embankment and into the drain. In a few years, most of the nitrate had been washed out of the embankment and the concentrations decreased. The nitrate trend in Well #2 was generally the same as that of the foundation drain, although concentrations were lower.

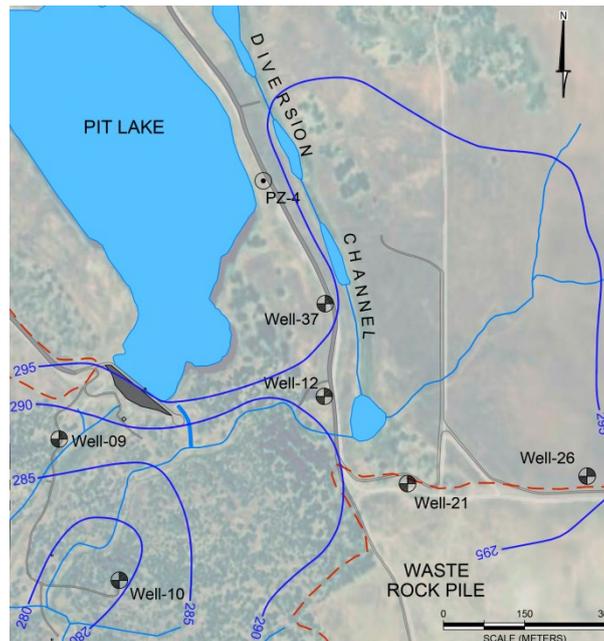
The second case study is for monitoring Well #12 at the same mine located near a diverted stream and one of the mine pits. A plan view of the area with current groundwater elevation contours is presented in Figure 5. The issue at Well #12 was principally the arsenic concentration, although there were several other constituents being monitored that exhibited a similar pattern. The arsenic concentration trend at Well #12 is shown in Figure 6 along with the groundwater elevation at Well #12 and the pit lake level.

Figure 5 Current groundwater elevation contours

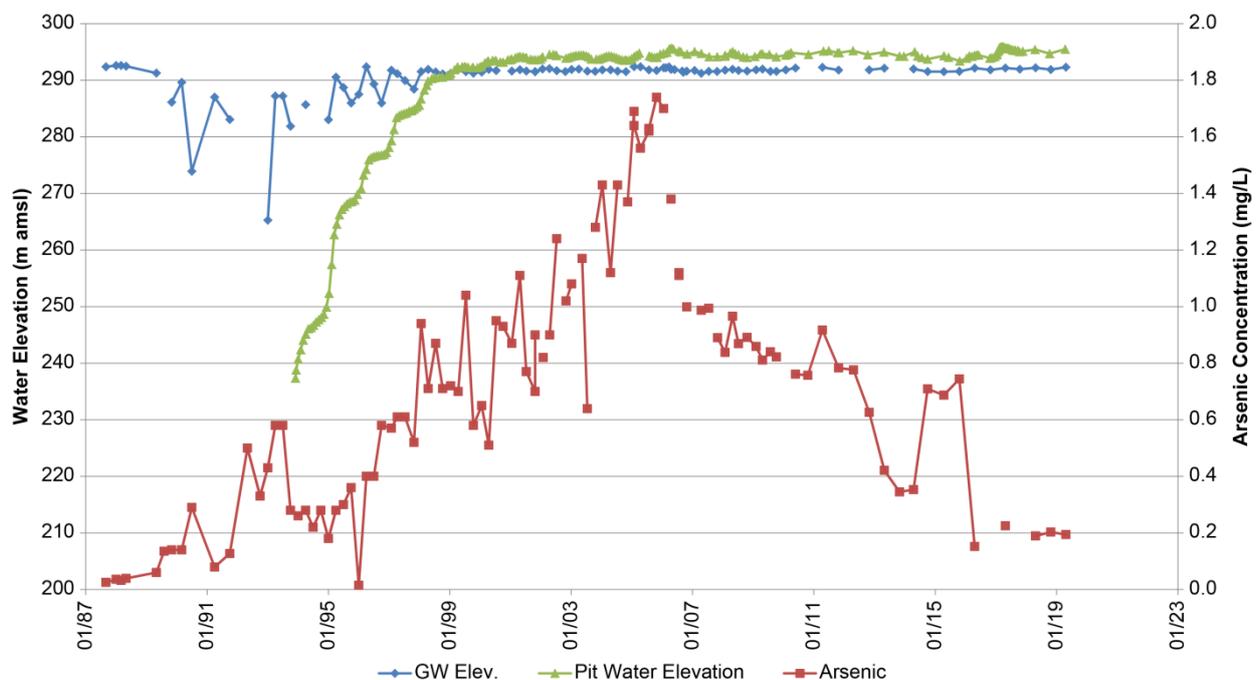
Figure 6 Arsenic concentration at Well #12 versus time

The hydrograph for Well #12 in Figure 6 shows that, during the period of mining, the groundwater elevation was fluctuating seasonally over a wide range (up to 15 to 20 m) and this is attributed to a hydraulic connection between the pit and groundwater in the area of Well #12. This large fluctuation in water level resulted in a condition that could be considered a large-scale in situ humidity cell, with alternating wet and dry oxidising conditions. Like a humidity cell, the conditions were optimal for increased sulphide oxidation. The oxidation of pyrite and arsenopyrite (which occurs in the mineralised zone) resulted in increasingly high concentrations of arsenic and sulphate in this area.

Mining ended in 1994, and the pit began filling with groundwater. As shown in Figure 6, the range over which groundwater levels fluctuated decreased during this period until the pit water level rose above the groundwater at the end of 1998, and then stabilised at the beginning of 2000. Thus, after 1998, the hydraulic gradient was from the pit towards Well #12 and the creek. The arsenic concentration continued to increase during this period. The concentration peaked in 2004 and then began decreasing.

The arsenic concentration of the pit lake ranges from 0.06 to 0.13 mg/L, so it is much lower than the concentration of groundwater at Well #12. As shown in Figure 6, the decreasing groundwater concentrations at Well #12 are approaching the pit lake levels. Figure 9 shows the trend in sulphate concentration at Well #12 along with the hydrographs of the well and of the pit lake level. The sulphate concentration at Well #12 increased during the period of mining with wide annual fluctuations, and continued increasing to the present possibly with the concentrations levelling off recently. The sulphate concentration of the pit lake ranges from 1,550 to 1,920 mg/L, which is similar to the recent concentrations at Well #12. Therefore, the arsenic and sulphate concentration trends and magnitude appear to be consistent with the pit lake water flushing out the high-arsenic groundwater. It also appears that, with more stable water level conditions, the “large-scale in situ humidity cell” no longer exists, which reduces the release of arsenic and sulphate from pyrites in the bedrock.

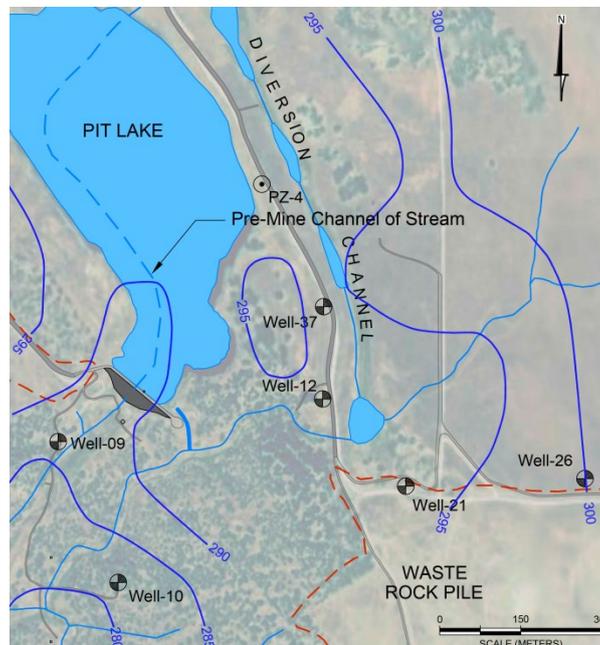
Figures 7 and 8 show the interpreted groundwater level conditions for pre-mine conditions and at maximum mine depth. These figures along with Figure 5 indicate how the direction of groundwater flow changed because of mine construction. The ephemeral stream flows only during the wet season, although some reaches near the well remain wet all year round. With the original alignment during the baseline period, there was no surface water near Well #12 and groundwater generally flowed westward in the vicinity of the well.

Figure 7 Interpreted groundwater level conditions for pre-mine conditions

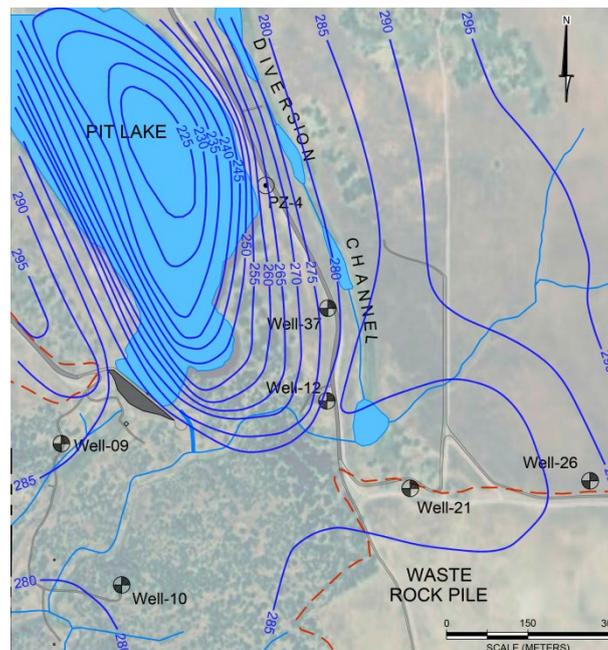
**Figure 8** Interpreted groundwater level conditions at maximum mine depth

In subsequent years, the pit was mined to a depth of approximately 110 m. As shown in Figure 8, the excavation and dewatering of the pit significantly lowered groundwater levels and changed the direction of flow at Well #12 from westward to northwestward.

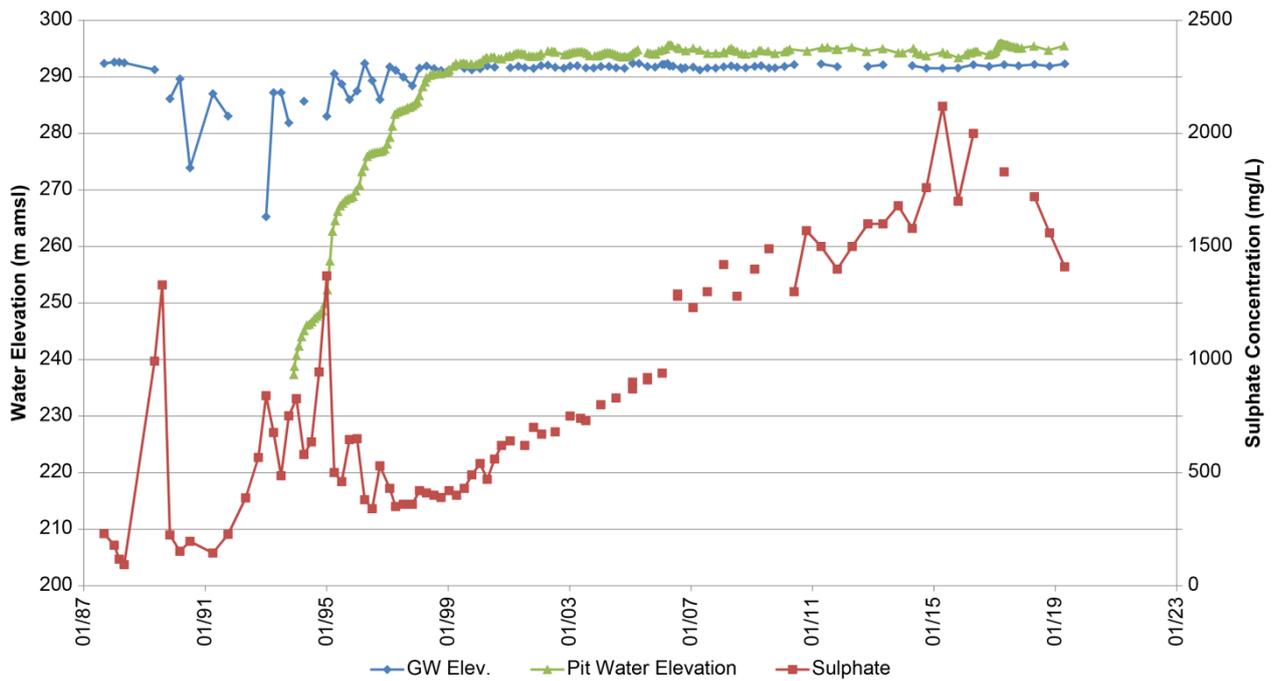
Figure 9 Sulphate concentration at Well #12

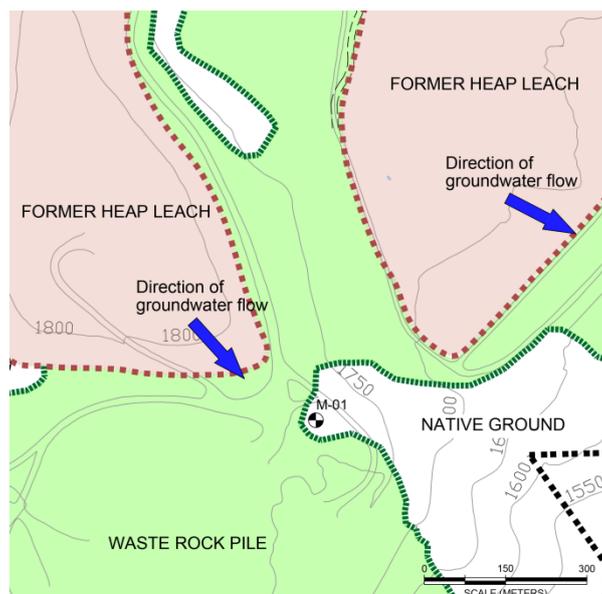
The third case study is for monitoring Well #M-1 at the second mine. Well #M-1 was installed in bedrock during the pre-mine period to characterise baseline hydrogeologic and water quality conditions at the mine. During and after mining, the well was used to monitor groundwater conditions downgradient of a heap leach pad constructed within a waste rock pile. The setting for the well is shown in Figure 10.

Figure 10 Vicinity location of Well #M-1

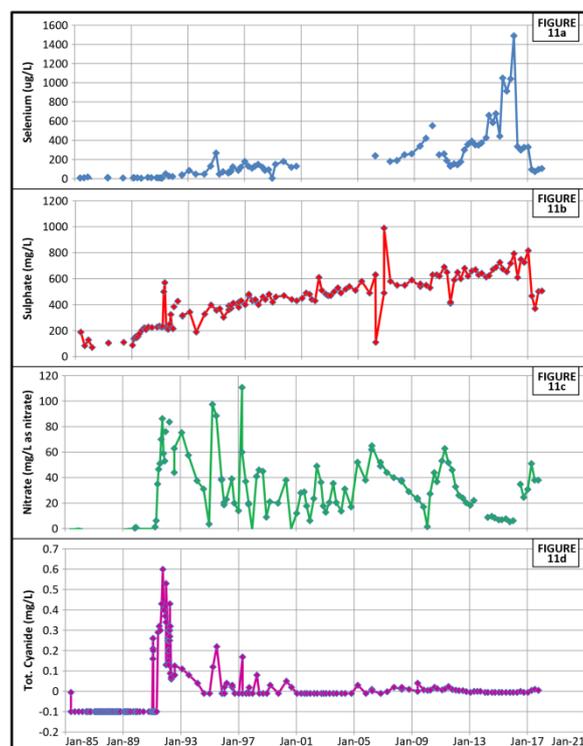
Figure 11(a) shows the trend in selenium concentration at M-1 during the baseline (1985), operational (1986–1990), and closure and post-closure periods. Selenium remained below the WQPS throughout the operational period, but started rising in mid-1991 and has remained above the WQPS since that time. As required by the regulatory program, an investigation was initiated to evaluate if the exceedance of the selenium WQPS was due to a release of mine water or waste. The selenium concentrations of heap leach pad and waste rock dump leachate were in the same range as the concentrations at M-1 at the time (i.e. 30 to 60 µg/L). In addition, the concentrations of mine waste indicator constituents (sulphate from sulphide oxidation, nitrate from blast residue and cyanide degradation, and total cyanide from leaching operations) had all increased in M-1 at about the same time as the selenium concentration (Figures 11(b) to 11(d)).

Figure 11(a)–(d) Trends in selenium, sulphate, nitrate and cyanide at Well #M-1

As shown in Figure 11, the corrective action did very little to resolve the groundwater quality changes at M-1; selenium and sulphate concentrations continued to increase, nitrate concentrations fluctuated up and down, and cyanide was consistently detected (although concentrations were decreasing) through 1993 with occasional small concentration spikes thereafter.

Figure 11(a) indicates several instances where selenium rose quite sharply, first to over 200 µg/L in December 1994, second to 634 µg/L in February 2010, and then to the overall peak concentration of nearly 1,500 µg/L in January 2016. The other constituents did not exhibit these peaks in concentration. The first two peaks occurred at approximately the same time as extreme wet years when groundwater levels were much higher than normal, so we postulated that perhaps the high selenium concentrations were due to a natural source in the unsaturated zone that was contributing the selenium. However, the very high peak concentration near 1,500 µg/L in 2016 actually occurred during the last year of a multi-year draught and groundwater levels were low. Therefore, the elevated concentration of selenium at M-1 is not related to either high or low groundwater levels.

The investigation concluded that the selenium and other constituent increases were due to terminating operation of the leach pad LCSs, which occurred in 1991 once active leaching was stopped and rinsing was initiated. The corrective action was to re-initiate removal of the leachate from the LCSs in 1992.
