Laser-based scanning to manage geotechnical risk in deep mines

DB Counter *Glencore Canada Corporation, Kidd Creek Operations, Canada*

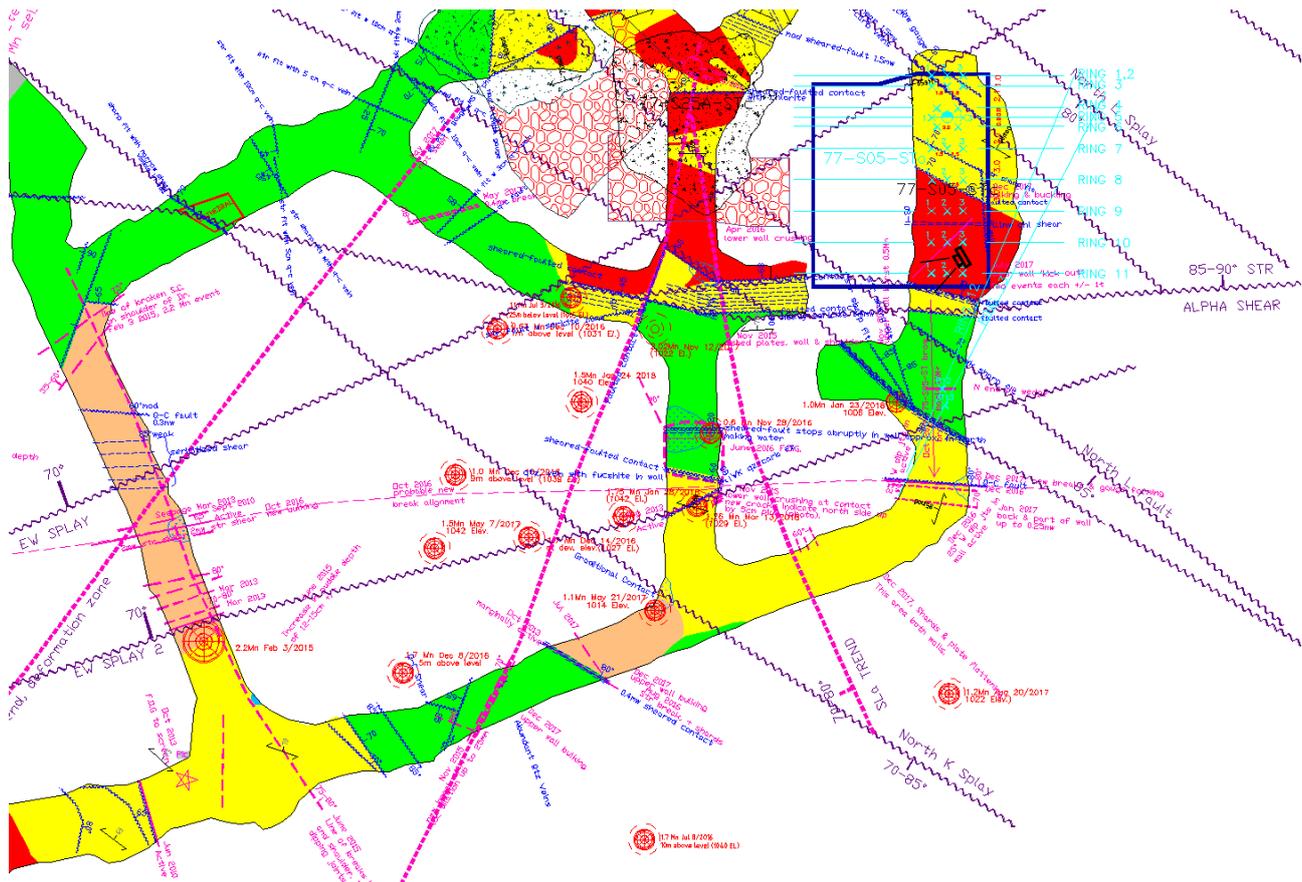
During development and drilling for the 77-S05 Stope, located at the upper right side of Figure 1, multiple seismic events occurred (M_N 1.2 on 21 August 2017 while taking a slash for the 75-S05 drill drift (DD), M_N 0.6 on 14 October 2017 while bolting in the 75-S05 XC, M_N 0.5 on 8 November 2017 while completing the reaming of the 77-S05 Stope slot raise, M_N 1.0 on 11 November 2017 during blasting the final round in the 75-S05 DD, and M_N 2.02 on 12 November 2017 approximately 29 hours later), which caused sufficient damage to require local rehabilitation. After the first production blast on 22 December 2017, the 77-S05 Stope was left full of muck to provide passive support to allow re-entry onto the top sill, given the ongoing seismic hazard and risk of caving. There were further seismic events (M_N 1.0 on 23 January 2018 and M_N 1.5 on 24 January 2018) while remotely drilling holes for the stope final blast to ensure operators were physically removed from the potential seismogenic zone, which was isolated by barricades on multiple horizons. The final blast was accompanied by a M_N 2.7 event on 27 January 2018 while access to the area was restricted under the site seismic re-entry protocol. A M_N 1.75 event occurred on 28 January 2018 with the onset of fully autonomous mucking from the surface (to ensure the continued safety of personnel), and a M_N 1.26 occurred on 13 March 2018 near the end of mucking, which was completed on 21 March 2018. Access to the seismogenic zone at the overcut elevation was restricted by barricades throughout the entire mucking process, as per normal isolation protocols.

Figure 1 Geology, south abutment 7,500 level. Major faults in purple. Recent mining-induced failure trends in magenta, including shear rupture planes (heavy dashed lines). Higher magnitude seismic events within 20 m above or below level at red circular icons. Rhyolite (yellow), andesite diorite (green), altered quartz porphyry (peach) and massive sulphides (red). The 77-S05 Stope is at the top right at the northern end of the 75-S05 XC (dark blue outline)

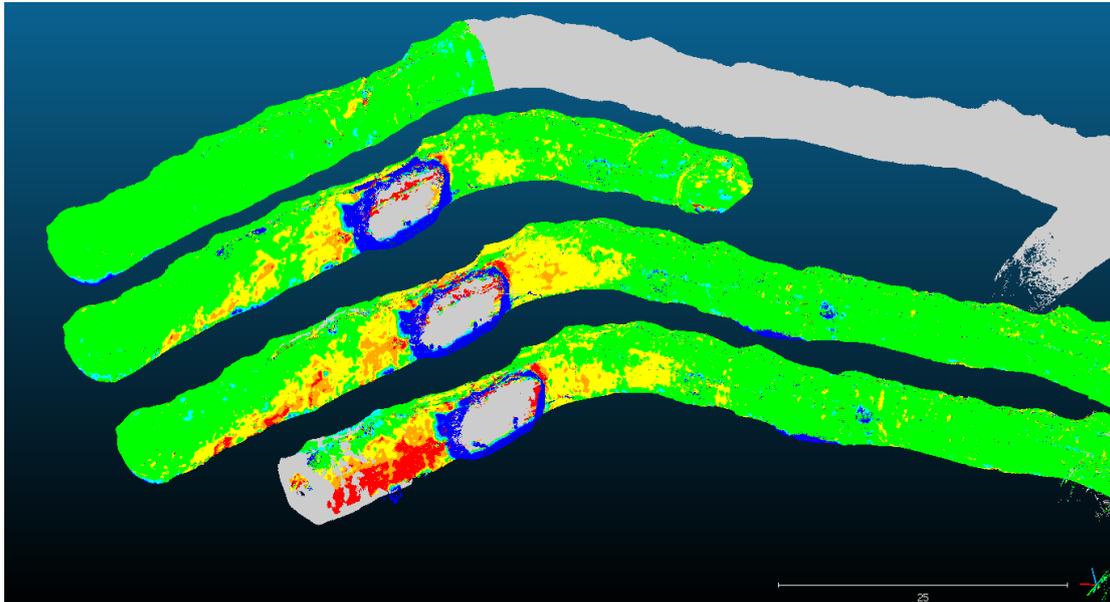
The CloudCompare images in Figure 2 show the changes to the west wall of the 75-S05 XC over roughly an eight-month period from 6 June 2017 through 31 January 2018, covering the development, production drilling and blasting associated with mining the 77-S05 Stope over four discrete periods. The first covers the deformation and seismicity associated with mining the nearby 75-S26B Stope from 6 June to 18 July 2017, before the start of drill drift development for the 77-S05 Stope. The second scan covers the development and raisebore processes, from 18 July to 18 November 2017. The third scan covers the period from 6 June 2017 to 26 January 2018, which incorporates all changes associated with development up to the time of the first production blast, and the seismic activity associated with production drilling in preparation for the final blast. The final scan shows the accumulated displacement for the period from 6 June 2017 to 31 January 2018, which covers the full development, drilling and blasting cycles of the stope, not including removal of the broken ore following the final blast or filling.

All the areas identified in yellow, red or dark blue in the CloudCompare images required re-support at various times during the extraction of the 77-S05 Stope and again after the final blast in order to regain access to the crosscut for the subsequent extraction of the 75-S05 Stope in the third quarter of 2018. Ground support failures consisted of loss of plates and failed heads from 22-mm diameter D bolts and failure of 0-gauge straps in areas with more than 13 cm of deformation, and breaking of mesh in areas with more than 7 cm of deformation. Rehabilitation consisted of removal of badly fractured rock (scaling or purging) and re-support with resin-based D bolts, or inflatable bolts in badly fractured ground, and the installation of additional dynamic bolts (Yield-Lok) within 0-gauge mesh straps along the walls. The back and wall of the drill drift were also cable bolted, with twin plain strand 15-mm diameter cables, which were

Figure 2 CloudCompare scans (top to bottom) of the periods from 6 June 2017 versus 18 July 2017—seismicity associated with blasting in nearby 75-S26B Stope; from 18 July 2017 versus 14 November 2017—seismicity associated with development of 75-S05 XC and drill drift (burst damage to lower walls) and reaming of the 77-S05 Stope slot raise; from 6 June 2017 versus 26 January 2018—seismicity following first toe blast in 77-S05 Stope on 22 December 2017 and ensuing production drilling; and from 6 June 2017 versus from 31 January 2018—following 77-S05 Stope final blast including M_N 2.7 and M_N 1.75 events. Areas not covered by both scans being used in the comparison process appear grey. Rehabilitation, including scaling, can result in a reduction in deformation and hence the appearance of less cumulative deformation over time, as seen between the third and fourth scan sets above

plated with custom blocks and tensioned to 10 tonnes per hole (5 tonnes per strand) to ensure that the bearing blocks were firmly connected to the cables while providing a minimum amount of pre-tension to maximise long-term capacity.

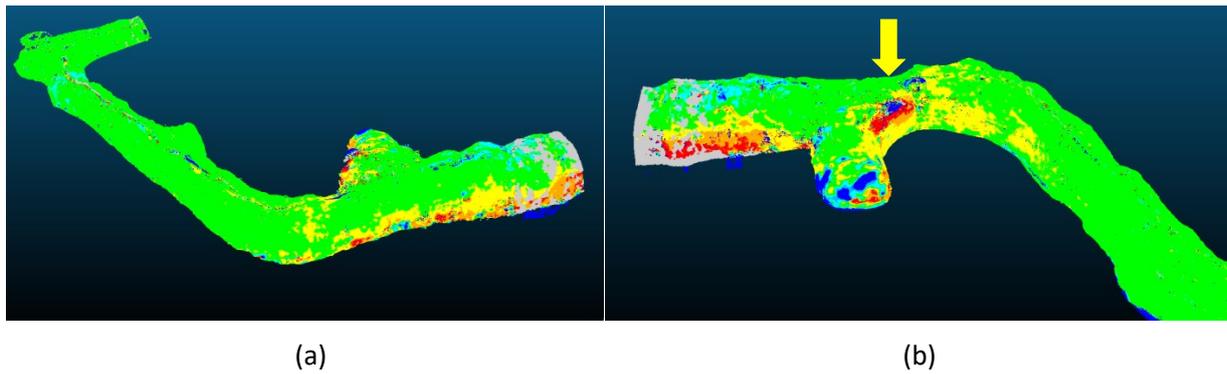
The CloudCompare images in Figure 3 show both sides of the 75-S05 XC and 75-S05 drill drift restricted to the period from 14 November 2017 to 21 March 2018 to solely show the deformation associated with the mining and seismic activity generated by the 77-S05 Stope, which is easier to reconcile with the strain plot from the Abaqus stress model associated with the same stope shown in Figure 5 (Beck Engineering Pty Ltd 2018). Historically, the stress models did not consider the excavation of access drifts separately from the extraction of the stope.

Figure 3 CloudCompare scans facing northwest (a) and southeast (b) showing the damage associated with blasting and mucking the 77-S05 Stope during the period from 14 November 2017 to 21 March 2018

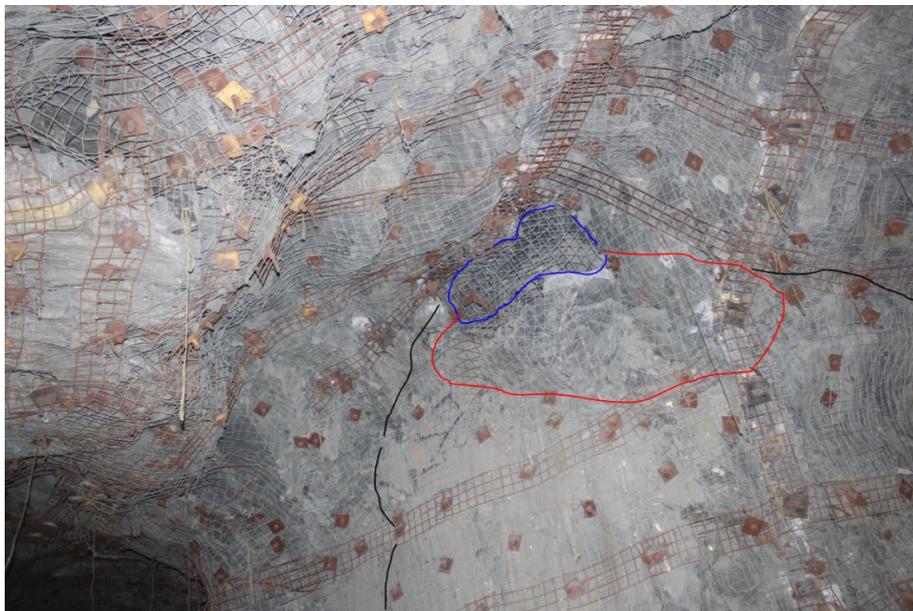
Figure 4 shows an area of the west wall of the 75-S05 XC at the entrance to the 75-S05 drill drift, facing southwest, where an area of the rock mass failed but was contained by the mesh. The blue area below the arrow in Figure 3(b) with an increased distance between successive scans in excess of 13 cm is outlined in Figure 4 where rock has fallen from the upper shoulder along a fault trace and accumulated in the mesh in the red area with a decreased distance in excess of 13 cm immediately below it, as shown in Figure 3. Where the wall has bulked along the fault trace as shown by the yellow area in Figure 3 where distances have decreased between 7 cm and 13 cm between scans, it has been outlined in a black dashed line in Figure 4. This area changed relative to the previous scan in Figure 2, as ongoing rock mass damage occurred during the mucking phase of the 77-S05 Stope caused by the removal of passive support, regional rock mass deformation and the subsequent seismicity. Note the correlation with the high-strain areas predicted in the Abaqus stress model as shown in Figure 5 (Beck Engineering Pty Ltd 2018)

Figure 4 Southwest corner of the 75-S05 XC and 75-S05 drill drift intersections, 21 March 2018

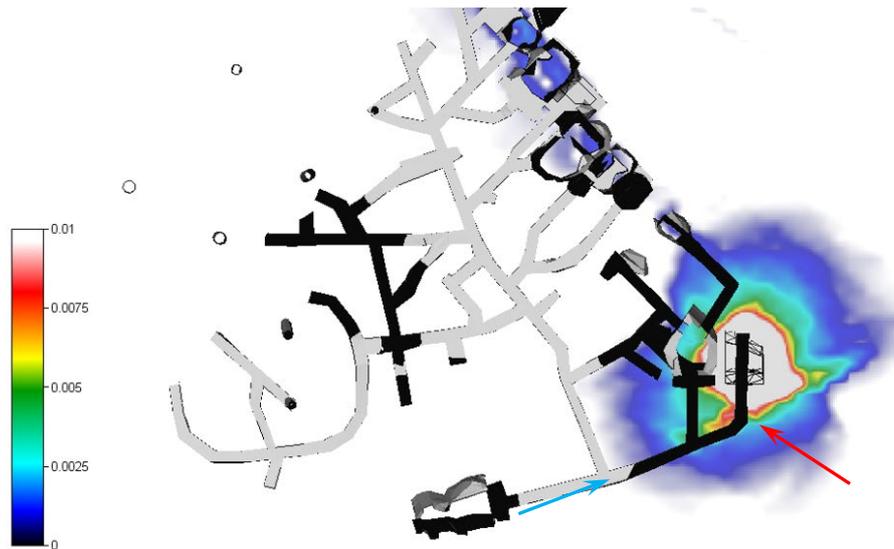
Figure 5 Abaqus stress model strain associated with 77-S05 Stope. The strain boundary caused by the North K fault is aligned with the red arrow, and the bulking and dilation following the East–West Shear Zone splay (as shown in Figure 1) is aligned with the blue arrow. Those areas are coincident with the most damage observed in the scan images in Figures 2 and 3 (Beck Engineering Pty Ltd 2018)

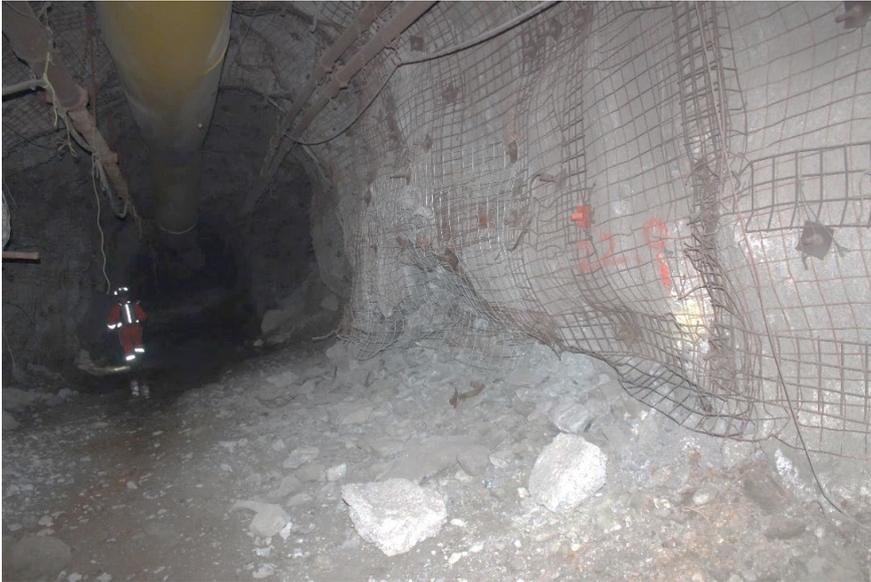
Figure 7 Ejected material, 70-S46 XC south wall and floor, near the trace of the Seismic Break 1A (SB1A) rupture surface, 19 December 2018. Note the number of cupped plates on the bolts in the walls, indicating load in excess of 17 tonnes on the tendons. Also, note the failed Super Swellex bolt, which has been both sheared and bent, potentially originating from the north wall, at the SB1A rupture surface in the centre of the image

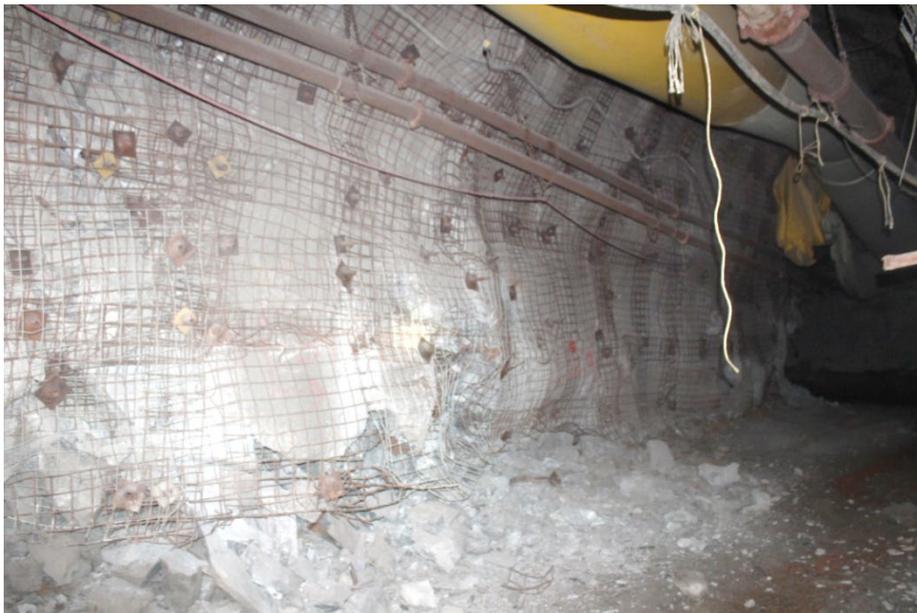
Figure 8 South wall of 70-S46 XC, facing west. Note the shattered nature of the rock mass and the amount of damage to the ground support systems, including bent plates, missing bolt heads and damage to the burst-rated membrane support near the drift floor, where the support has the highest loading (since the floor is not bolted)

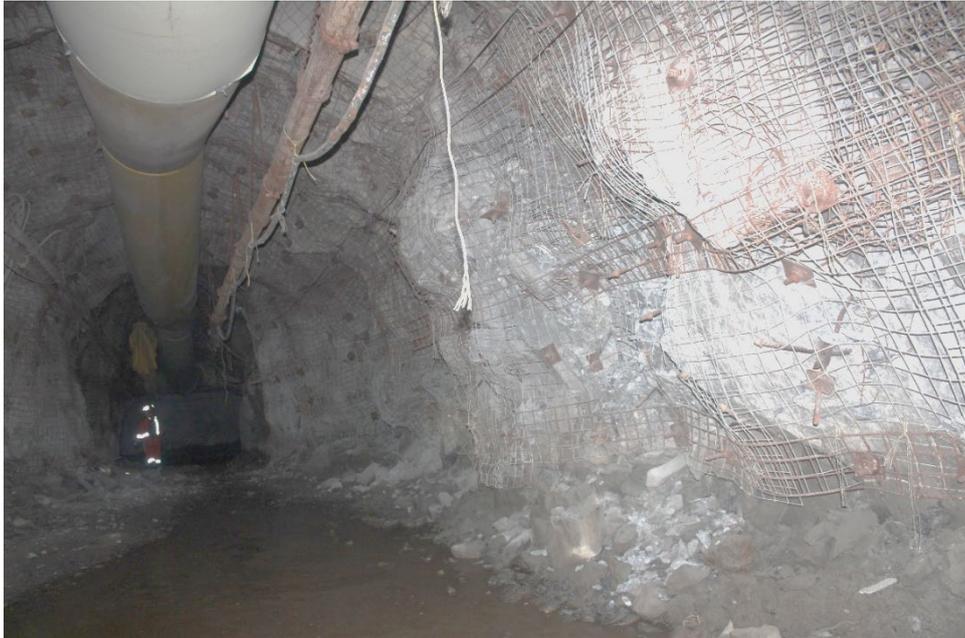
Figure 9 North wall of 70-S46 XC, facing west. Note the highly shattered rock mass in the upper wall near the centre of the image, contained by the mesh. Note historic rehabilitation resulting in heavy ground support covering older 'bent over' bolts, done following the 2011 M_N 3.8 burst, confirming that re-support is necessary following high-magnitude events since the development remained intact even though the slip surface crossed directly through it

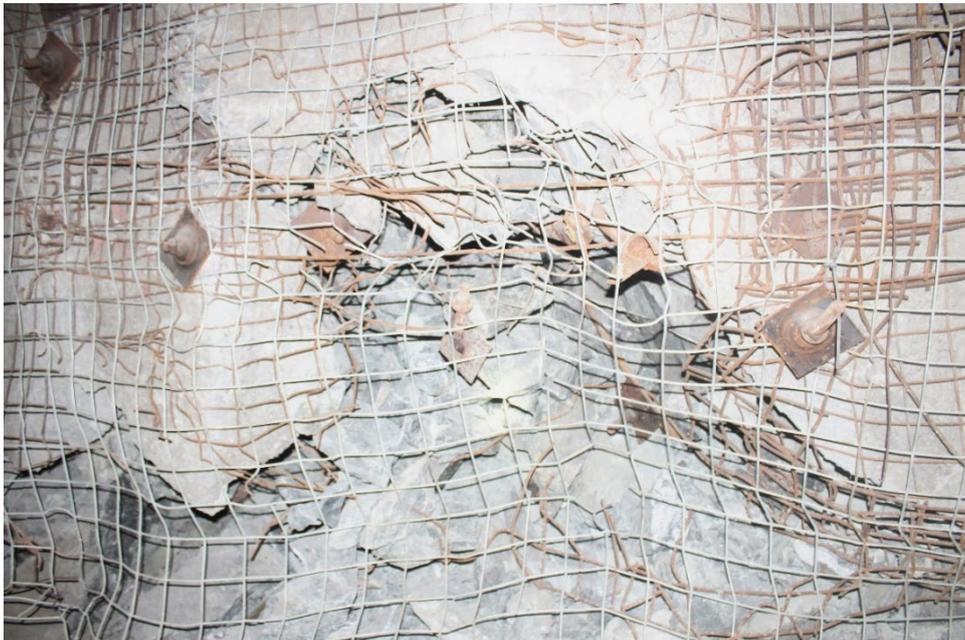
Figure 10 Close-up of damage shown in Figures 7 and 8 on south wall of 70-S46 XC. At least two bolt plates have been pulled through the mesh, with at least one new bolt having been pulled through an older 0-gauge strap that had been covered by mesh during a previous rehabilitation campaign (just left of centre of image)

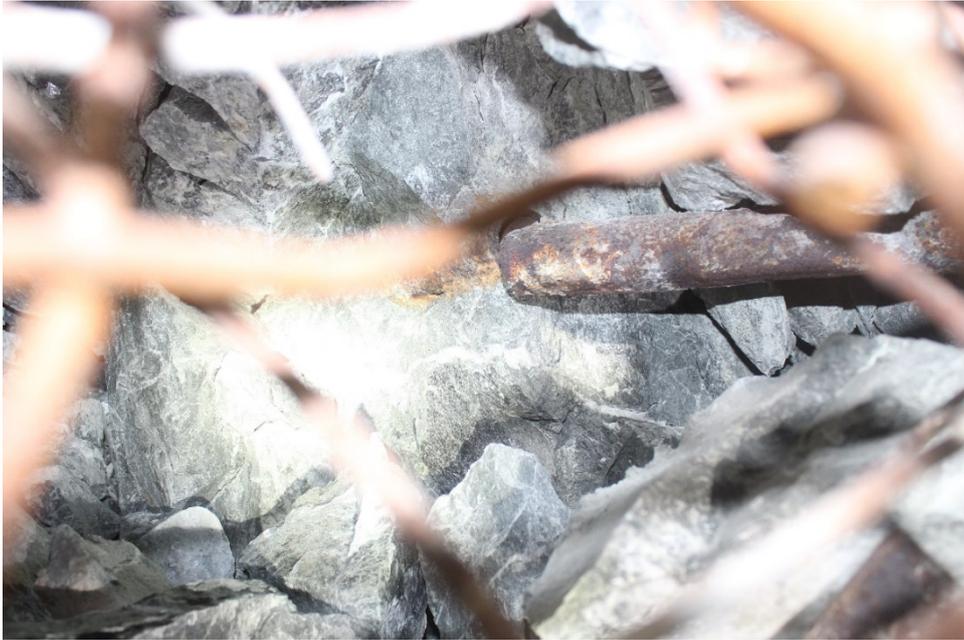
Figure 11 Close-up of sheared D bolt in the same area as Figure 10. This bolt had to be loaded to in excess of 25 tonnes to fail. Failure through full diameter shank of bolt, below highest deformed anchors near collar of bolt

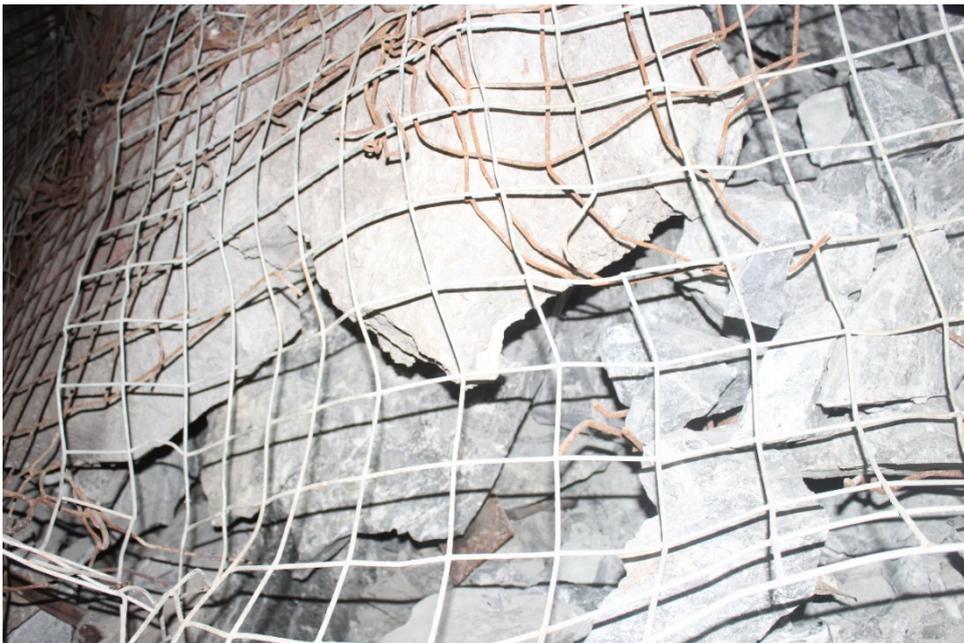
Figure 12 Close-up of lower east side of damage area from Figure 10. Note in the lower centre of the image the D bolt, which has remained in its original location. The rock mass has bulged out well beyond the plate of the bolt and has torn the mesh at the original point of attachment (lower left corner in figure). There has been over 40 cm of displacement in this area since it was originally scanned in August 2017 and in excess of 20 cm of displacement as a result of the production blast and associated seismic event since the drift was scanned on 7 December 2018, as shown by the most recent scan taken 19 December 2018

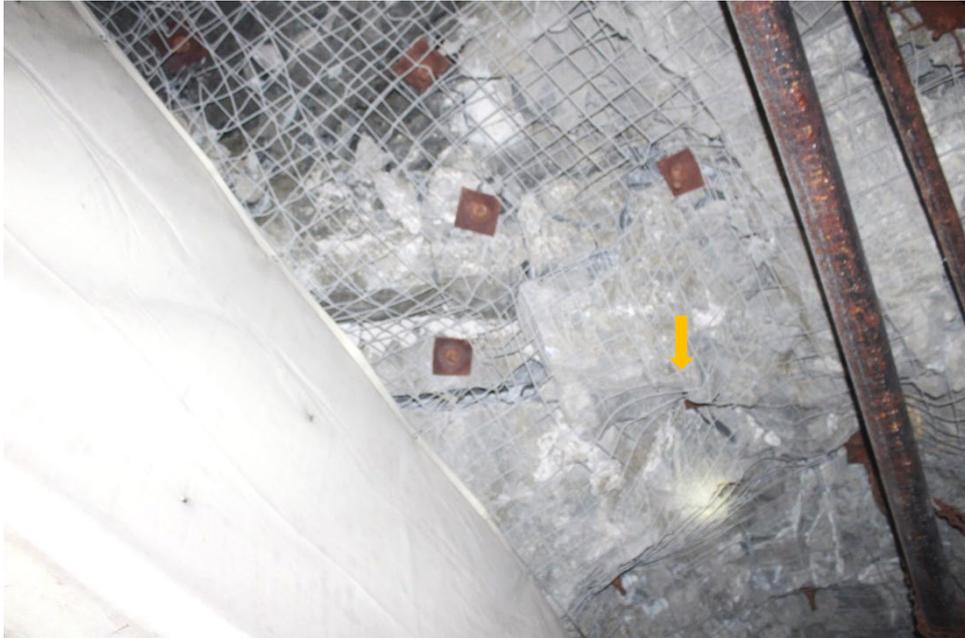
Figure 13 Back of 70-GW Acc just south of Seismic Break 1A (SB1A) intersection, facing north. Note the open shallow joints in the roof, where wedges have formed to the hanging-wall side of SB1A. Also, the plates have become dog-eared, indicating either increased load on the support system or the rock mass bulking to the point where individual bolts are almost no longer visible (at arrow)

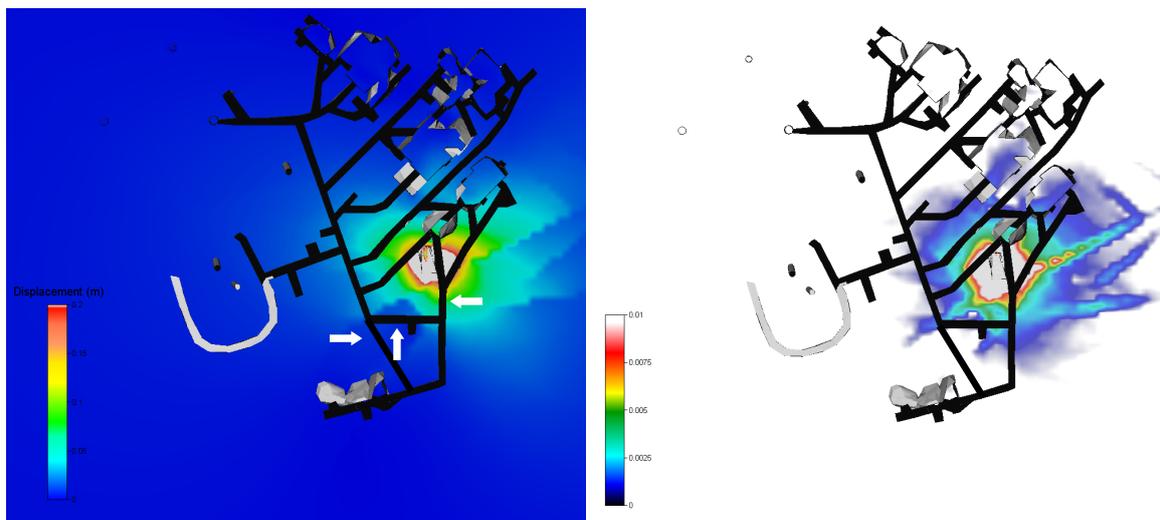
Figure 14 Deformation and strain plots for the 71-S43 Stope, from the 19th version (sequence update) of the Abaqus stress model (Beck Engineering Pty Ltd 2018). Note the strong 'boundary' in the magnitude of deformation created by the Table Top Trend and other structures, including Seismic Break 1A indicating a high potential for 'fault slip' seismicity. Note how the strain is focused along unique structures in the accompanying strain plot for the same stope. Plot centred on the stope volume, 20 m below the 7,000 level. Structures intersect development on the overcut elevation at arrows in left image

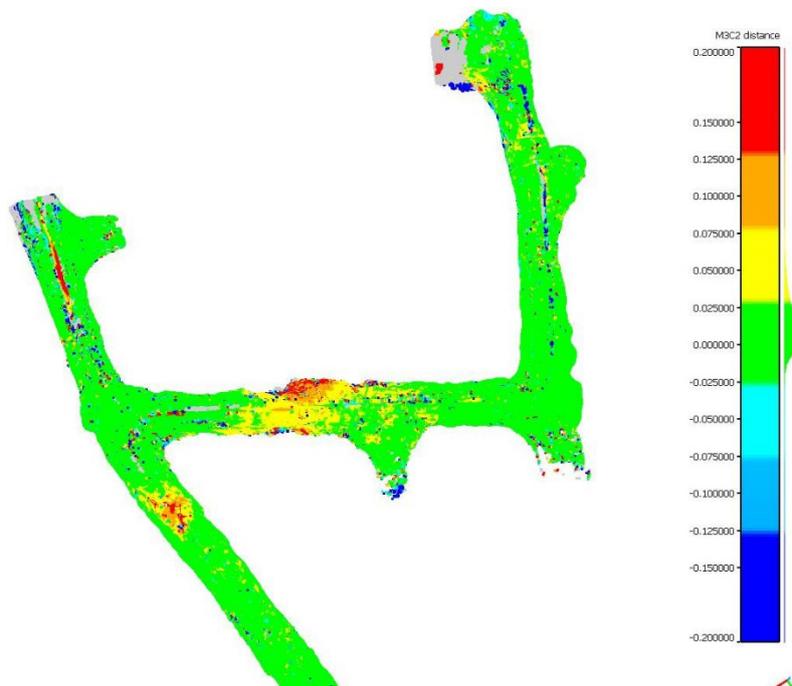
In the first image in Figure 15, the deformation is shown from the most recent sets of scans; in the 70-01 S and 70-S46 XC, those scans were taken on 7 December 2018 and 19 December 2018 respectively; therefore, the deformation occurred within a 12-day period, almost all of it associated with the 71-S43 Stope final blast and subsequent M_N 1.96 induced seismic event of 18 December 2018. The scans for the 70-GW Acc were done on 27 June 2018 and 19 December 2018 respectively, and they have been digitally

Figure 15 CloudCompare output file for merged ZEB scans of the 70-01 S and 70-S46 XC (taken on 7 December 2018 and 19 December 2018), and for the 70-GW Acc development (taken on 27 June 2018 and 19 December 2018 respectively). Very little change was observed in the 70-S40 SL (northeast corner of image) over this relatively short period, even though this access leads directly to the overcut of the 71-S43 Stope

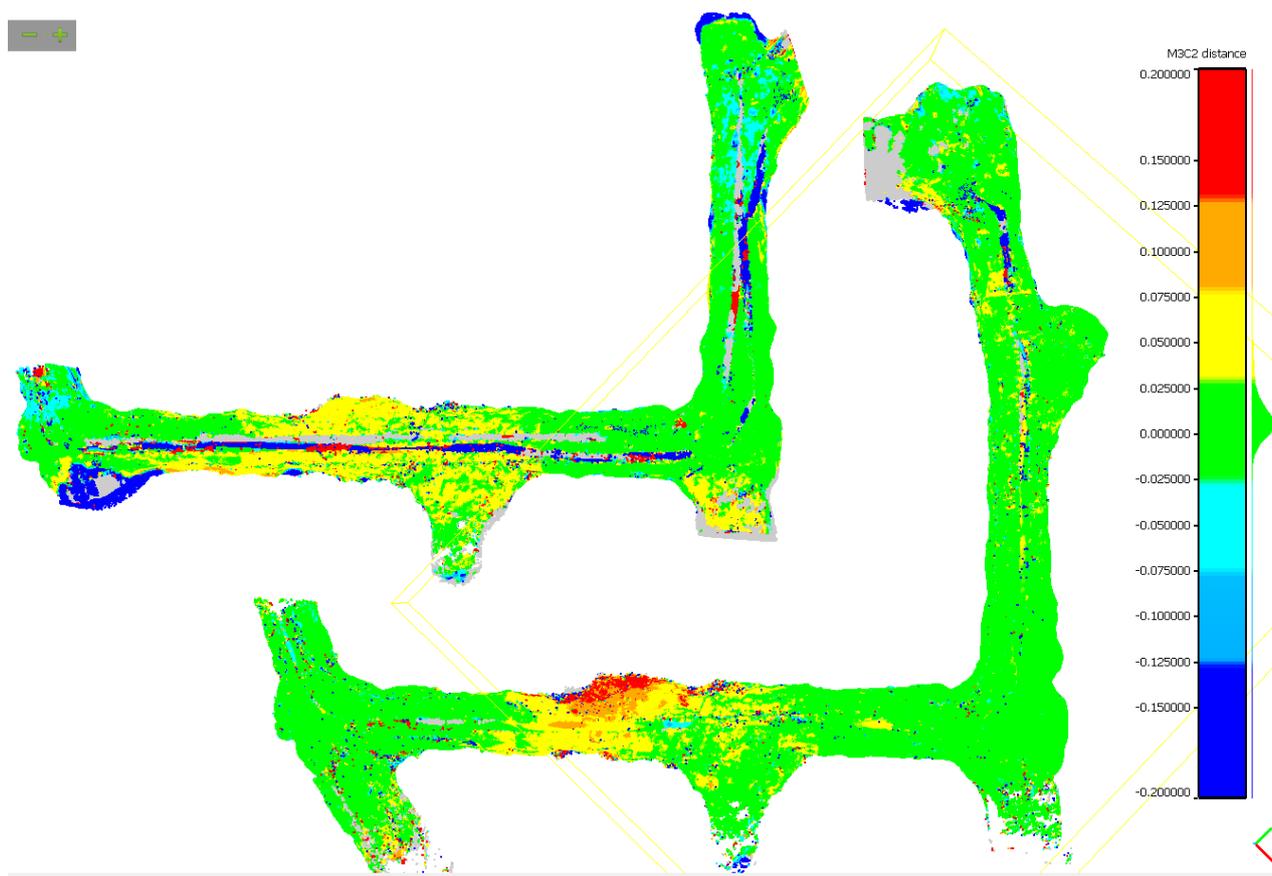
stitched to the scans taken in the 70-01 and 70-S46 XC. As shown in Figure 16, almost all the deformation is concentrated along the SB1A rupture plane (compare yellow and red areas with mapping in Figure 6). The deformation areas identified in the ZEB scans correlate with the damaged rock mass and ground support as described in the observations above.

Over a longer period, the deformation associated with mining other south abutment stopes, such as the 73-848, 70-S43, 69-883, 75-S05 and 69-789, becomes more apparent. See Figure 16, which separates the most recent deformation attributed to the M_N 1.96 seismic event and/or the final blast in the 71-S43 Stope (lower right of image) from the longer term creep within the area that occurred between 25 August 2017 and 7 December 2018 (upper left part of image). It is apparent not only that long-term deformation (creep) is clearly associated with the SB1A rupture surface but also that the most significant rock mass damage from the 71-S43 Stope final blast and subsequent seismic events is also concentrated in an area that had the most long-term deformation and therefore the highest 'pre-burst' strain induced into the ground support systems (i.e. bolts and mesh in the area had been loaded by static strain and were therefore more prone to failure under the subsequent induced dynamic load).

When the earliest and most recent scans are compared (after merging the 7,000 GW Acc development scans), the total deformation from 25 August 2017 to 19 December 2018 is much more significant. Since the period is longer, the area where deformation exceeds 13 cm has grown disproportionately and includes the combined effects of long-term creep, with recent seismicity tied to fault slip. Given that some of the displacement is very gradual, it makes identification of at risk areas extremely difficult if solely using visual clues; the scanner is capable of resolving changes in the profile of the development greater than ± 2.5 cm, which would be difficult to identify visually, and below which would be unlikely to cause significant damage to support systems.

Figure 16 Deformation plots for 70-S46 XC and 70-S40 SL for two periods. Upper left image is scan comparison from 25 August 2017 to 7 December 2018, showing deformation trends over a 15.5 month period, associated with mining a number of stopes in the south abutment of Block 1, and possible effects of mining south abutment stopes in Block 2 and Phase 2. Lower right image is scan comparison from 7 December 2018 to 19 December 2018, which only includes the deformation and seismic activity associated with the final blast in the 71-S43 Stope. The most significant damage is concentrated along the Seismic Break 1A lineation. The 70-GW Acc development did not exist in 2017 when the first scan was taken; therefore, there is no 'area' to compare in the longer period scan (dark blue)

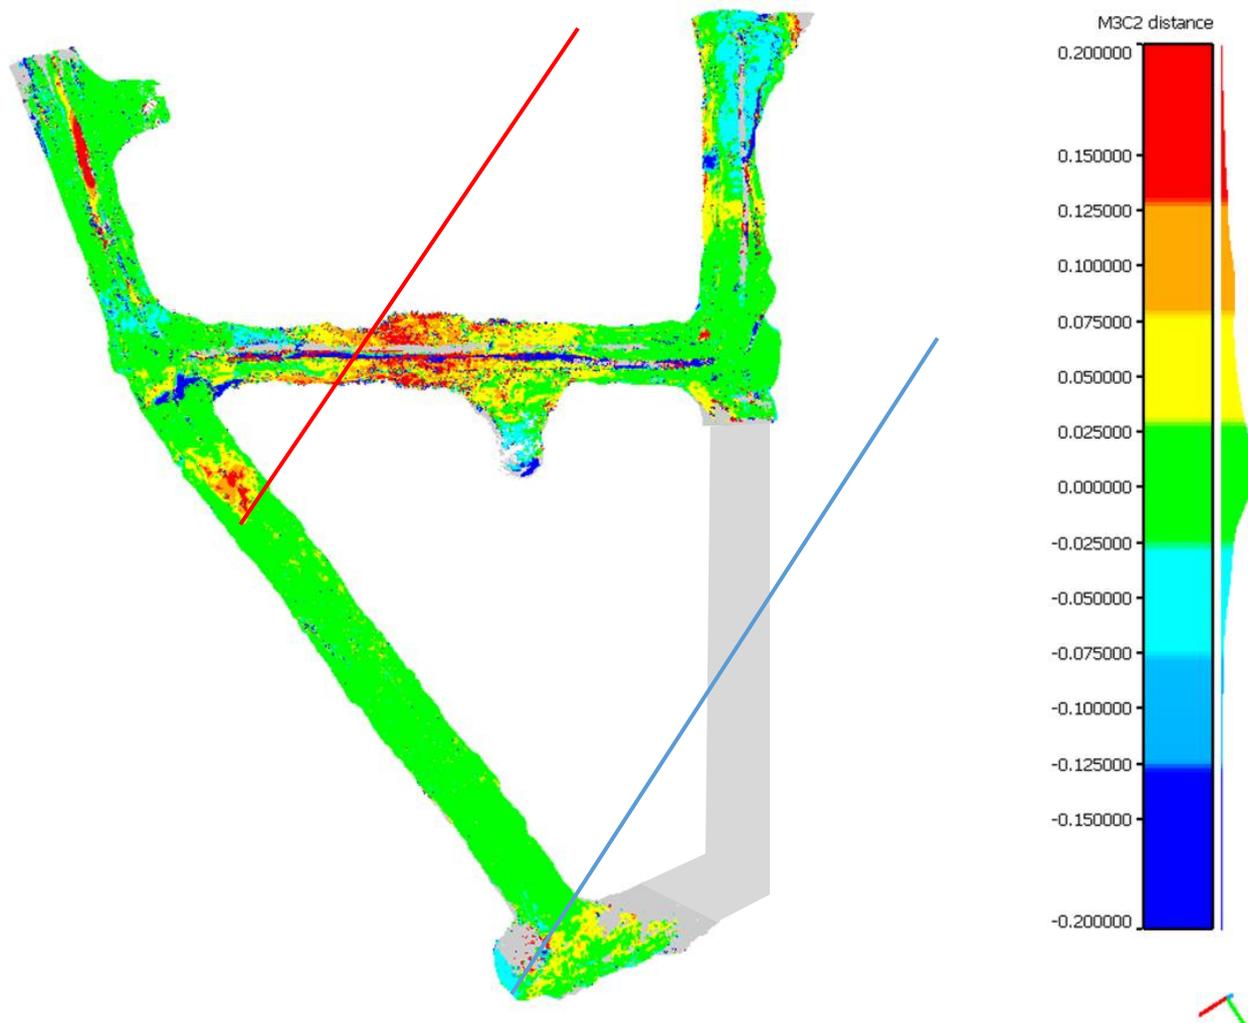
Figure 17 CloudCompare deformation plot, south end of 7,000 level, from merged scans taken 25 August 2017 and 27 June 2018 (70-S46 XC and 70-GW Acc respectively), which were considered 'baseline', compared with the scan of 19 December 2018. This scan comparison shows total deformation over a 16-month period and indicates the areas at highest risk of future damage due to induced bolt loading or failure. Seismic Break 1A (red) and Seismic Break 2 (blue) rupture trends have been superimposed on the scan image for reference. The scan data may allow further refinement of the actual break surfaces (sliding planes), as the exact location of the surface can occasionally be difficult to identify in extended zones of intense fracturing and rock mass bulking
