Corroded rock support issues: implementation of an investigation and rehabilitation program

JF Dorion *Raglan Mine, Canada*

Abstract

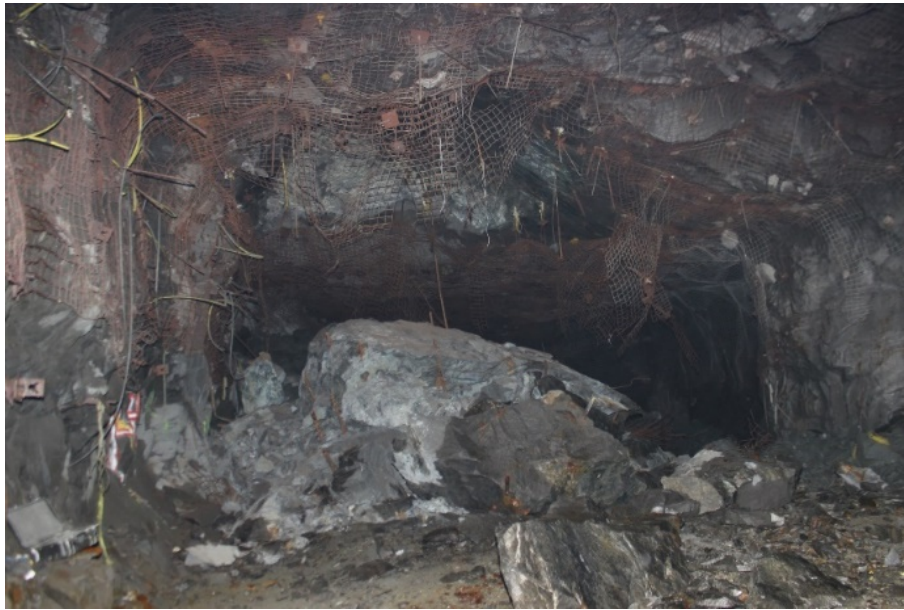
Risk management associated with fall of ground is a concern at Glencore. At Raglan Mine, the goal is zero fall of ground incidents, and a detailed and specific program for managing this risk has been implemented. This program specified the causes of fall of ground (FOG), performance standards, and preventive controls (including critical controls). The inspection and rehabilitation of capital expenditure (CAPEX) excavations are critical controls. Figure 1 presents a FOG in a drawpoint attributed to corroded ground support. Figure 2 shows corroded inflatable rockbolt from that FOG.

Figure 1 Fall of ground in a drawpoint caused by reduction of support system capacity related to corrosion

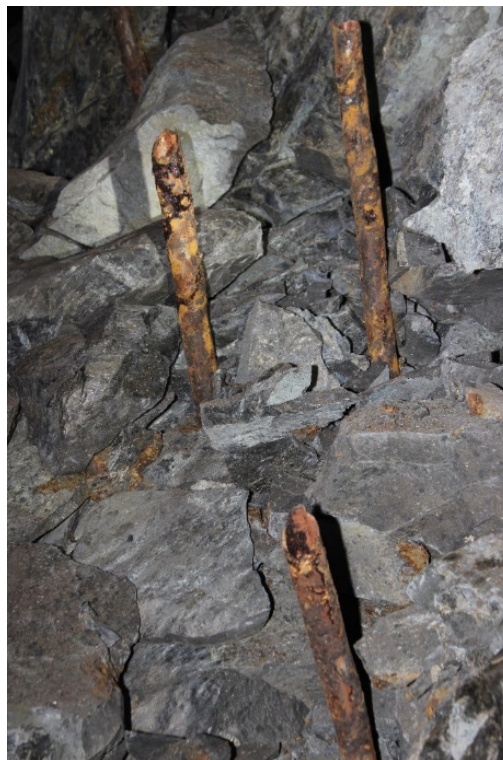
Figure 2 Heavily corroded inflatable bolts attributed to a fall of ground

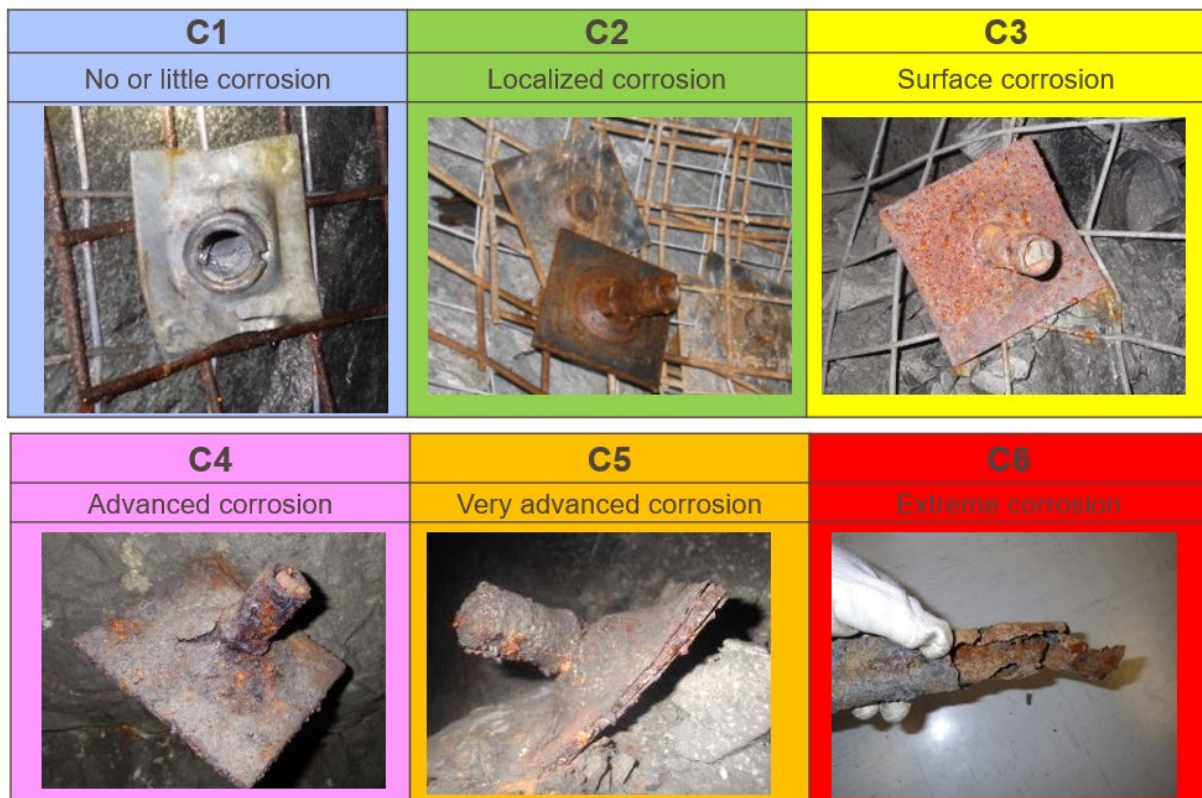
Figure 3 Level of corrosion of rock support

A descriptive chart of corrosion levels is used. This one is divided into six categories. Figure 3 shows this chart of level of corrosion (Dorion 2013).

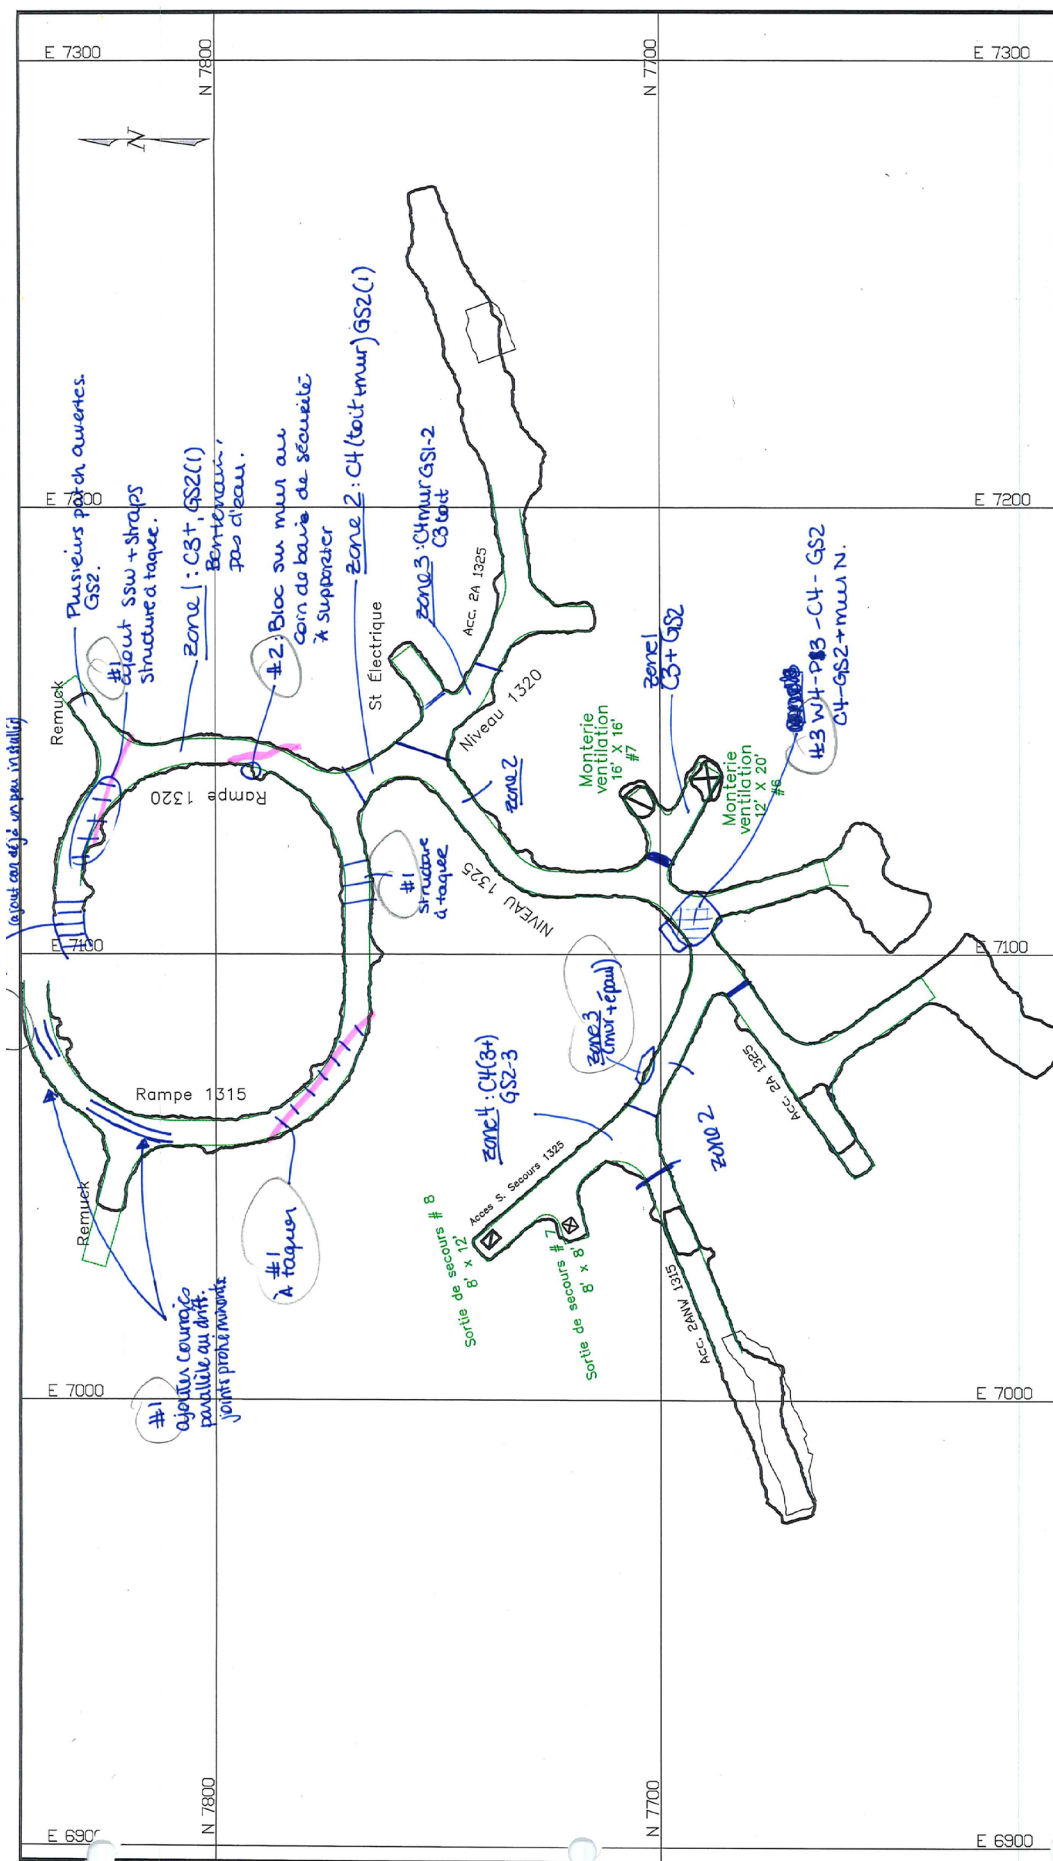
Figure 6 Example of inspection data collected on a mine plan

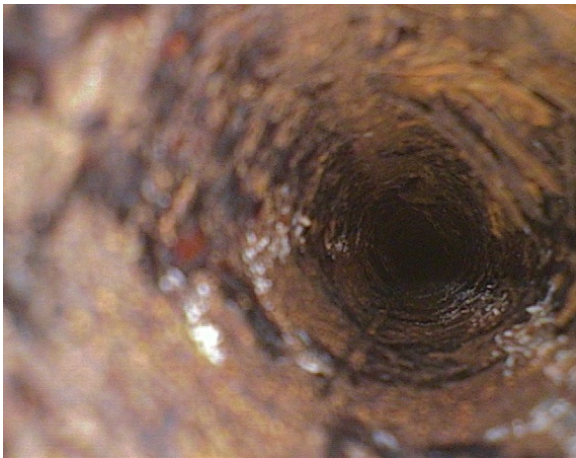
Depending on the inspection results, pull test on bolts may be performed. The type of bolt, its age and the corrosion level are noted. The pull test can be destructive or non-destructive. Because inflatable bolts are the main type of rock support at Raglan Mine, a camera is occasionally used to inspect the corrosion inside a given bolt after a destructive pull test. Figure 8 shows the inside of one such bolt.

Figure 8 Picture of the inside of an inflatable bolt

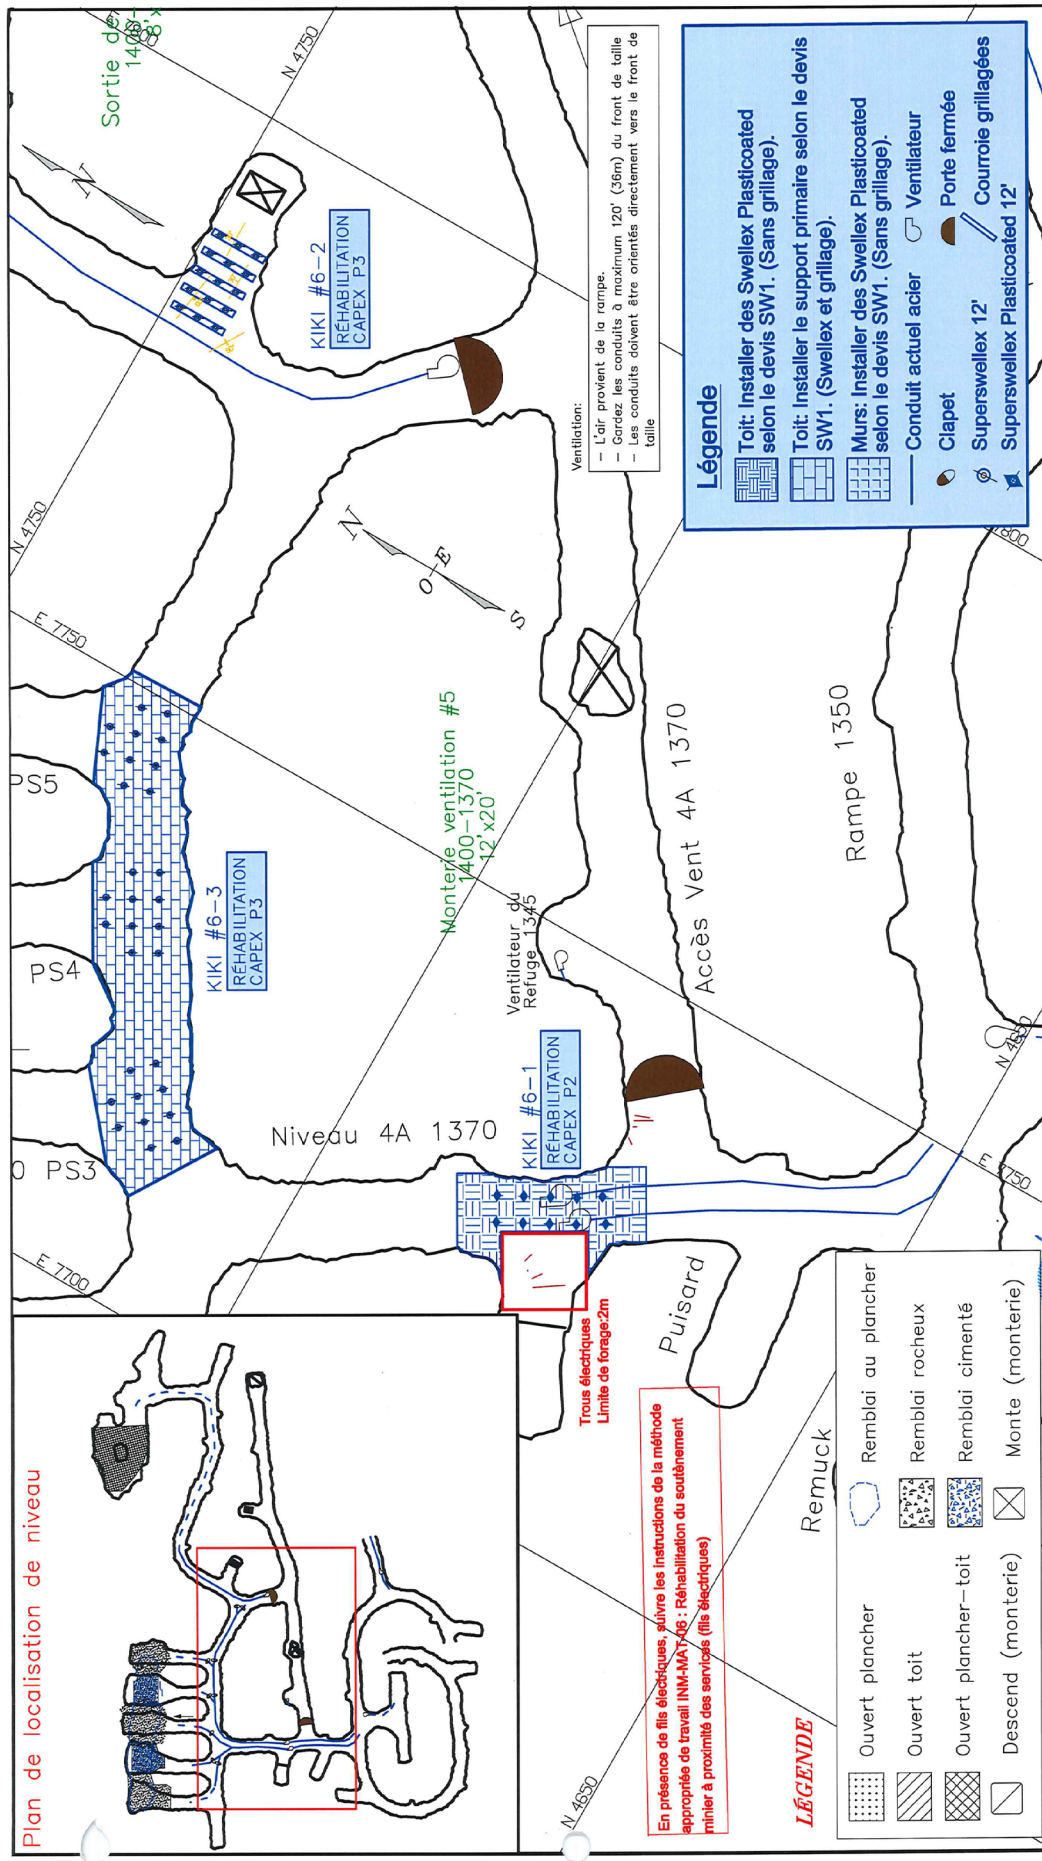
Figure 10 Example of a work plan for underground operations

According to established priorities, plans are distributed to underground operations (Figure 10). Each of the locations is indicated underground with a reference number. Priorities are also indicated on the plans. At each shift, a miner is given a work card with the plan indicating the work done, on which they describe any work completed. Thus, the field control team has the ability to follow the day-to-day rehabilitation work. As this work is carried out by a contractor, this system also facilitates the management of the budget.

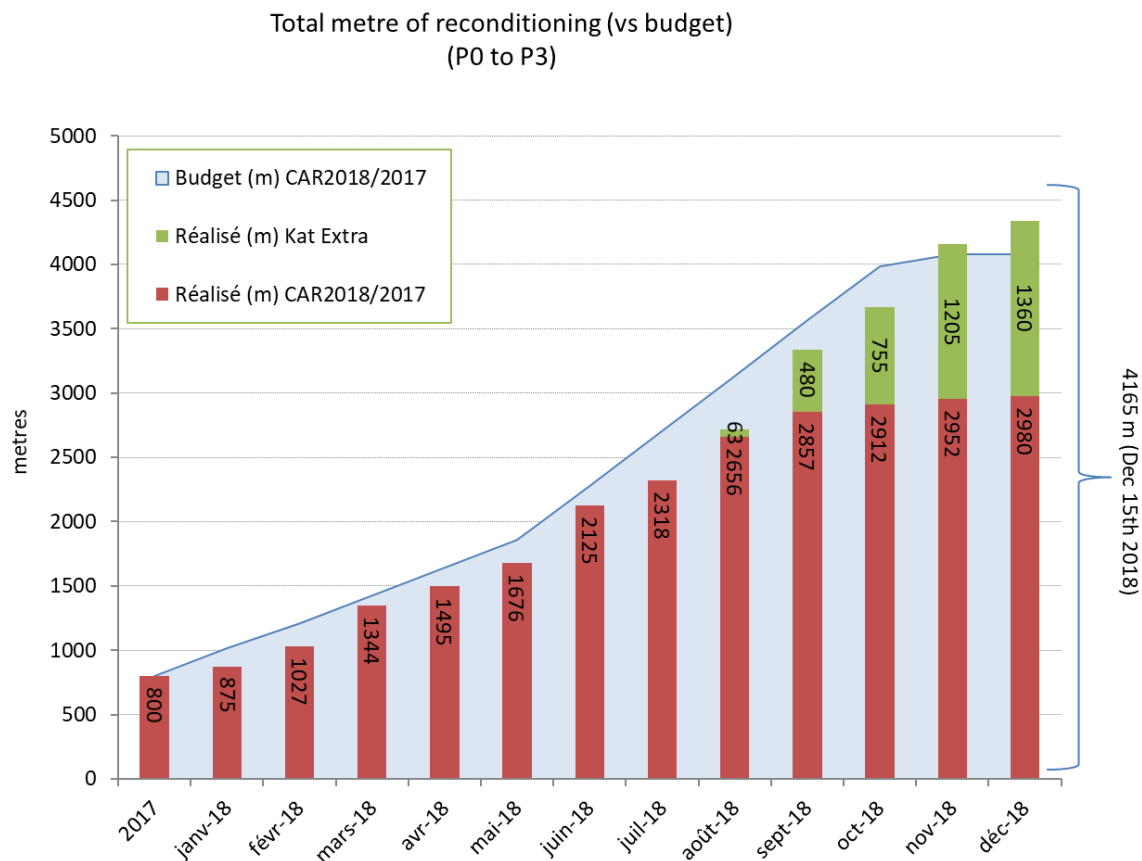
Figure 11 shows the progress of work on a monthly basis. It is possible to follow the metres of rehabilitation carried out compared to the planned budget. The cost overrun is associated with additional requests added during 2018.

Figure 11 Graph of total rehabilitation metres compiled
