Corroded rock support issues: implementation of an investigation and rehabilitation program

JF Dorion *Raglan Mine, Canada*

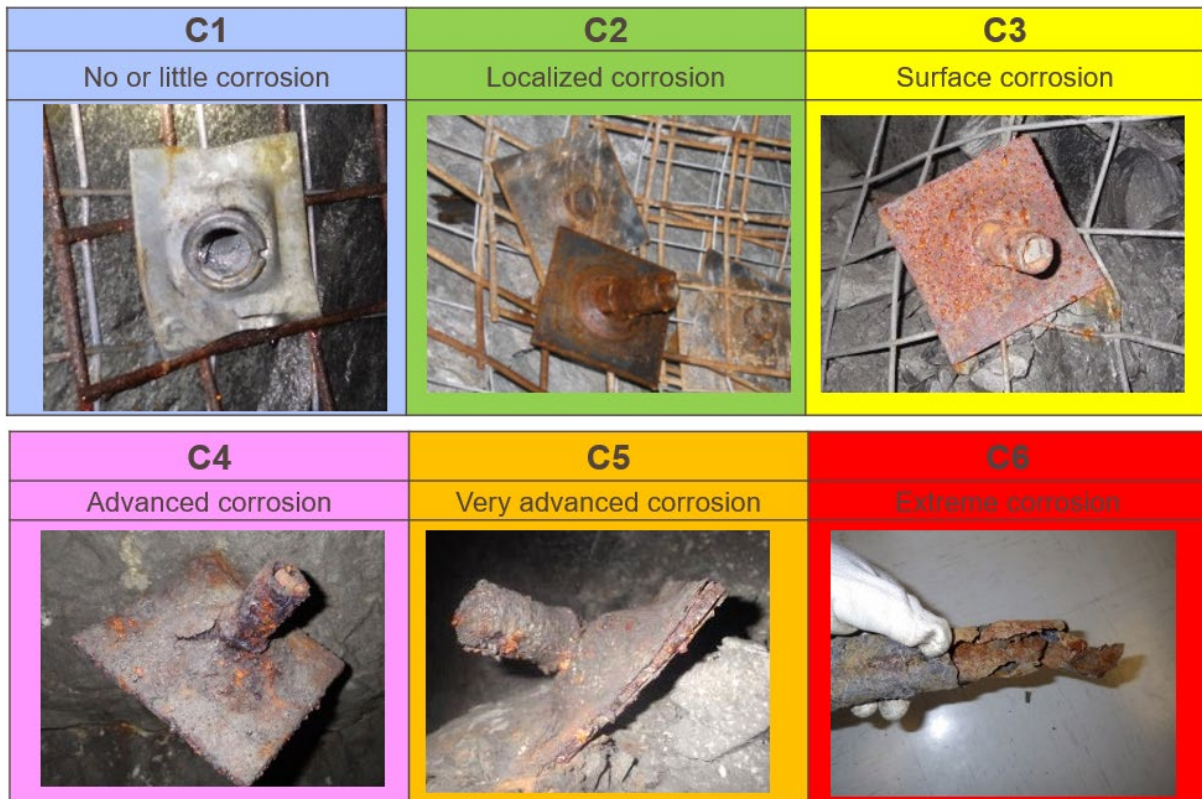
Figure 3 Level of corrosion of rock support

A descriptive chart of corrosion levels is used. This one is divided into six categories. Figure 3 shows this chart of level of corrosion (Dorion 2013).

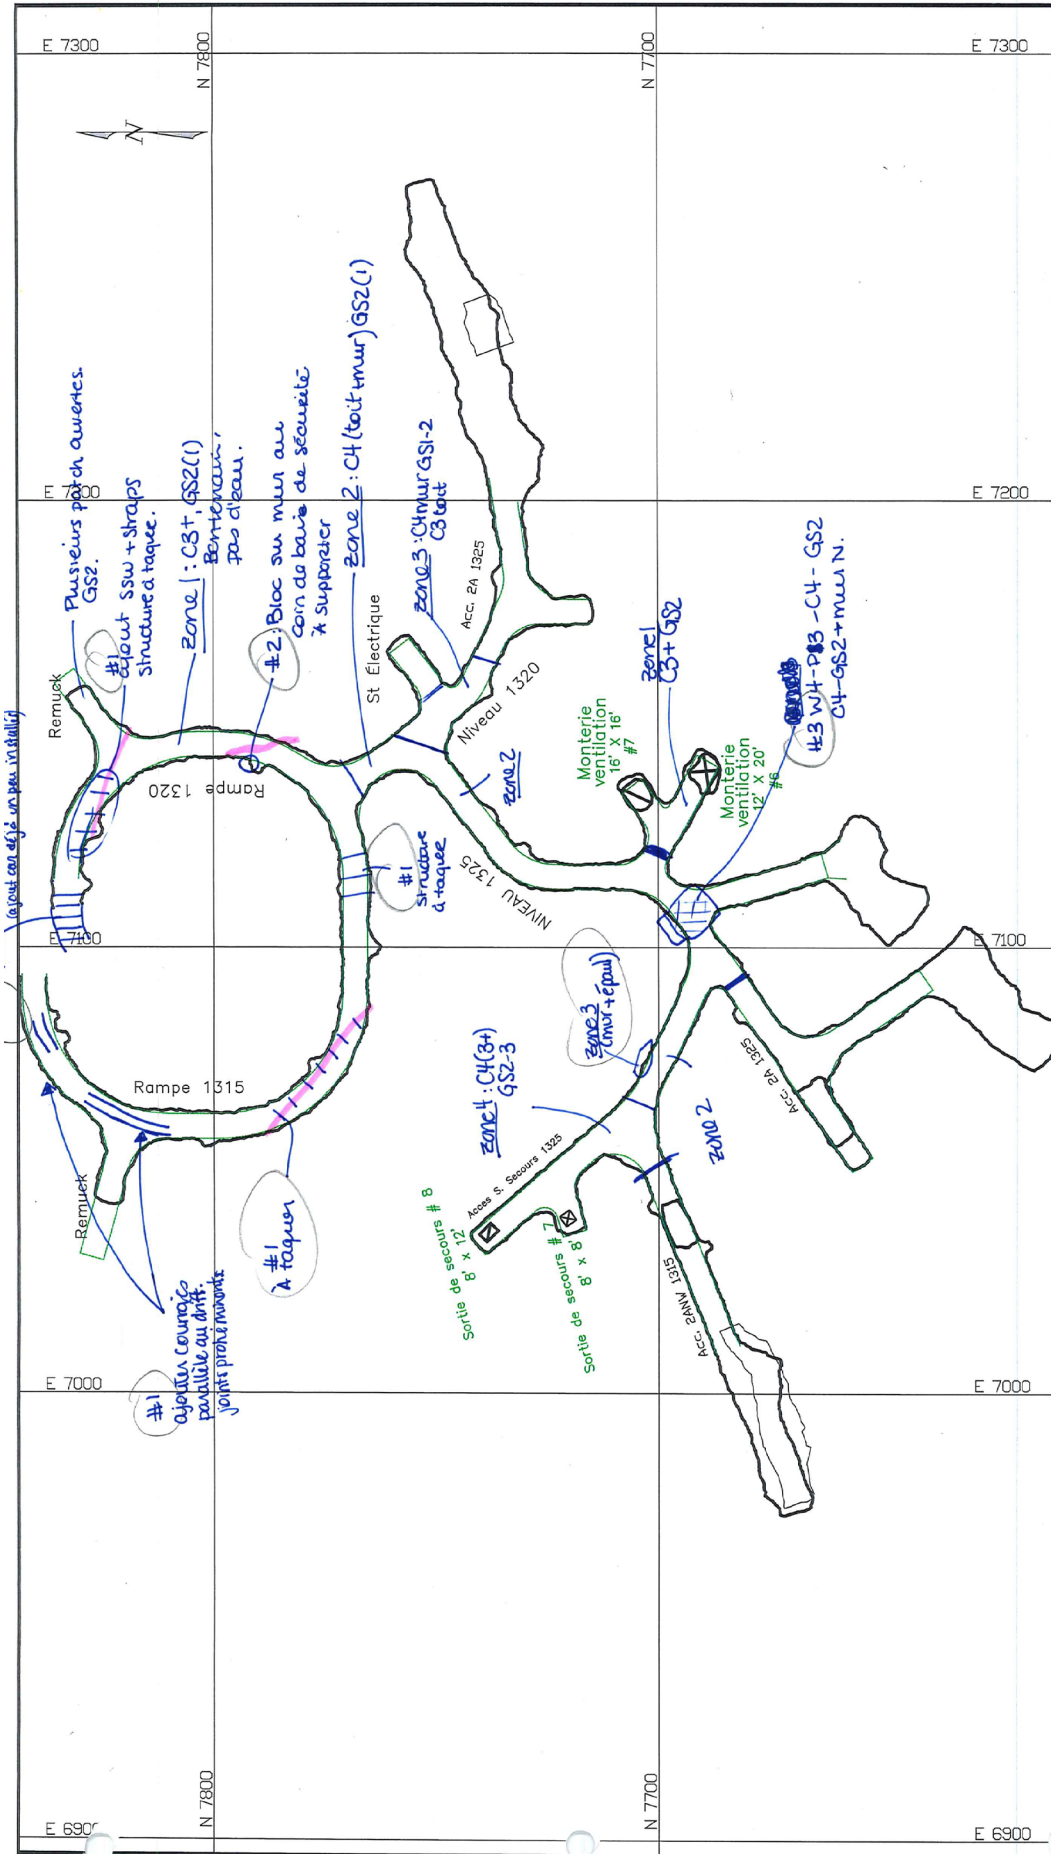
Figure 6 Example of inspection data collected on a mine plan

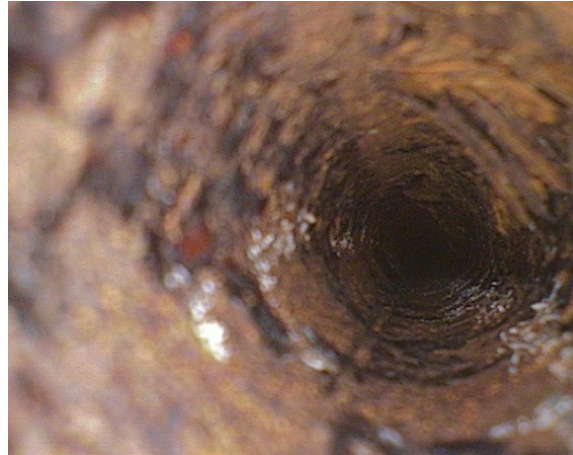
Depending on the inspection results, pull test on bolts may be performed. The type of bolt, its age and the corrosion level are noted. The pull test can be destructive or non-destructive. Because inflatable bolts are the main type of rock support at Raglan Mine, a camera is occasionally used to inspect the corrosion inside a given bolt after a destructive pull test. Figure 8 shows the inside of one such bolt.

Figure 8 Picture of the inside of an inflatable bolt
