Addressing pit wall instabilities in Africa's largest open pit copper mine

GC More O'Ferrall *First Quantum Minerals Ltd, Zambia*

Abstract

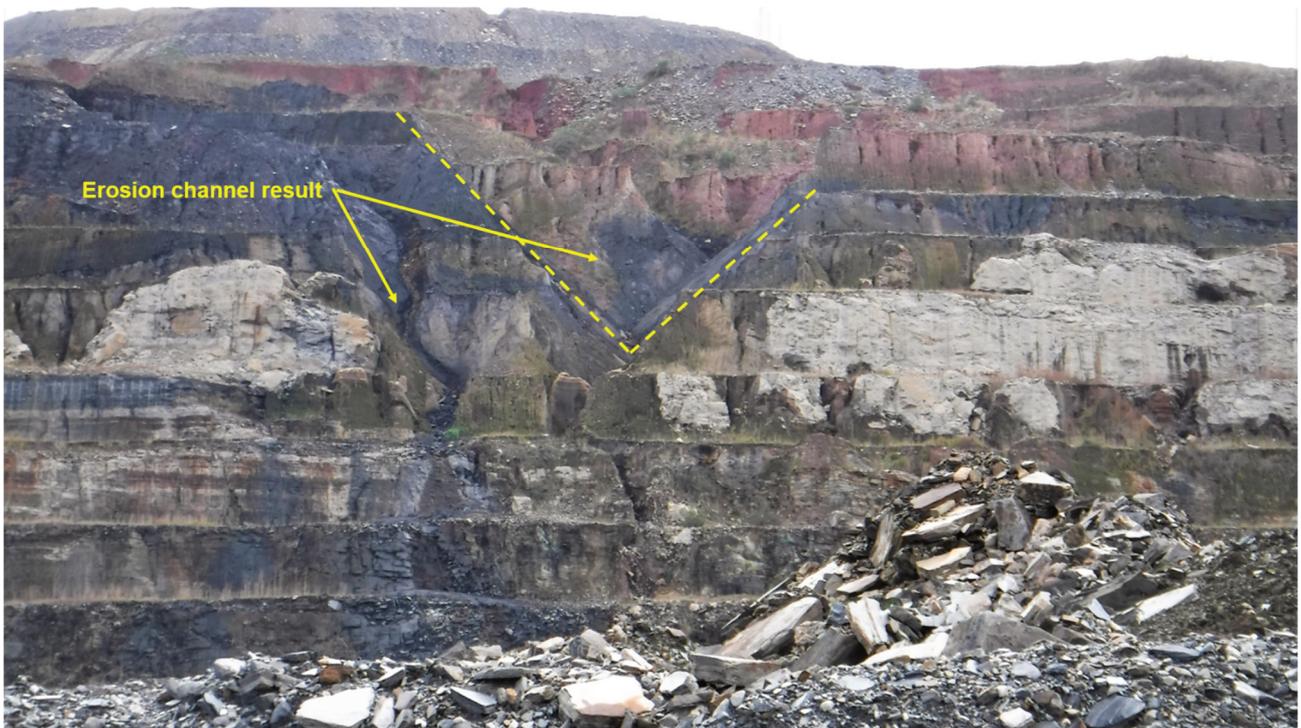
Failures within the weathered zone vary from erosion channels (Figure 4) due to inadequate surface water management, to larger wedge-type failures associated with geologic structure and pit wall orientation. In the highly-to-moderately weathered zone, pit wall configuration comprises 5 m bench heights with 5 m wide catch berms and bench face angles of 65°. Double berms are designed at 25 m (weathered zone) and 50 m (fresh rock) vertical intervals. To date no bench-scale failure within the weathered zone in Main Pit has occurred.

Figure 4 Erosion along relict structures in saprolite benches

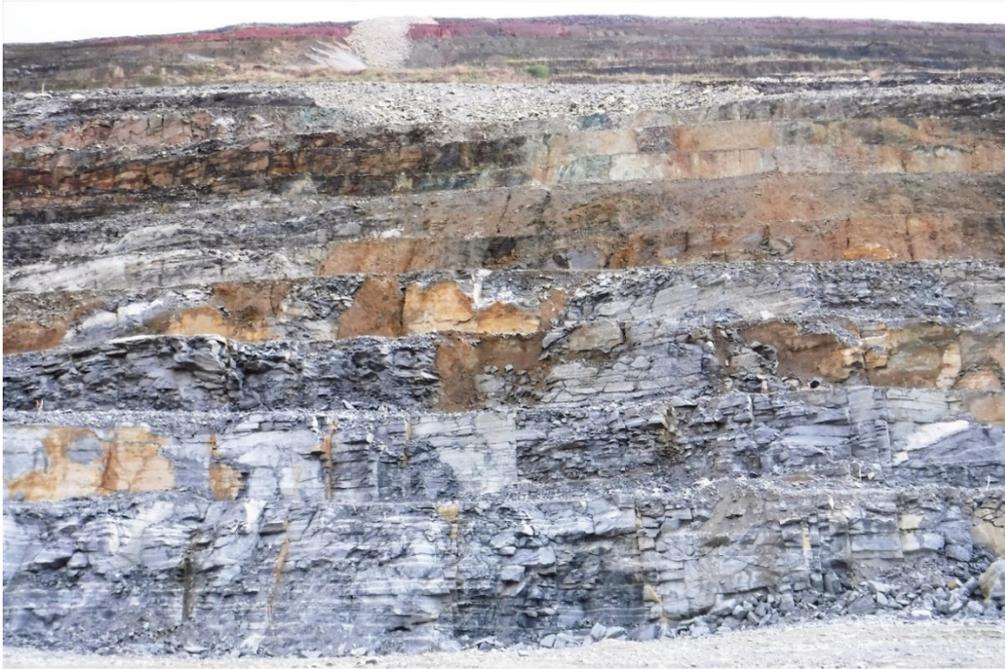
Failures within the transition zone (Figure 6) are generally associated with deeply weathered geologic structures.

Figure 6 Benches in the transition zone between weathered and fresh marble

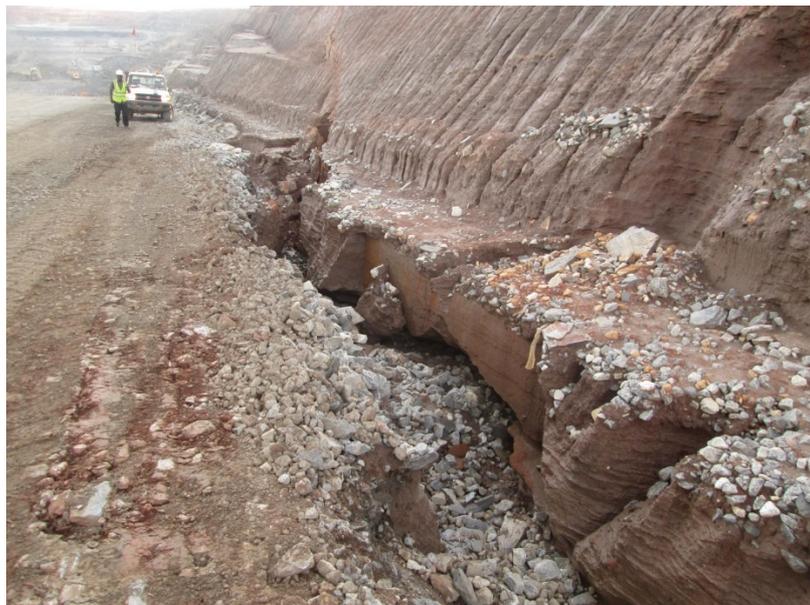
Instability of Main 10 ramp was first identified during 2014, when the occurrence of sinkholes (varying in dimension from approximately 1.5 m diameter to 1.5 m deep to over 2 m diameter and 2 m deep) was noticed in line with the trolley-assist plinths on the highwall side. More sinkholes were observed during early 2015 (Figure 7). It was thought, despite it being the wet season, that the formation of these sinkholes was due to the presence of groundwater.

Figure 7 Sinkholes observed on Main 10 ramp during early 2015

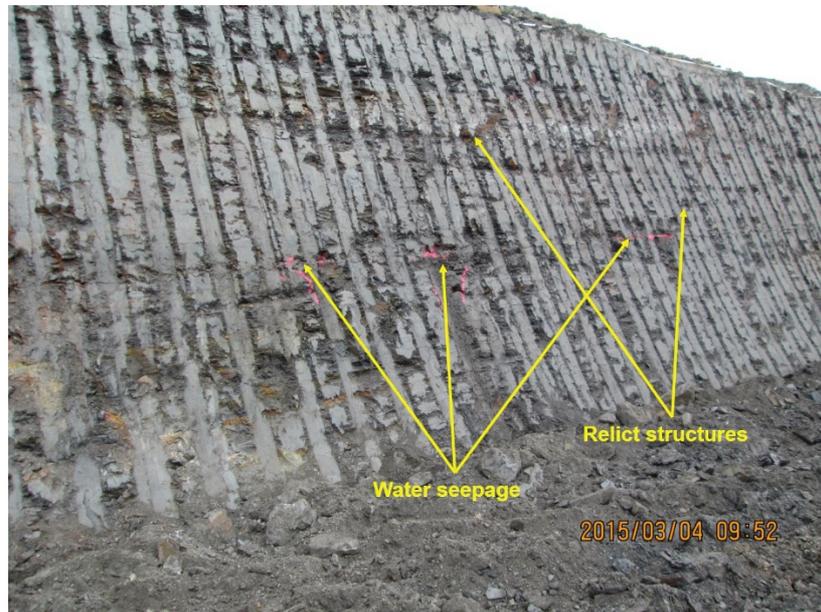
Around the same time that this sinkhole was observed (end of 2014 or beginning of 2015), sloughing of the saprolite benches beneath the ramp commenced; the initial failure was associated with steep-dipping foliation dipping into the pit and relict structures (Figure 8).

Figure 8 Cause of the onset of bench failure below the ramp

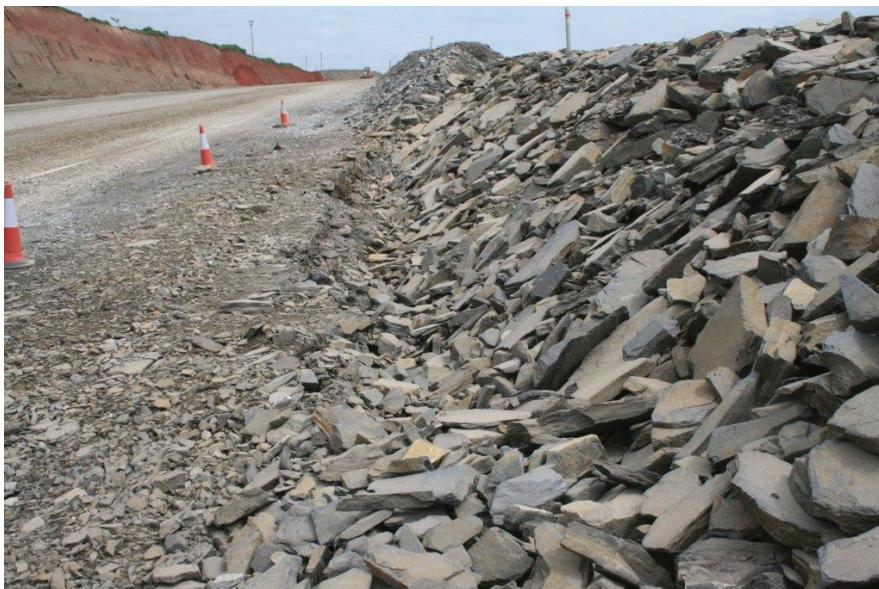
Figure 9 Slumping of the windrow on the M10 trolley ramp

The recommendations at the time included construction of a windrow around the tension cracks that appeared on the ramp surface (Figure 9), and the installation of prisms on the windrow, which would be monitored to determine the rate of slumping.

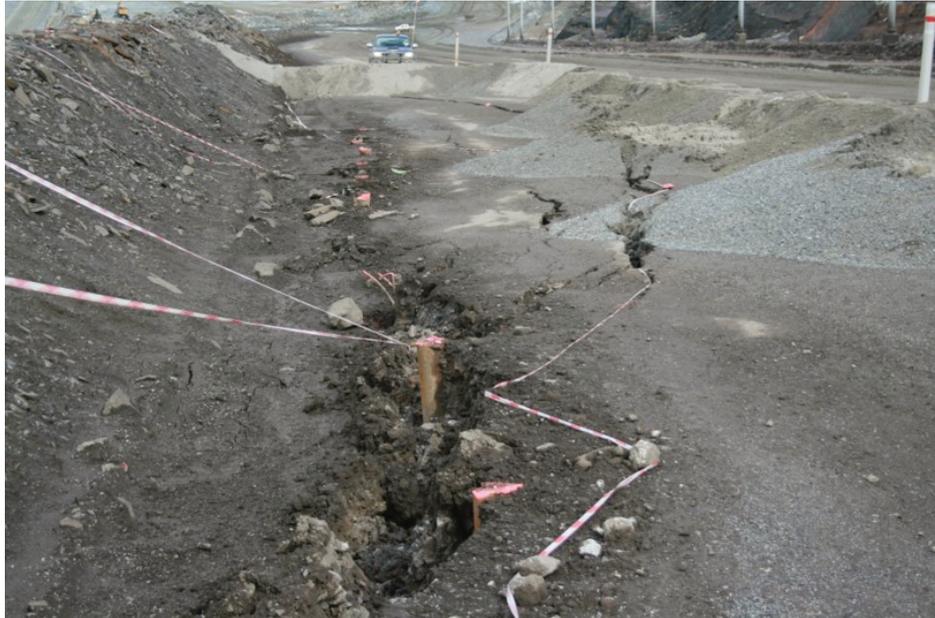
Figure 10 Six-metre long piles exposed along tension cracks on the ramp in February 2016

Sometime between February 2015 and February 2016, six-metre long piles, comprising 150 mm internal diameter steel pipes filled with concrete) were installed on the ramp in an attempt to limit the extent of the tension cracks that formed on the ramp (Figure 10).

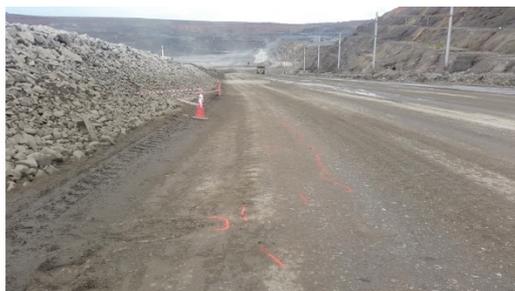
04 December 2017 (tension crack development)

Figure 11 Failure of the open edge of the ramp during December 2017 and March 2018

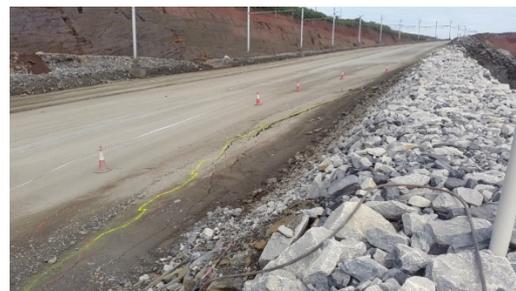
01 February 2018 (vertical displacement along tension crack)

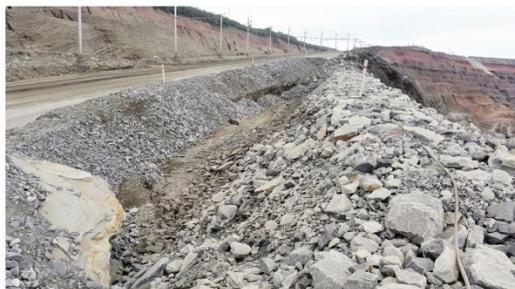
09 March 2018 (0.6 m vertical displacement along tension crack)

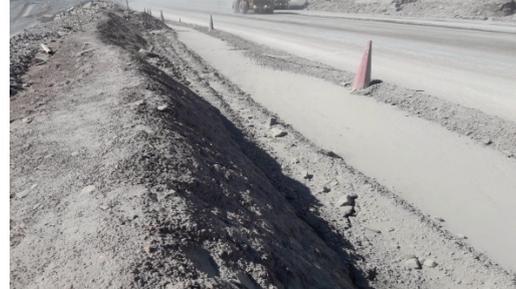
Despite this remedial action, failure occurred again between December 2017 and March 2018 (Figure 11). Following the end of the wet season (April 2018), the affected portion of the ramp was rehabilitated, and a capping layer of compacted laterite was placed. This reduced the impact of instability during the November 2018 to March 2019 wet season; however, that did not prevent sloughing.

22 March 2019 (sloughing of windrow over the wall)

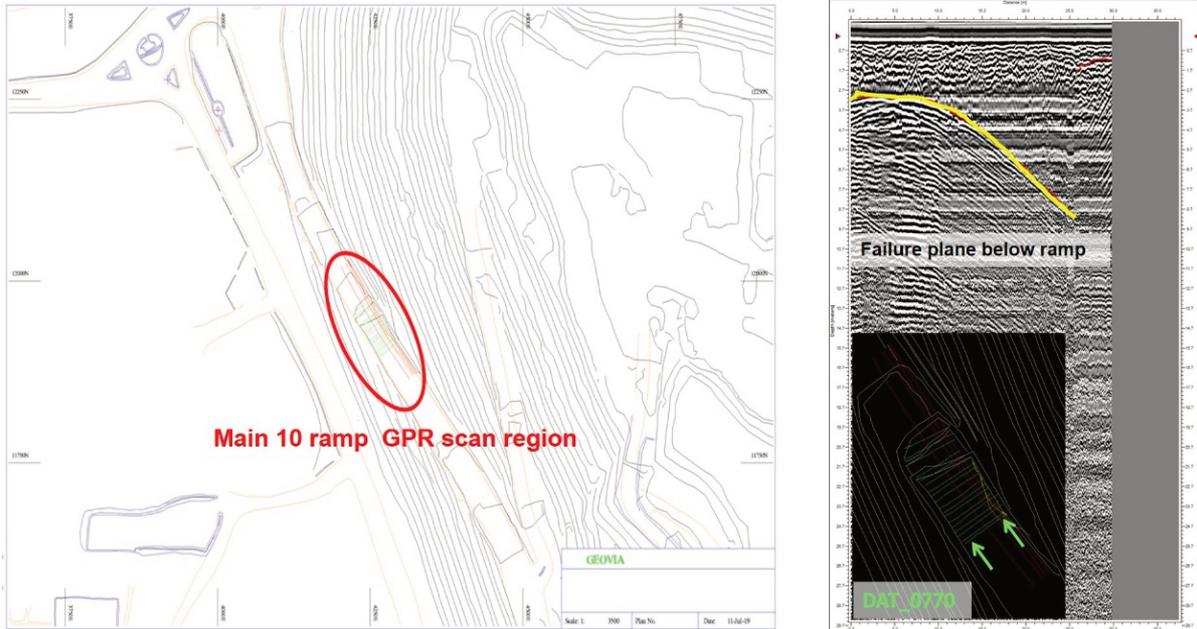
During August 2019, a ground penetrating radar (GPR) scan was conducted over the rehabilitated portion of the ramp in an attempt to determine the depth of the failure plane (Figure 12). From the scan, it was identified that the potential failure surface is possibly a foliation plane dipping towards the open edge of the ramp. The surface varies between 6.7 m in the middle of the ramp to 11.7 m at the open edge.

Figure 12 Ground penetrating radar (GPR) scan region and results

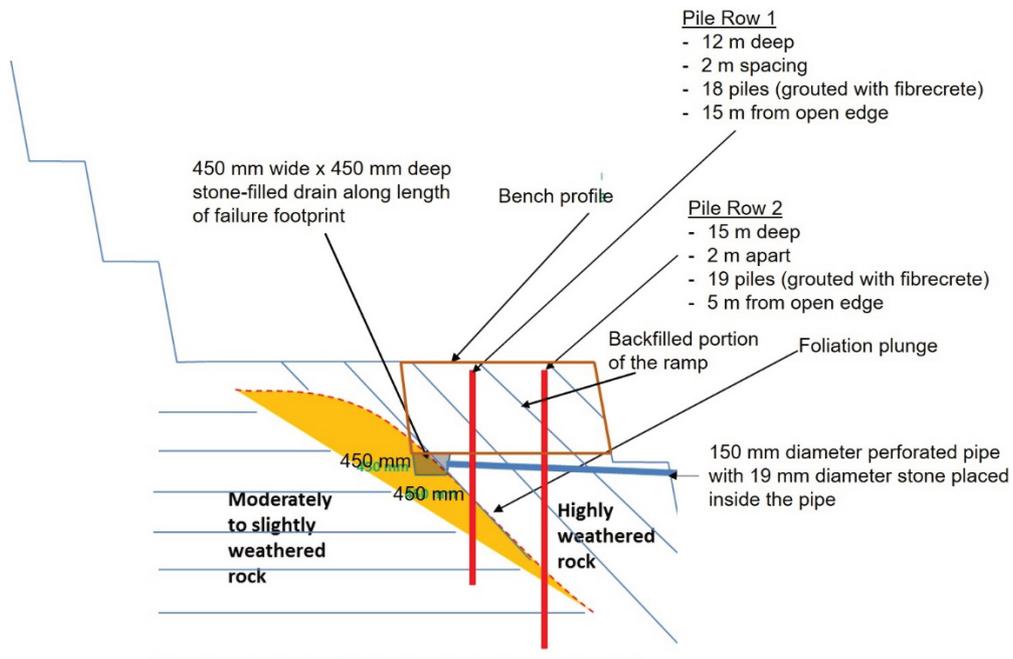
Figure 13 Section through the planned sub-surface drainage to manage groundwater along the foliation

A remediation plan (Figure 13) was developed, which includes diverting groundwater away from the failure surface in the rehabilitated portion of the ramp and will be implemented during the 2020 dry season.

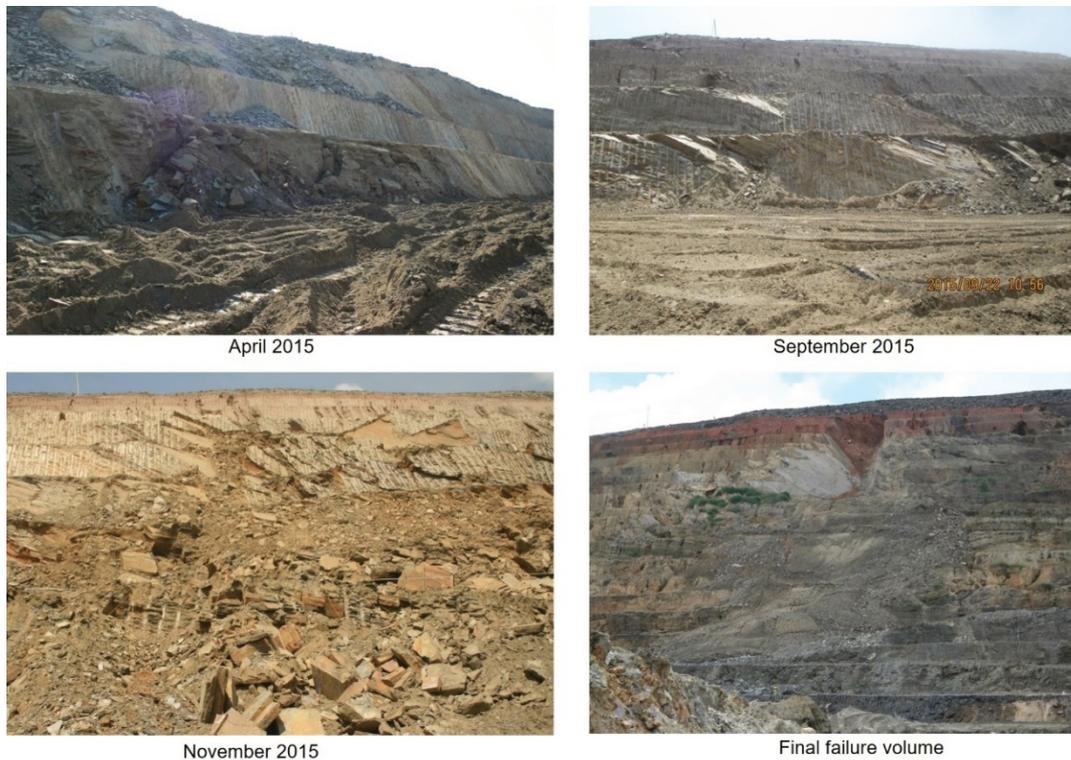
In November 2015, an approximately 600 m³ wedge failure incorporating 14 five metre high benches occurred in the saprolite in Main 12. The first signs of instability in this portion of the wall were observed during April 2015, and over the following months the instability was observed in lower benches (Figure 14). The failed material was initially contained on the catch berms of the benches below the failure.

Figure 14 Progression of wedge failure in Main 12

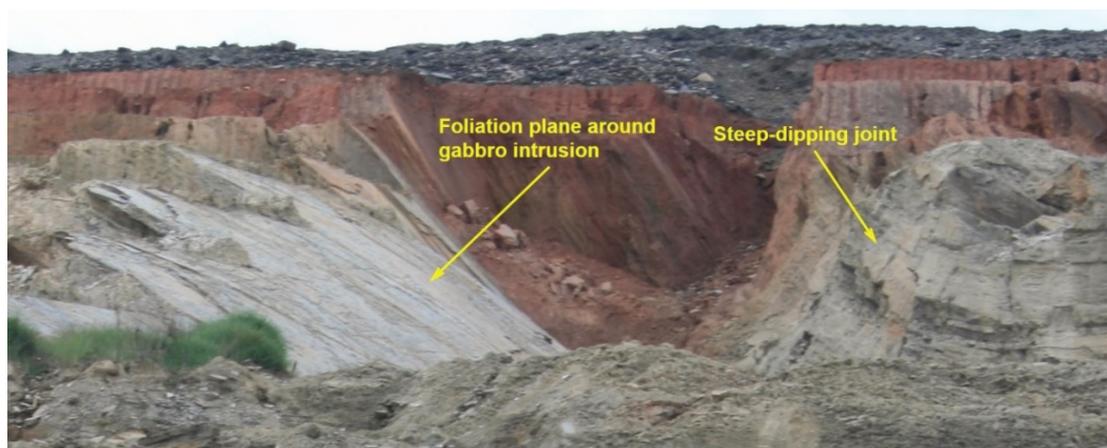
The wedge was formed by the intersection of the steep-dipping foliation around a gabbro intrusion and an approximately 85° dipping joint (Figure 15). The intersection of these two geologic structures daylighted out of the slope. Therefore, no further failure on the downdip side of the wedge is expected.

Figure 15 Boundaries of Main 12 wedge

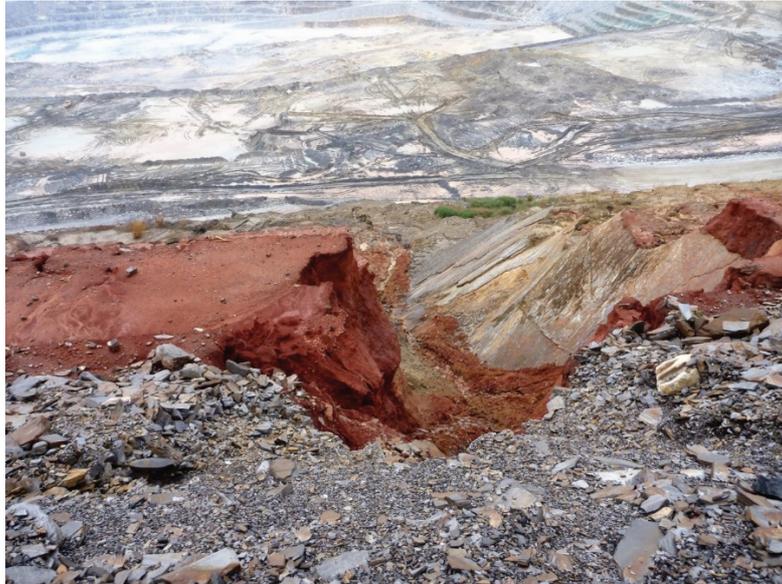
Failure of the scarp continued through until December 2017 (Figure 16), with the potential of the failure continuing onto the Main 12 trolley-assist ramp.

Figure 16 Continued sloughing of saprolite from the scarp of the wedge failure

It was hypothesised that the source of the water saturating the saprolite was from the waste rock dump to the north of this section of the pit. Two 15-metre deep dewatering investigation holes were drilled along the northern shoulder of the ramp to identify whether water was indeed flowing from the waste rock dump, beneath the ramp foundation towards the pit. The investigation revealed that water was indeed flowing from the north towards the pit.

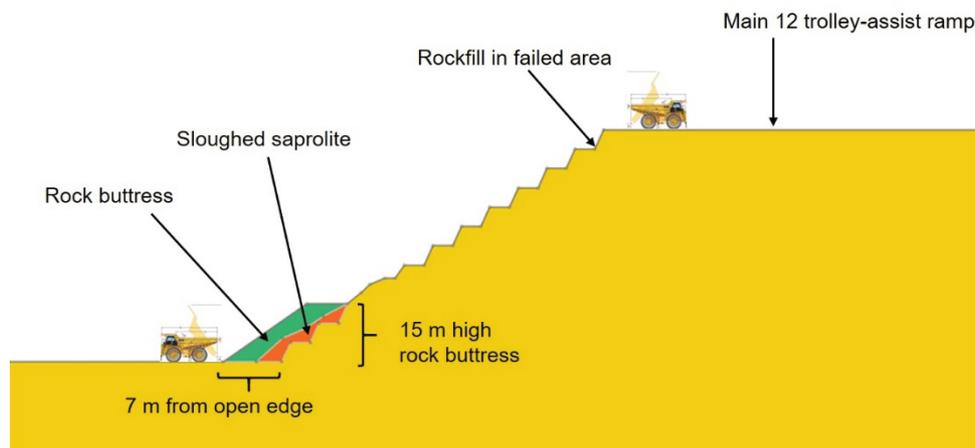
Figure 17 Schematic of remediation plan for Main 12 wedge failure

A remediation plan was developed which included initially removing some of the sloughed material at the base of the failure during the dry season, constructing a rock buttress at the toe of the failure, and placing waste rock into the failure footprint from the ramp (Figure 17).

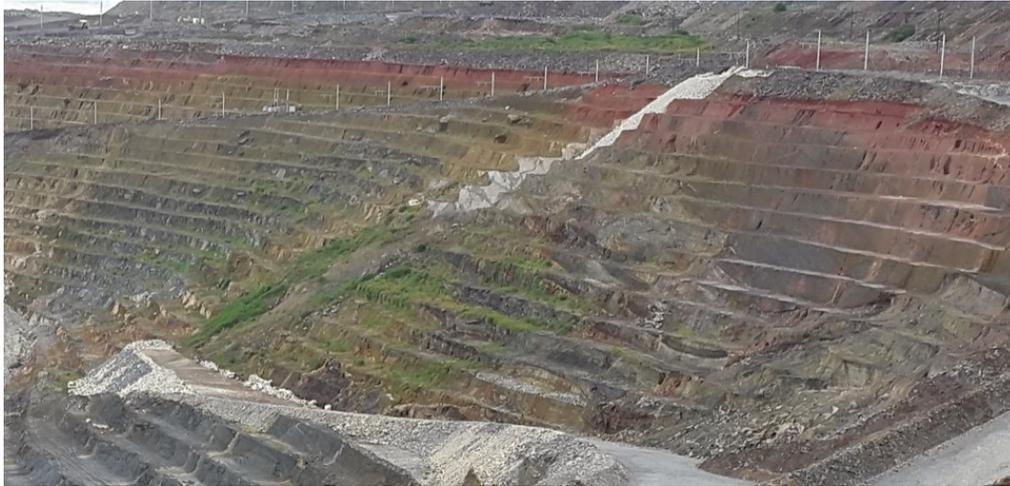
Figure 18 Backfilled wedge failure footprint and constructed abutment

The placement of the waste rock was to minimise the potential for the scarp to fail into the ramp (Figure 18). The surface water management plan was then revisited to ensure that drains at the base of this waste rock dump were lined with compacted laterite and graded to facilitate water drainage towards the northeast.

Since the completion of this remedial action, no further instability has been experienced in this specific portion of Main 12.

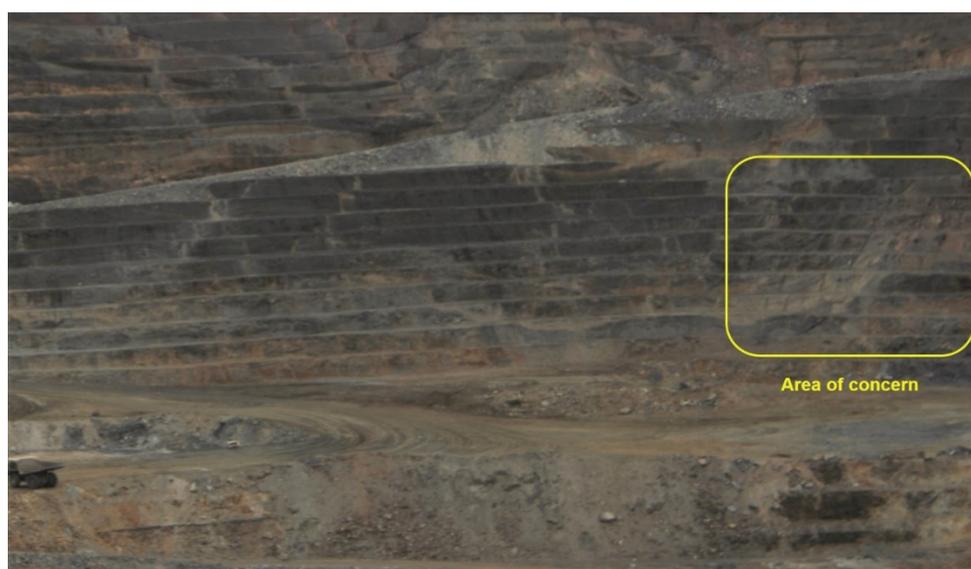
Evidence of this is resulting in instability of a specific portion of Main 12 North-East wall (Figure 19).

Figure 19 Continued weathering of exposed walls in Main 12 North-East (November 2017)

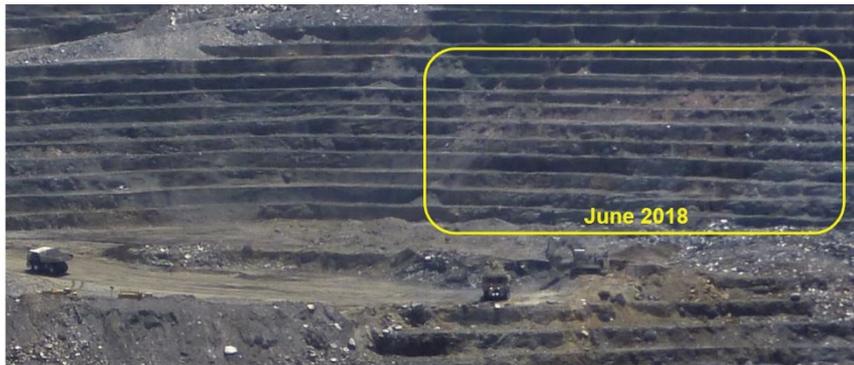
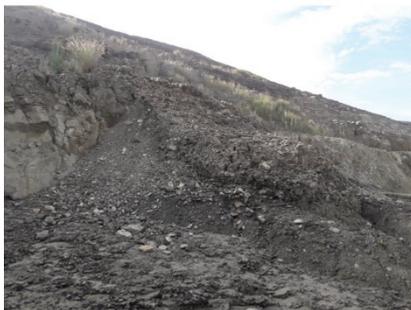
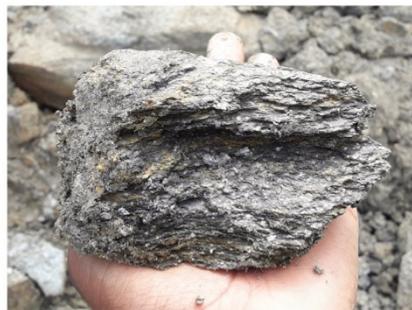
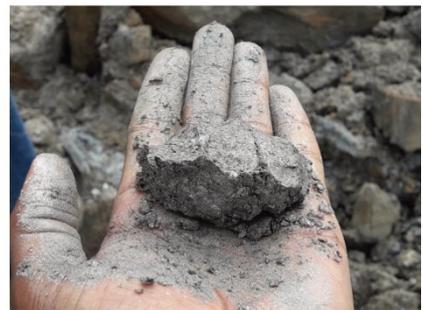
June 2019

This specific portion of the pit was mined approximately five years ago, and what was initially assumed to be stable fairly weathered phyllite benches, has now deteriorated to unstable saprolite benches (Figure 20).

Figure 20 Degradation of the phyllite benches in Main 12 North-East

A number of legacy issues pertaining to slope performance are beginning to materialise, particularly the effect of exposure of the northeastern phyllite benches in Main 12. The phyllite, which is being exposed to both groundwater and surface water runoff, has started to weather from a saprock to a saprolite, and this has started to creep. Fortunately, there is a ramp a couple of benches below this material, and therefore containment capacity to prevent the failed material from creeping onto the benches below the ramp. Unfortunately, this is a final wall, and there is no opportunity to push this wall back to a shallower angle.

A dewatering and depressurisation (of the saprolite) program has been developed and will commence in January 2020. This program has been specifically developed for Main Pit, and the vertical dewatering holes are planned to be fitted with vibrating wire piezometers and small pumps (on alternate holes). The horizontal depressurisation holes are planned to be drilled to a depth of 100 m and spaced 50 m apart in specific cutbacks.

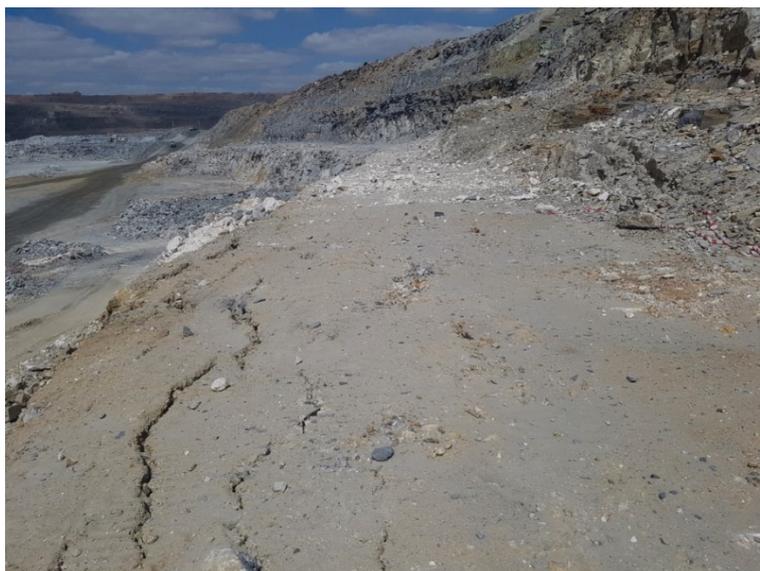
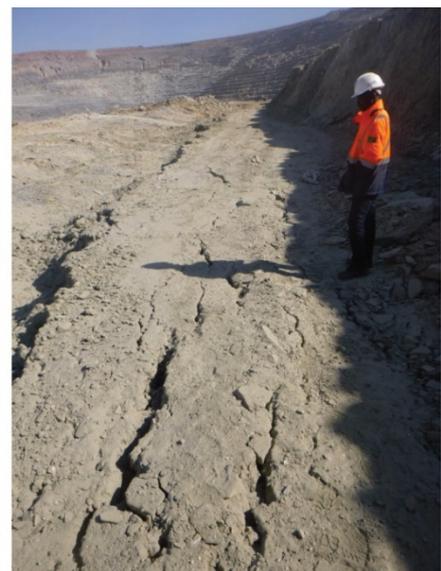
Presplitting has not been successful as a result of variability of the material comprising the pit wall. Completed presplit blasting has not been encouraging, due to recorded blast damages or back-break in the transition zone between the weathered and unweathered units (Figure 21). This has resulted in localised bench-scale failures. A review of material boundary within the transitional zone is being defined to delineate suitable layers to enhanced presplit and other appropriate wall control blasting to minimise blast-induced damages.

Figure 21 Examples of overbreak from the presplit blast

Presplit blast design in the transition zone is being reviewed. It has been realised that the 'normal' presplit design used in fresh rock should not be used in transition zones. A programme is being developed where the Blast Engineer first walks the block where the blast is to be designed, and then designs the blast specific to the block, taking the various material competencies and mechanical properties into account.

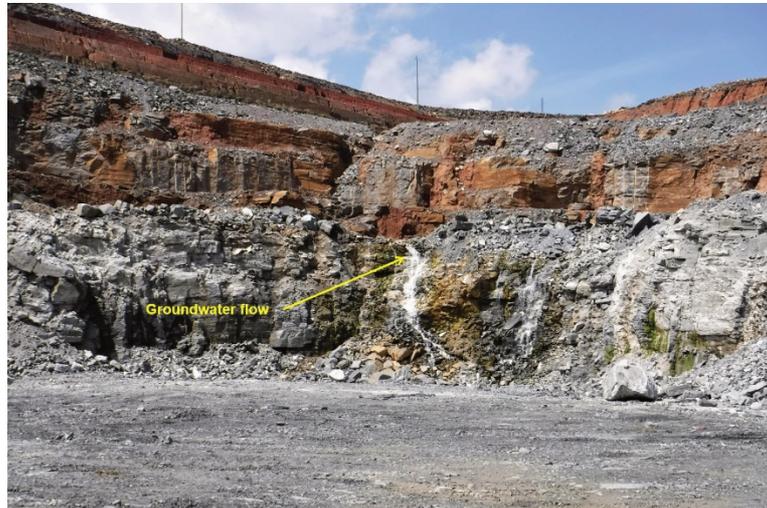
Historically very little was done to develop an understanding of groundwater on the mine, and slope design assumed that the walls were dry. However, over the past couple of years, attention is being paid to determine the source and direction of groundwater flow, as it is impacting on the dewatering of the Main Pit floor particularly during the wet season, and drilling in West 2 of North West Pit (Figure 22).

Figure 22 Groundwater flow in the western corner of North West Pit
