Evaluation and management of toppling failures at the McArthur River Mine, Northern Territory

Abstract

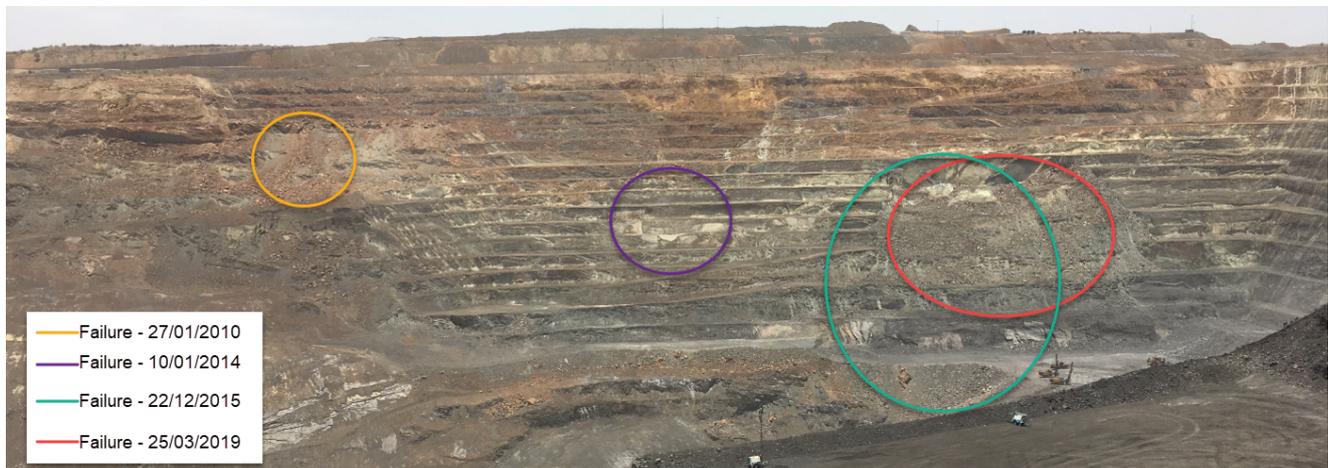
Since January 2010, there have been four toppling failures, shown in Figure 1, along the western wall termed the 'Footwall Quarry' (FWQ). The largest of the toppling failures occurred in December 2015, an inter-ramp failure with an estimated failure volume of 355,000 m³. The second largest occurred in March 2019 with an estimated failure volume of approximately 36,000 m³. All of the failures occurred after heavy rainfall events, two of which occurred during a cyclone (January 2010, Cyclone Olga and March 2019, Cyclone Trevor). The combination of weaker rock mass, unfavourable bedding orientation, and water infiltration during the wet season, the potential for toppling has been, and will remain, a continuous geotechnical risk for the MRM.

Figure 1 Footwall Quarry along the northwestern wall of the pit highlighting the areas subjected to previous failures (October 2019)

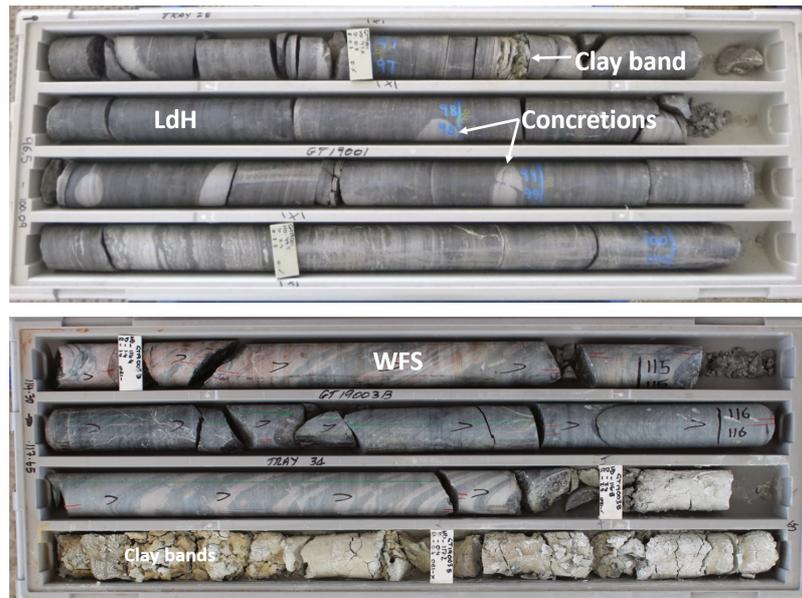
Figure 2 Lower dolomitic shale (LdH) consisting of interbedded shale (dark grey colour) with dolomitic concretions (light grey). W-Fold Shale (WFS) pink and grey with a green tinge. Clay bands are consistently interbedded throughout the Footwall Shale

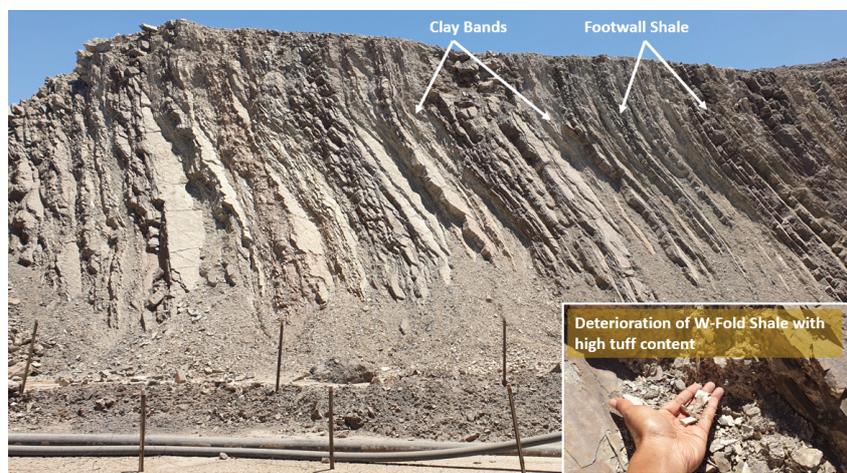
Interbedded throughout the hanging wall to the footwall is the tuffaceous bedding also known as the clay bands. The clay bands are strata-bound and vary in thickness and spacing. Similar to the lower dolomitic and W-Fold shales, the clay bands deteriorate rapidly within a number of days. Due to the tuffaceous bands' low permeability, they act as a barrier for ground and surface water, thus increasing the pore pressure behind the FWQ wall. The clay bands are consistent within the FWQ wall at an average spacing of approximately 1–2 m as shown in Figure 3.

Figure 3 Exposure along the northwest wall showing interbedded footwall shales and clay/tuffaceous bands

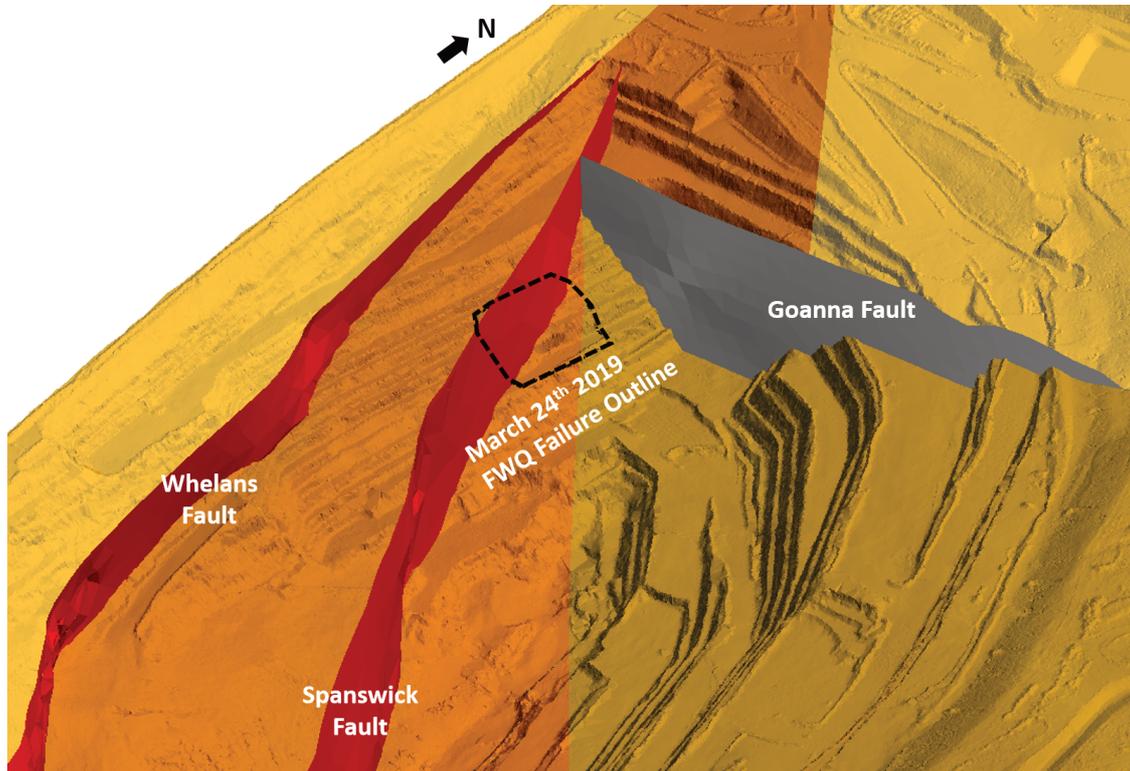
The thin bedding planes in the footwall quarry are regularly spaced and strike near parallel to the slope face. Field mapping and borehole data show dips of 55° to 85° into the pit. However, as a result of folding in some areas the dip can vary along the same bedding plane. Two major faults, the Whelans, dipping East at approximately 85°, and Spanswick, dipping northeast at approximately 80°, are near parallel to these bedding planes, whilst the Goanna Fault, dipping north at approximately 85°, is perpendicular to bedding towards the northern corner of the FWQ wall as shown in Figure 4.

Figure 4 Plot showing major structures within the northwestern wall of the Footwall Quarry

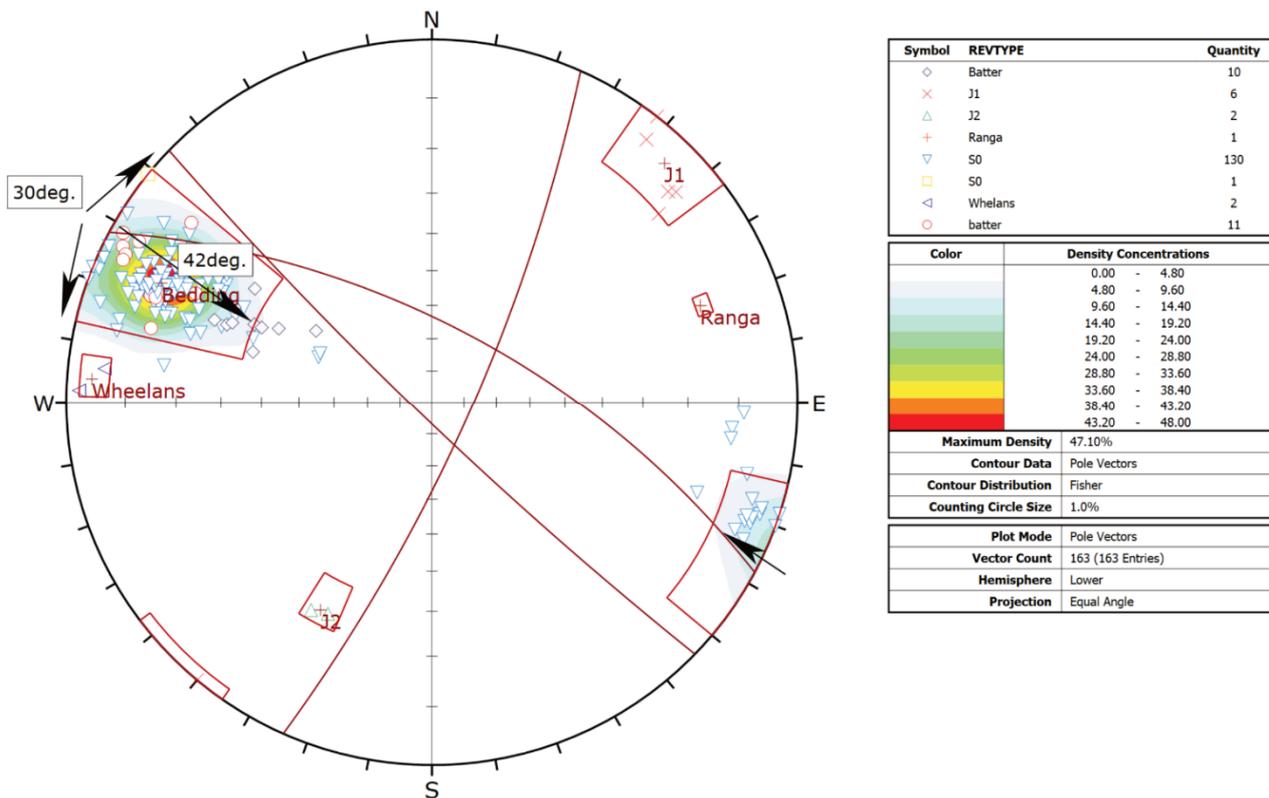
Figure 5 is a stereonet plot presenting major structures and bedding mapped in the FWQ as slopes have been exposed during mining. The dip and dip direction of the assessed major sets are bedding 78°/115°, joint set 1 (J1) 83°/120° and joint set 2 (J2) 65°/030°. The steeply dipping bedding plane dipping parallel to the pit slope can be attributed to the instabilities in the FWQ.

Figure 5 Stereonet projections of the northwest wall

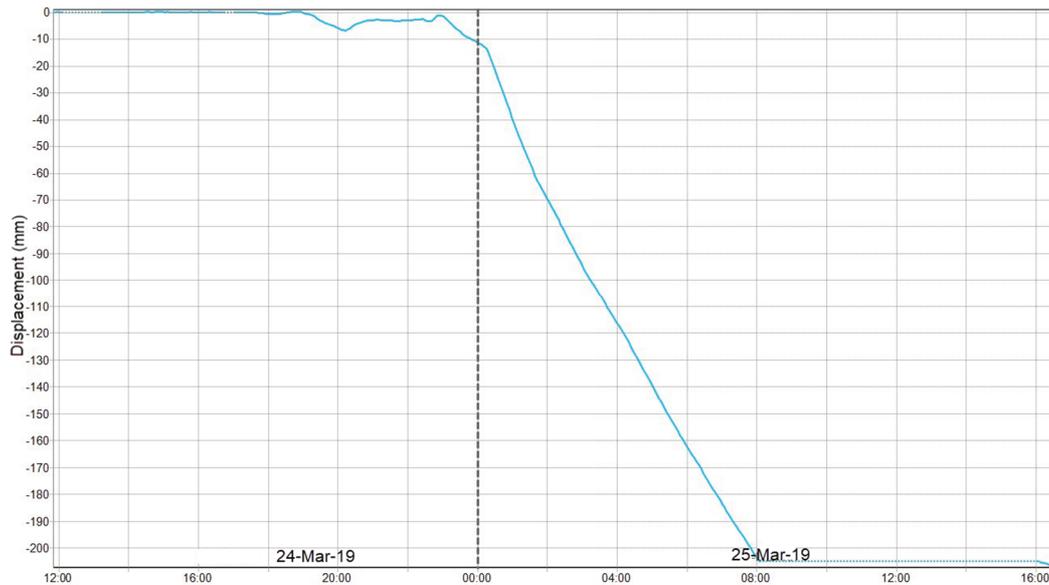
Figure 6 Displacement graph from IBIS radar showing events leading up to the failure

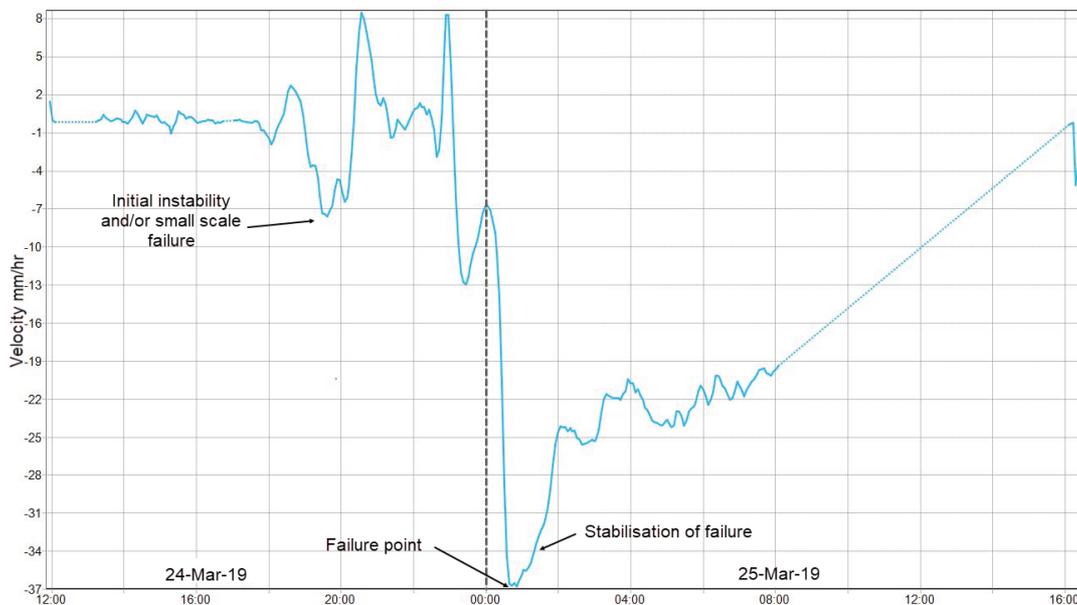
Figure 7 Velocity graph from IBIS radar showing events leading up to the failure

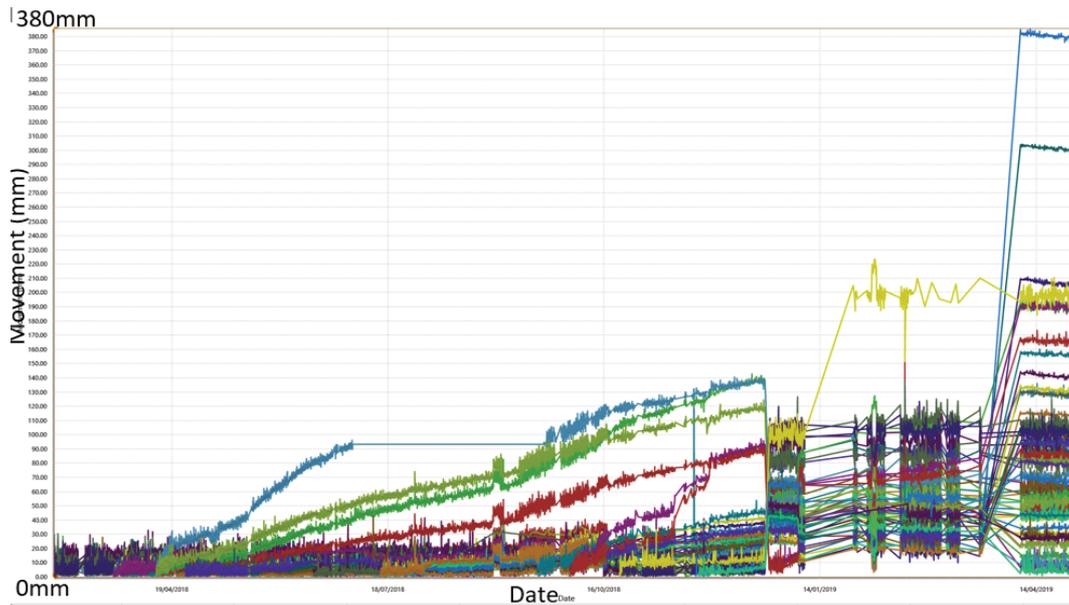
Prism data recorded in the FWQ in the year leading up to the failure, Figure 8, shows there was continuous displacement on multiple prisms located near the failure zone. The movement is triggered in April 2018 and remains constant for most of 2018. Issues with total stations and the requirement to relocate the monitoring pillar as the result of a cut back in early 2019 resulted in large data gaps throughout the start of 2019. Data acquired during this period is relatively stable. No prism data is available during the failure as the total

Figure 8 2D velocity graph of Footwall Quarry prisms from October 2018 to early March 2019

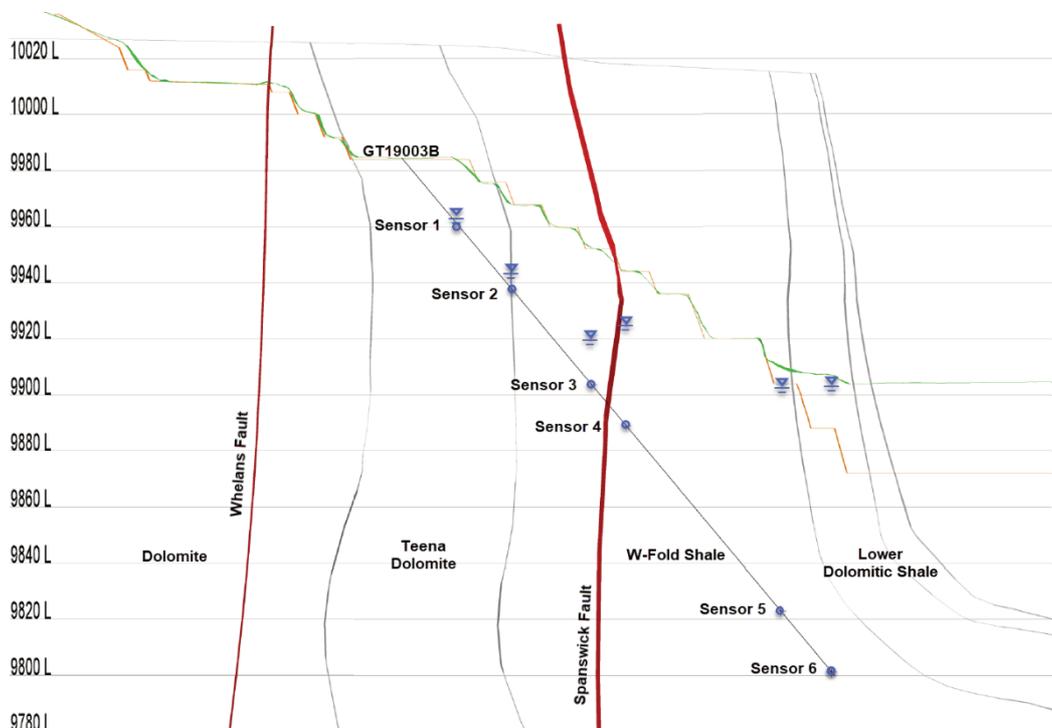
Figure 9 Cross-section of the vibrating wire piezometers installed prior to the failure indicating the pressure head achieved at the time of failure

The VWP data from the instrumented hole, as shown in Figure 9, indicate a distinct pressure spike during the major rainfall event. The increase in pore pressure was experienced by all VWP sensors, particularly sensor 4

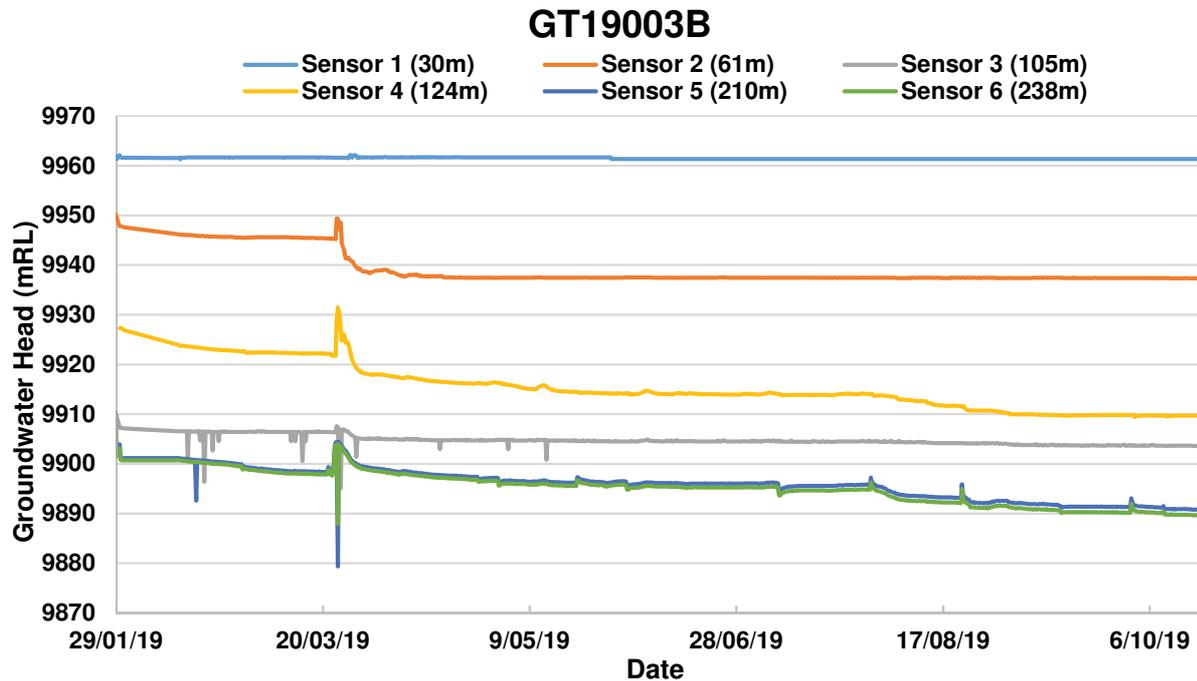
which already had elevated pore pressure due to the apparent interaction with the Spanswick Fault, shown in Figure 10. The VWP data indicate that hydro-mechanical coupling was occurring throughout the cyclone period, hence influencing the mechanical properties of the rock mass.

Figure 10 Vibrating wire piezometers (VWP) pressure head graph for VWP sensors located directly behind the failure

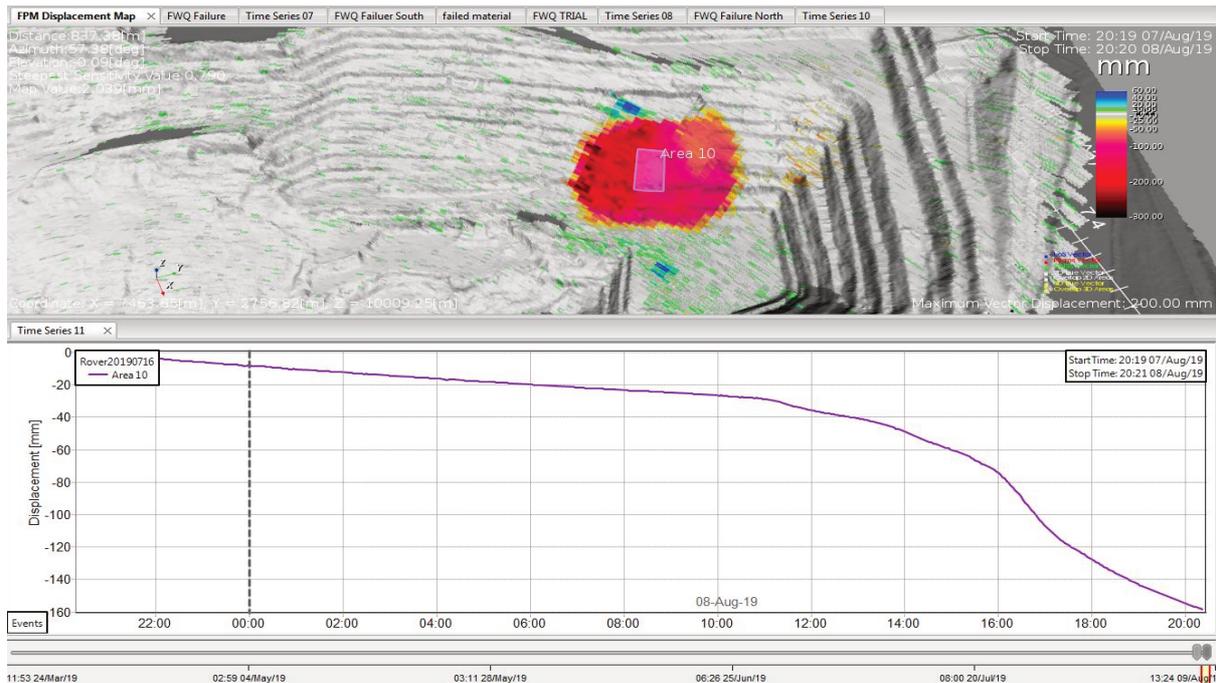
Radar monitoring and applicable alarm thresholds have been vital for the continued safe and efficient mine production. The radar alarm thresholds at MRM have been re-assessed and modified following every failure event to better depict the behaviour of the slope. Since the initial failure was observed in March 2019, movement of the slope had continued with failure of the lower benches and lateral extension of the failed zone occurring, as displayed in Figure 11. Due to the continued extension of the failure, radar threshold alarms were set as shown in Table 3. The failure velocities achieved between the in situ wall and post-failure rill are significantly different which has been taken into consideration when setting the radar alarm thresholds. The comparison of the failures shows a failure lower velocity rate prior to failure for in situ rock mass (approximately 7 mm/hr) compared to post-failure rill (approximately 30 mm/hr). It should be noted that the movement rates are site based and reflect the specific geology and historic behaviour of the FWQ wall.

Figure 11 Displacement graph from IBIS radar showing events throughout the remediation of the March 2019 failure

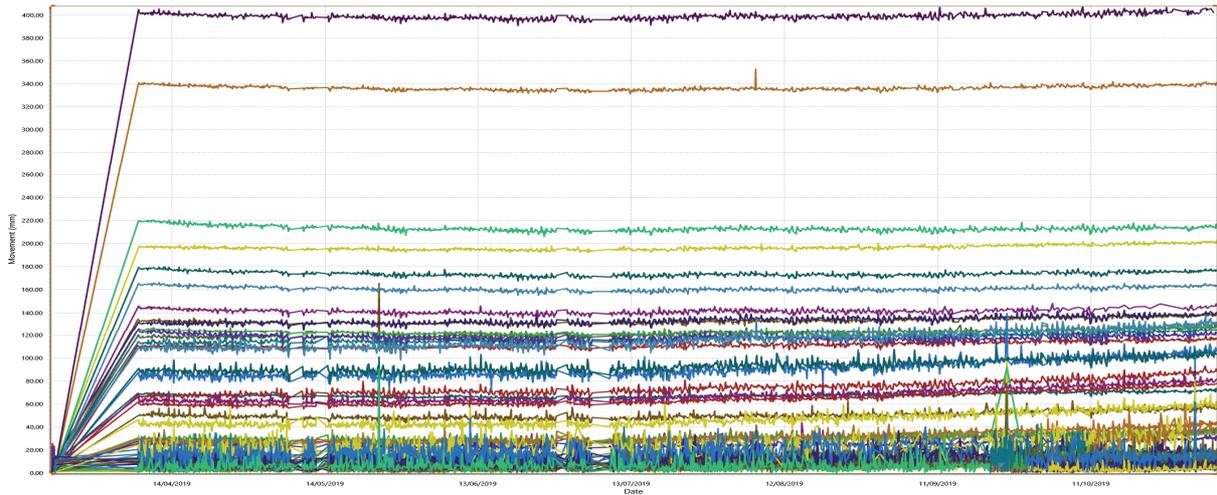
4.2.2 Prism monitoring

Figure 12 Prism movement on the west wall following March 2019 failure

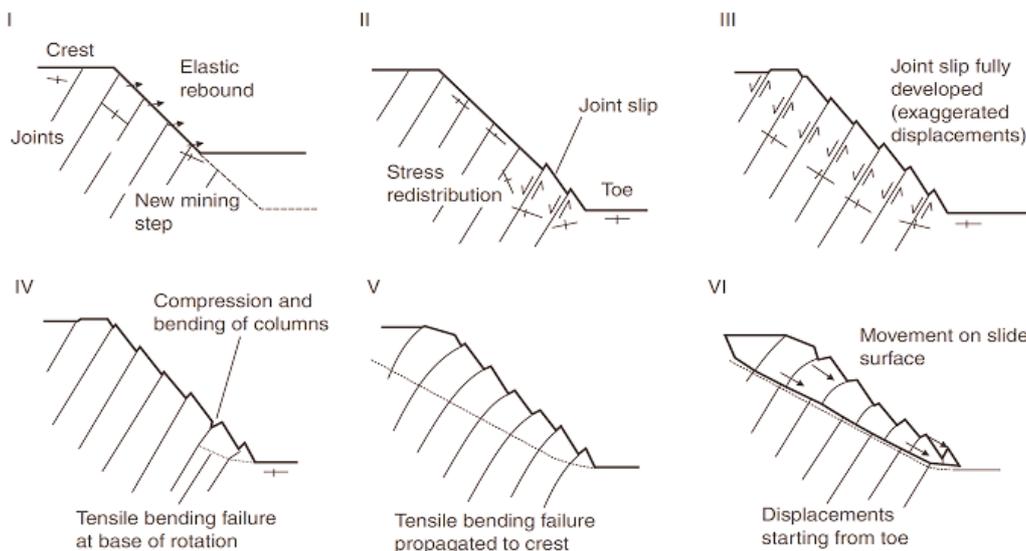
Figure 13 Cross-section showing development of a toppling failure (Read & Stacey 2009)

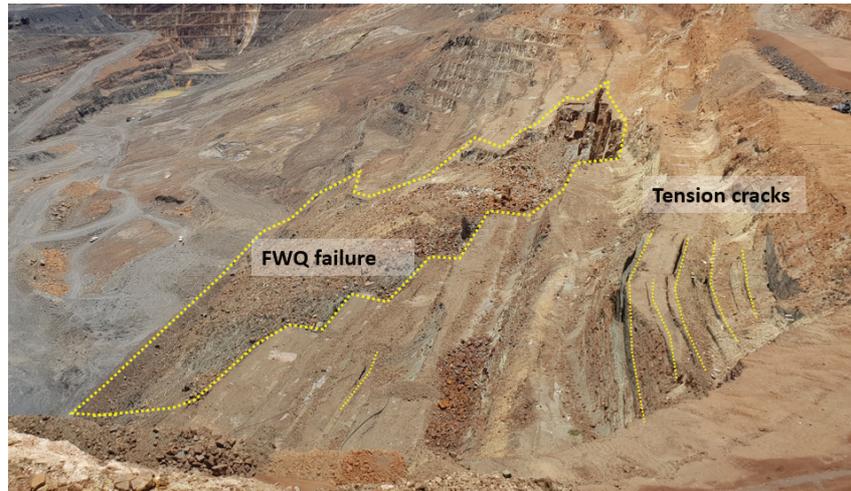
It is believed that 2019 FWQ failure was initiated from the toe of the failure one bench above the active mining area on the 9,920 metre reference level (mRL) triggering a flexural toppling failure. The bedding orientation of the western wall dips into the slope which is not typical for a toppling failure, typical toppling failure mechanism shown in Figure 13. The toppling mechanism for the western wall is believed to initiate due to the swelling of the clay infills coupled with water ingress with external forces on the bedding wall causing the beds to rotate as shown in Figure 14.

Figure 14 Photo of the western wall highlighting the rotation of the sub-vertical bedding due to water ingress and swelling of the tuffaceous bands

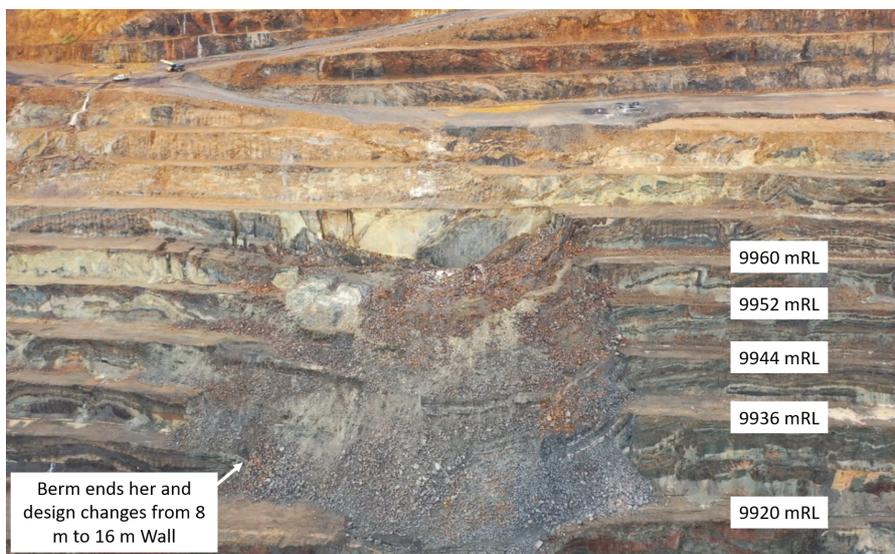
Onsite interpretation determined the failure initiated on the northern half of the FWQ wall where there was a change in batter height from 8 m to 16 m in an area with weaker rock mass, batter height highlighted in Figure 15. As-built berms along the south may have acted as a buttress preventing the failure mass from extending south within slightly better rock mass.

Figure 15 Photo taken of the Footwall Quarry failure on 25 March 2014

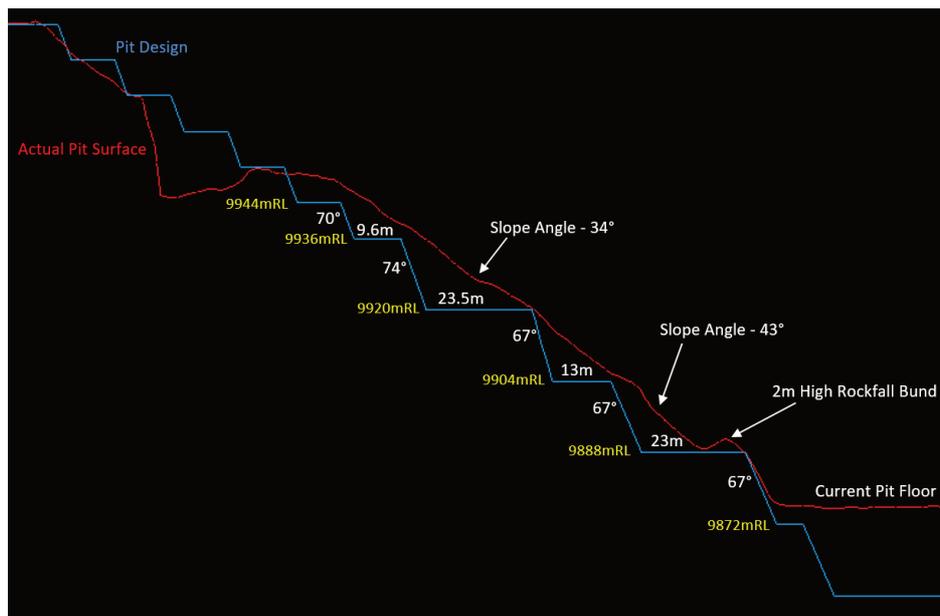
Initially work was completed by Operations to remove material from the toe of the failure, this was successful in reducing the volume of failed material on the wall. However, the result left a 50 m high rill slope with the top 34 m angled at 34° and the lower 16 m steepened to 48°. A cross-section of the failure highlighting angles is presented in Figure 16.

Figure 16 Cross-section comparing current pit surface to pit design (cross-section through middle of failure zone)

A step-out was designed with the berm below the failure being extended from the 8.5 m design to 13 m. This change in design left room on the berm to install a 1.5 m high catch bund to assist in reducing rockfall risk to personnel working below the failure. This approach was successful and enabled production to continue safely on the 9,904 mRL. Since firing and excavating the next shot, the slope has continued to settle, filling up the catch bund resulting in the failed material sitting at a continuous angle of 34.5°.
