# Evolution and management of large-scale instability: a case study from Ok Tedi

G Kennedy *PSM, Australia*

D Casagrande *PSM, Australia*

*This paper provides an overview of the failure mechanism of Block 1A, the use of monitoring to understand the movement triggers and behaviour, and the pit slope risk management program which has allowed the successful mining of the West Wall cutback to continue with ongoing pit slope movements.*

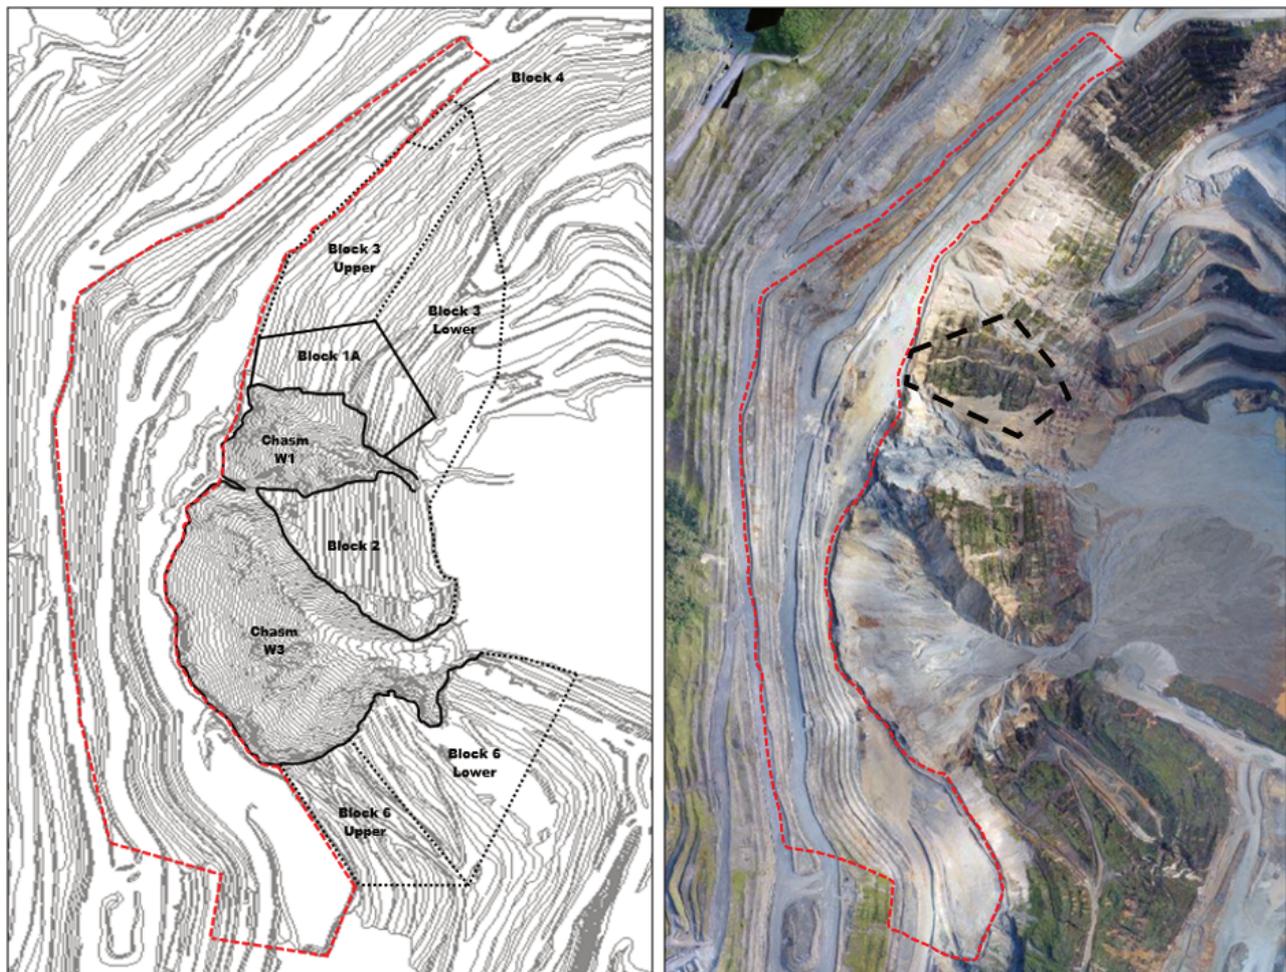
Figure 1 Schematic map illustrating West Wall chasms, failure ‘blocks’, and area (dashed red line) which unloading cutback has excavated since July 2017. Block 1A is illustrated in dashed black

'block' failure areas are roughly illustrated in Figure 1, which highlights the numerous areas which were separated based on movement trends, and often bordered by tension cracks and geological structures.

An important aspect of the management of the slope instability was the immediate implementation of a cutback above this failure zone after the significant tension cracking which occurred in July 2017. The unloading cutback continues above the entire West Wall immediately above the zone of instability as illustrated in Figure 1. Since this time, the cutback has unloaded approximately 120 m of the West Wall immediately above the Chasm and complex failure blocks.

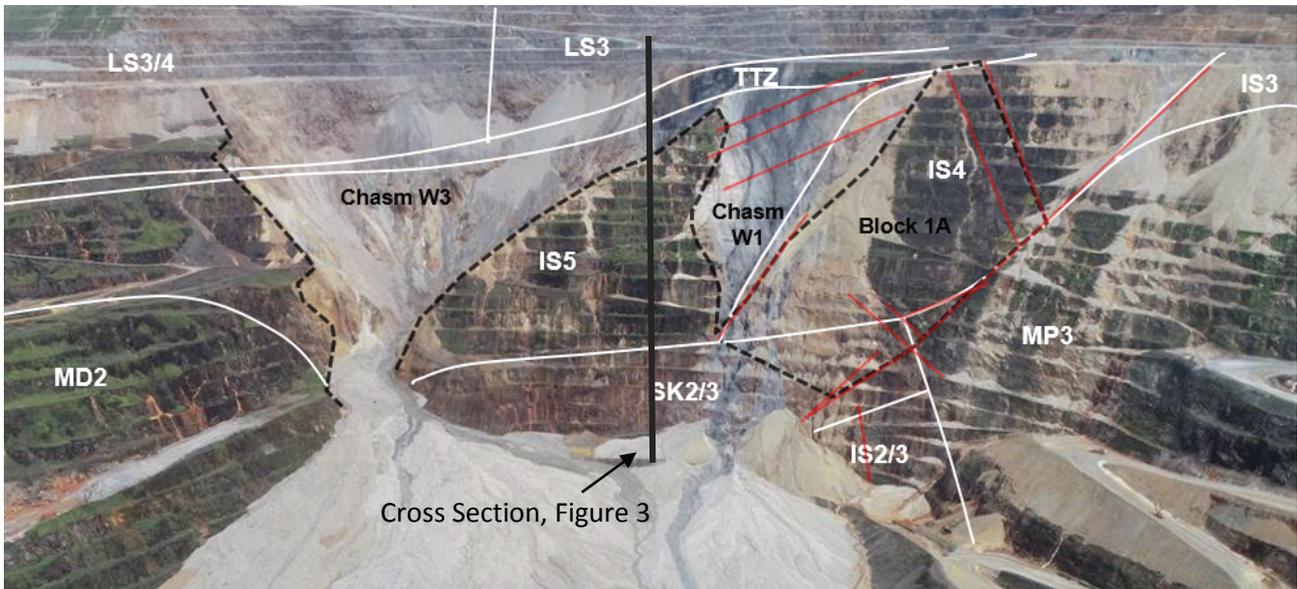
Of note, the development of Chasms W1, W3 and Block 1A have largely been within the Taranaki Thrust Zone and underlying West Wall Weak zone. The Taranaki Thrust is a structure in itself, but from a rock mass quality perspective is modelled as a zone that comprises a poorer rock mass in the Darai Limestone above and poorer rock mass zone in the Ieru Siltstone below it. The WWWZ is a zone of poor rock mass that commences in the south of the pit and extends through the entire West Wall through to the north in across the area illustrated in Figure 2. Within the West Wall failure area, the zone lies predominantly within the Ieru Siltstone, with areas of Monzodiorite and Skarn encountered at the base of Chasm W1. The WWWZ zone does not extend into or above the Taranaki Thrust Zone. Outside the WWWZ the rock mass is better quality with a gradual increase in quality to the west and sharp increase towards the east.

Figure 2 Rock Mass Model, Chasm W3 and W1, and Block 1A illustrated on West Wall. West Wall Weak Zone through centre, within the IS4 and IS5 rock mass

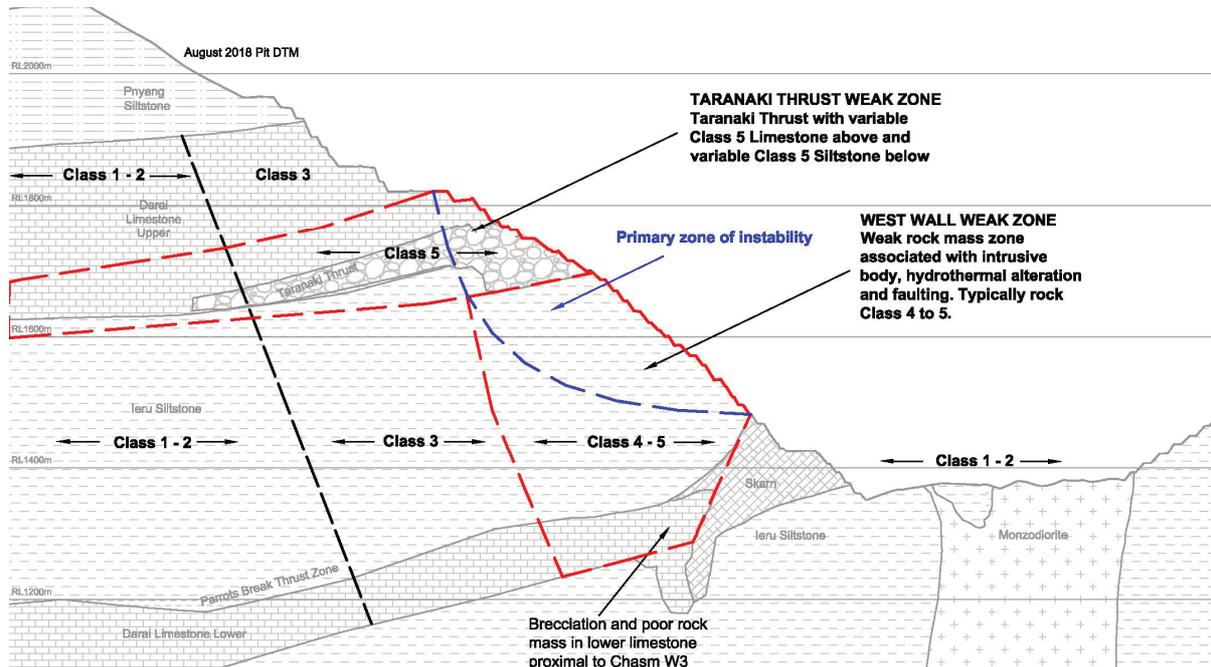
Figure 3 Geology and simplified rock mass model in cross-section, through West Wall in approximate location illustrated in Figure 2

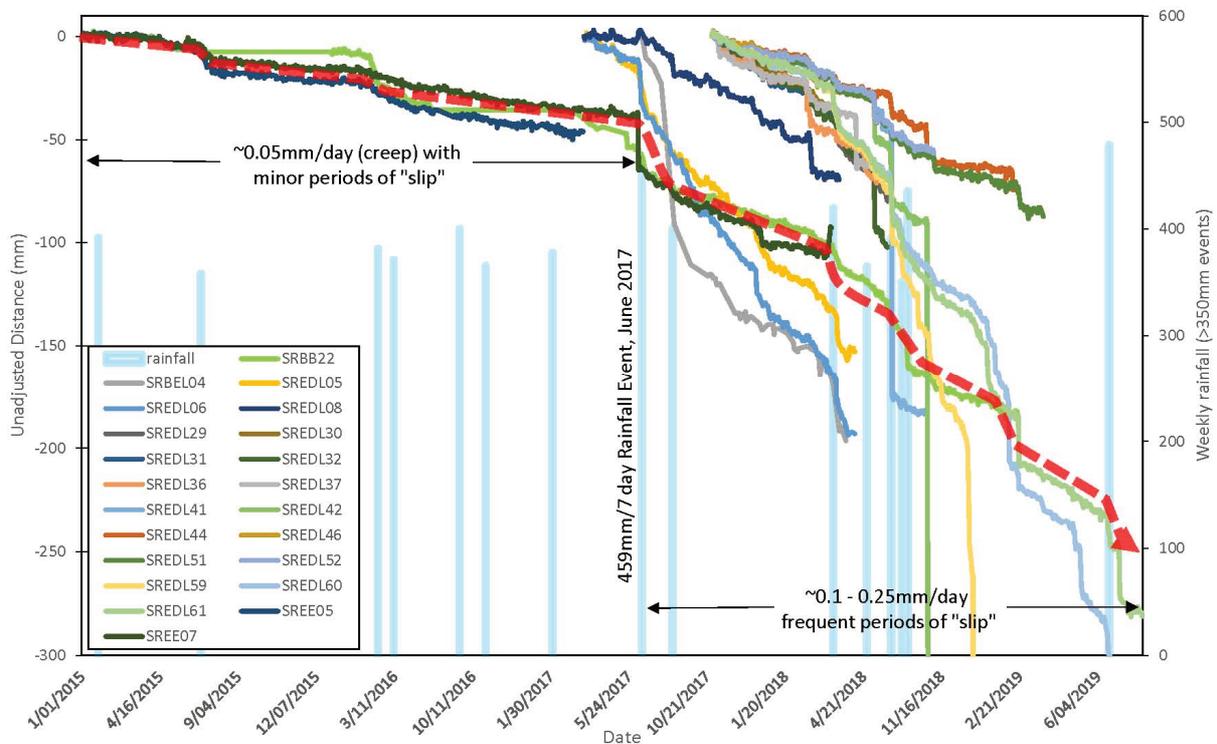
Block 1A of the West Wall showed long-term creep movements of approximately 0.05–0.1 mm/day (~20–35 mm p.a.) from 2005 to mid-2017, with the latter part of the creep movements (2015–2016) with minor slip events for Block 1A illustrated in Figure 4. While this movement did not directly affect the mining operation during that time, it did result in significant dilation and an increase in the storage capacity and permeability of the rock mass.

Figure 4 Block 1A Prism Movement, January 2015 to August 2019, illustrating transition from creep to advanced ‘cracking and dislocation’ movements in June 2017

In April of 2017, a significant tension crack (~500 mm wide) opened up in a bench 45 m above the northern edge of Chasm W3. In June of 2017, a rainfall event of 459 mm over seven days occurred which then triggered the slope to advance to the cracking and dislocation stage with movements illustrated in Figure 4.

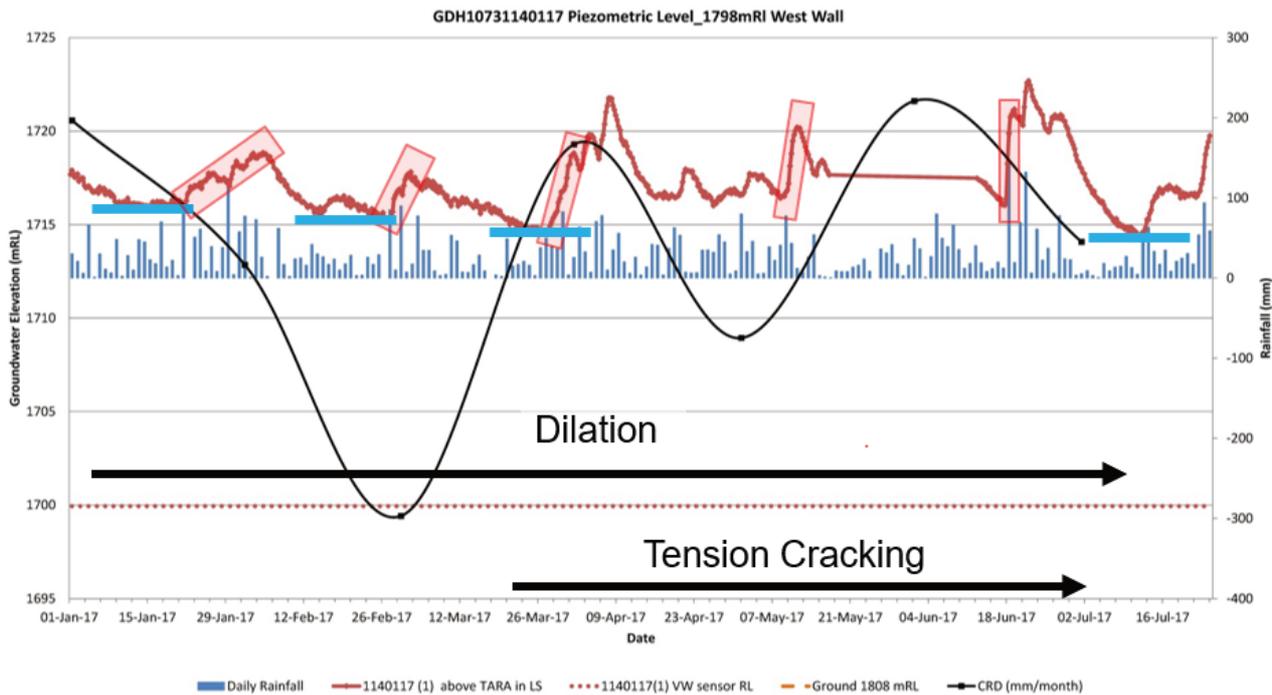
This increase in rock mass permeability and pore pressure response with continued dilation of the slope is evident in the piezometer data for Block 1A, Figure 5, which shows:

1. An increasingly rapid response of pore pressures (highlighted in red) in the slope with successive high rainfall events, in particular, prolonged (~7 day) high rainfall events.
2. A decreasing residual groundwater level after each prolonged high rainfall event (highlighted in blue).

The decrease in groundwater level occurs as with each prolonged and high rainfall event, further movement/dilation of the slope occurs, and the increased permeability allows the slope to drain to lower residual groundwater levels.

The piezometer data in Figure 5 shows Block 1A transitioning through sub-stages 1 through to 4. Importantly, the piezometric response is evident prior to the onset of the significant and widespread surface tension cracking which occurred during the high rainfall event in June 2017, highlighting how groundwater monitoring provides a valuable and early insights into pit slope performance.

Figure 5 Piezometer response to rainfall, Block 1A. Rising groundwater levels pre-2017 not illustrated

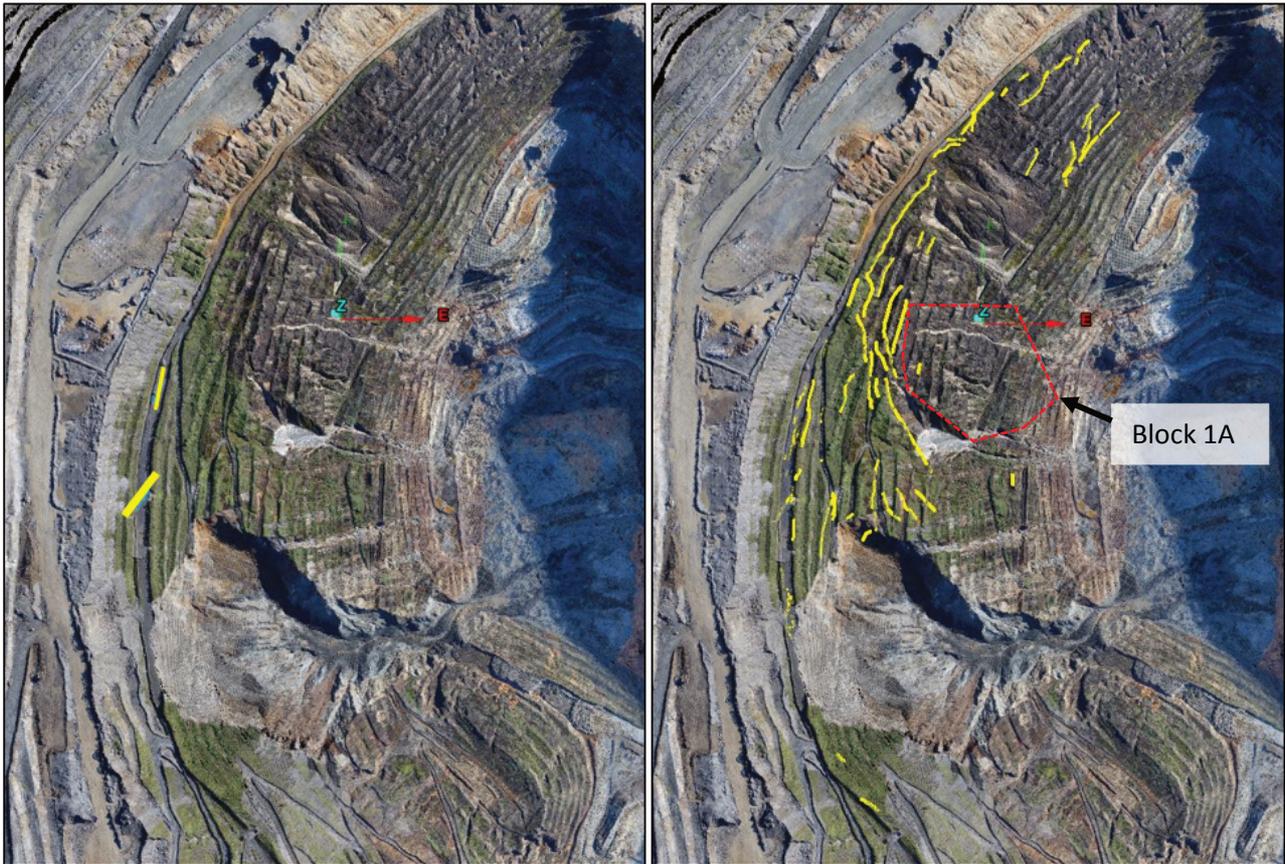
Mapped tension cracks were then illustrated in plan, which allowed a greater understanding of the evolution of pit slope deformations. This development is illustrated in Figure 6, showing mapped tension cracking in April 2017, and then again in August 2017. August 2017 includes the significant tension cracking which occurred following the high rainfall in June 2017.

Figure 6 Tension Crack Mapping, April 2017 and August 2017 showing distribution of tension cracks after June 2017 rainfall event and location of Block 1A relevant to early tension cracking

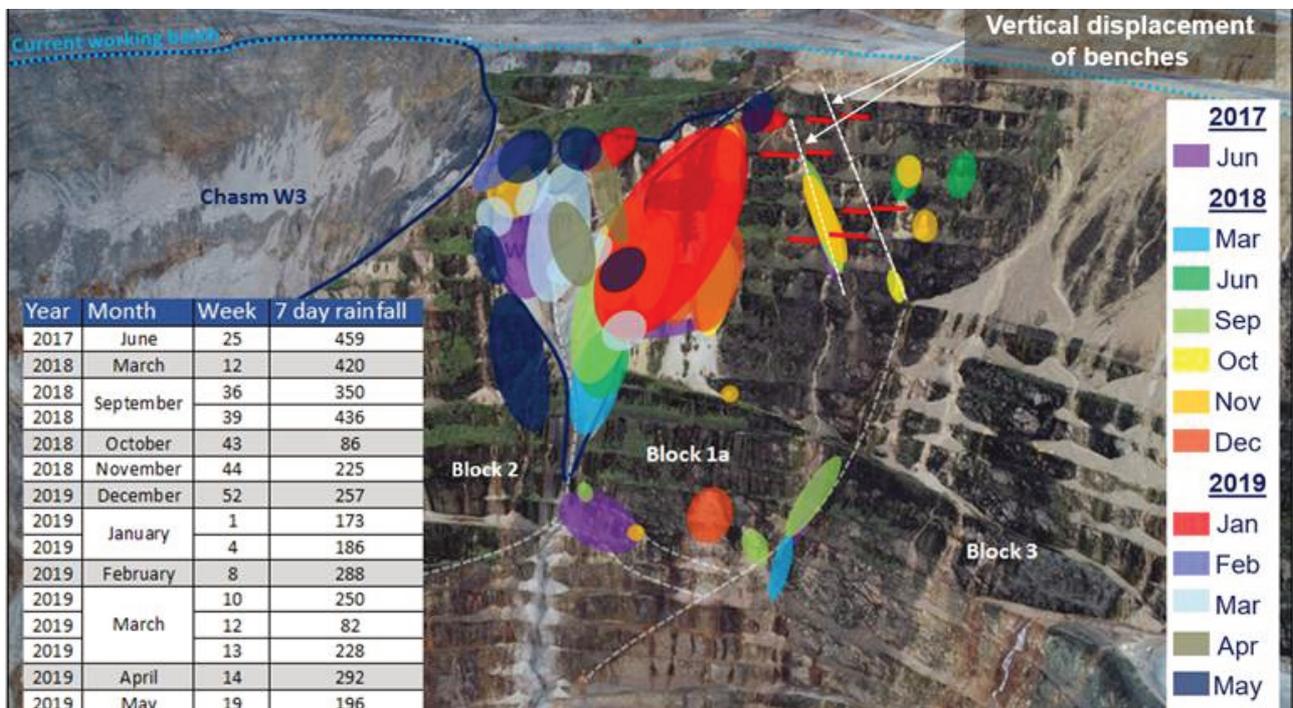
The evolution of the slope breakup was also mapped and documented using drone photography. Drone photos were compared following ‘slip’ movement events, to visually identify areas of slope breakup and ravelling which allowed understanding of the evolving slope behaviour and stress distributions within the slope. This evolution of failure/ravelling areas from June 2017 through to May 2019 is illustrated in Figure 7. Also evident in these photos is the vertical displacement of Block 1A compared with the surrounding rock mass.

Figure 7 Illustrated areas of failure around Block 1A, June 2017 to May 2019. Ravelling failures concentrated within and near boundary of Block 1A. Note vertical displacement of benches evident

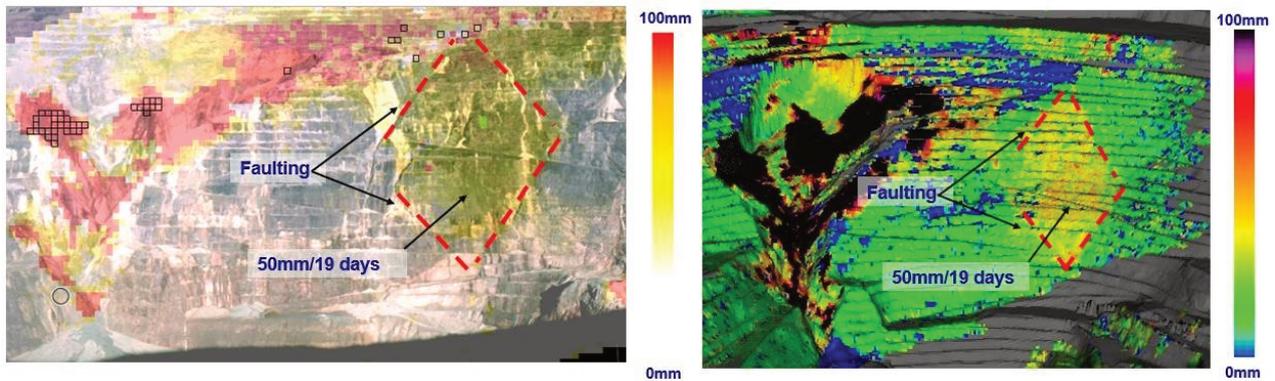
Figure 8 Radar movement, West Wall, 19 day movement for GroundProbe (left) and IDS (right) radars, early July 2018

Figure 8 illustrates the initial movement of the Block 1A zone following the June 2017 rainfall event. This movement was evident over a large area, picked up by both IBIS and GroundProbe radars, with the movement zone well defined by bounding geological structures.

Figures 8 and 9 show slope movement but also the evolution of the Block 1A movements, in this case the slope dislocation and breakup, sub-stage 7. Initial pre-failure movements of Block 1A involved the entire block as evident in Figure 8. Over time, as Block 1A continued to dislocate and breakup, zones of concentrated movements began to emerge, which often moved independent of each other. After the large rainfall event

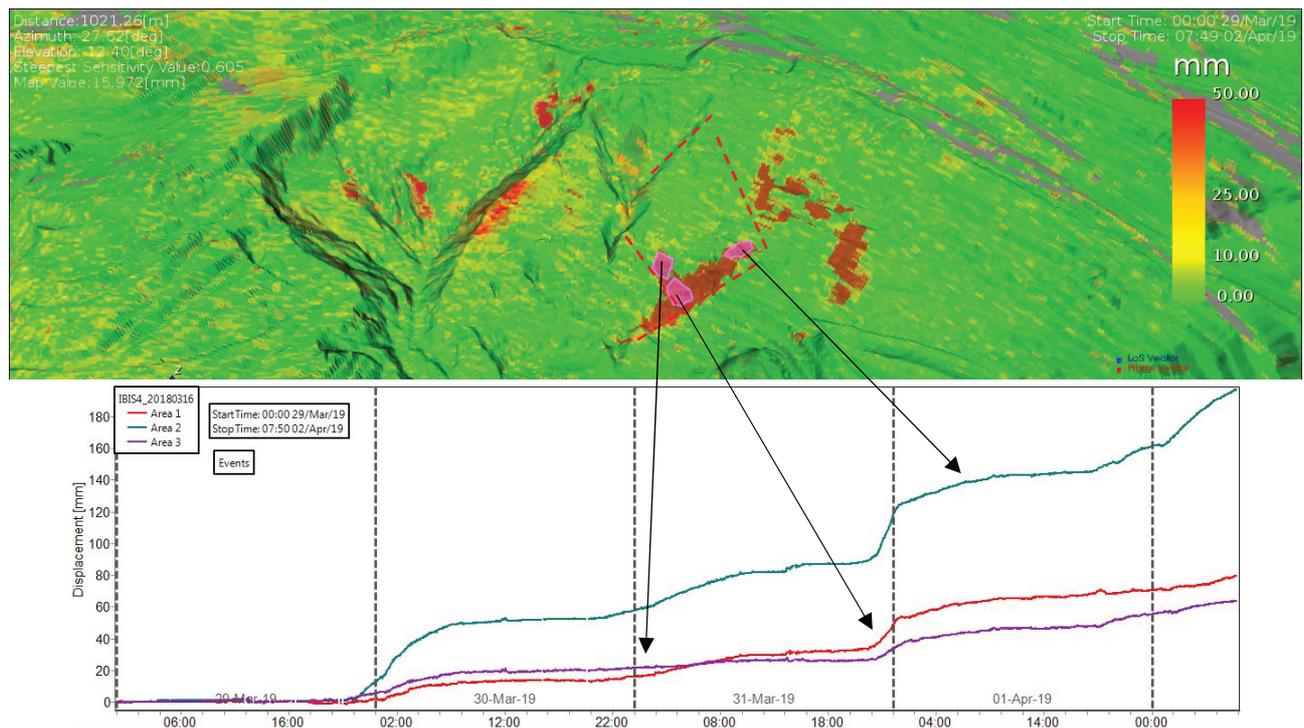
Figure 9 Radar movement, West Wall, 4 day movement for IDS radar, 29 March to 2 April 2019

in March/April 2019, the lower section of Block 1A moved 200 mm over three days, while the upper section of Block 1A showed significantly less movement (Figure 9).

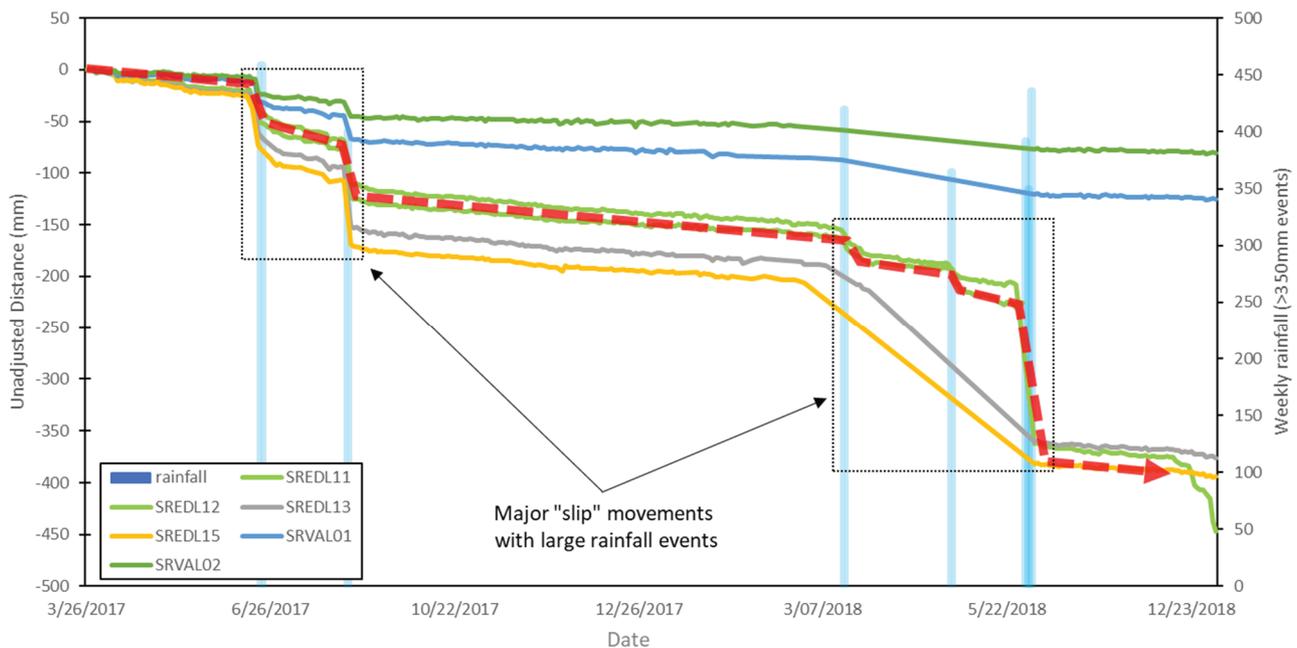
Figure 10 Block 1A prism movement, March 2017 to December 2018. Rainfall events of >350 mm/week are shown in the plot, with accelerated prism movement evident

Figure 10 illustrates that the movement behaviour of Block 1A is 'stick-slip', i.e. movement is cyclical, triggered by prolonged high rainfall events (initially >350 mm/7 days), with relatively short episodes of high movement caused by slip movement along structures within the rock mass. After short periods of sharp acceleration, the movement then decreases to a more linear and generally constant displacement rate. This is also evident for movement over shorter time periods as illustrated in the radar movements in Figure 9.

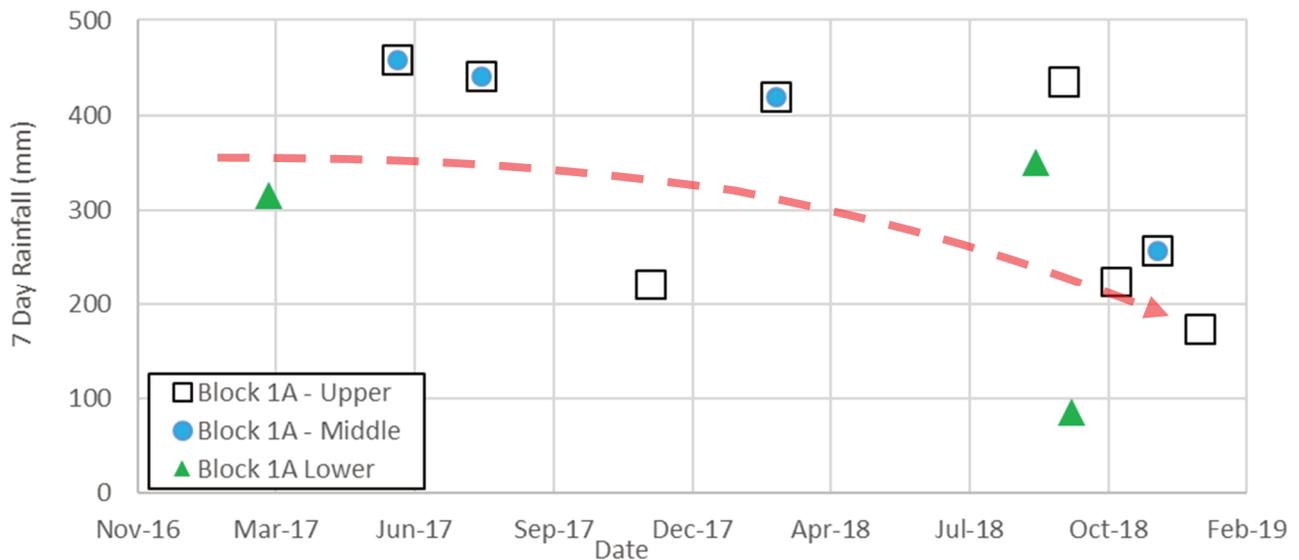
Rainfall monitoring in combination with prism, radar and visual monitoring also provides a valuable insight into the increasing sensitivity of the Block 1A slope as it continues to evolve. Figure 11 illustrates the rainfall events which triggered slope movement/failures within Block 1A between November 2016 and February 2019. This shows the movement triggering level of 7 day rainfall totals decreasing over time, indicating the slope is becoming more sensitive to rainfall as it continues to breakup, which not only decreases the rock mass strength within the slope but also results in higher pore pressure spikes following rainfall as more surface cracking opens up.

Figure 11 Rainfall Events triggering movement, Block 1A, showing decreasing total required to trigger slope movement over time
