Case study: analysis of a highwall toppling failure and development of a successful mine re-entry plan using RS2, RocFall and Dan-W at a coal mine in Canada

C Clayton Tetra Tech Canada Inc., Canada

A Bidwell Teck Coal Limited, Canada

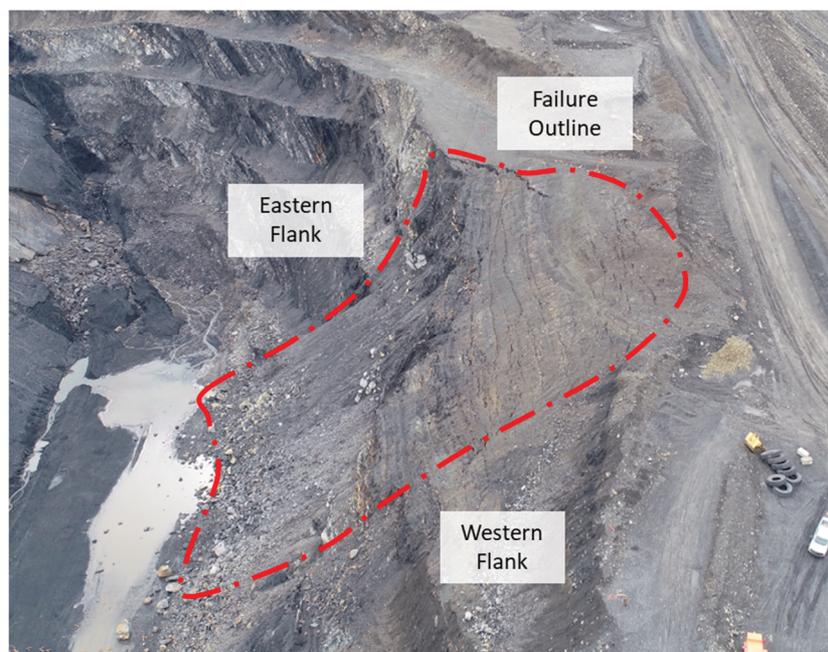
A failure of the south highwall of the H3 Pit occurred on 9 July 2017. The highwall was approximately 60 m high. Routine due diligence radar monitoring of this section of highwall was established three days prior to the initial failure, however, the baseline data collected up to 9 July 2017 was insufficient to predict the failure as the time did not allow for a progressive trend to be identified. A subsequent failure occurred on 5 August 2017 and the radar was successful in detecting early signs of the developing failure. Neither failure resulted in injury or damage to vehicles or infrastructure. Mining of the pit was suspended pending an assessment of the wall stability, and the development of an appropriate and safe re-entry mining plan. Figure 2 shows the extents of the failure.

Figure 2 View of H3 pit failure extents

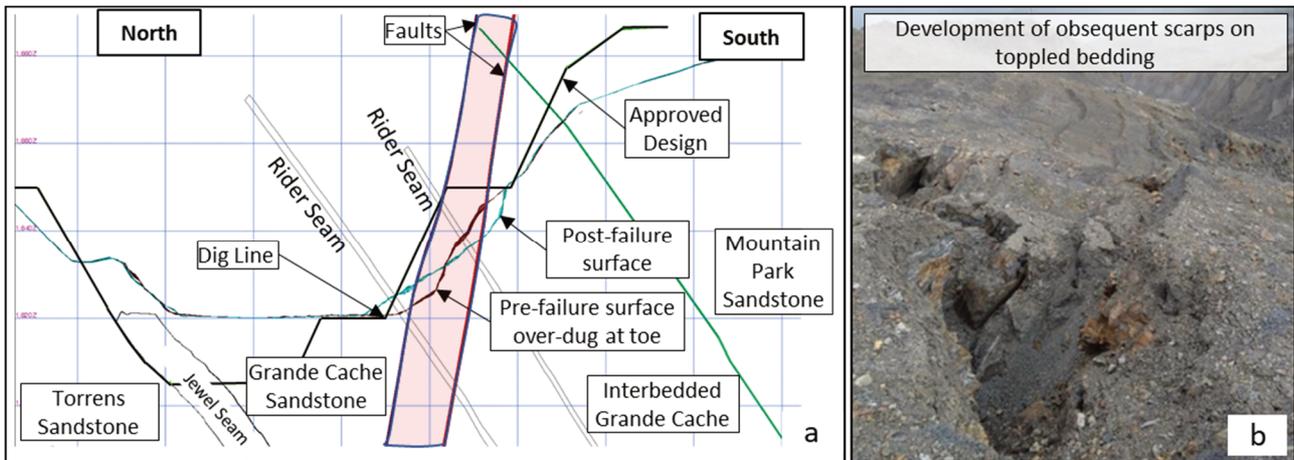
Figure 4(a) illustrates the general profile through the failed slope showing the approved pit design profile and the as-mined topography to early July 2017. Figure 4(b) is a photograph of the development of obsequent fault scarps along bedding planes at the crest of the slope following the August 2017 failure.

Figure 4 (a) General slope profile pre- and post-failure; and (b) Obsequent fault scarp development

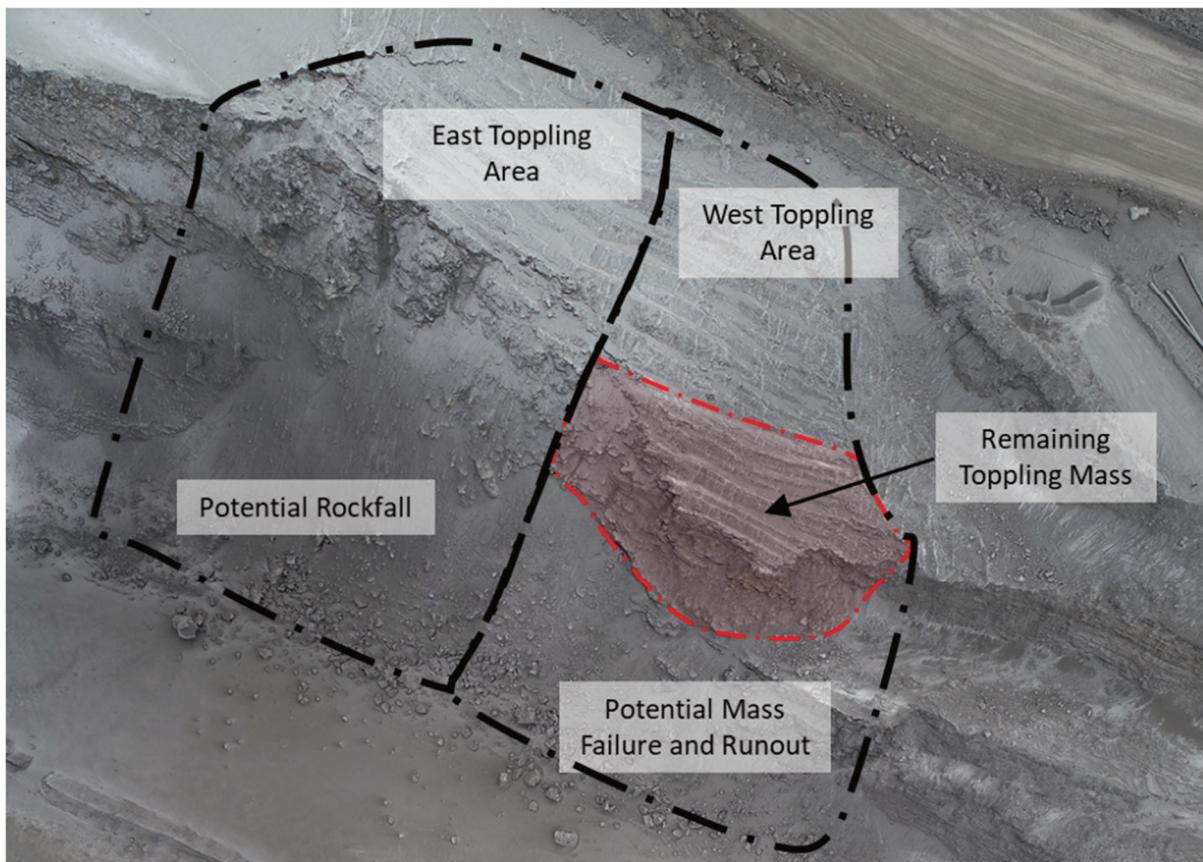
Following the failure, two hazards to re-entry remained. The eastern portion of the failed highwall was characterised by potential rockfall hazards (east rockfall area). The western portion of the failed highwall was characterised by a larger toppling rock mass which had not fully failed, leaving a potential mass runout hazard (west toppling area). Figure 5 shows the two hazard areas.

Figure 5 Remaining hazards to mining re-entry

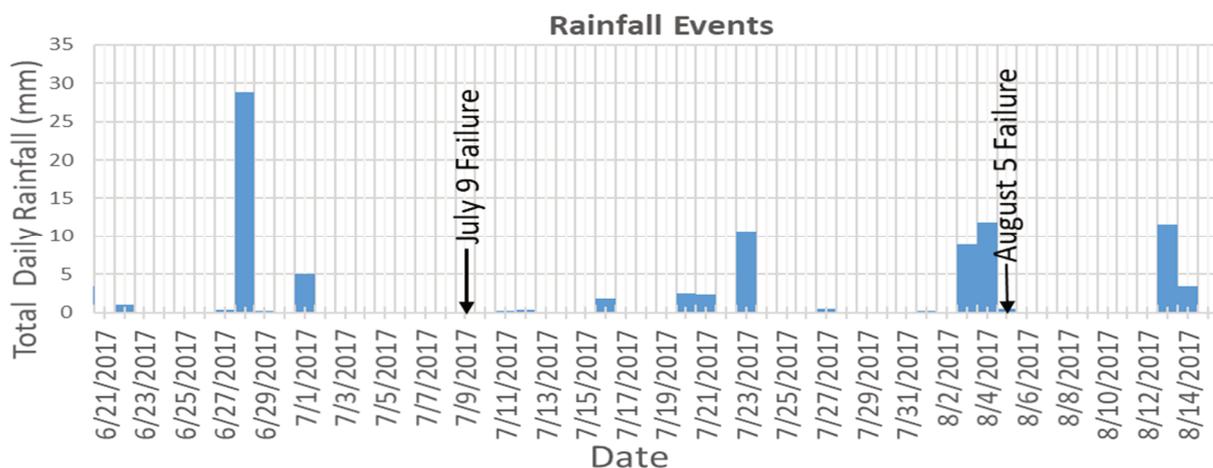
Data from a nearby weather monitoring station were reviewed. A period of heavy rainfall occurred approximately one week prior to the 9 July failure; two days of rainfall were recorded on 3 and 4 August 2017 preceding the 5 August 2017 failure, as shown in Figure 6.

Figure 6 Rainfall events preceding failures

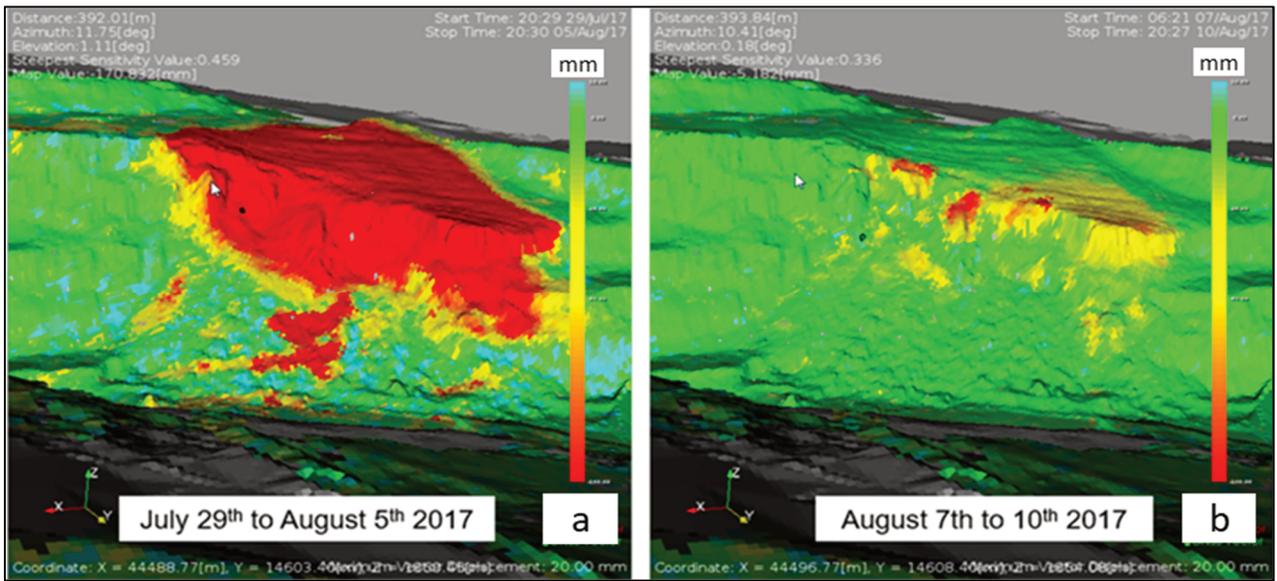
The second failure on 5 August 2017 was identified in advance based on slope deformation (Figures 7(a) and 7(b)), velocity and inverse velocity trends. Figure 8 presents an inverse velocity graph that shows an accelerating trend developing around 31 July and possibly as early as 29 July, leading up to the 5 August failure.

Figure 7 Radar slope displacement monitoring (a) Before; and (b) Following the 5 August failure

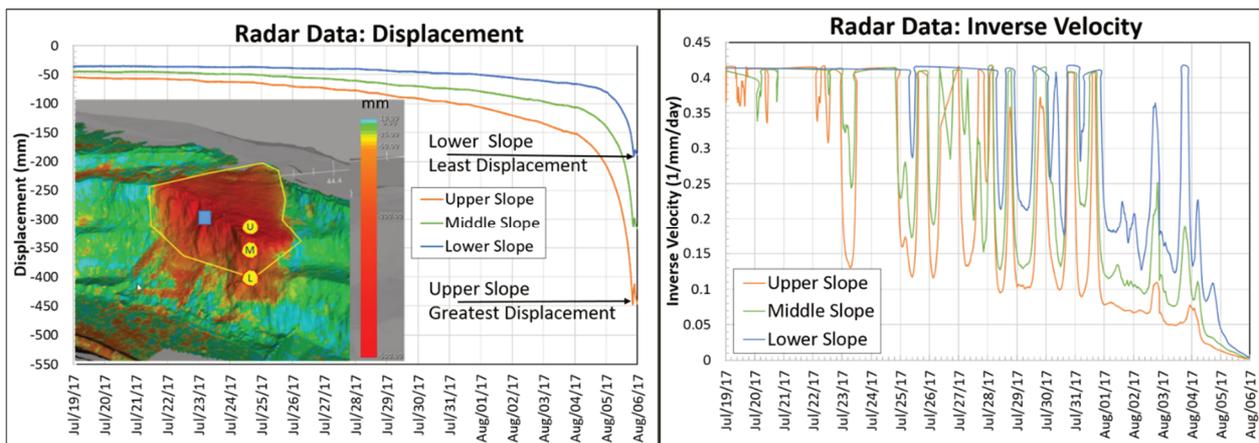
Figure 8 Displacement and inverse velocity plot

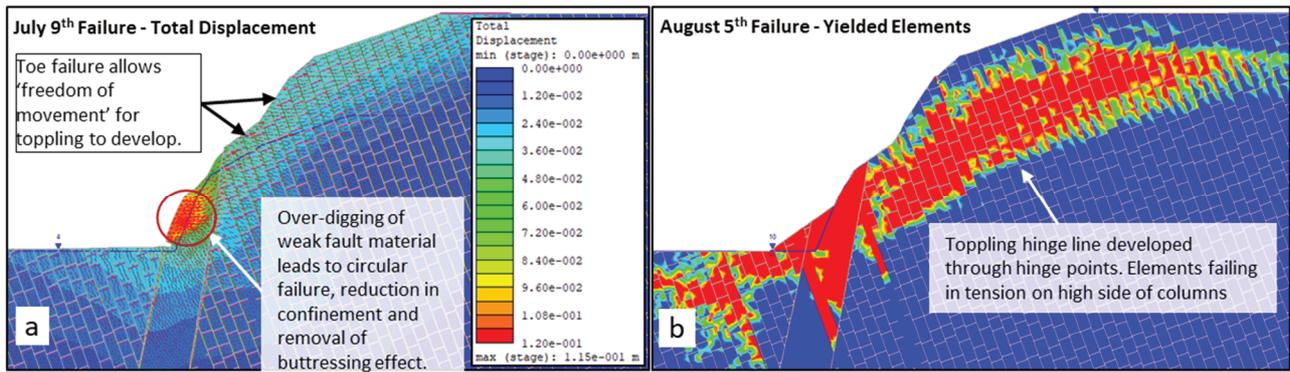
The model was calibrated through a back-analysis of the 9 July (initial) and the 5 August 2017 (second) failures. The results of the back-analysis are consistent with the interpreted failure sequence, suggesting that the initial failure initiated by over-digging of the weak inter-fault material at the toe of the slope resulting in a circular failure within this material. The subsequent loss of confinement at the toe allowed toppling movement of the steeply dipping bedding and leading to the development of the obsequent faulting along bedding planes visible in the slope crest. The shear strength reduction (SSR) method was used to estimate the strength reduction factor (SRF) following the 9 July and 5 August 2017 failures, and for the slope profile at the time of the study. Table 4 summarises the results of the SSR back-analysis shown in Figures 10(a) and 10(b).

Figure 10 Results of RS2 back-analysis showing (a) circular failure initiating toppling on 9 July 2017 failure; and (b) Subsequent deep hinge line development during 5 August 2017 failure

The results of the SSR analysis indicate that the naturally buttressed slope following ongoing raveling of material does not meet the design acceptance criteria (DAC) for the project. An SRF of 1.3 was targeted for design for re-entry below the unstable slope.

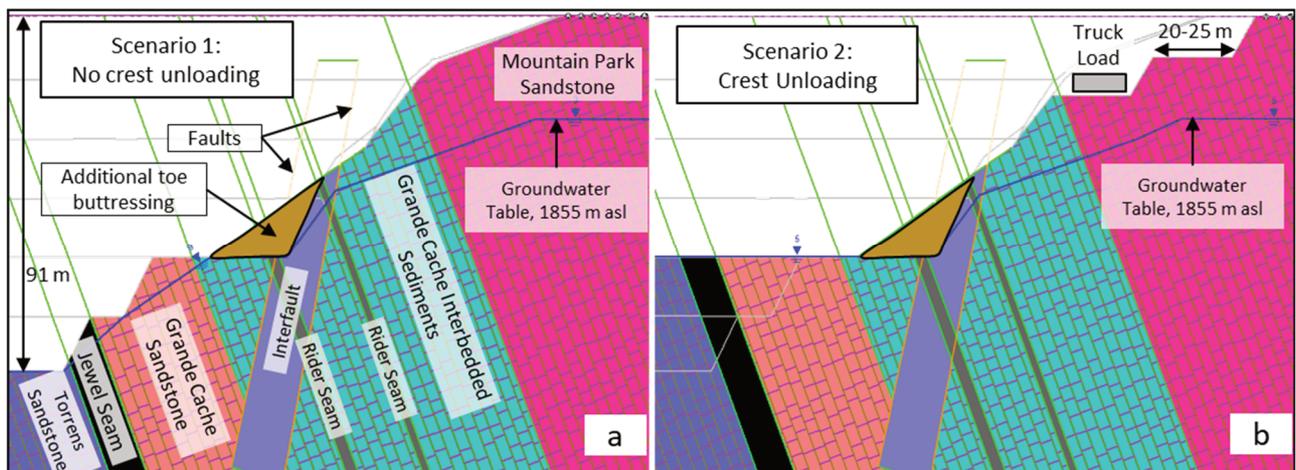
Figure 11 Modelled re-entry scenarios for (a) Scenario 1; and (b) Scenario 2

The modelling of Scenario 1 showed that continued mining to the final 1,790 m elevation could potentially re-initiate the toppling failure of the slope.

The modelling of Scenario 2 indicated that benching down through the failed material of the crest area, combined with removal of the toppling hazard, and development of a rockfall containment berm on 1,820 m platform would result in an overall slope meeting a DAC (SRF \geq 1.3) for mining to the 1,805 m elevation, and SRF of 1.1 during the final sub-out which would be completed using a retreat-mining method.

Re-entry Scenario 1 involves the construction of a rockfall deflection or containment berm at the toe of the failed slope, with no unloading of the crest area. An 8 m wide bench would separate the pit-side toe of the berm from the crest of the next bench. The east rockfall hazard and west toppling (mass runout) hazard would remain. A final 15 m high bench would be taken down to the 1,805 m elevation, followed by a sub-out of remaining coal in the final 1,805 m pit floor and down to approximately 1,790 m elevation during the sub-out retreat.

Re-entry Scenario 2 involves unloading of the crest by benching down through the failed material on two 10 m high, 20 m to 25 m wide benches. The objective would be to remove or force the failure of the west toppling hazard and to stabilise the slope by removing some of the failed crest. Following unloading, a rockfall containment berm would be constructed at the toe of the slope. An 8 m wide bench would separate the pit-side toe of the berm from the crest of the next bench. A final 15 m high bench would be taken down to 1805 m elevation, followed by a sub-out of remaining coal down to approximately 1,790 m elevation during the sub-out retreat.

Scenario 2 was selected based on the SSR analysis results. Subsequent analysis and design focussed on estimating the appropriate size and location of the rockfall deflection/containment berm to be constructed at the toe of the slope. For the west toppling hazard area, it was assumed that during benching down of the upper slope it was not possible to fully remove the toppling hazard, and the berm in the west area was designed accordingly and conservatively to accommodate a mass runout event.

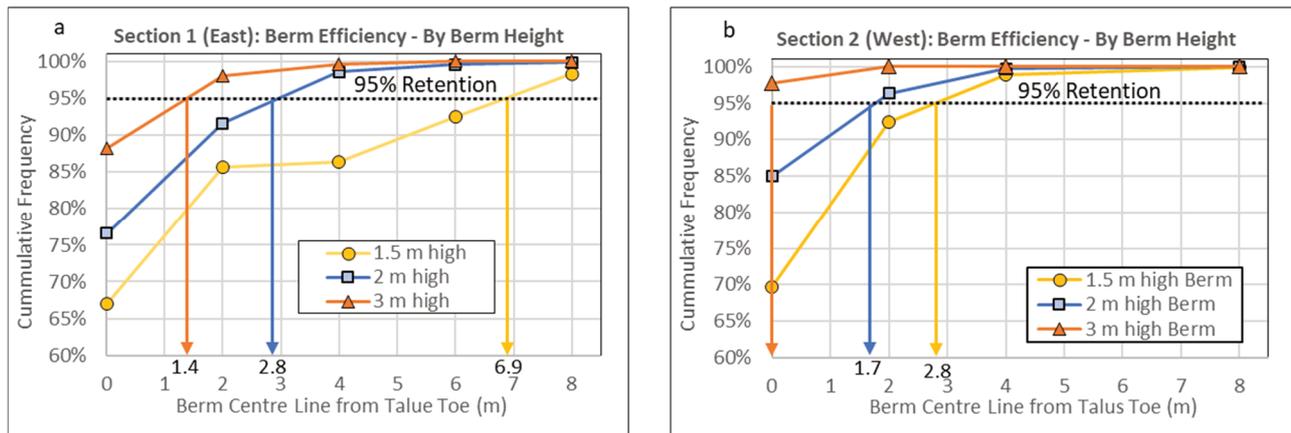
The calibrated model was used to assess the effectiveness of a rockfall containment berm at the toe of the slope to retain discrete rockfalls and travel distance from the slope. A target performance of 95% retention was set and three berm heights were evaluated: 1.5, 2, and 3 m high. The efficiency of each berm height was assessed to determine the optimum berm height and centre line location (offset from toe of slope) to achieve 95% retention, while minimising the berm footprint to optimise coal recovery. Figures 13(a) and 13(b) present the results of this analysis for the different berm heights. Berms placed further from the talus toe would require less material and time to construct but would encroach on the remaining coal resource; berms close to the toe would require more material and larger equipment to construct but would allow better access to the remaining coal.

Figure 13 Results of rockfall travel to optimise berm geometry for (a) East; and (b) West areas

The east rockfall hazard area was assessed using a rockfall analysis to provide guidance on potential berm sizing and location to achieve a target of 95% retention of the modelled runs, suggesting either a 2 m high berm at 4 m from the toe or a 3 m high berm at 3 m from the toe can achieve this.

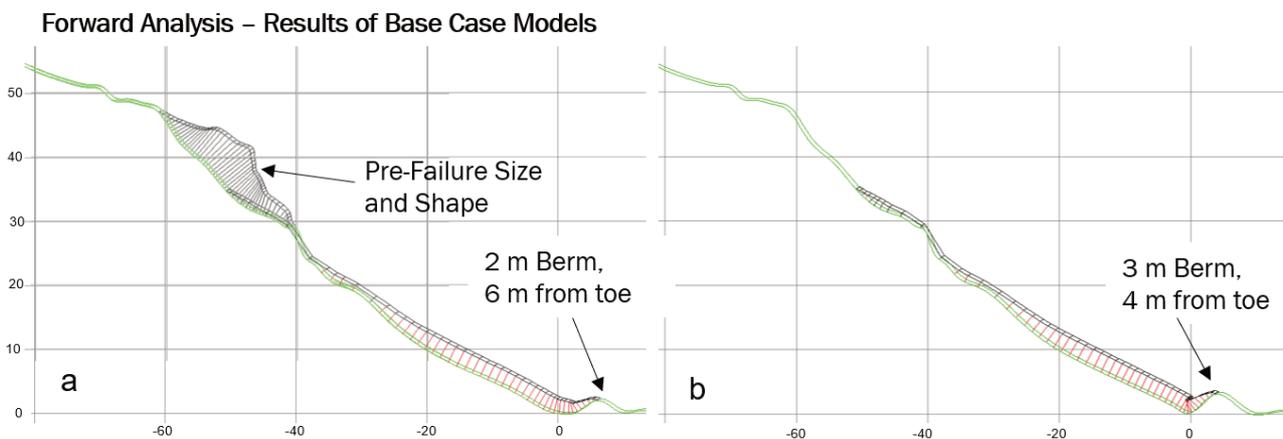
Following the back-analysis, a forward analysis was completed to evaluate the potential for a mass failure of the western toppling hazard to over-top a containment berm at the toe of the slope. The results from the analysis were used to develop effective berm size and placement. The analysis used available topographic surveys and aerial photographs to estimate a pre- and post-failure slope. The failed mass shape included a concave base and an inflection point. The inflection point allowed the failed mass to simulate the toppling motion as best as possible. Figure 15 presents the results of the two base cases.

Figure 15 Summary of forward analyses for base cases (a) 2 m berm; 6 m from toe; and (b) 3 m berm, 4 m from toe

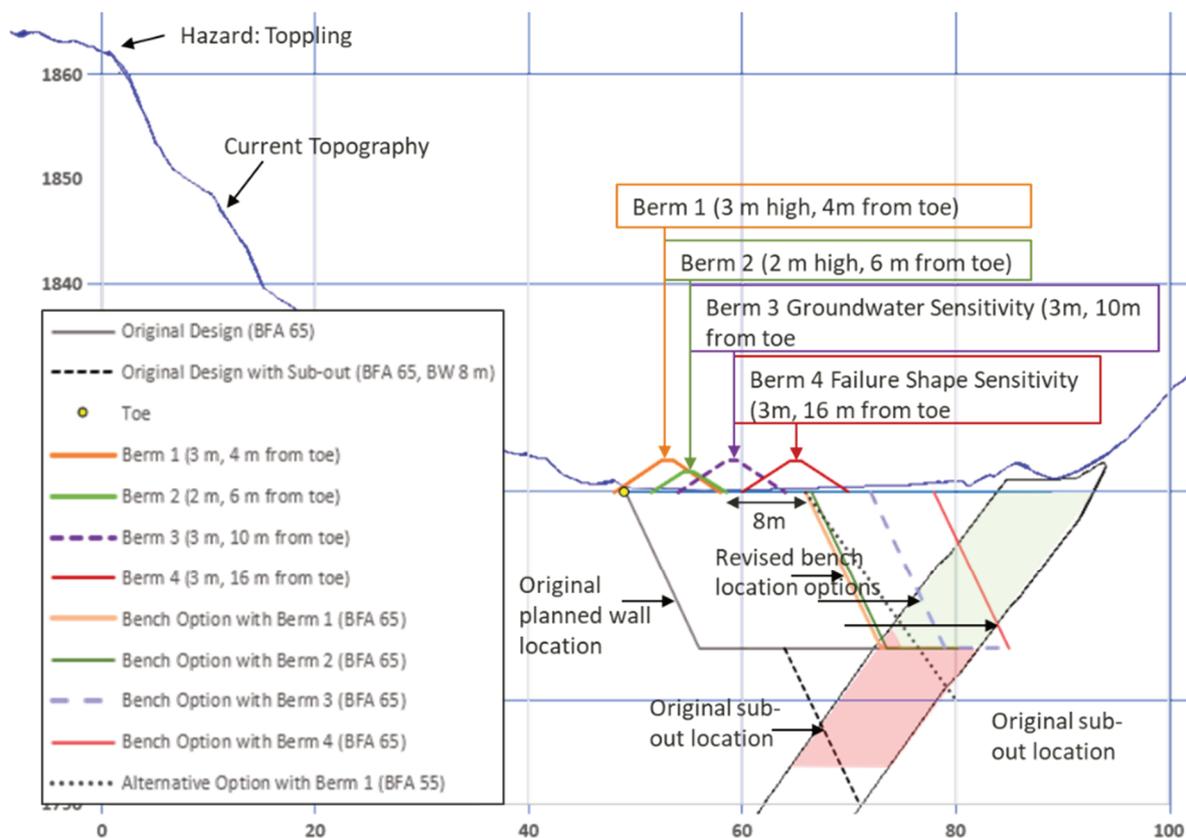
Figure 16 Options for debris runout berm geometry and location

The modelling results suggest that construction of a containment berm at the toe of the slope below the west toppling hazard would be effective for containing debris runout from a potential mass failure with either: a 2 m high berm at 6 m from the failure toe, or a 3 m high berm at 4 m from the toe. Groundwater and failure shape sensitivity cases suggested a 3 m berm at 10 m from the toe or a 3 m berm at 16 m from the toe, respectively, would be needed to contain the runout. Figure 16 illustrates these configurations.
