# Characterisation of a rock slope showing three weather-dominated failure modes

**Keywords:** rock slopes, failure modes, weather triggers, remote sensing, material susceptibility

### 1.1 Site C018

Site C018 is a 500 m long, 60 m high rock slope along a section of Highway 837 that parallels the Red Deer River at the base of the Red Deer Valley, as shown in Figure 1. This slope is predominantly in a weak, poorly

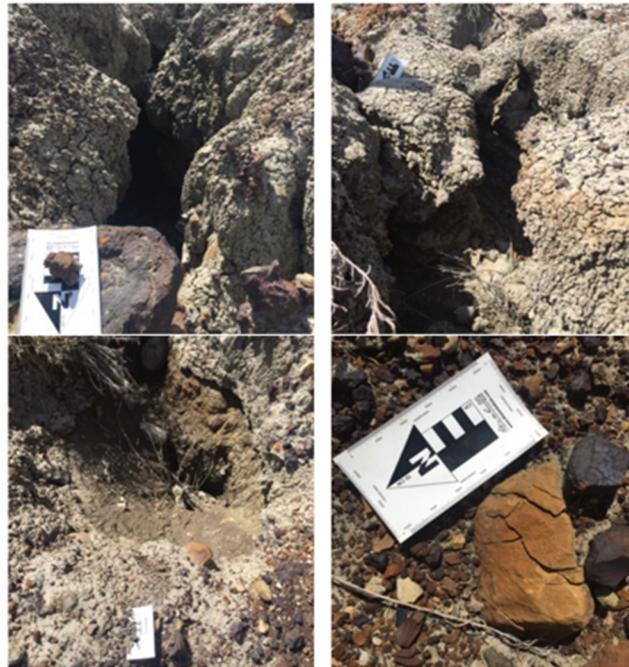
The slope at site C018 shows extensive signs of weathering processes including deep gullies, sinkholes, weak runoff marks, and pipe or tunnel erosion, as shown in Figure 2. It can also be observed that weathering processes are ubiquitous. Weathering of the exposed bedrock results in a soft soil-like material at surface with the bedrock structure almost eradicated. Discontinuous blocks of more indurated bedrock remain as less weathered cohesive blocks on the slope (Klohn Crippen Berger Ltd 2018).

**Figure 2** Wide and deep gullies, runoff marks and pronounced cracks in exposed rocks of the slope as a result of weathering processes

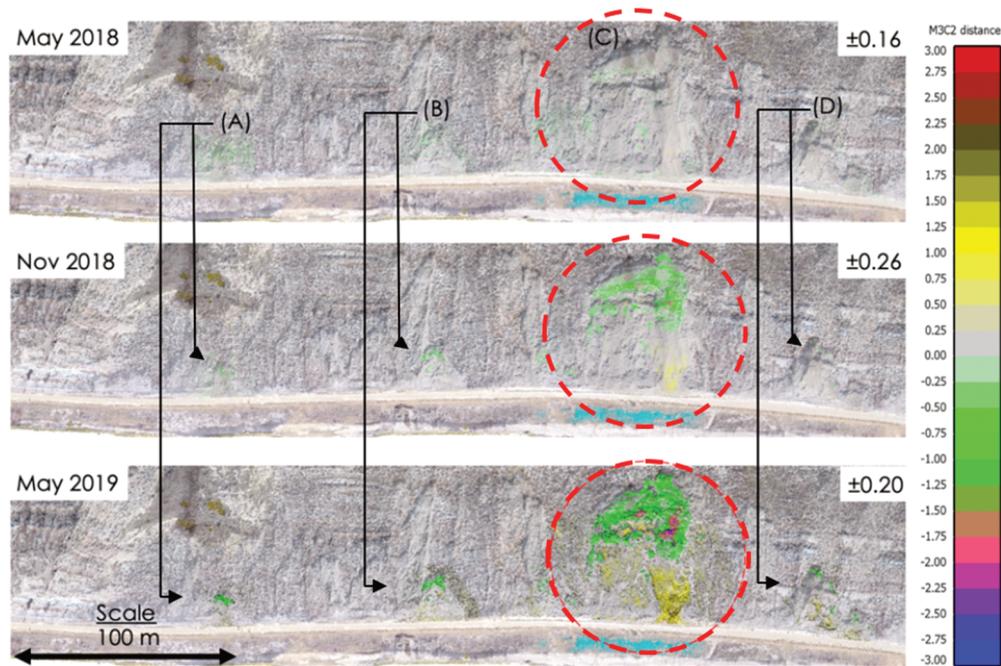
Remote sensing monitoring campaigns were initiated in December of 2017. These consisted of bi-annual Unmanned Aerial Vehicle (UAV) photogrammetry used to provide an enhanced perspective view of the rock slope and to calculate slope volumetric changes. The photogrammetry was obtained using a DJI Phantom 4 UAV with its ‘of-the-box’ camera (35 mm equivalent format lens, 12.4 megapixels), and the images were processed using the software Pix4D. Pix4D allows for exporting a point cloud of the photogrammetric surface model which is then imported into the software CloudCompare. CloudCompare is then used to calculate the changes in the slope surface through change detection techniques. In this study, the M3C2 method was used, which consists of comparing the normal distance between two point-clouds within a given sample area. Figure 3 shows the photogrammetry models of site C018 for May 2018, November 2018 and May 2019. The calculated change (material gain or loss perpendicular to the slope) is superimposed to the photographs (in metres) relative to the model for December 2017. Figure 3 includes the detection limits for the slope change calculations (in metres). The detection limit represents the minimum change that can be measured in a reliable manner. In this study, the detection limit was calculated as one standard deviation of the changes calculated at areas that did not present visual changes (mean change of zero). Figure 3 identifies four active zones within the rock slope at site C018 between December 2017 and May 2019. Zones C has presented the most activity, with material losses between 1 and 2 m. Zones A, B and D showed smaller areal extents of

Closer examination of the modes of failure attributed to the changes detected in Figure 3 corroborated that failure modes included earth flows of highly weathered material and the development of overhangs that would promote the detachment of blocks from the slope (Figure 4).

Figure 3 Photogrammetry models of site C018 for May 2018, November 2018 and May 2019. The calculated change (material gain or loss perpendicular to the slope) is superimposed to the photographs (in metres) relative to the model for December 2017. Upper right corner includes the change detection limits in metres for each model. Largest change is indicated in red circles

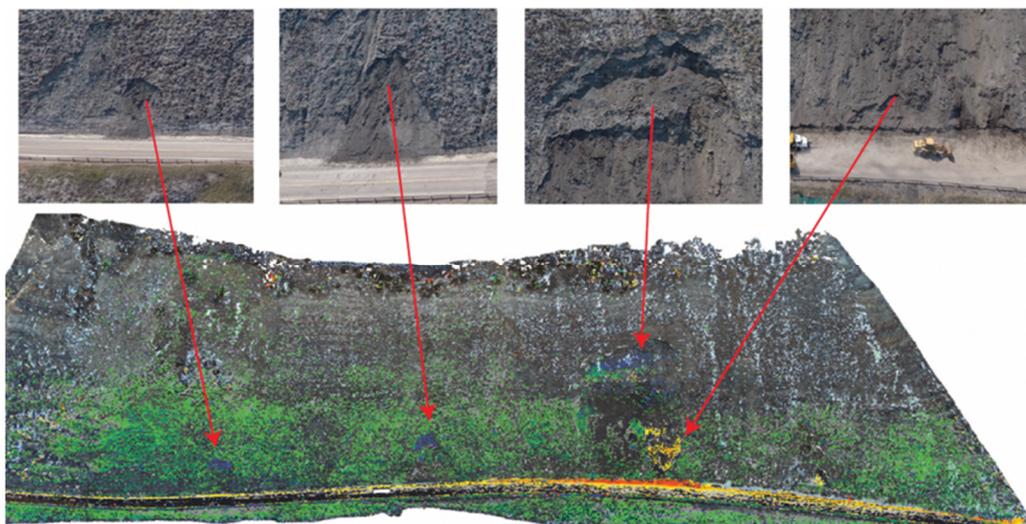
Figure 4 Change detection (photogrammetry-based) between December 2017 and May 2018, and photographs of the active areas highlighting earth flows and the development of overhangs of stronger rock

The presence of weak, poorly indurated sedimentary rock with layers of stronger sandstone, siltstone, and coal sets the stage for differential weathering of these layers. Progressive mass wasting and earthflow events would undermine stronger rock layers (Figure 4, centre right). Continuous weathering of these blocks and loss of support would lead to block detachments and subsequent rockfall occurrences (Second mode of failure).

The presence of weak, poorly indurated sedimentary rock with layers of stronger sandstone, siltstone, and coal sets the stage for differential weathering of these layers. The different degree of susceptibility of the various bedrock facies in this slope to moisture content, wetting-drying and freeze-thaw cycles results in differential weathering rates. Some bedrock layers weather faster than others, which increases the potential for stronger layers of bedrock to be undermined. This increases the likelihood of rockfalls and slides of intact bedrock blocks (second mode of failure). This phenomenon has been observed in some locations of the slope as shown in Figure 4.

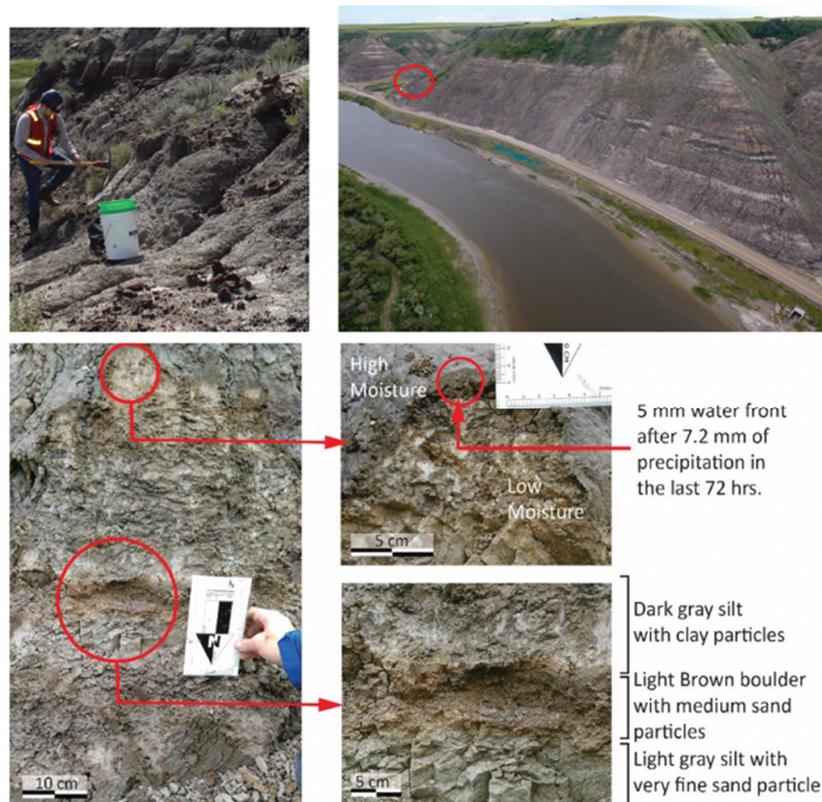
Three rock samples were collected from different rock layers during a site visit in November 2018 (Figure 5). The samples were obtained near the base of the slope and consisted of fine sandstone and siltstones with different levels of cementation and fines content.

Figure 5 Views of location where samples were collected from different rock materials. The figure shows surface moisture after precipitation event

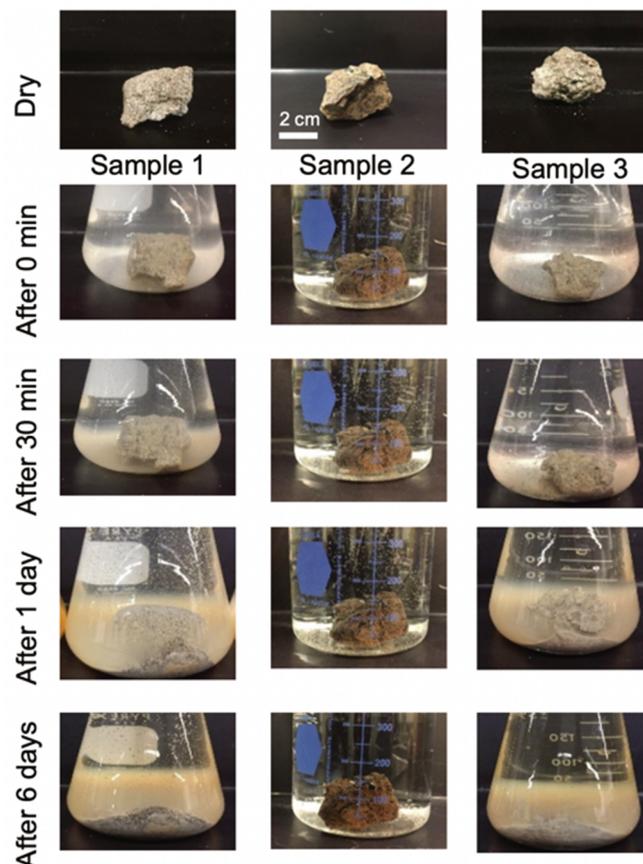
Water reaction tests were performed on three samples to observe the degradation of the material after being submerged on water for up to six days. This process resulted in a deterioration of the structure of the material. Figure 6 shows the sequential process of these samples reacting to water immersion at 0 and 30 minutes, one day and six days. Samples 1 and 3 appeared to be disaggregating after 1 day, while Sample 2 showed more resistance. It was noticed that at six days samples 1 and 3 completely lost any sign of their initial structure. Sample 3 showed the most swelling potential, before disaggregating completely. This suggests that the clay fraction for this specimen dominates in its behaviour.

Figure 6 Water reaction results after six days

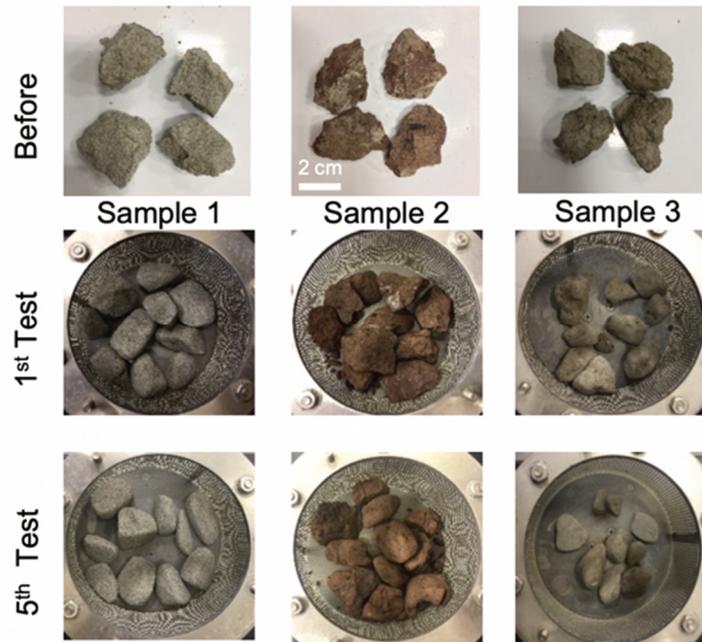
Figure 7 shows the changes in the profiles of samples after five slaking cycles. It can be seen that Samples 1 and 3 have more slaking potential and significantly deteriorated more during the test, in comparison to Sample 2. The slaking durability indexes of these three rock samples were calculated through equation 1 after each test and the results were plotted versus the number of slaking cycles in Figure 8(a). This figure shows the slaking indexes of Samples 1 and 3 decreased significantly during the cycle while Sample 2 was more resistant. The reductions of these indexes are 7%, 40% and 47% for Samples 2, 1, and 3 respectively.

Figure 7 Slaking durability results after five cycles

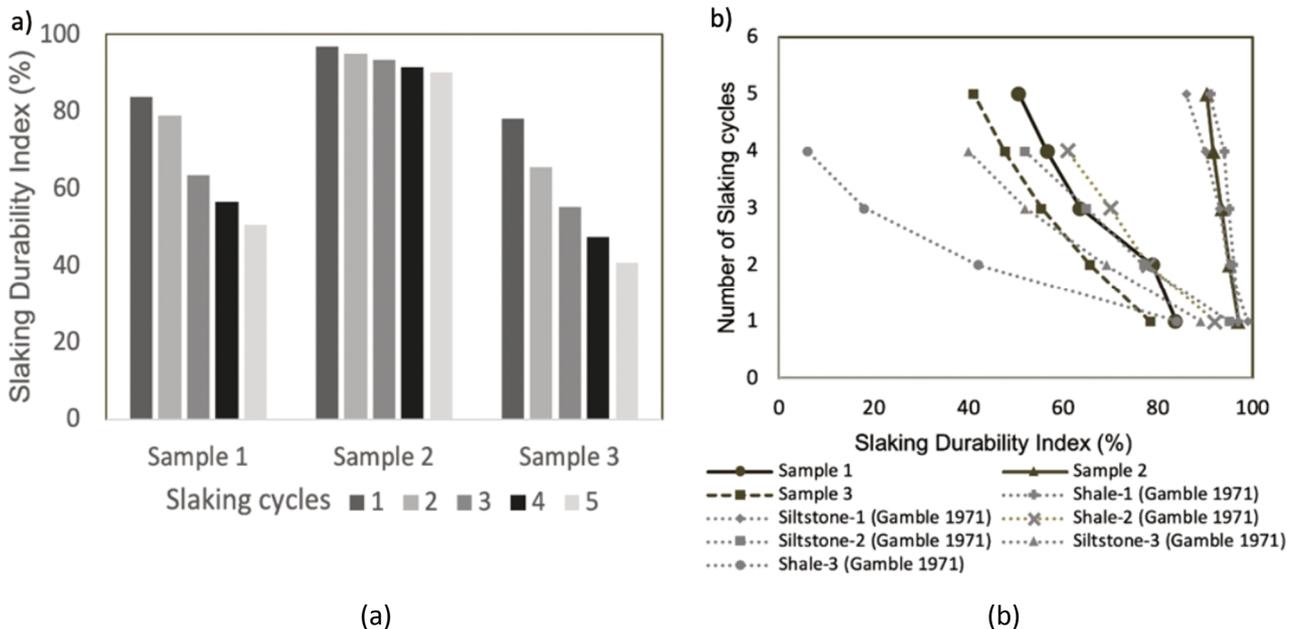
Results were also compared against the findings by Gamble (1971), which provide insights into the material behaviour class according its slaking durability index (Figure 8b).

Figure 8 (a) Slaking durability indexes after five cycles and (b) Slaking durability indexes and rock types

This classification has six classes of durability: very high (100–98%), high (98–95%), medium high (95–85%), medium (85–60%), low (60–30%), and very low (30–0%). Moreover, Masada and Han (2013), McGlade et al. (1982) and Underwood (1967) found that ranges of this index could be correlated with the behaviour of siltstones (65–90%), shales (20–90%) and claystones (0–60%). According to these studies and observations of the tested materials, Sample 1 behaves as a weak sandstone, Sample 2 as a hard shale or siltstone, and Sample 3 as a weak dispersive siltstone or claystone.

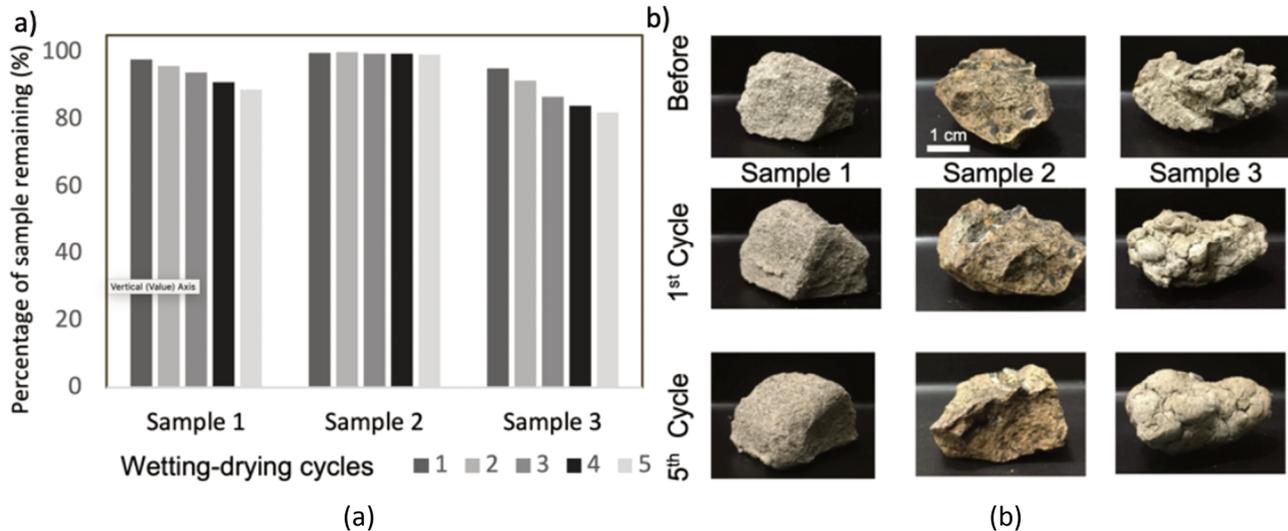
Figure 9(a) shows sample material loss after each wetting-drying cycle. This figure shows that Samples 1 and 3 have faster rates of breakdown than Sample 1. The percentage of the weight of the sample remaining compared to the original weight is also plotted versus the number of cycles in Figure 9(b).

Figure 9 (a) Percentage of material weight after five wetting-drying cycles and (b) visual aspect of samples for the three materials tested

These results showed that just five wetting-drying cycles can disaggregate 11% and 18% of Samples 1 and 3, respectively. Only 1% is loss for Sample 2 under the same conditions. Figure 10 shows the water evaporation indexes after each wetting-drying cycle. The water evaporation index of Sample 3 increases significantly with number of cycles when compared to Samples 1 and 2. This increasing trend is associated with an increase in the number and size of pores and microfissures (Diop et al. 2008). This suggests that materials represented by Sample 3 exhibit higher swelling behaviour than other materials in the slope.

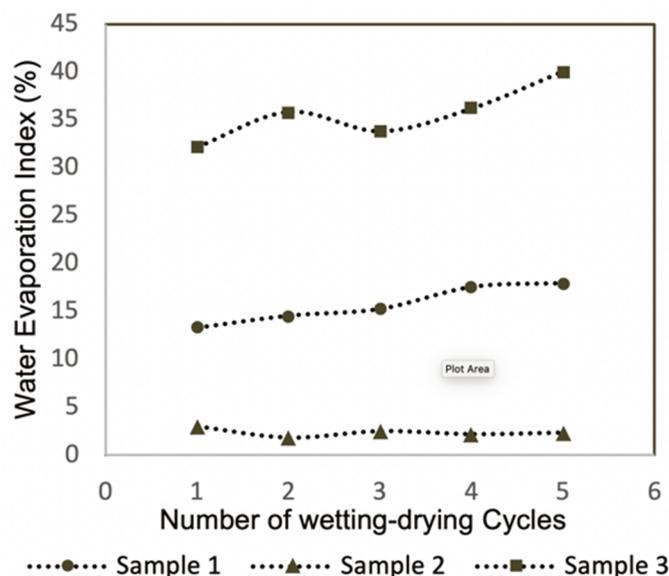
Figure 10 Water evaporation indexes of the rock samples after five wetting-drying cycles

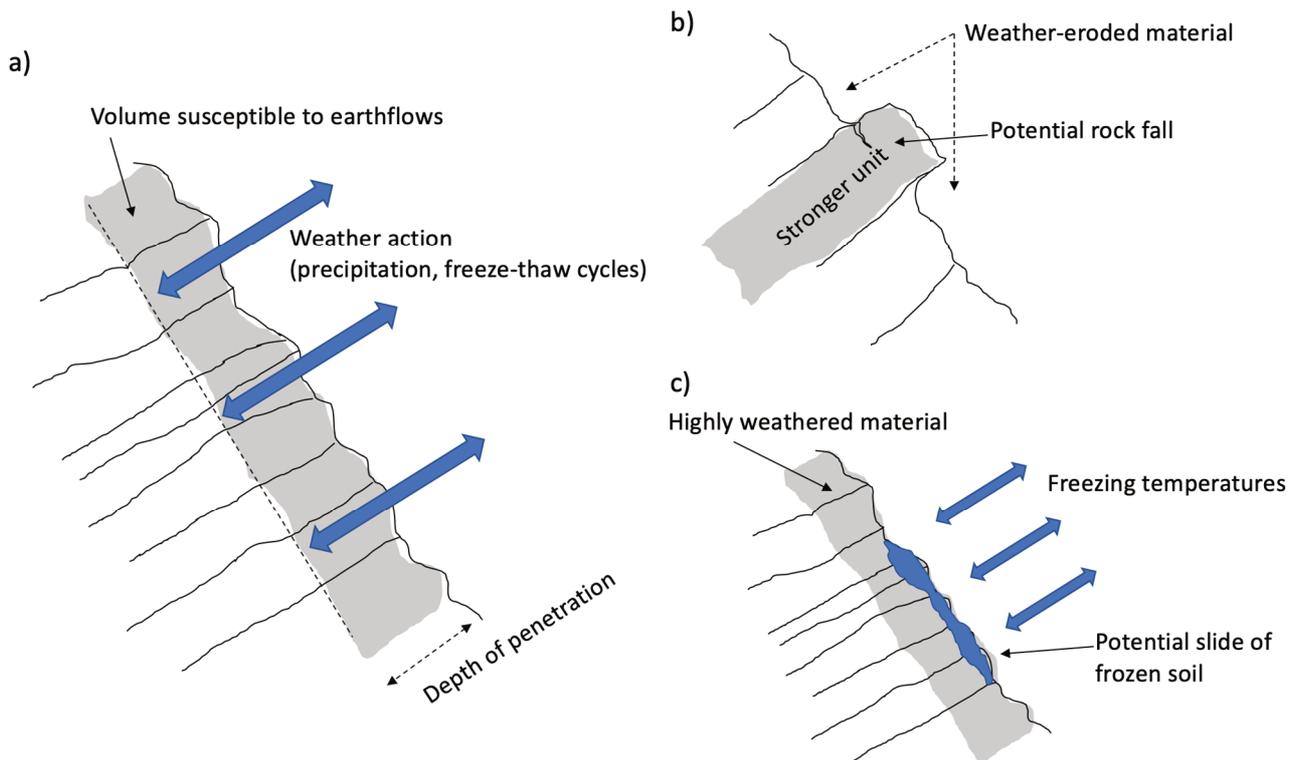
Site C018, a 500 m long, 60 m high rock slope along a section of highway, displays extensive signs of multiple weathering processes that result in near eradication of the exposed bedrock structure and produce a soft soil-like material. Discontinuous blocks of more indurated bedrock remain as less weathered blocks on the slope. This site has shown a long history of instabilities, mostly associated with moisture conditions of the near-surface slope materials (moisture content and liquid/solid state). The observed failure modes include 1) earthflows associated with heavy rainfall; 2) rockfalls that result from differential weathering rates and undermining of various rock units, and; 3) slides of frozen slabs of highly weathered rock. These are schematically illustrated in Figure 11 and discussed in more detail.

**Figure 11** Modes of failure identified at the site, and their development mechanisms for (a) earthflows, (b) rockfalls, and (c) slides of frozen slabs
