Monitoring and managing large deformation pit slope instabilities at a British Columbia copper mine

Abstract

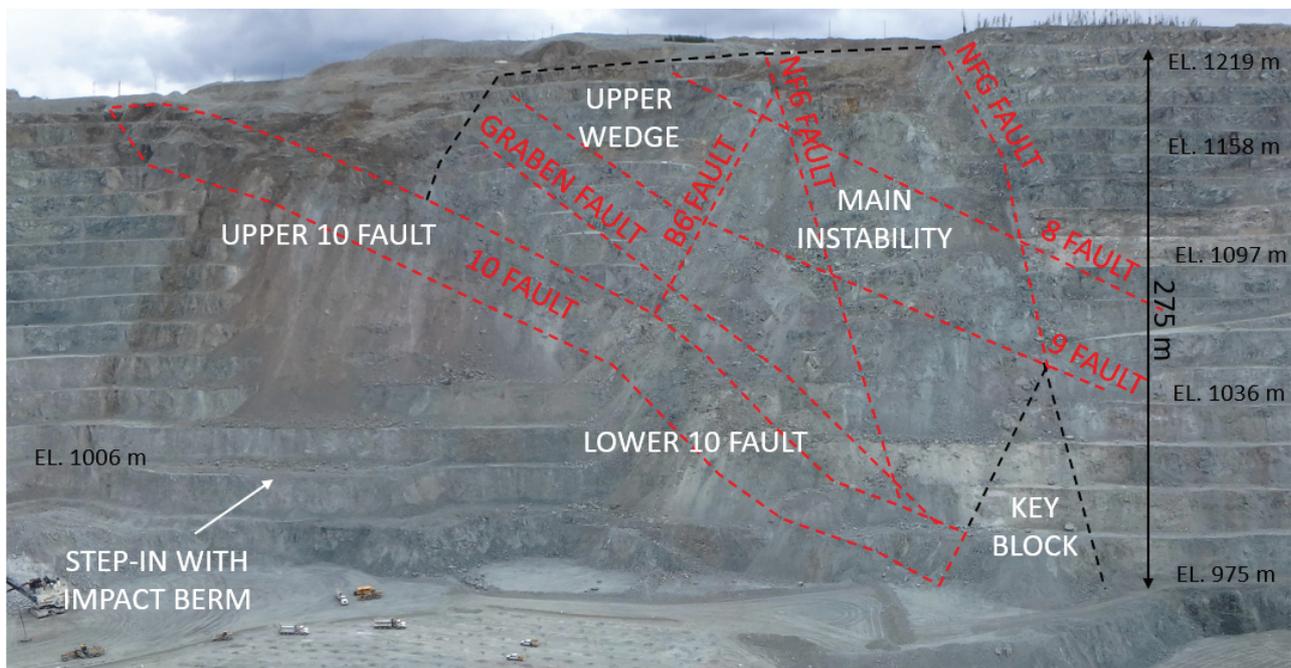
Figure 2 View of Southwest Wall instability and defined instability zones on May 11, 2017

- The Main Instability Zone is also associated with high deformation rates, with toppling occurring on 8 Fault, 9 Fault and Graben Fault in the mid-portion of the slope and a non-daylighting wedge formed by the NF6 and NFG faults in the upper portion of the slope. The NFG Fault appears to be truncated by 9 Fault, and, as a result, the movement associated with the wedge does not extend to the toe of the slope.

- The Upper Wedge Zone is relatively stable and bounded by 10 Fault and B6 Fault.
- The Key Block Zone is defined by the rock mass between the lower extent of the NFG Fault and 10 Fault, leaving a block of relatively 'stable' rock in the toe of the instability. The western extent of the Key Block zone (i.e. the right side on Figure 4) is not defined by a sharp contrast in deformation, suggesting that side of the failure is not fault controlled.

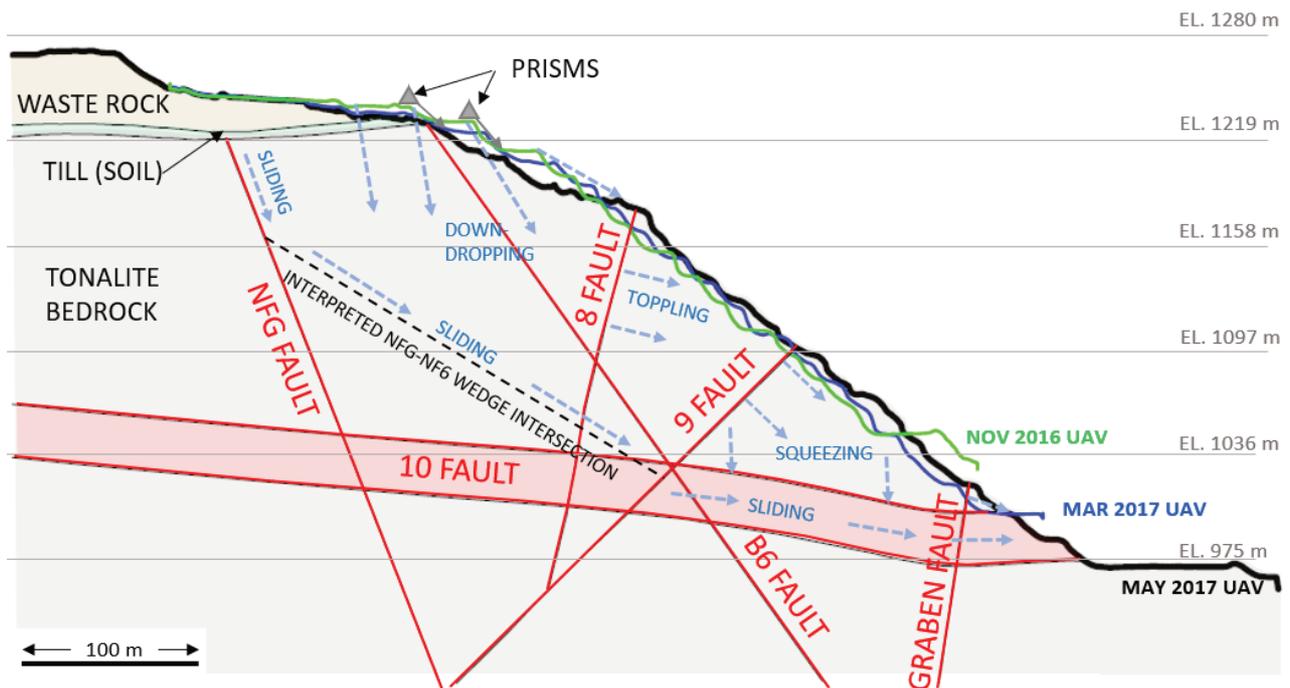
The failure mechanism of the Phase 5 Southwest Wall instability is still not fully understood; however, it has been interpreted to be a complex toppling instability due to the presence of at least three major faults dipping steeply into and striking subparallel to the pit slope. A non-daylighting wedge created by the NFG Fault (which was not recognised during Phase 4 mining) and NF6 Fault allowed mobilisation of the upper slope, while limiting the extent of failure retrogression behind the slope crest. Toppling along 8 Fault caused increased displacement and down-dropping of the upper slope. The highly disturbed rock mass within the 10 Fault zone experienced squeezing and shearing, possibly providing a basal shear plane for the toppling instability.

Figure 3 Cross-section through the Main Instability and Lower 10 Fault Zones illustrating the interpreted failure mechanism

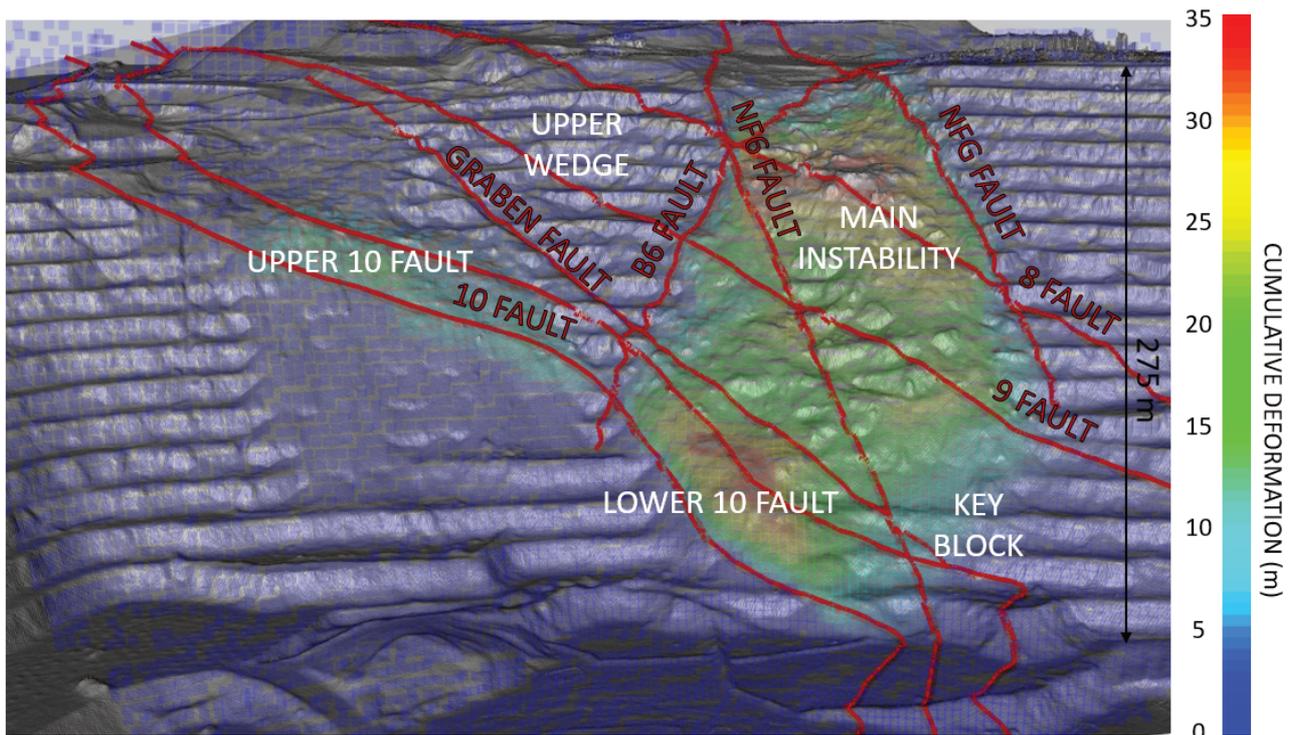
- The Upper and Lower 10 Fault Zones are soft and continuously deform (squeeze), resulting in filled benches and rockfall hazards. These zones are highly sensitive to mining at the toe of the slope.

Figure 4 Slope stability radar cumulative deformation measurements between March 15 and May 11, 2017, overlain on the May 1, 2019 DTM with geological faults

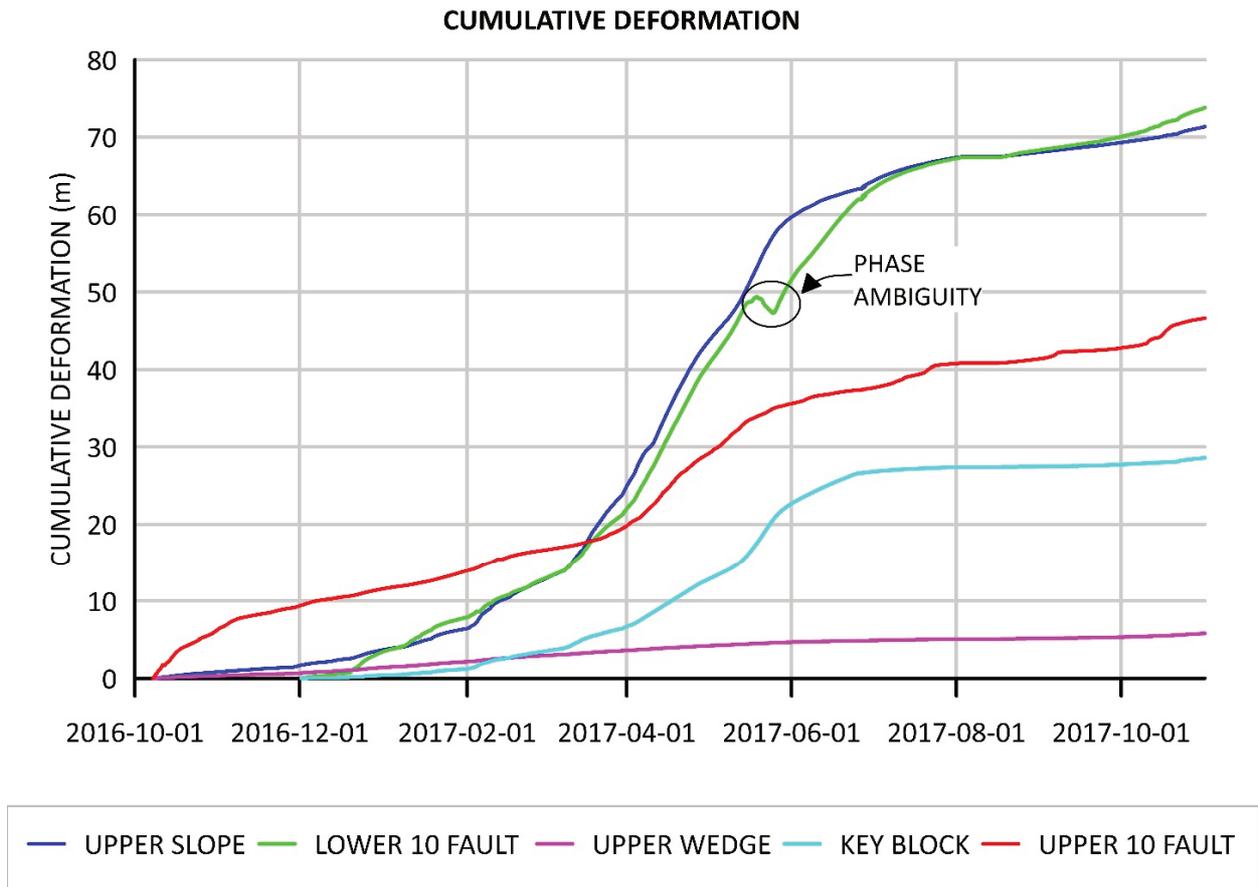
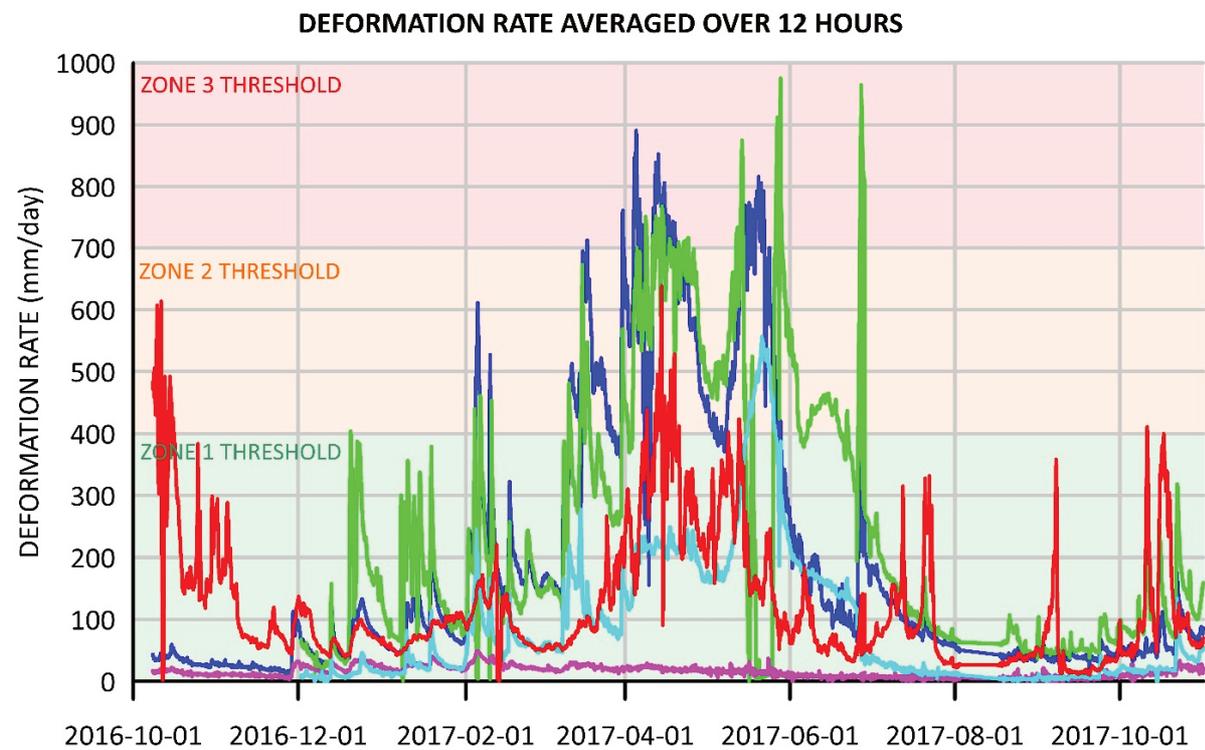
Figure 5 Slope stability radar cumulative deformation and deformation rate trends for the five monitoring areas between October 7, 2016 and November 1, 2017

- Accelerating displacement of the Main Instability (Upper Slope) commenced at the beginning of December 2016 while the Lower 10 Fault acceleration began approximately three weeks later.

- An increase in acceleration trends of the Main Instability commenced early February 2017. The Key Block deformation rates remained relatively low but constant until February 2017, when an acceleration trend began to develop.

- The largest deformations occurred at the onset of mining the El. 991 m and the El. 975 m benches in March and April 2017 as 10 Fault became more exposed on the pit wall.

- The instability was strongly reactive to mining events (blasting and digging at the toe).
- The slope displaced enough between sequential radar scans on May 20, 2017, that a radar phase ambiguity occurred in the Lower 10 Fault Zone.

- The Key Block was an important component of the instability, providing a buttressing effect and limiting the potential for catastrophic failure, despite total deformations of over 25 m in this portion of the slope.

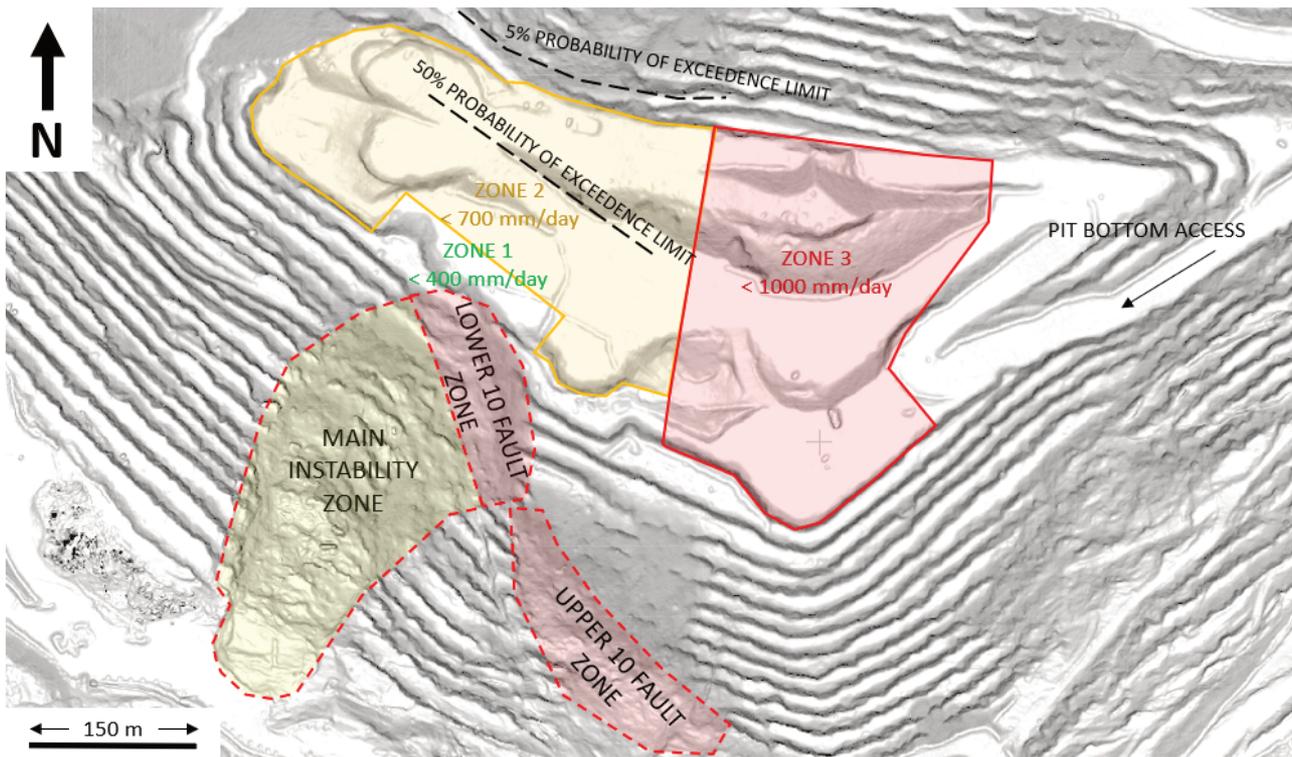
- Zone 1 is at the toe of the instability within the area for potential rockfall. Mining operations in Zone 1 are permitted if the displacement rates are below 400 mm/day.
- Zone 2 is within the interpreted runout area of the instability. Mining operations in Zone 2 are permitted if the displacement rates are below 700 mm/day.
- Zone 3 is outside the interpreted runout area of the instability. Mining operations in Zone 3 are permitted if the displacement rates are below 1,000 mm/day. Zone 3 was located outside the interpreted runout zone but includes an area requiring access for pit dewatering.

Figure 7 Granite Pit safe operating areas and estimated runout limits overlain on the May 1, 2017 unmanned aerial vehicle digital terrain model

The potential runout distance for the Main Instability Zone was estimated using the methodology proposed by Whittall et al. (2016). The estimated runout angles for a 50% and 5% probably of exceedance was found to be 28° and 21°, which corresponds to a runout length of approximately 180 m and 270 m from the toe of the slope, respectively. The estimated runout limits are shown in Figure 7.

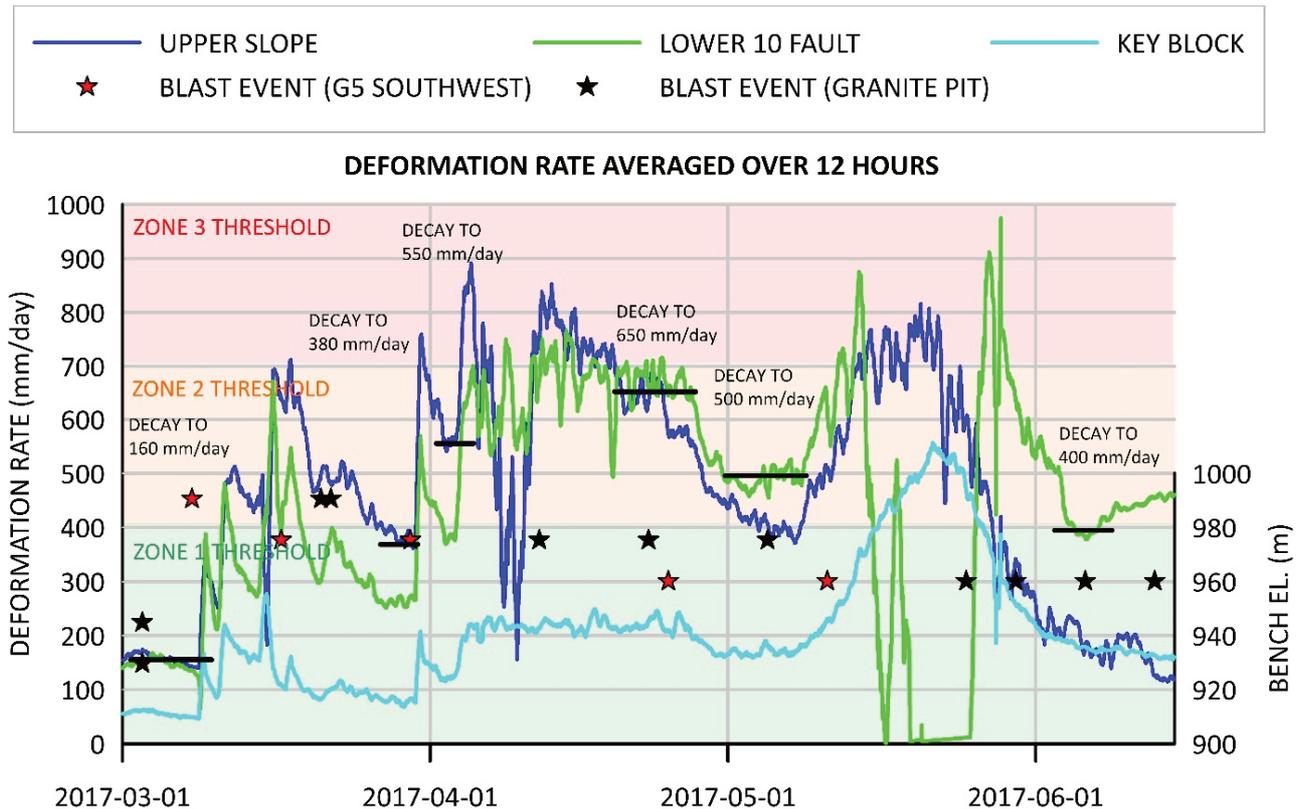
Figure 8 shows the deformation rate trends for the most active period of the instability, between March 1, 2017 and June 15, 2017. As mining at the toe of the El. 975 m bench and exposure of 10 Fault progressed, so did the time it takes for the deformation rates to decay below the safe operating thresholds following mine events.

Figure 8 Slope stability radar deformation rate trends between March 1, 2017 and June 15, 2017

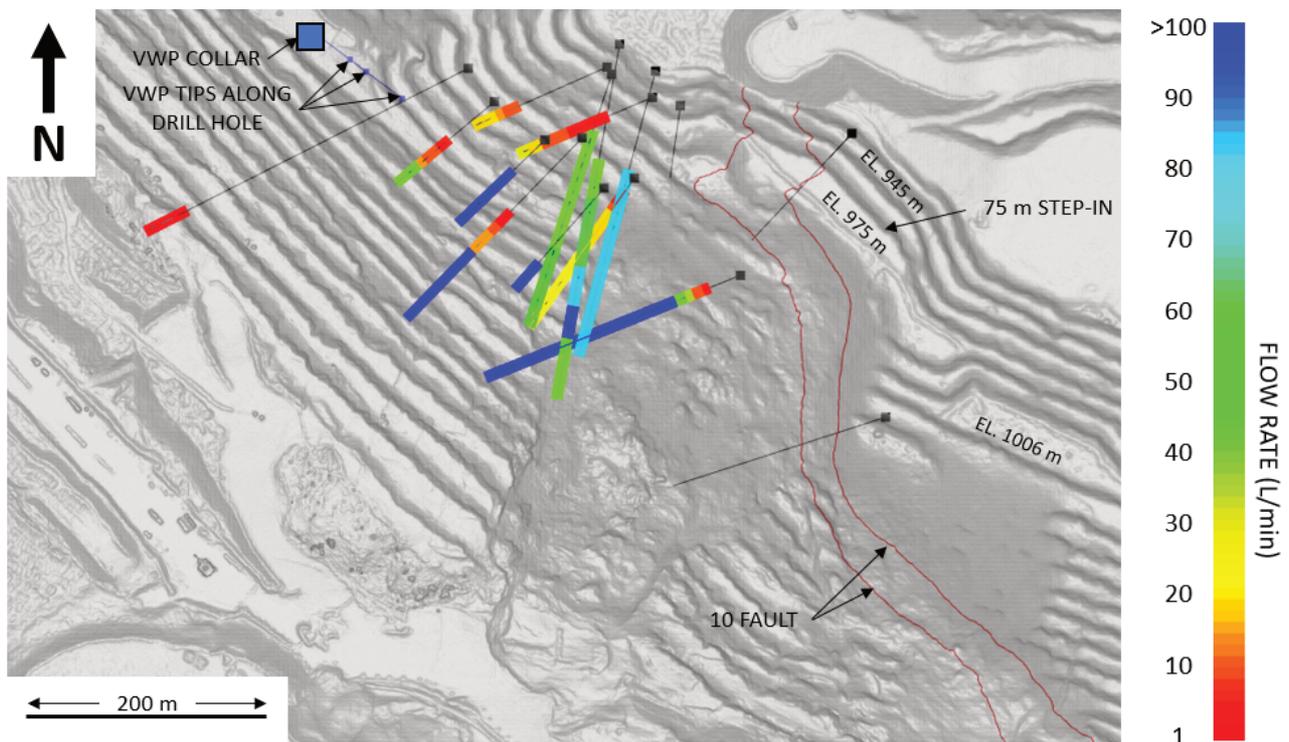
faults act as barriers. Eleven (11) of the HDHs produced water, with a maximum observed flow rate of 1,200 L/min when the interpreted 8 Fault boundary was intersected.

Figure 9 Horizontal drain holes locations and observed flow rates along the drillhole trace overlain on the December 1, 2017 unmanned aerial vehicle digital terrain model

Sixteen (16) HDHs were drilled into the Southwest Wall in 2017 between the El. 1021 m (drilled in January 2017) and El. 945 m (drilled in August and September 2017) benches with lengths varying between 100 m and 300 m. HDHs were implemented as historical VWP data in the Southwest Wall showed only a limited amount of passive depressurisation of the slope due to mining. The HDH traces and observed flow rates along the drillhole are shown in Figure 9. The main targets for HDHs were major geological structures (i.e. faults) as they have typically acted as groundwater water barriers. Increases in HDH groundwater flow rates were observed at the projected interpretations of 8 Fault, 9 Fault, and NF6 Fault boundaries confirming that these

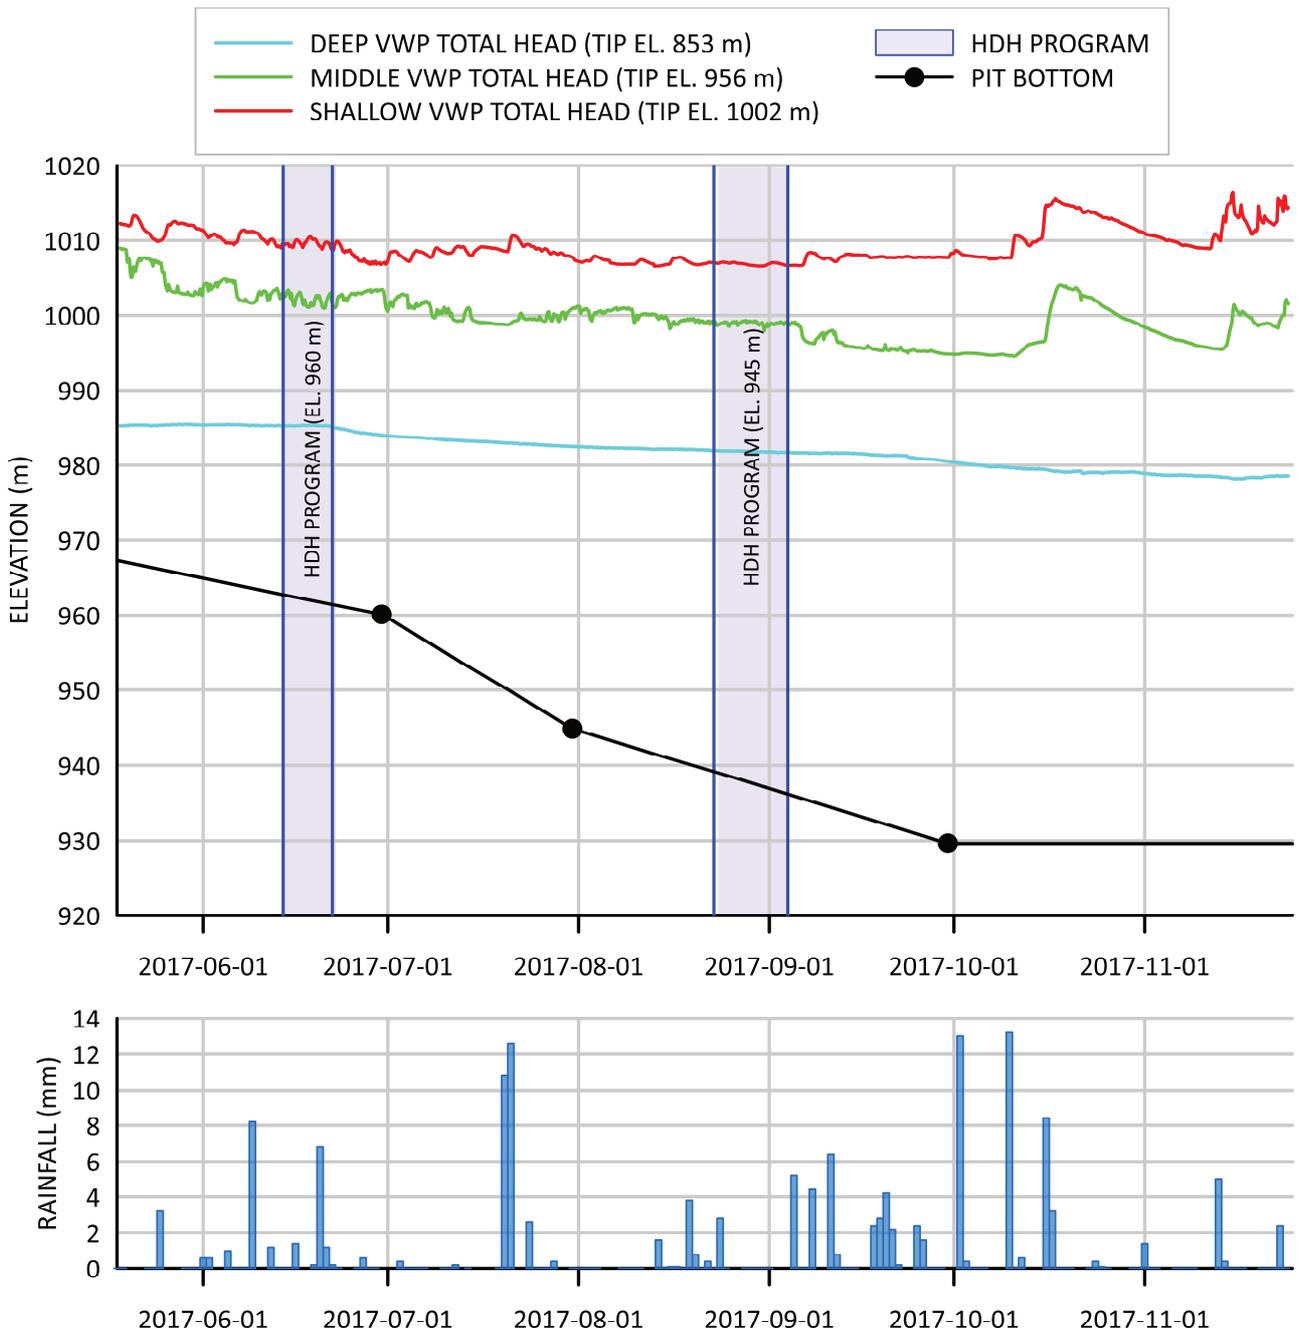
A nest of three VWPs was installed in May 2017, as shown in Figure 9. Figure 10 shows the hydrographs for the three VWPs with the timing of the HDH drilling program. The middle and deep VWP show an overall decrease in hydraulic head, possibly affected by the HDHs but more likely due to passive drainage associated with mining as the distance from the drain holes to the piezometers was high. An increase in hydraulic head was observed in the middle and shallow VWPs mid-October 2017, considered likely in response to rainfall events. The deep VWP was installed below 10 Fault and does not show a similar response as the middle and upper VWPs. Groundwater seepage has been observed in the pit walls below the footwall of 10 Fault, providing further evidence that 10 Fault is a boundary between groundwater regimes.

Figure 10 Hydrograph and rainfall measurements for the nested vibrating wire piezometers in the Southwest Wall
