# Modelled versus observed open cut performance in weak transition rock: the Dubbo Quarry case study

**D Trani** *GHD Pty Ltd and University of Wollongong, Australia*

## Abstract

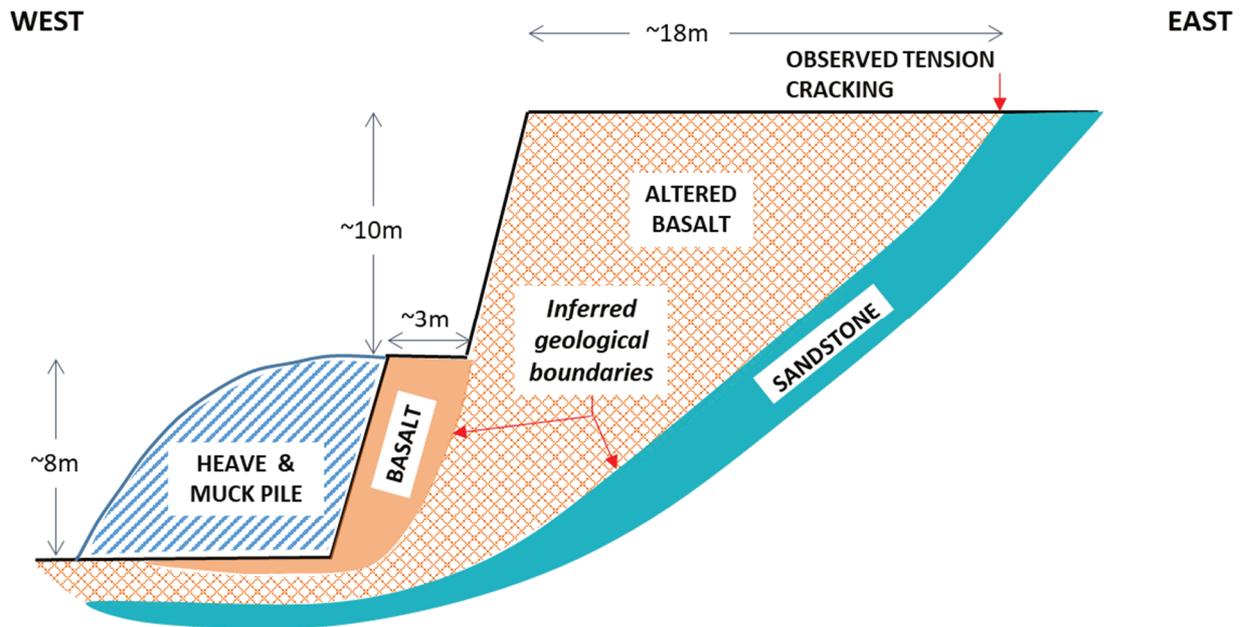
The current eastern highwall of the quarry has been developed over two benches. The first bench was approximately 8–12 m in height and was blasted and mined in two production shots; first the northern half and then the southern half. The second bench (approximately 8 m in height) was then blasted with a 3–5 m wide berm. This second bench was blasted in a single production shot and mining began at the southern end. This second bench is expected to be the final cut along this eastern highwall. A sketch of the generalised geological section of the exposed cutting on the eastern side of the quarry is presented in Figure 2.

Figure 2 Generalised geological cross-section of the exposed cutting on the eastern side of the quarry

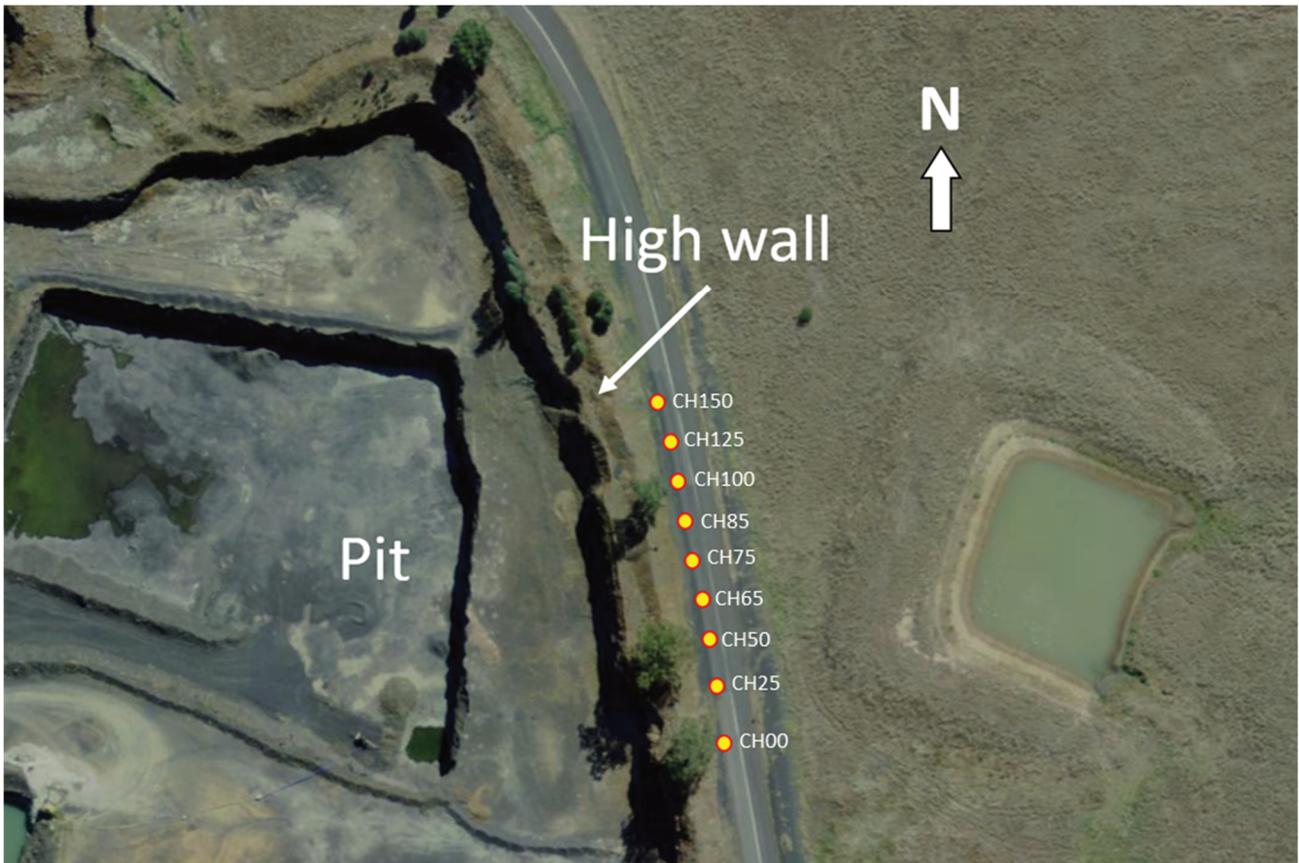
Nine prisms and three backsights were set up at intervals along the line of cracking, which was supposed to be the back scarp of a potential failure. The general location of the prism monitoring set-up is shown in Figure 3. These prisms were monitored at regular intervals, initially fortnightly then increasing to twice weekly over the course of three months. The prism data were plotted on graphs which showed the changeover time in recorded Easting, Northing and Height above a reference level. The change in these fixed points was interpreted to represent movement of the prism in three-dimensional space. Trends associated with these changes were used to infer development of a highwall failure. Trigger levels for change per measurement in Easting, Northing and Level were also set, so that significant movements could be flagged for attention.

Figure 3 Prism monitoring set-up (approximate) shown on an aerial view of the highwall pre-failure

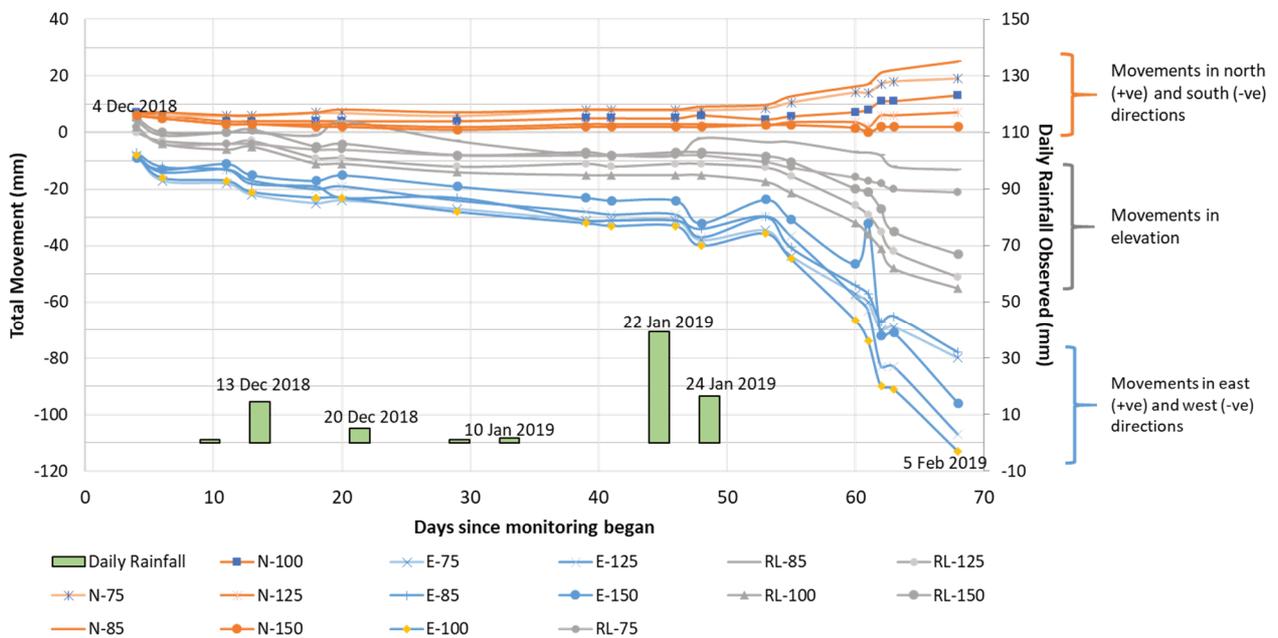
During the course of the monitoring, a trend of movement to the west was noted for five of the nine prisms, with an acceleration in movement during the fortnight before the failure occurred. A smaller magnitude of movement was also noted towards the south and downwards for these prisms. This provided information regarding both the increasing likelihood of failure, as well as the mode of failure. The recorded total movements from some select prisms are presented in Figure 4.

Figure 4 Movements as recorded from the installed prisms over time (N = northing, RL = reduced level, E = easting, ## = chainage as represented in Figure 3)

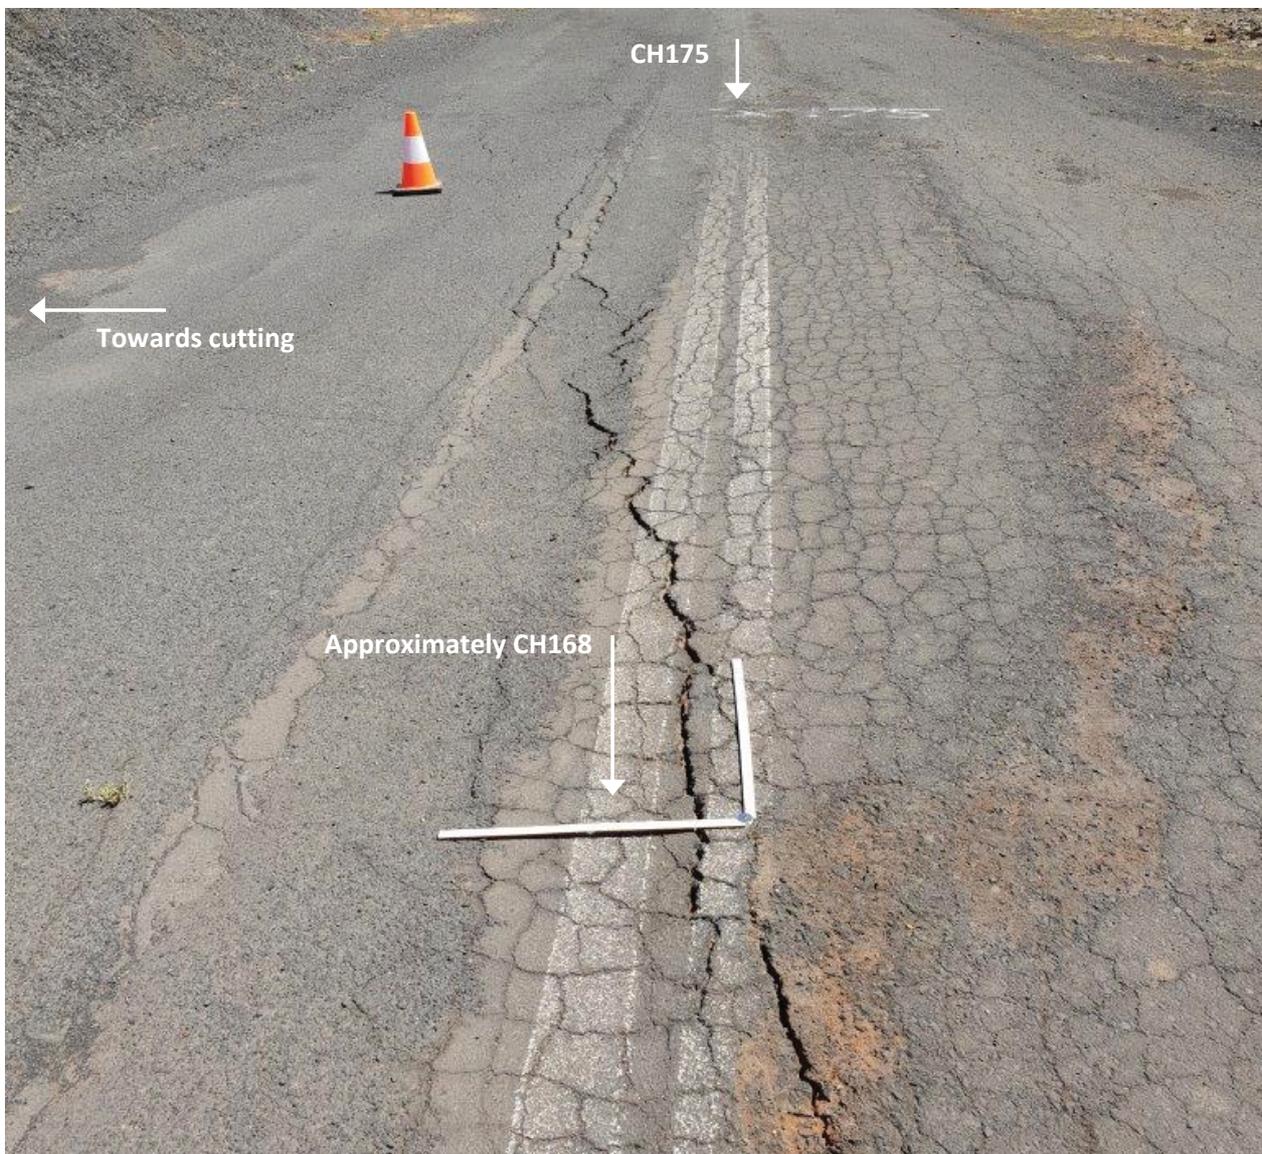
- At approx. chainage 100 m, cracking was observed to be up to 20 mm wide and up to 300 mm deep. Wash out of the edge of the crack was observed, due to recent rainfall. Cracking extended into a nearby windrow.
- At approx. chainage 150 m, cracking was observed to be up to 30 mm wide and up to 600 mm deep.
- At approx. chainage 168 m, cracking was observed to be up to 15 mm wide and up to 50 mm deep.
- At approx. chainage 50 to 75 m, cracking appeared to be finer. This was corroborated by prism monitoring which shows relatively minimal movement in these prisms.

The cracks were generally observed to be between 5 to 18 m behind the crest of the east wall, and were generally subparallel to the crest. A typical photograph of the tension cracks along the asphalt sealed access road is shown in Figure 5.

Figure 5 Cracking within asphalt access road behind eastern highwall (facing north)

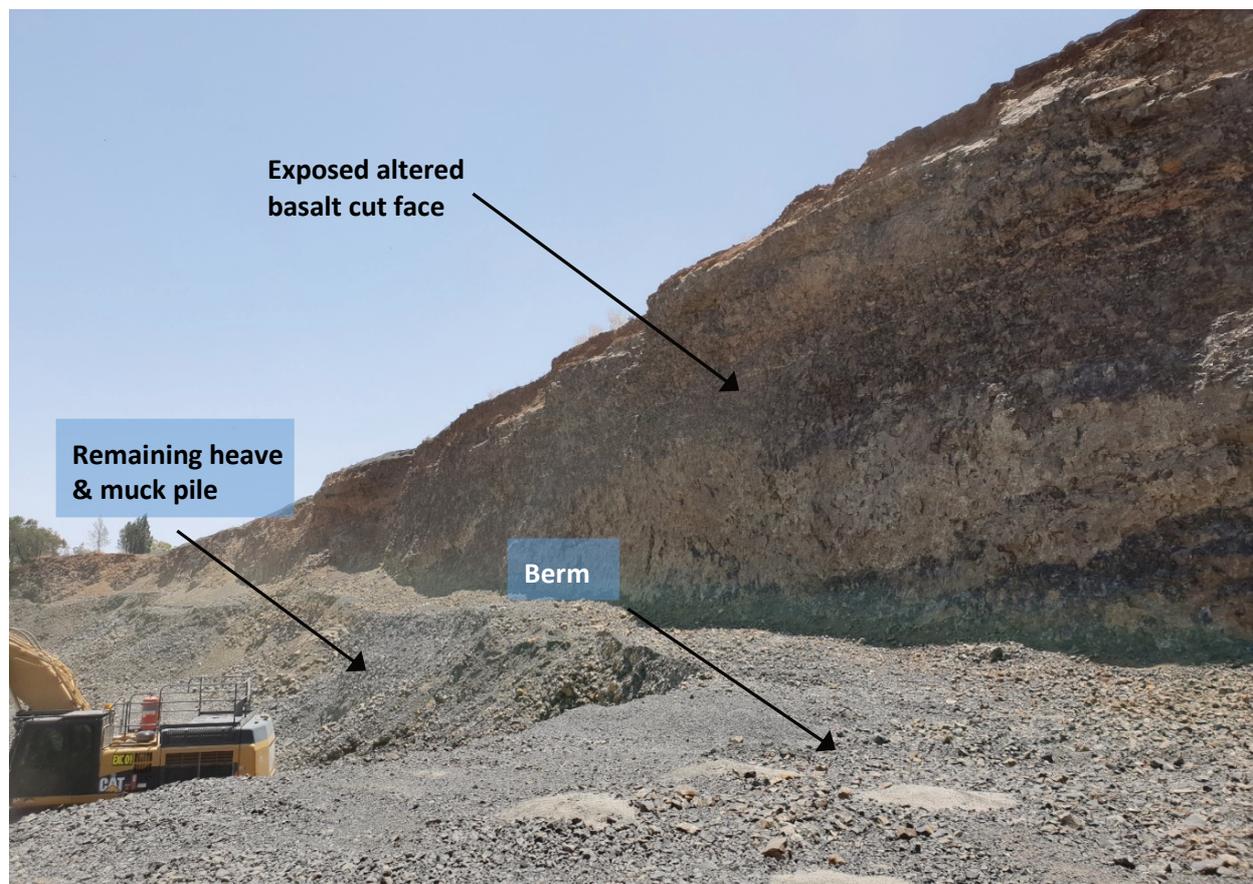
When observed from the floor, the eastern highwall was generally composed of the altered basalt with some lenses of competent basalt still upon the face. In the area where cracking was observed to have moved furthest to the west and downwards, the face was almost entirely composed of altered basalt. This altered basalt was generally orthogonally jointed, with some persistent defects being noted within the face, generally dipping at 30° to 40° to the west. A potential shear plane was also noted near the crest, again apparently dipping out of the face. Joint planes were observed to be stained to clean, smooth to rough, planar and tight.

Figure 6 A typical view of the exposed cutting on the eastern side

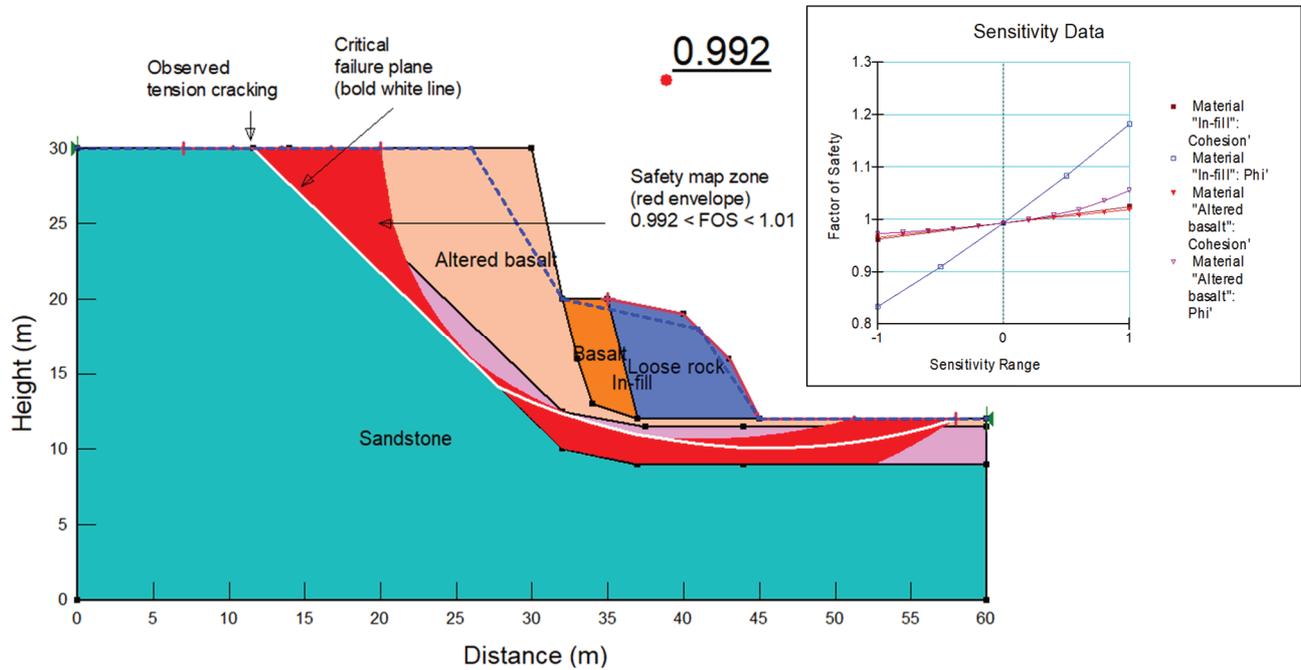
The result of the analysis indicates that with the high groundwater level and reduced strength within the contact zone and the altered basalt, the highwall would fail ( $FoS < 1.0$ ) through an adversely sloping failure plane at the altered basalt–sandstone contact zone (Figure 7).

Figure 7 Result of the limit equilibrium slope stability analysis (with inset sensitivity analysis plot) of a typical highwall geometry

Based on the sensitivity analysis plot (inset in Figure 7), the stability is much more sensitive to changes in the *infill* friction angle. The impact to the stability of the changes in the *infill* cohesion and *altered basalt* cohesion and friction angle are somewhat similar. For the slope to be about the meta-stable state (i.e. FoS of unity), the strength parameters for both the *infill* and *altered basalt* materials need to be two increments above their average values as provided in Table 2.

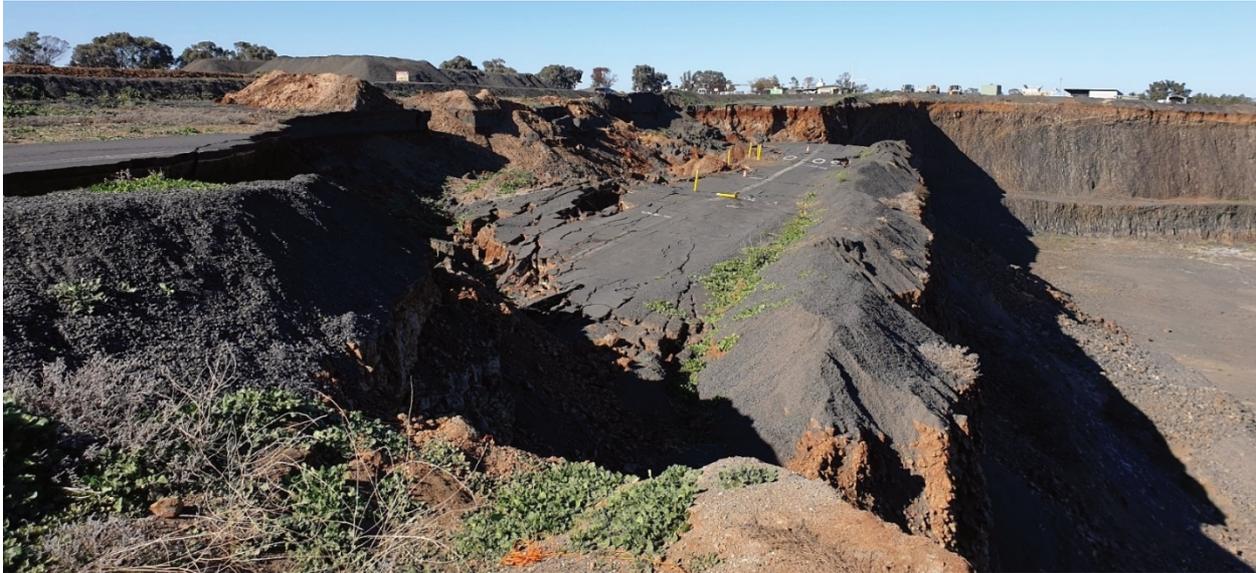
On 8 February 2019, the eastern highwall failure slid down approximately four metres. The area of failure was roughly 80 m in length, and up to 20 m in width, between prisms no. 75 and 175. A general view of the failed highwall is shown in Figure 8.

The prisms within this area (nos. 85, 100, 125 and 150) had recorded the greatest movement to the east (-ve) during the period of monitoring, and had also shown an acceleration in easterly movement in the ten days beforehand. The back scarp of the failure did not reveal the lithic sandstone of the footwall, but observations of the failed material on 9 February confirmed that it was due to translational-planar failure along the altered basalt–sandstone contact zone. The geometry post failure was assessed to have marginal stability and Factor of Safety close to unity, but cannot be readily quantified due to limited understanding of the sub-surface failure profile and the altered strength parameters.

Figure 8 View of the failed highwall on the eastern side of the quarry
