Case study: back-analysis of a historical open pit highwall failure at a coal mine in Canada

Abstract

This paper presents the key findings from the back-analysis including the results of the finite element modelling, as well as conclusions which were relevant to the design of the proposed highwall slope.

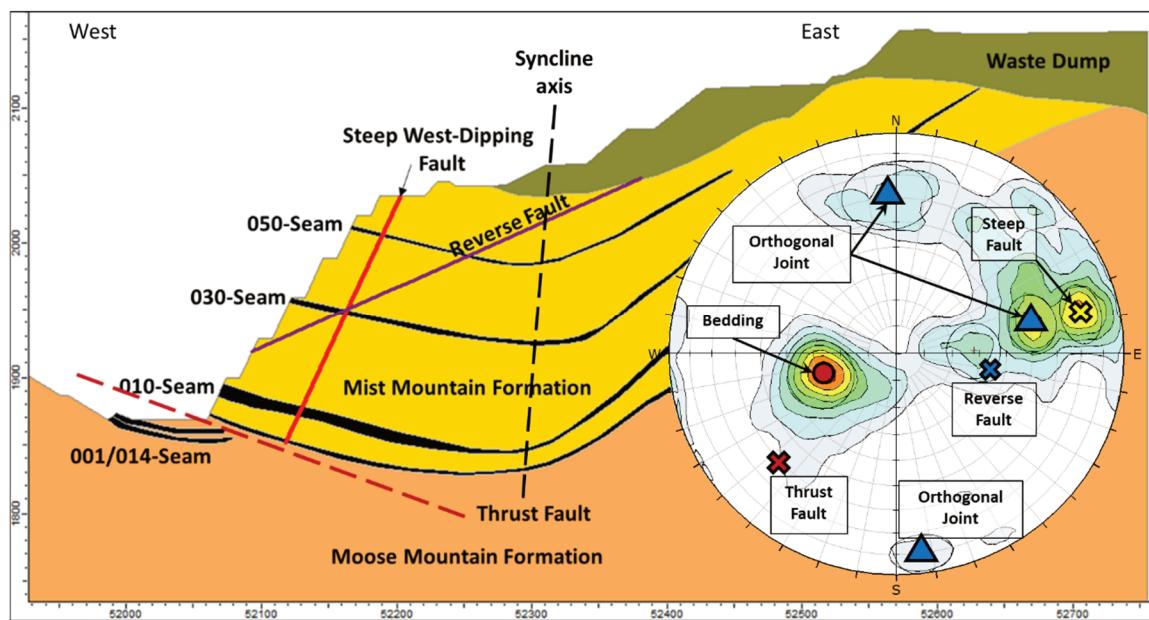
Figure 2 Idealised geological cross-section through the P3 highwall depicting key geological structures and geometry

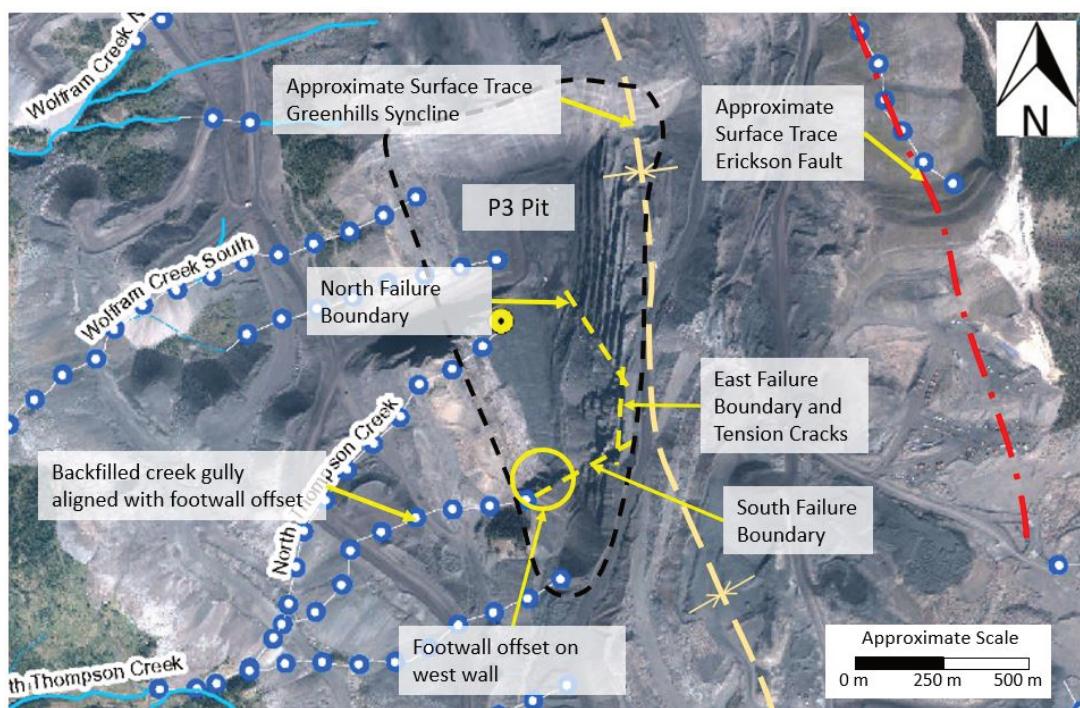
The total length of the failed portion of the P3 highwall slope is approximately 340 m. The height of the failure zone is approximately 165 m. Three main bounding structures interpreted as faults define the failure area, as shown in Figure 3. A north boundary fault trends into the east wall; an east boundary fault trends in a north-south direction behind the wall and is associated with the development of a large tension crack (Figure 4); and, a south boundary fault trends northeast-southwest, offsetting stratigraphy in the west footwall slope.

Figure 3 P3 Pit highwall failure boundaries and relevant major structures

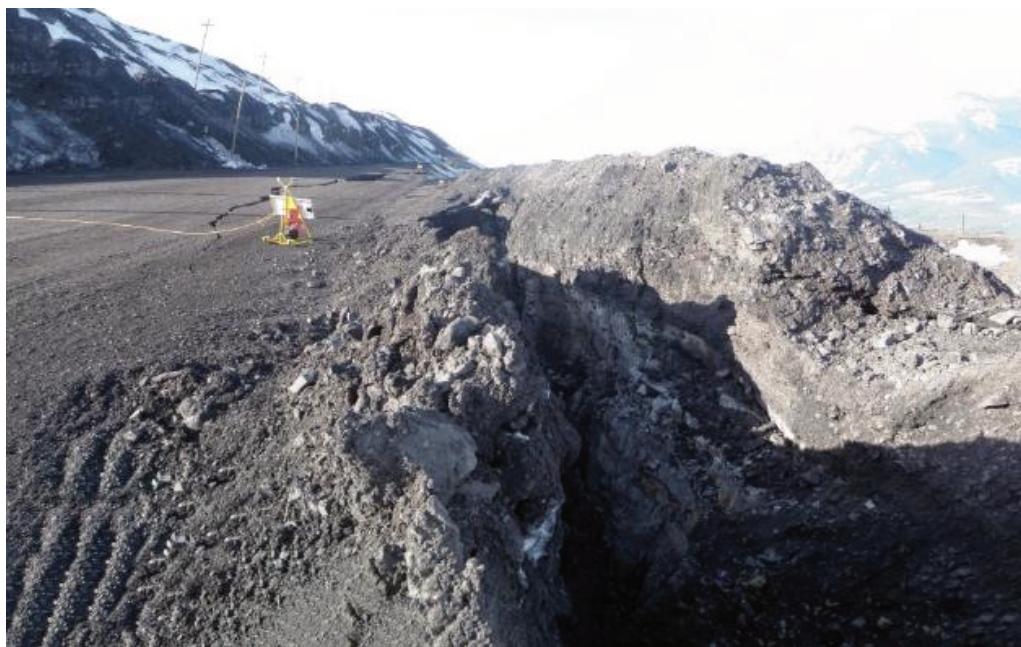
Figure 4 Tension cracks at crest of east highwall preceding failure

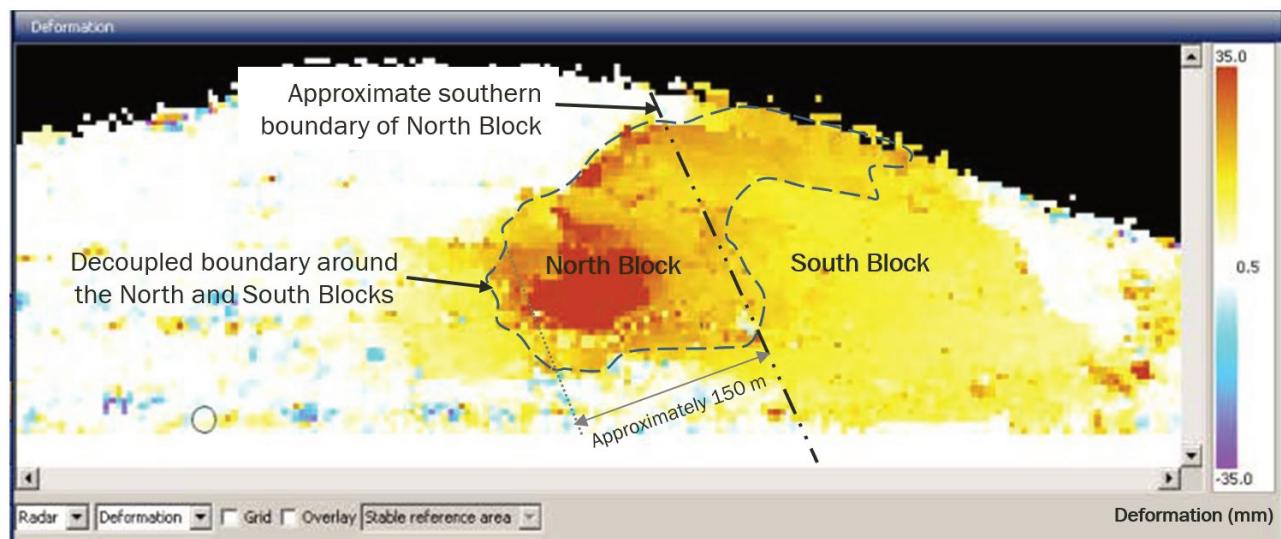
Stage 1 (April 22/23 to May 3, 2011): The North and South Blocks deform uniformly at a constant velocity of approximately 2 mm/hr across the face. Ravelling of the North Block face increases. An irregularly shaped decoupled boundary developed around the North and South Blocks as shown on Figure 5. Figure 6 shows the failed North Block.

Figure 5 Slope radar image showing highwall deformation during Stage 1 between May 1, 2011 at 14:43 hrs and May 1, 2011 at 20:40 hrs. The decoupling of North and South Blocks is visible in the deformation contouring

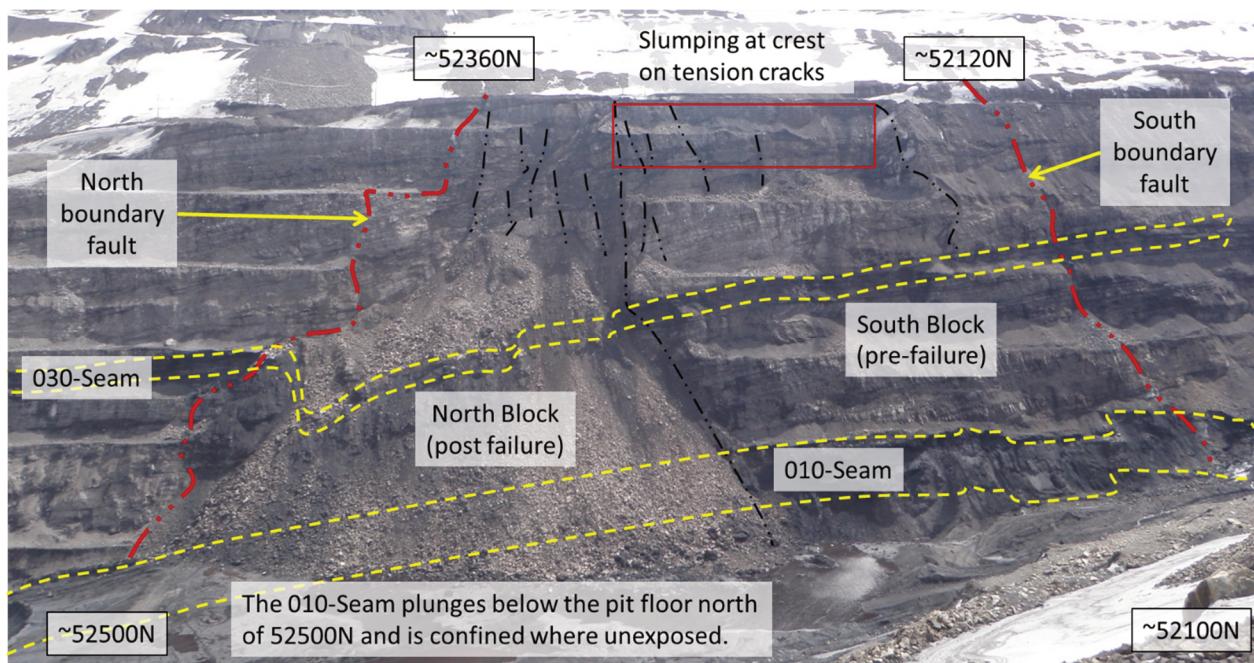
Figure 6 Highwall following North Block failure

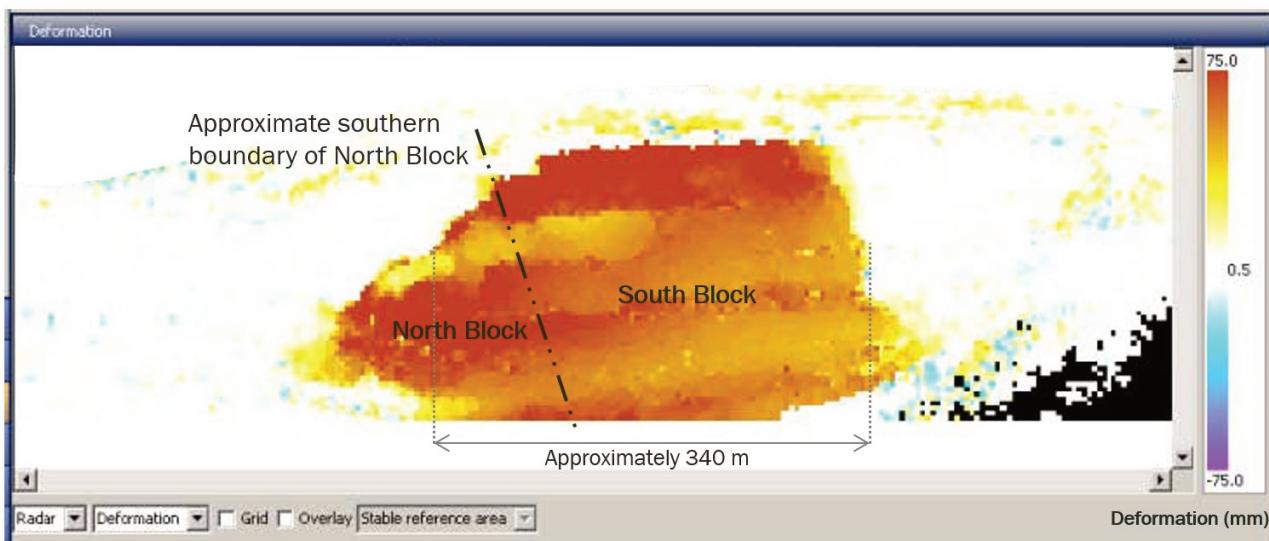
Stage 2 (May 3 to 5, 2011): The surface ravelling stopped, but radar displacement velocities of the North and South Blocks accelerated to approximately 13 mm/hr. Horizontal ‘banding’ is observed on the radar associated with the benches, but also associated with the stronger stratigraphic units separating the coal seams, as shown in Figure 7. Tension cracks formed in the road at the slope crest (Figure 4). The North Block failed on May 5, 2011, the upper benches slumped downwards, translated outwards, and broke up on the talus slope.

Figure 7 Slope radar image showing highwall deformation during Stage 2 between May 4, 2011 at 13:18 hrs and May 4, 2011 at 19:24 hrs. The Horizontal banding associated with deformation of the benches but also with the weaker coal seams separated by the more competent sandstone is visible

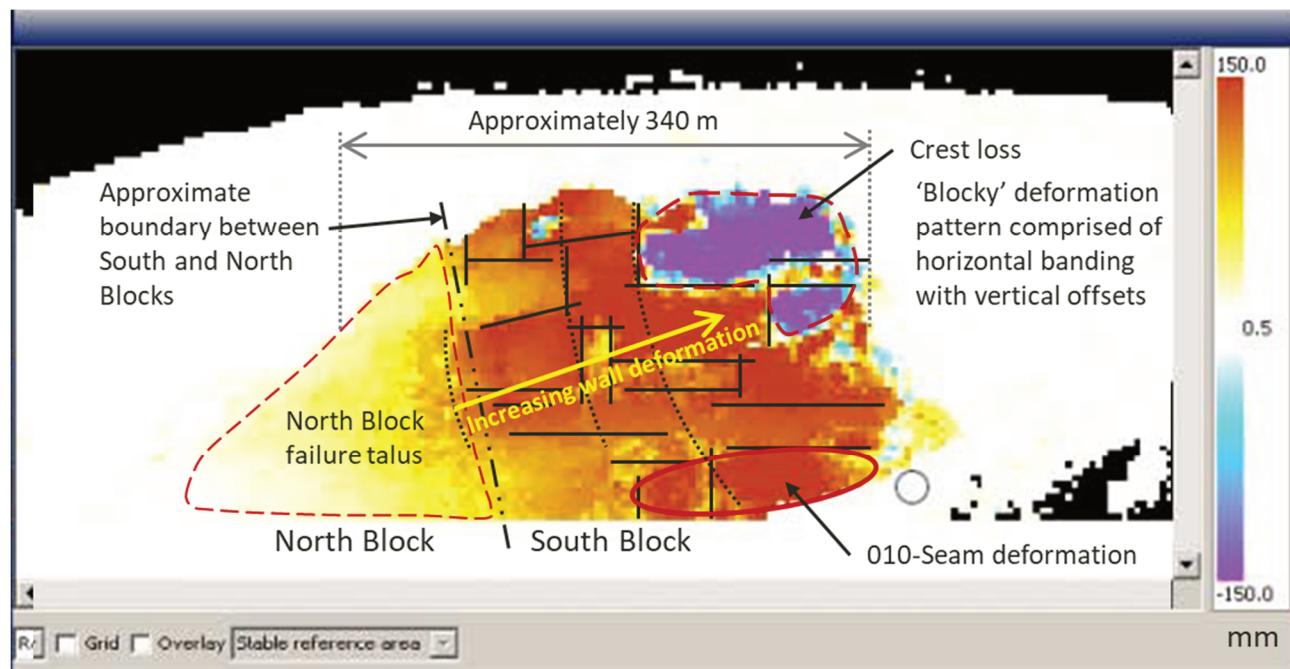
approximately 25 mm/hr at the south end. Horizontal deformation bands continued to develop, which were disrupted by vertical offsets forming discrete blocks, as shown in Figure 8. Figure 9 shows the final wall geometry after the failure.

Figure 8 Slope radar image showing Stage 3 highwall deformation in South Block between May 8, 2011 at 00:14 hrs and May 8, 2011 at 06:08 hrs

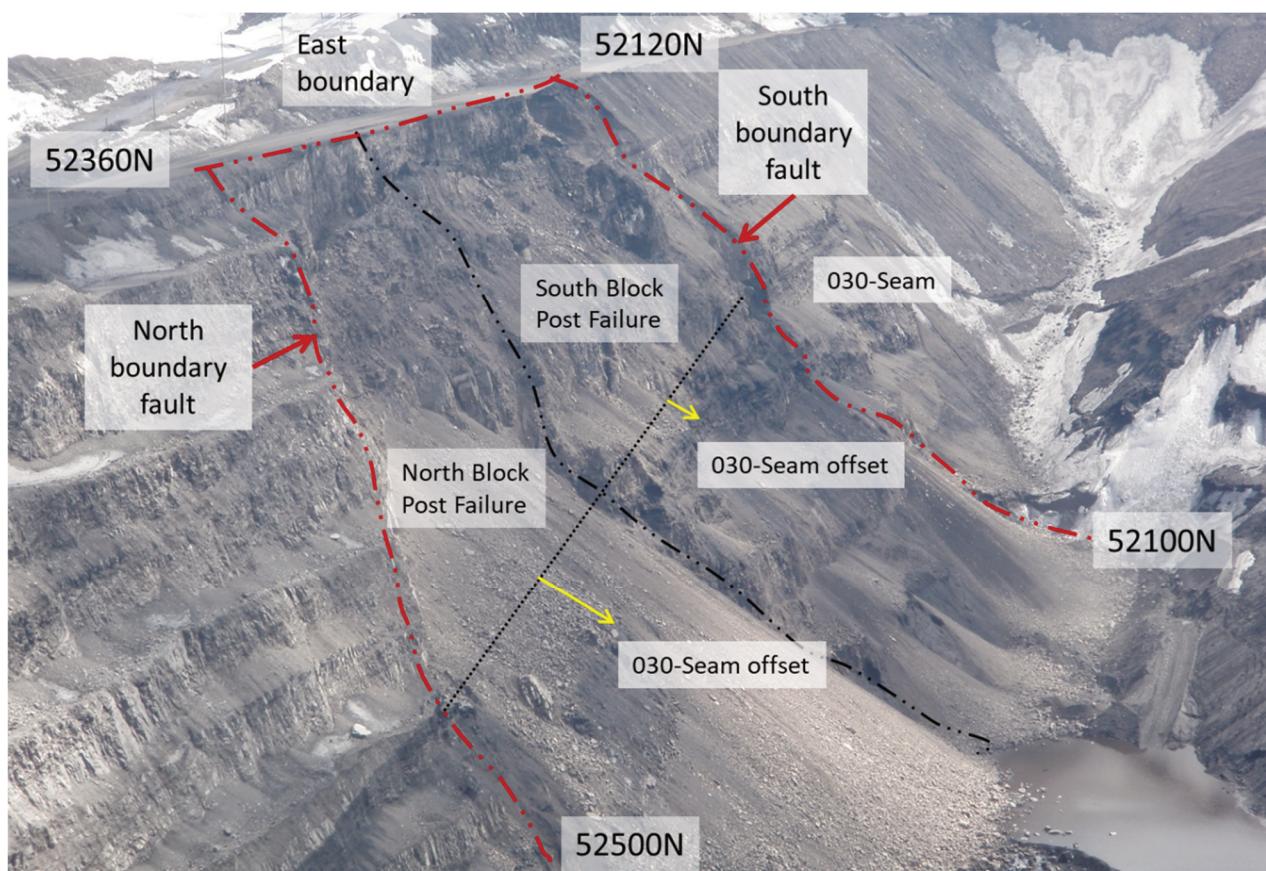
Figure 9 Highwall following South Block failure

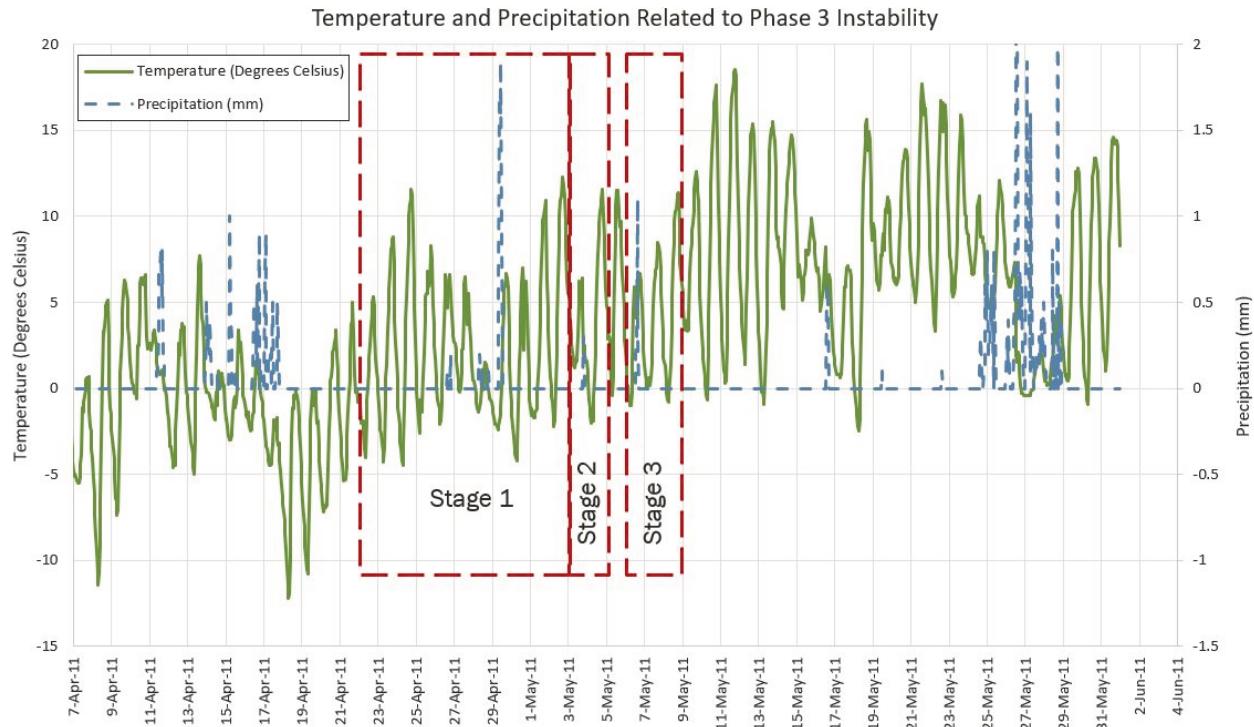
The air temperature and precipitation data during the weeks leading up to the failure are shown in Figure 10. These data suggest a possible correlation between the development of the failure and the date at which daily temperatures consistently remain above freezing during the transition from winter to spring. The onset of spring freshet likely released significant water from melting snow, and from the release of water from ground ice.

Figure 10 Temperature and precipitation data

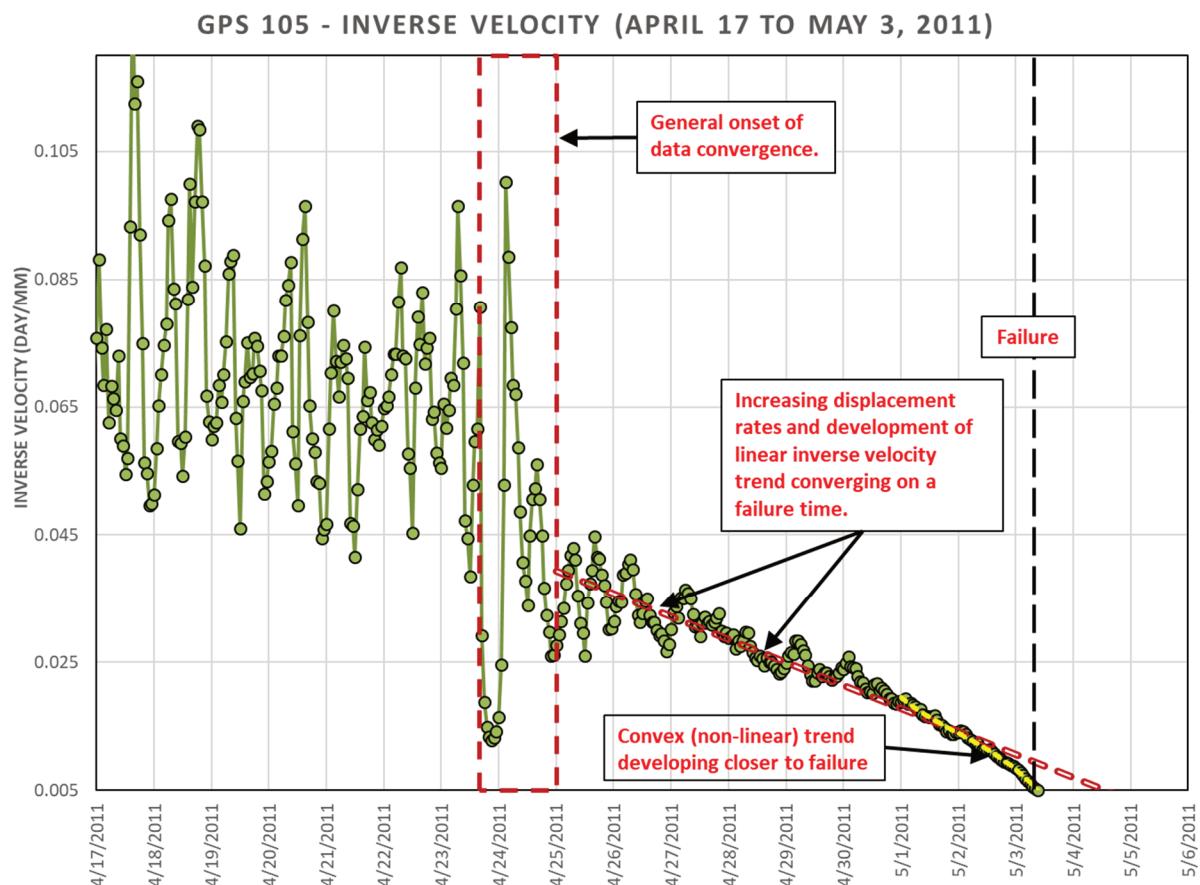
The northing, easting, and elevation data from four GPS monitoring points installed at the crest of the P3 Pit instability were reviewed, including the inverse velocity trends. Only GPS monitoring point GPS-105 showed the development of an inverse velocity trend prior to the failure. Post filtering of the one-hour GPS 3D velocity monitoring data indicated that averaging over 12 readings (i.e. 12-hour average slope distance velocities) provided the most appropriate amount of data filtering for observing trends. The data from GPS-105 suggest the inverse velocity data convergence commenced on approximately April 24, 2011 as shown on Figure 11. A linear projection of the trend suggested a failure date between May 5 and 6; however, as displacement rates increased closer to the projected failure date, a convex (concave-downward) inverse velocity trend developed beginning on May 3 and converging on a failure date of May 4.

Figure 11 Inverse velocity graph of GPS Point 105 (GPS-105) data

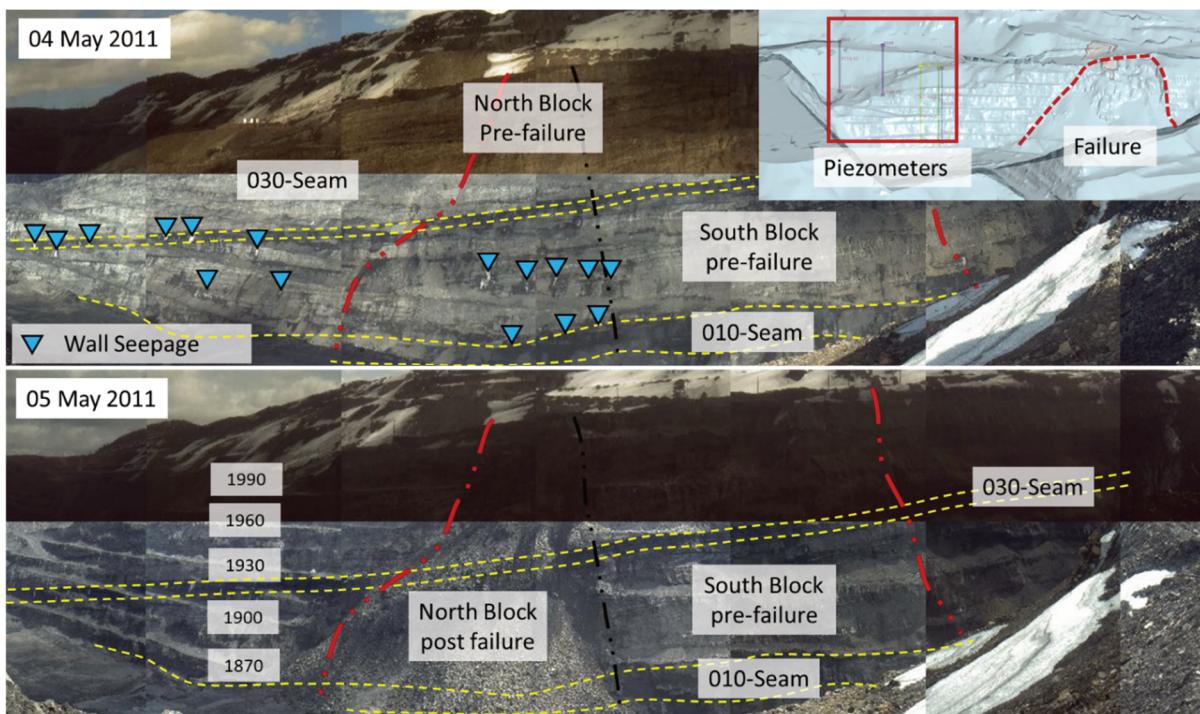
Nine vibrating wire piezometers were installed in four boreholes located approximately 350–700 m north of the failure (Figure 12). There does not appear to be any significant change in pressure head leading up to the failure, although immediately following the failure there is a notable increase in groundwater pressure in several of the piezometers. It is difficult to determine if these are directly related to the failure itself or are responses associated with annual freshet cycles.

Figure 12 Seepage faces on coal seams and piezometer locations

Wall seepage is visible on photographs of the highwall from April 4, 2011 prior to the failure (Figure 12). Seepage is visible within the coal measure rock midway between the 010-Seam and the 030-Seam, as well as within the 030-Seam (the approximate coal seam locations are shown on Figure 12). The locations of seeps on the wall are consistent with the available vibrating wire piezometer data which suggest that the coal, and associated finer grained sediments are acting as aquitards.

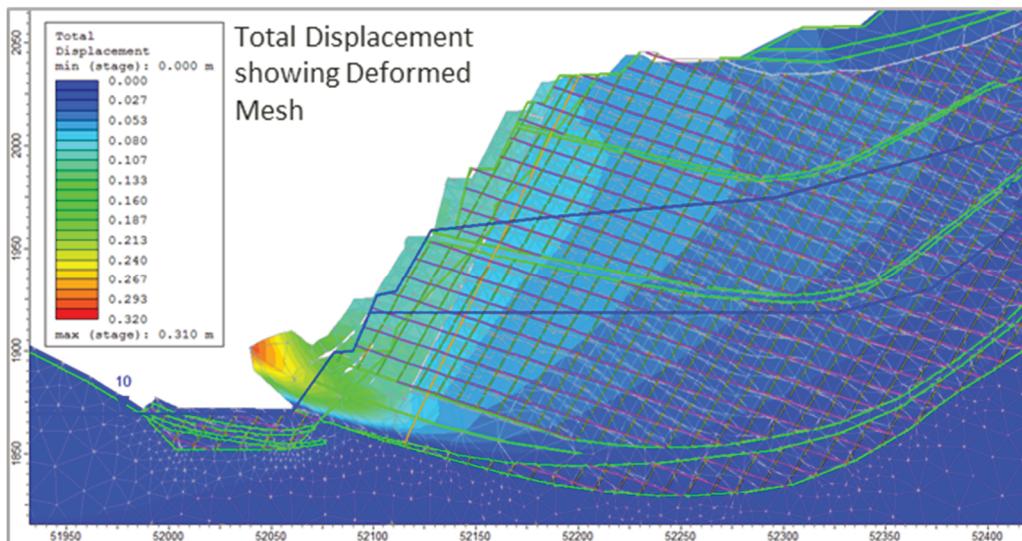
Figure 13 Example finite element modelling results for Case 1

The results of the FE modelling indicate that the thick, weak coal seam at the toe was a key factor which contributed to the highwall instability. The modelling captured two potential and important failure modes: the first is related to deformation of the coal seam in association with the presence of a steep west dipping fault behind the slope, while the second incorporates the additional displacement associated with the presence of a moderately west dipping reverse fault.

The model displacement contours indicate the deformation is concentrated within the 010-Seam. The magnitude of deformation that can be captured by an FE model before it becomes unstable (i.e. non-convergent) is limited by the model mesh. Therefore, the FE models do not capture the full development of the global slope instability, but instead capture its initiation immediately following the excessive deformation of the 010-Seam at the slope toe. The deformation contours show displacement above the 010-Seam, but the magnitude of the displacement is generally lower than that observed in the GPS and radar data which capture the full failure displacements. The general shape of the deformed mesh and displacement contours generally represent the slope deformation observed visually (from still-photographs), and from the radar images which show the development of the horizontal boundaries corresponding to weaker materials. The eastern extent of the displacement contours at the slope crest approximately correlate to where the tension cracks were observed leading up to the failure.

Deformation of the 010-Seam during mining coupled with structure in the highwall was the likely cause of the P3 Pit highwall instability. The presence or absence of large-scale faults and systematic jointing, coupled with the sheared and structurally thickened, weak soil-like coal seam at the toe of the proposed P4 Pit highwall are critical considerations for wall stability. As the maximum height of the pit highwalls increases this could potentially lead to greater deformation within the weak coal seam. Deformation will likely occur during mining, even before the material is exposed in the slope face. The use of instrumentation such as slope radar, piezometers, and survey points were recommended for managing risk and detecting potential issues. The design of future highwalls may require a geotechnical berm, or step-out, at some elevation in the slope to decouple the overall slope into two separate inter-ramp slope areas, with a shallower overall slope angle.
