Engineering geology investigation and numerical modelling design of the Ramp 12 highwall

B Roache *Mining One Consultants Pty Ltd, Australia*

AR Johnstone *BHP, Australia*

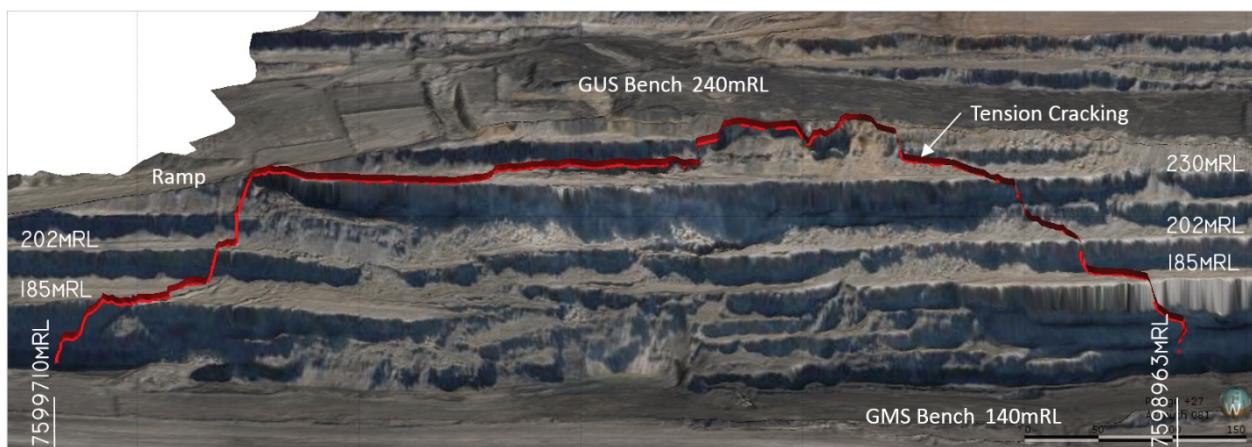
The Ramp 12 highwall between the GUS and GMS benches was first reported to be cracking and deforming in February 2016. The highwall continued to deteriorate into a progressively moving slope failure over a period of months and was 100 m high and 750 m in extent, as shown in Figure 2. The scale of the wall failure and the progressive nature of the slope movement presented challenges to safely stabilise and remove the failure. Following removal of the failure, it was important to correctly account for the identified failure mechanism in design of the next highwall strip position and maintain highwall stability. The Ramp 12 highwall was mined using truck and shovel methods, with a slope angle considered to be relatively conservative at 45° between the GMS and GUS benches. Thrust faults, which intersect the slope and are associated with poorer rock mass conditions, were not initially considered to contribute to the observed failure.

Figure 2 Front on view of the Ramp 12 highwall failure

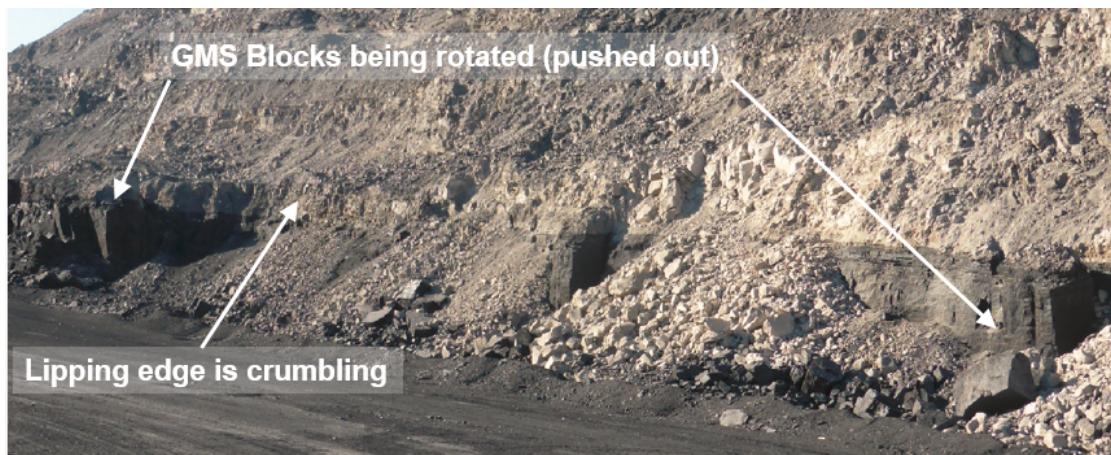
The overbank bedding was recorded during pit wall mapping at an average dip of 13° into the pit. The overbank structures were considered a likely contributor to the development of wall failure, but detailed visual observation of the failure toe (at the GMS bench level) did not indicate any significant lipping, or buckling failure of GMS coal, as shown in Figure 3. This indicated that sliding on the carbonaceous layer at the top of the GMS coal was not the only cause of the advanced slope deformation that had moved metres over a period of months.

Figure 3 Observations from the Ramp 12 highwall at Goonyella Middle Seam (GMS) level

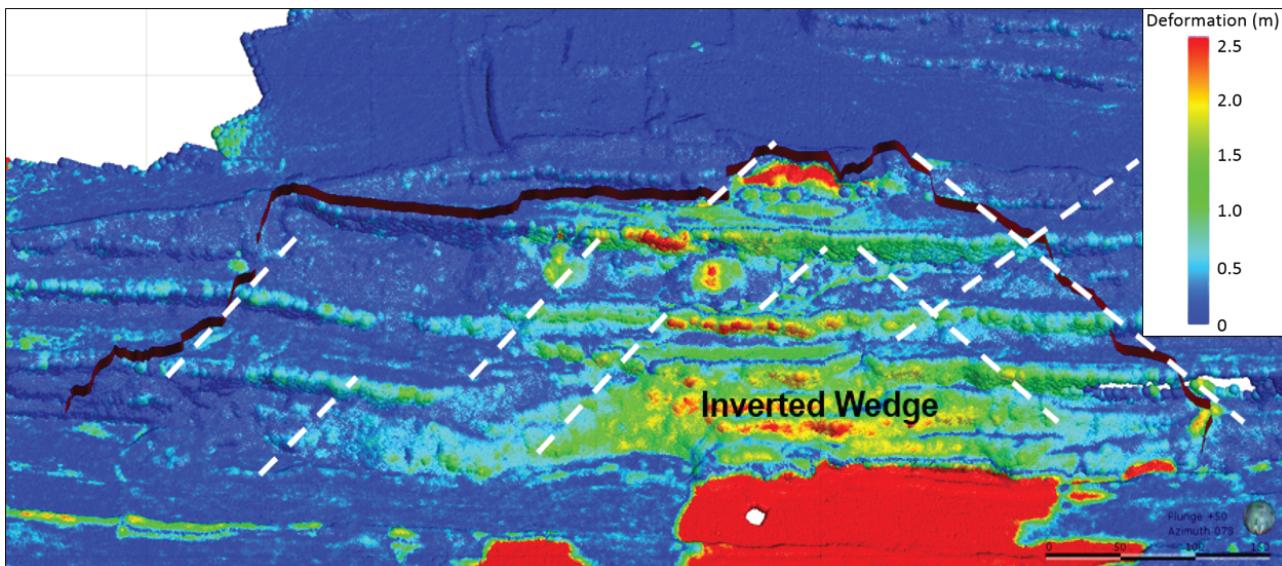
The Ramp 12 highwall deformation characteristics were monitored over a number of months. LiDAR survey data was regularly collected, as is general practice at the large Bowen Basin open pit coal mines. Interrogation of the LiDAR data enabled interpretation of the highwall deformation, which was determined to be bounded by structural controls. Tension cracks had formed on the two vertical joint sets at the GUS bench. The majority of slope deformation occurred in a shape that appeared to be an inverted wedge located at the southern end of the failure area, as shown in Figure 4. The deformation of the inverted wedge allowed further movement to occur deeper into the slope, on the same structure set combinations.

Figure 4 Ramp 12 highwall LiDAR scan deformation

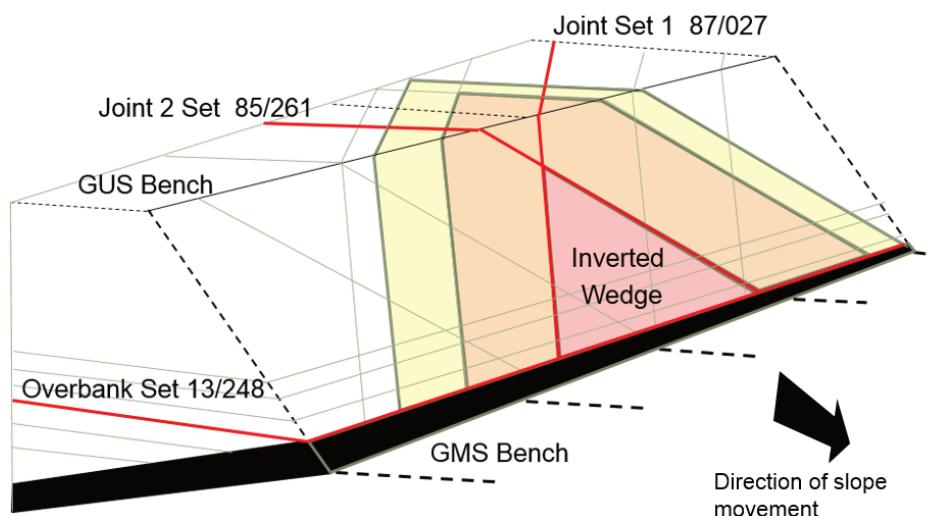
Interpretation of the data indicated a large highwall failure, continuing to fail progressively with structural controls defining the slope into a number of movement zones. It was possible to describe the failure in a number of ways, but it can be thought of as a composite wedge, where three structure sets are combining to define the slope deformation. A simplified representation of the slope failure mechanism is shown in Figure 5.

Figure 5 Ramp 12 highwall slope failure mechanism

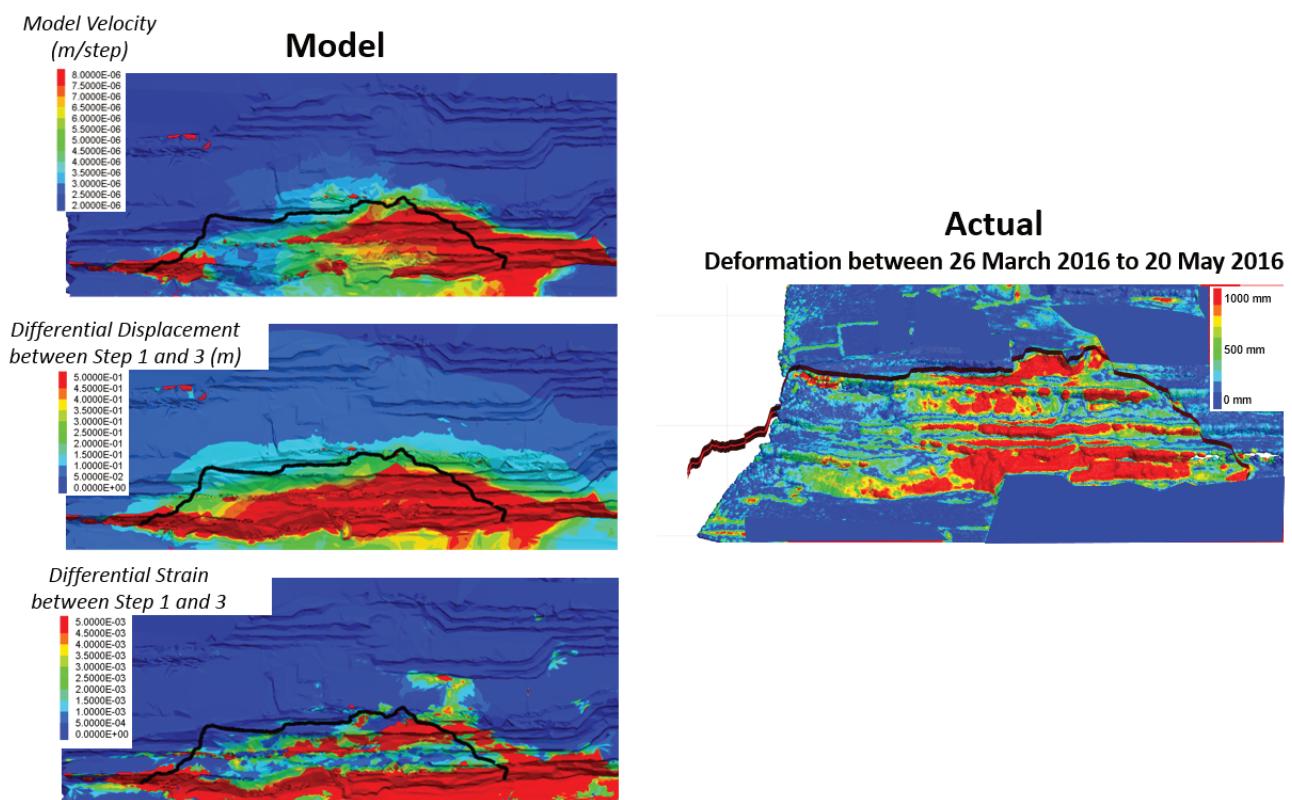
The back-analysis results shown in Figure 7 indicated that early deformation was associated with the thrust fault's intersection with the highwall. Displacements were concentrated at the toe of the failure and the modelled area of displacement correlated well with the observed failure area. This result provided an excellent starting point for modelling predictive scenarios for slope stabilisation and future design. A comparison of back-analysis derived deformation to the actual slope deformation from LiDAR survey data provided a reliable match of predicted to actual in terms of location of slope deformation and amount of movement.

Figure 7 Ramp 12 highwall slope failure back-analysis model, perspective view

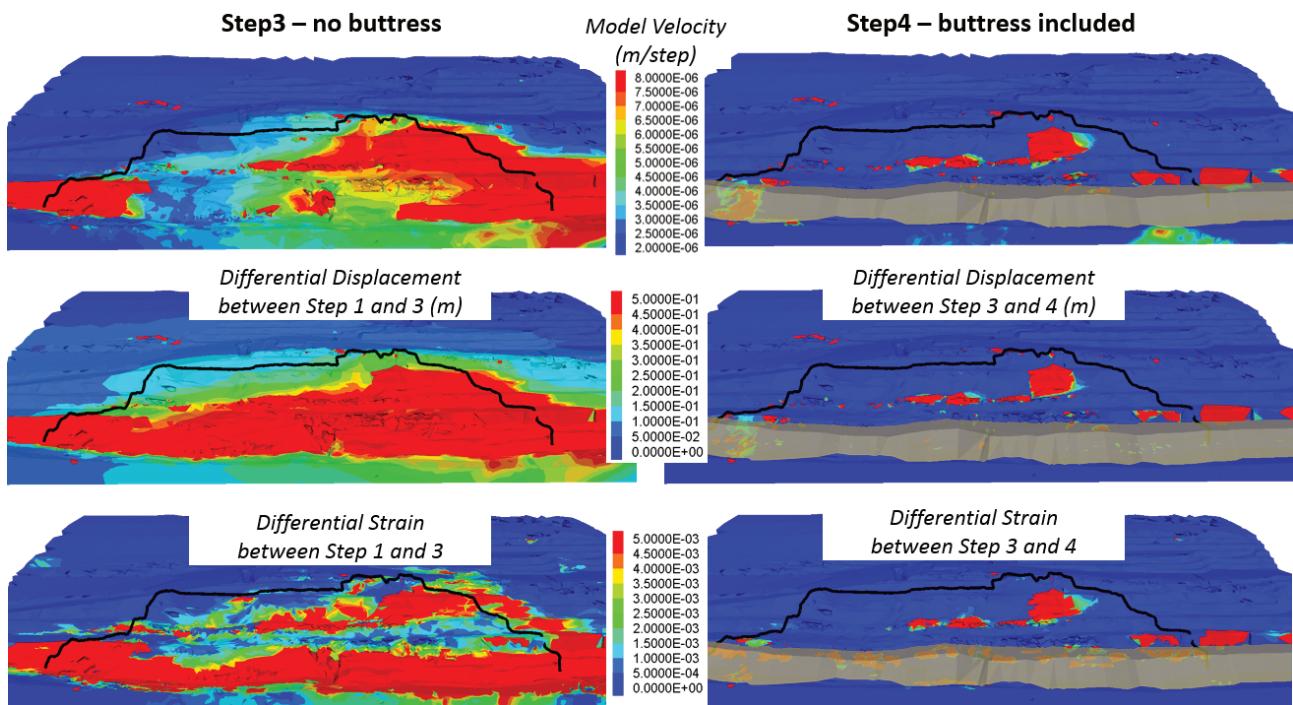
Figure 8 Pre- and post-buttress slope failure deformation

The initial limit equilibrium stability assessment indicated a 30 m high and 40 m wide toe buttress was required to stabilise the overall slope deformation. The three dimensional numerical model used in the back-analysis was extended to add the buttress. It demonstrated the buttress size was suitable in slowing the overall slope deformation, although localised shallow slope deterioration was expected to continue on a batter scale, as shown in Figure 8.

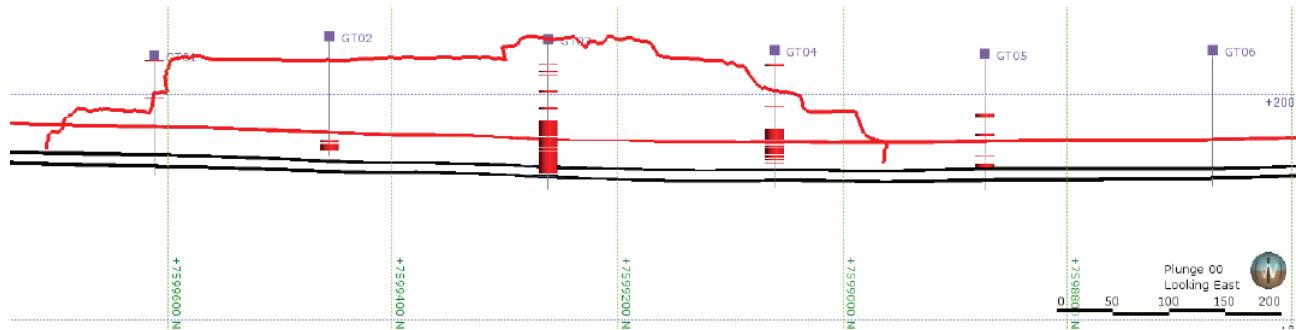
The overbank structures, having also played a contributing role, were assessed to check their ongoing influence on the future slope position. Mapping data from laser scanning and field mapping clearly showed the overbank structures dipping into the pit void and bedding orientations from drillhole acoustic televiewer files located immediately behind the failure showed the ongoing concentration of overbank structures, concentrated in the vicinity of the failure, as shown in Figure 9.

Figure 9 Acoustic televiewer data showing dip direction – red indicate dip direction 230° to 270° (dipping into the pit at dips $\geq 15^\circ$)

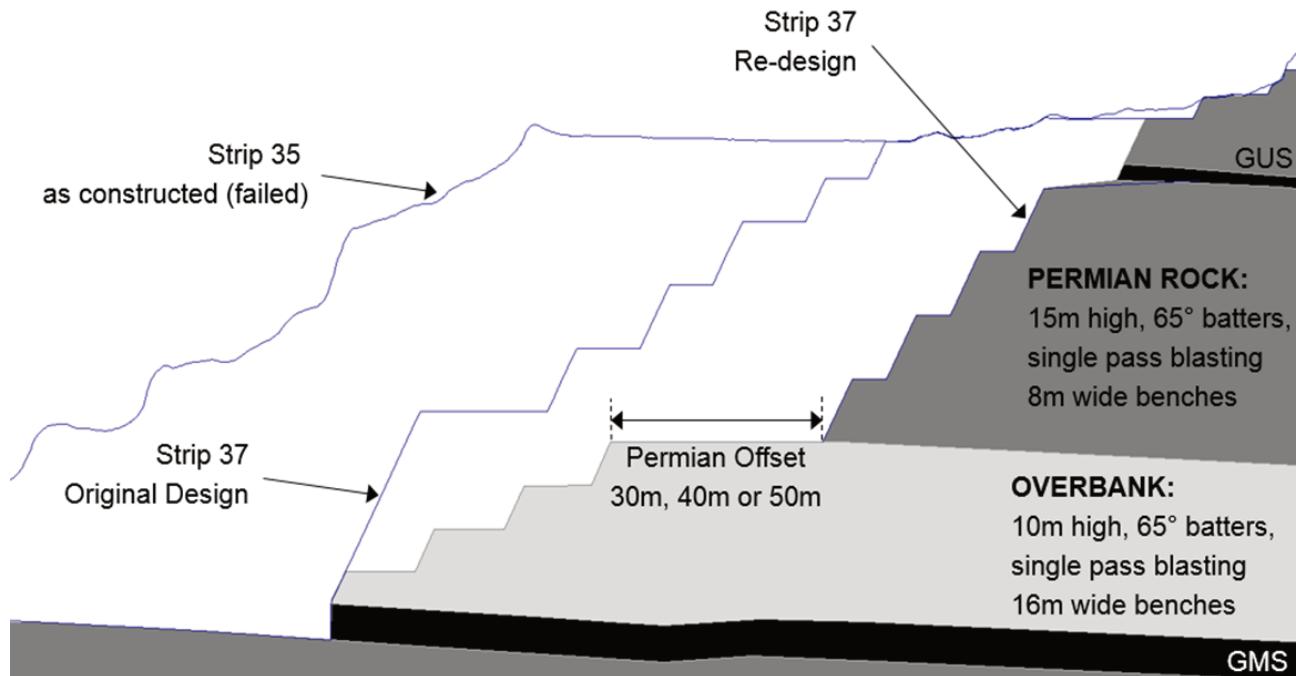
Figure 10 Redesigned Ramp 12 highwall

A conceptual Ramp 12 slope design was developed and assessed in the same three dimensional numerical model. A feature of this slope was an optimised 40 m wide offset distance in the Permian material, as shown in Figure 10. This was intended to unload the overbank structures which were present in the next highwall and improve highwall stability performance.

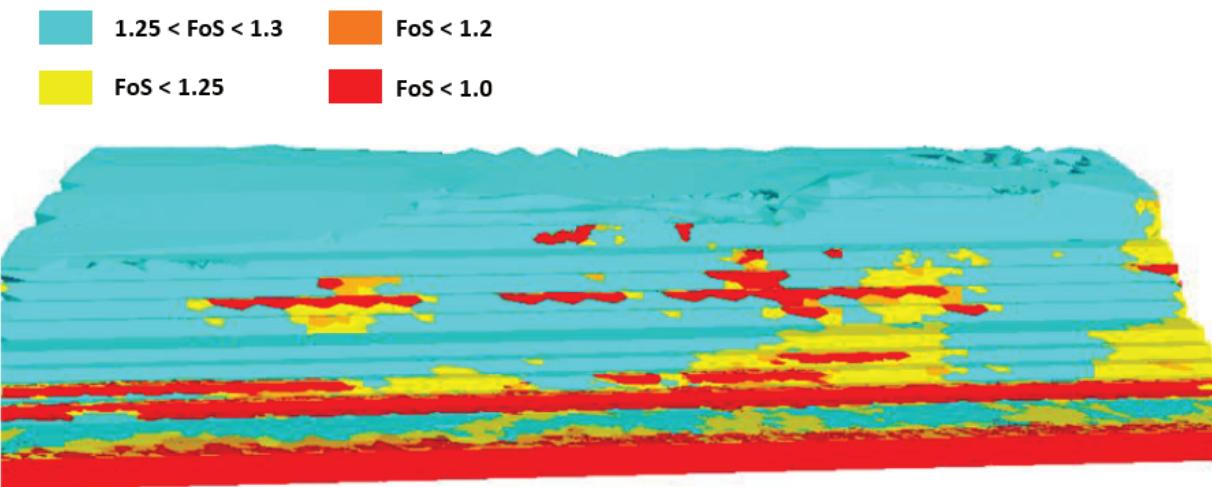
Modelling predicted batter scale failure and some multi batter failures were indicated, but deep seated or overall slope failure remained above a Factor of Safety of 1.2, as shown in Figure 11.

Figure 11 Numerical stability model results for the redesigned highwall, perspective view
