The Kiruna seismic event: important insights from the geotechnical model

Abstract

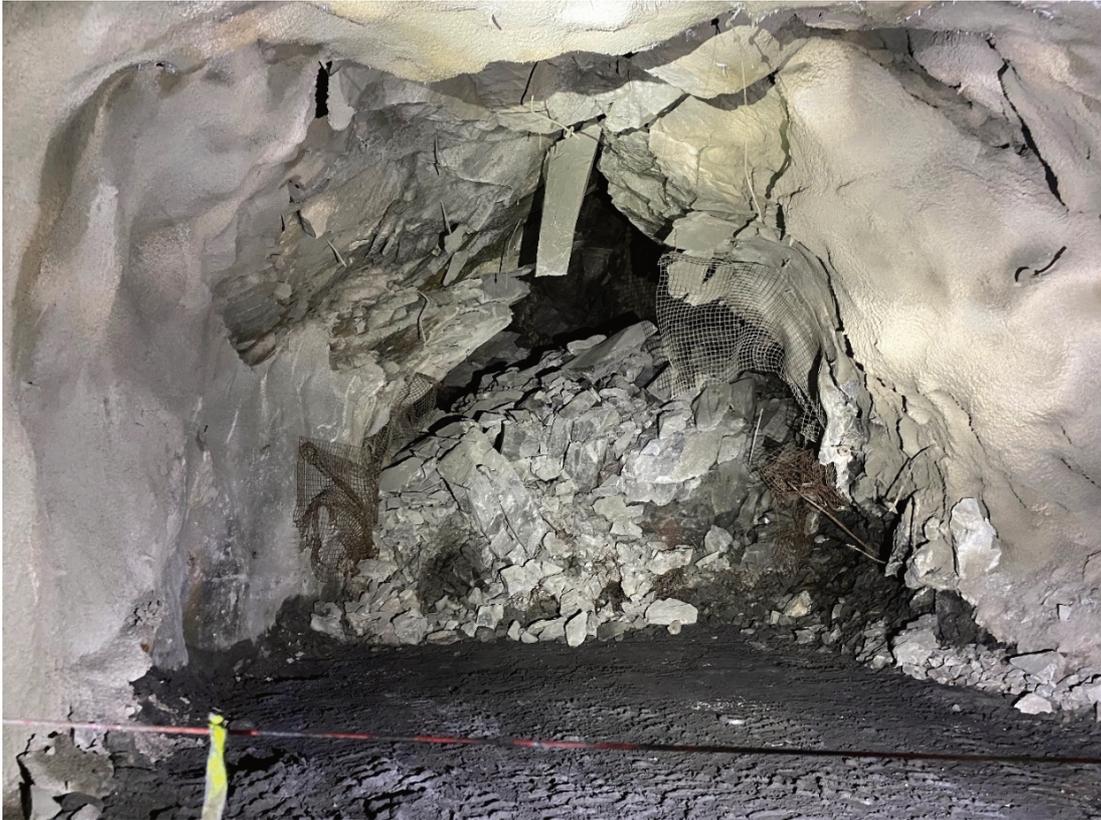
Complete failure of footwall – crosscut intersections are common on several levels. The dimensions of the fallen rock blocks clearly show (i) some blocks have been released along discontinuities to their smallest block size (Figure 2), a function of the penetrative fracture sets and veins in the rock mass, and (ii) blocks and fragments with fresh failure surfaces which has been exposed to enough high stresses to almost achieve complete fragmentation without blasting. Once fragmenting, the back continues to fail along existing fracture sets until a stable arch is achieved (Figure 2). The height of the now stable back can be more than 10 m – inaccessible to personnel – but, where, possible these voids are scanned with drones.

Figure 2 Level 1079 footwall drift looking north showing fragmentation from the back and a void above the rock pile

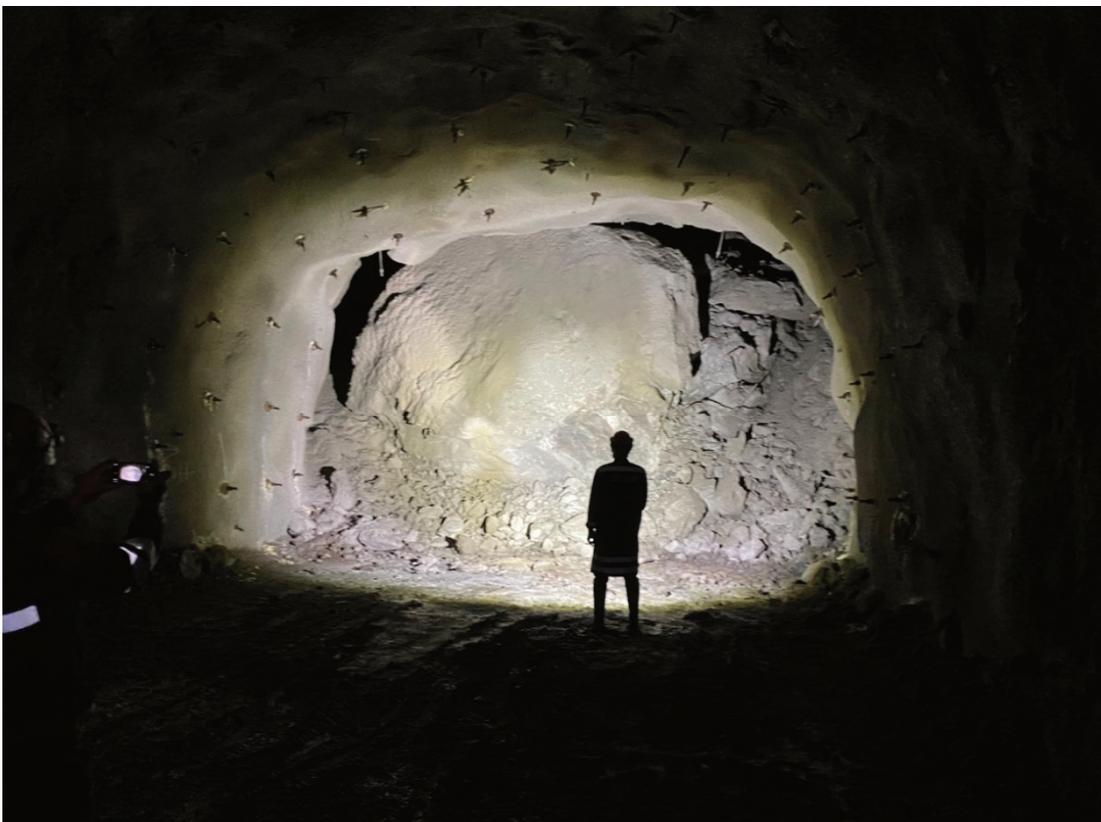
Other blocks are large enough to show unbroken, internal discontinuities (Figures 3 and 4). The block face of Figure 4 represents the ore-parallel fracture set used by the block to fail into the development. The vertical shear fractures guide the failures of some damage areas and can accommodate large vertical displacement. Utilising the vertical, ore-parallel shear fractures, large blocks drop into a development, completely sealing the crosscut tunnel (Figure 4).

Figure 3 Level 1079, Y202 crosscut looking west, fragmentation and oversized boulder

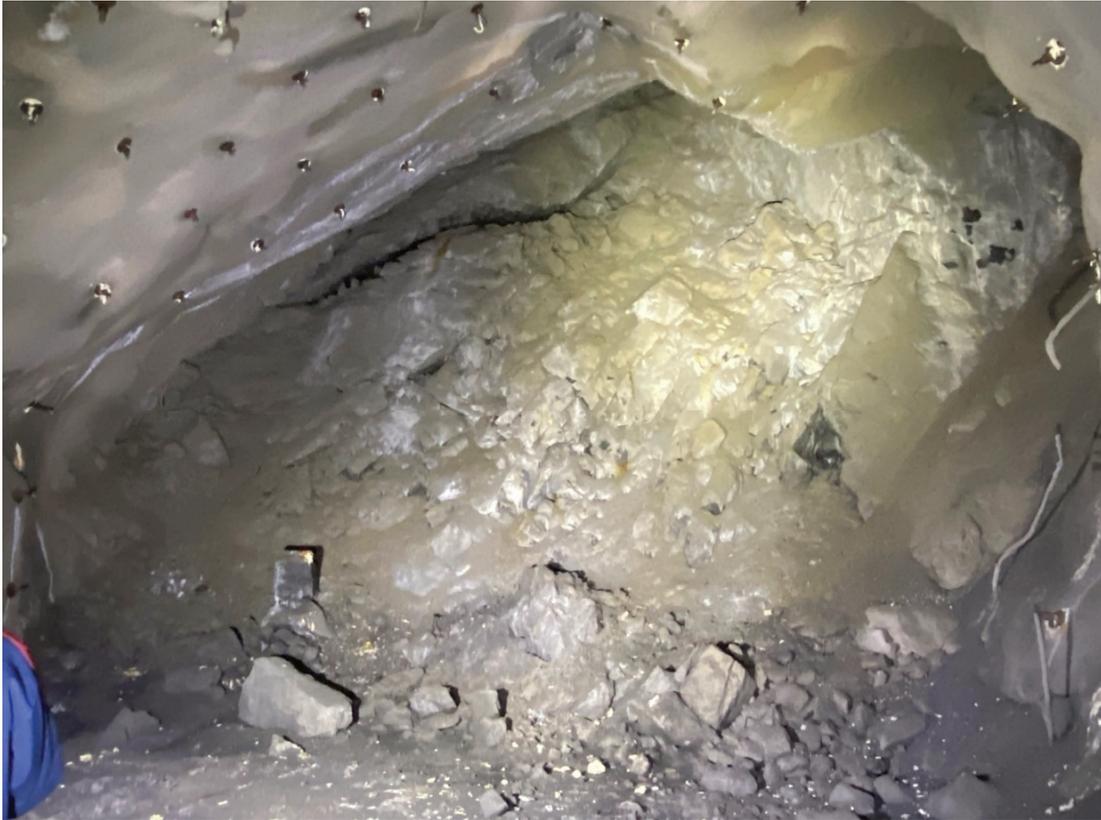
Figure 4 Level 1079 crosscut Y204 looking west, complete sealing of development

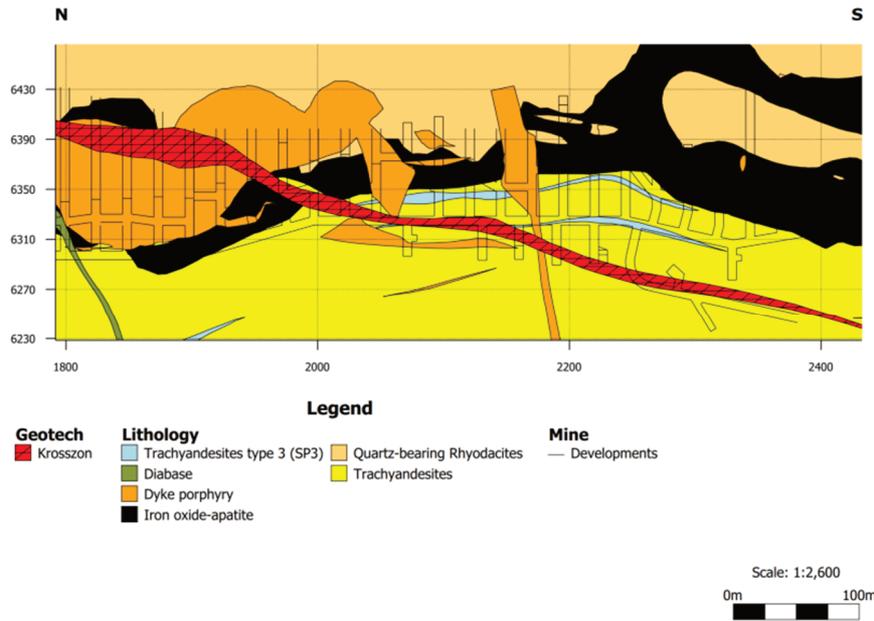
The crush zone strikes subparallel to the orebody. In the south of Block 22, it starts 100 m deep in the footwall and travels north to obliquely cut the orebody (Figure 6). At the intersect between the orebody and crush zone the orebody is heavily brecciated, and drilling shows regular core loss. Complex lithological geometries of the orebody and dyke porphyries are significant in Block 22 (Figures 6 and 7).

Figure 6 Block 22 geology at Level 1079, showing a thin orebody, country rocks, and the crush zone in red hatch

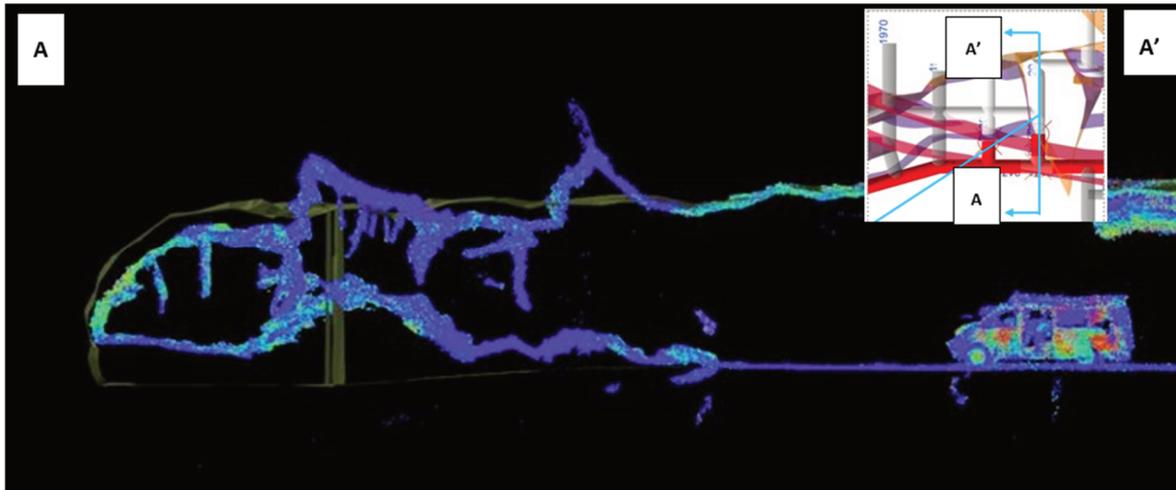
Within the crush zone, tunnel scans before and after the large event show floor heave, roof sag and overall compression (Figure 8). Reverse and normal faulting have also been documented along ore-parallel structures.

Figure 8 Level 1079, Y22 pre-event and post event scans, looking north. Blue dots, post seismic event show floor heave, roof sag and collapse of back. Scan NGM Automation, D Jatko

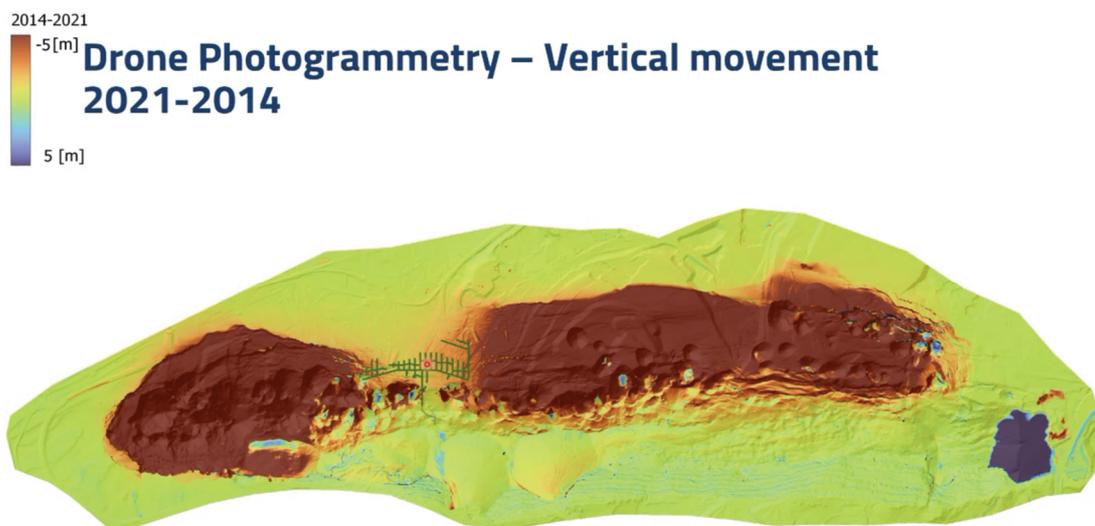
Figure 9 Surface subsidence shows the stalled cave in the Kiirunavaara hanging wall. Block 22's development position, Level -1108 m, in blue and the event hypocentre as a red dot
