Applying monitoring data to measure and improve rehabilitation performance at four mine sites in the Pilbara region of Western Australia

SJ Gregory *Mine Earth Pty Ltd, Australia*

TJ Sprenkels *Atlas Iron Pty Ltd, Australia*

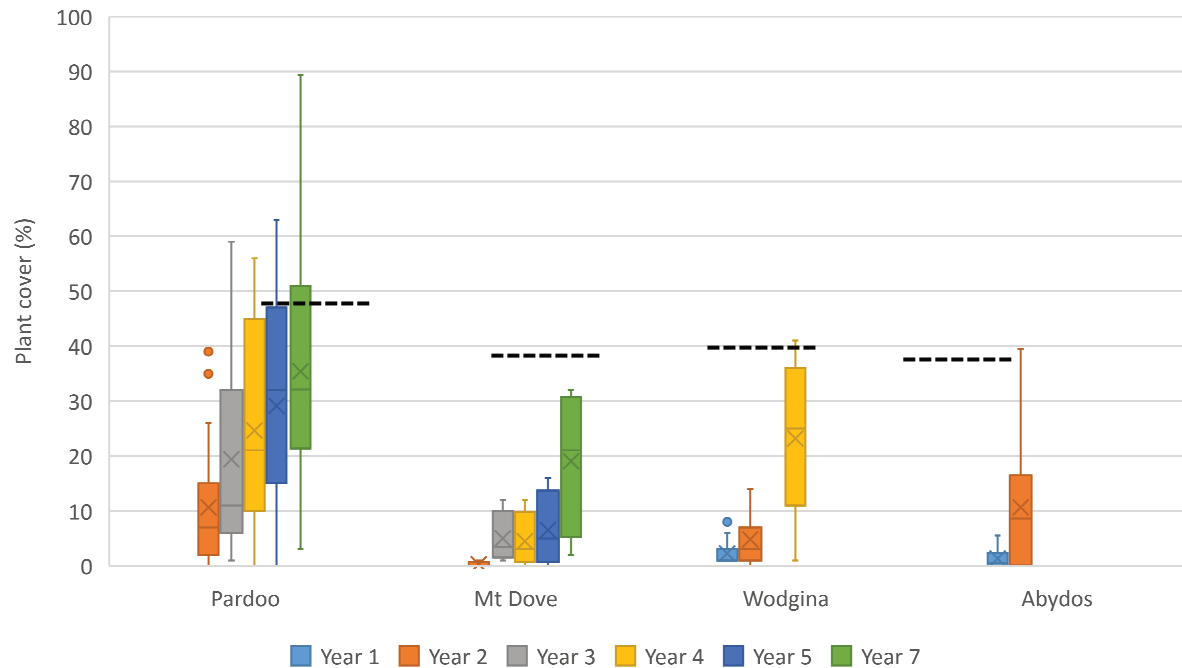
Perennial plant cover data is presented in Figure 3 along with the range of standards for each project. Plant cover has increased over time at each project. Plant cover at Pardoo is outperforming Mt Dove, which has a similar age, and is exceeding the calculated plant cover standard. At Wodgina, the plant cover in year four fell within the range of values recorded from Pardoo. For Abydos, plant cover was similar at year two to Pardoo, indicating that plant cover may follow a similar trajectory.

The development of perennial plant cover at Mt Dove has been slow and plant cover has remained low during the first five years of monitoring (Figure 3). Data from the year seven monitoring event has shown a considerable increase at Mt Dove, with average plant cover increasing to slightly below the standard. Revegetation performance at Mt Dove has been impaired by stock grazing.

Figure 3 Box plot of plant cover (%) at each project by age of rehabilitation against the site-specific project standard (represented by the black dotted line)

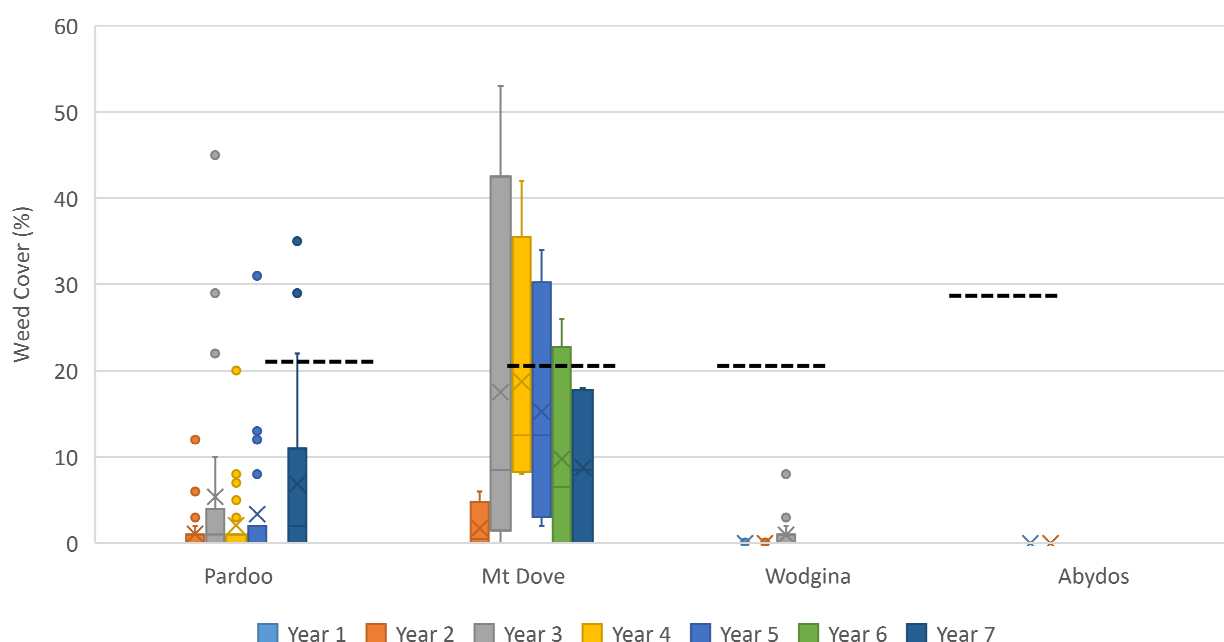
Weed cover at Pardoo was typically low and below the 10% standard (Figure 5). A few outliers at Pardoo were recorded and these were from sites where topsoil was scarce. Weed cover had increased considerably in the most recent assessment and this was related to the occurrence of Kapok (*Aerva javanica*) on the Bobby WRL. This species has tended to dominate a small rocky section of the WRL which was reworked after the initial rehabilitation program to improve the trim and contour ripping on the final slope, which subsequently buried the topsoil in this area. Ongoing weed management has been implemented across all projects to manage weed populations.

Weed cover at Mt Dove was high and has shown a decreasing trend over time as native perennial plant cover has increased (Figure 5). The Mt Dove WRL was also dominated by Kapok (*Aerva javanica*). It is likely that the spread of weeds at Mt Dove is associated with stock grazing on the WRL. It is interesting to note that as weed cover on the Mt Dove WRL has decreased, species richness has increased (Figures 4 and 5).

Figure 5 Box plot of weed cover (%) at each of the projects by age of rehabilitation against the site-specific project standard (represented by the black dotted line)

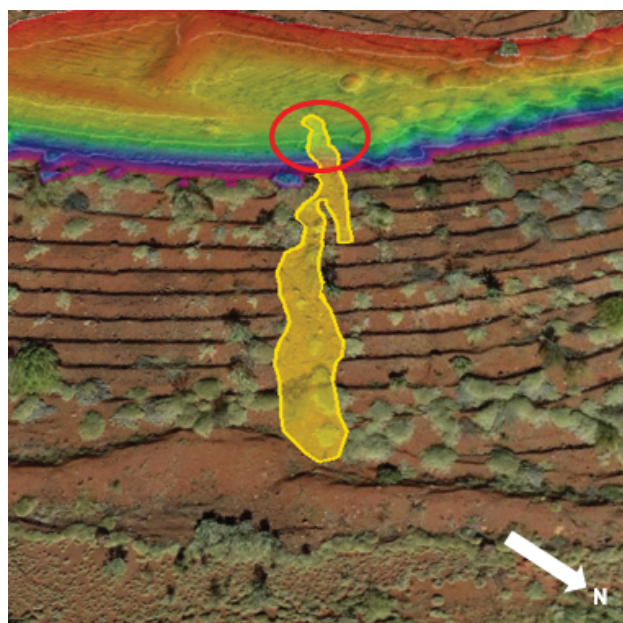
One red gully was recorded from the South Limb WRL at Pardoo (Table 4). This gully formed from ponding on a small mid-slope berm and failure of a crest bund (Figure 6). Remedial works are planned for this area during 2022 (see Section 6).

Figure 6 Elevation heat map of the Red gully at South Limb (Pardoo). Red circle indicates crest bund failure point

Minor remedial works will be undertaken at Pardoo during 2022 to repair the cause of the red gully on the South Limb WRL. Local material will be used to reform and stabilise the existing crest bund on the small mid-slope berm. The berm will be reconfigured such that water does not pond adjacent to the crest bund. A fence will also be constructed around the Bobby WRL during 2022 to reduce the impacts of livestock grazing on vegetation performance.

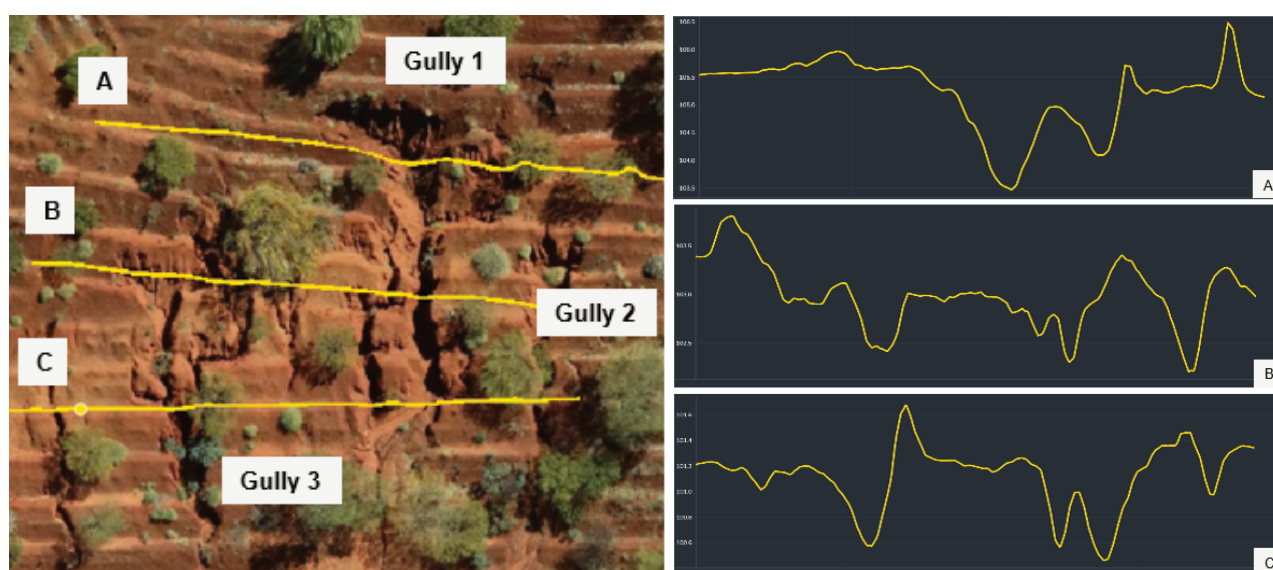
Three red gullies were identified on the Mt Dove WRL in 2021 (Table 4). All three gullies were located on the eastern WRL batter and were attributable to a combination of low stability materials, concentrated drainage along rip lines and impacts from cattle grazing (Figure 7). Remedial works were completed on this area in late 2021 and are described further in Section 6.

Figure 7 Three Red gullies present on the Mt Dove WRL. Cross-sections showing the elevation along rip lines (A, B and C) relative to batter surface

Remedial works were undertaken during October 2021 on the eastern batter of the Mt Dove WRL to repair the three red gullies and rectify the causes of the gullies (Figure 7). These gullies had formed in this area due to a surface exposure of low stability material, drainage concentration along rip lines and cattle tracks. The remedial works involved stripping topsoil and vegetation from the eastern batter, shaping and trimming the batter and infilling the red gullies, stabilising the batter by sourcing and spreading rock armour (up to 1 m thick), respreading the topsoil and vegetation mulch. The eastern batter was ripped on the contour and hand seeded.

Remedial works were also completed on the ramp and top surface of the Mt Dove WRL to improve drainage controls by bolstering crest and cells bunds, and scalloping cells on the WRL ramp. The entire Mt Dove WRL was reseeded by hand and a fence was installed around the WRL to reduce the impacts from grazing livestock.

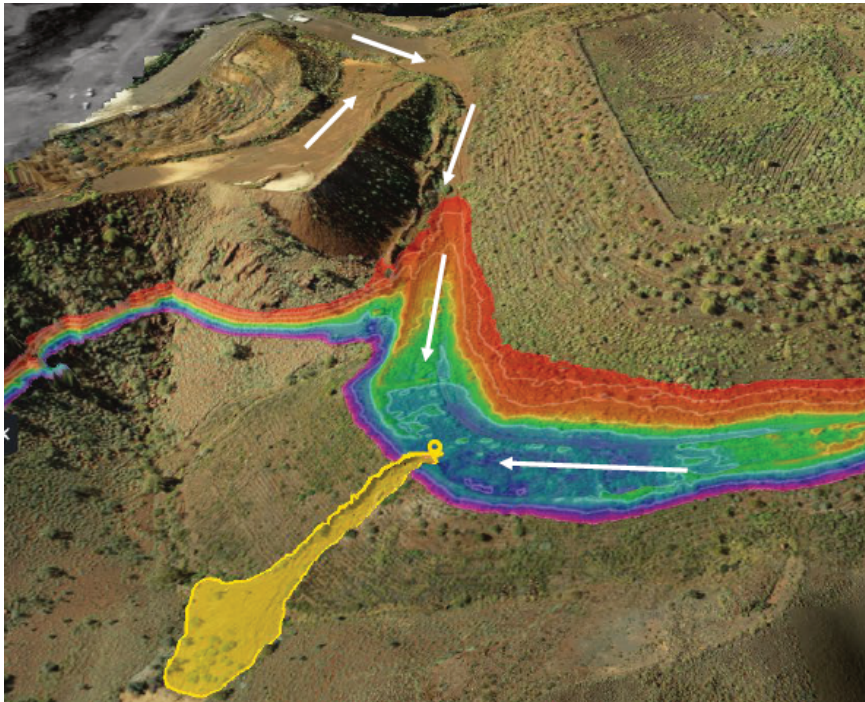
Five red gullies were recorded at Wodgina in 2021 and were on the Anson WRL. Three of the red gullies on the Anson WRL formed due to substantial upstream catchments (including pit ramps) reporting to the WRL crest and onto downstream WRL slopes (Figure 8). These upstream catchments remained open during rehabilitation works to allow access to the project areas. The remaining two red gullies on the Anson WRL

formed due to concentrated runoff along a narrow forward-sloping berm. Remedial works were undertaken for all red gullies on the Anson WRL during late 2021 (see Section 6).

Figure 8 A Red gully on the Anson WRL being fed by an upstream catchment

Remedial works were undertaken at Wodgina on the Anson WRL during October 2021. The aim was to repair all red gullies and rectify the causes of the gullies across three work areas; the northern, eastern and southern areas. These gullies formed as a result of surface water flow from upstream catchments which remained open to allow access to project areas.

Works in the northern area on the Anson WRL were focused on diverting runoff from a substantial upstream catchment (including a pit ramp) away from the WRL crest and downstream slope. The large red gully in this area was backfilled and back-sloping crest bunds were bolstered. The gully repair area and associated berm were shaped to a neat trim, contour ripped, and hand seeded.

In the eastern area on the Anson WRL, works were again focused on diverting runoff from a substantial upstream catchment (including a pit ramp) away from the WRL crest and downstream slope. The head of the red gully was backfilled and made safe, WRL crest bunds were bolstered and the repair area was shaped to a neat trim, contour ripped, and hand seeded.

Works in the southern area on the Anson WRL were undertaken to remove a narrow, forward-sloping mid-slope berm by cross-blading with a dozer to establish a single slope profile. The original closure design called for a single slope, however light vehicle access was required, and the resultant berm was not constructed as per the work pack instructions. The existing crest and cell bunds at either end of the repair area were bolstered to improve drainage controls. The repair area was then ripped on contour and seeded.

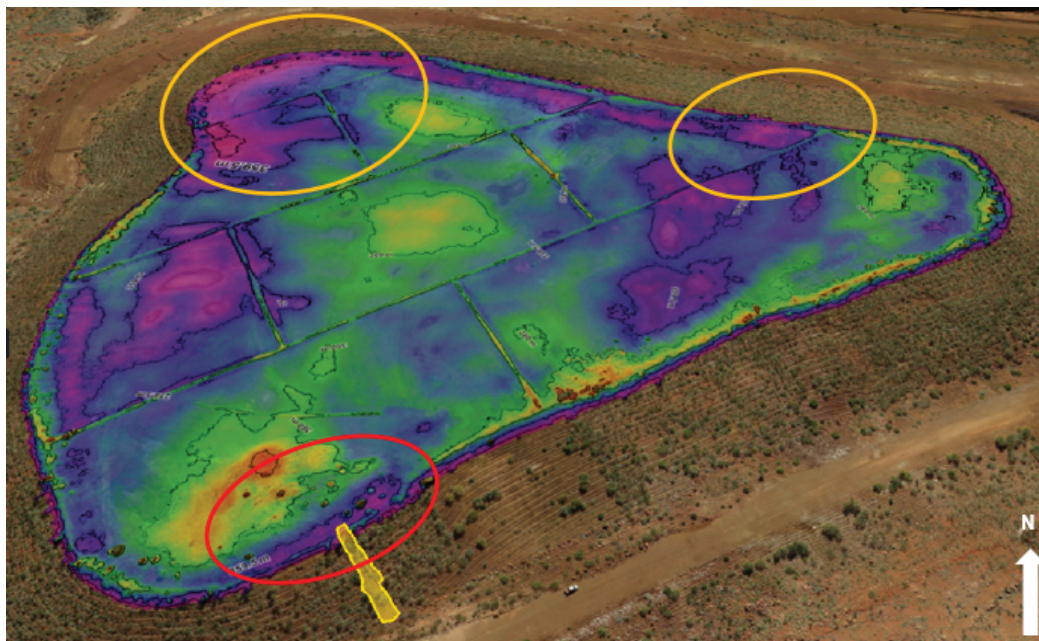
Six red gullies were recorded at Abydos in 2021, three on the Leightons WRL, two on the Mettams WRL and one on the Trigg WRL. The red gullies on the Mettams and Trigg WRLs (Figure 9) have formed from concentrated drainage on the WRL top surfaces that has reported to downstream WRL slopes. Rehabilitation of the top surface (including the construction of drainage controls) of the Mettams and Trigg WRLs has not been undertaken and is scheduled for late 2022 (see Section 6).

Figure 9 Trigg WRL top surface elevation. Circles indicates area of drainage concentration and potential (amber) and actual (red) overflow onto downstream batter

Remedial works will be undertaken at Abydos during 2022 to construct drainage controls and complete rehabilitation of the top surfaces of both the Mettams and Trigg WRLs and rectify the causes of the red gullies. This will involve constructing back-sloping crest bunds, levelling the top surfaces and establishing cells and cells bunds. Top surfaces will be ripped on the contour and seeded.

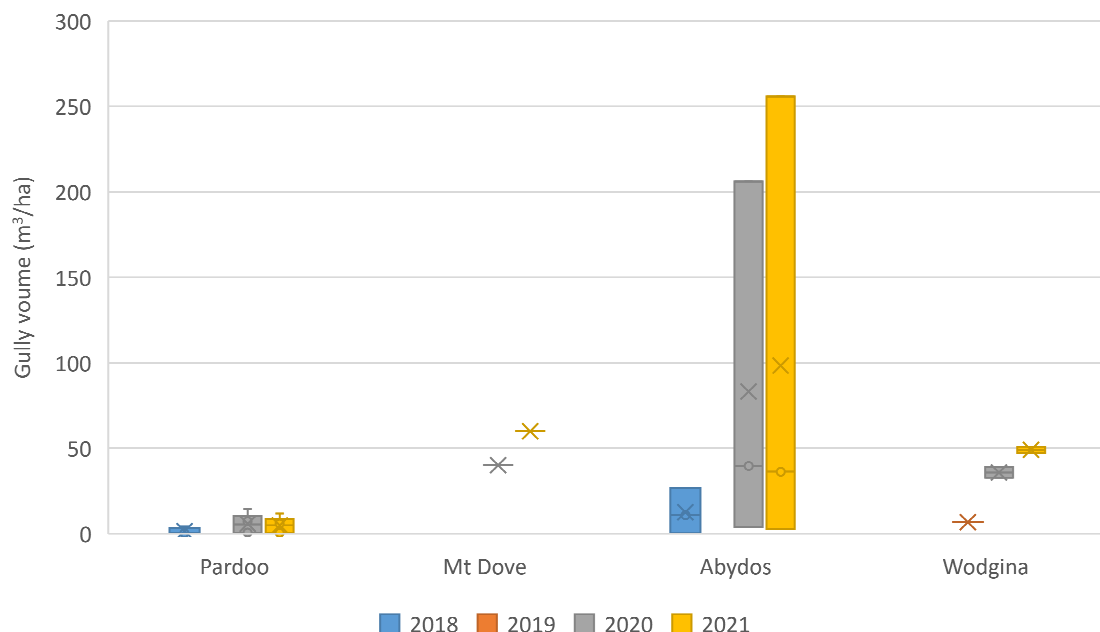
The temporal change in gully volume for each project is presented in Figure 10. Increases in gully volume between the 2020 and 2021 monitoring events was typically modest. Gully volume at Abydos is much greater than the other projects which is mainly due to the three red gullies on the Leightons WRL which had a combined volume of 250 m³/ha.

Figure 10 Box plot of gully volume (m³/ha) at each project
