Clinton creek abandoned mine/interim spillway reclamation project—status of the channel restoration effort

K Myers *The MINES Group/Geo-Logic Associates, USA*

M Nahir *Parsons, Inc., Canada*

C Gillis *Yukon Government, Canada*

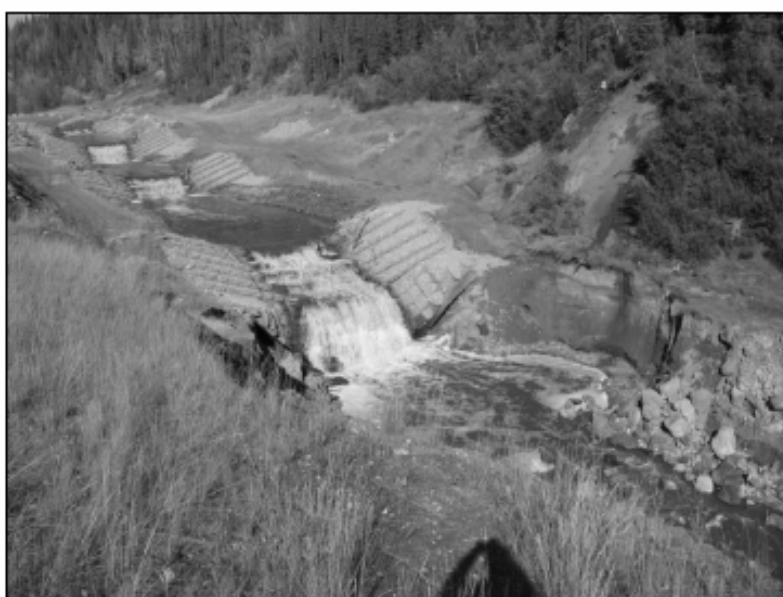
In August of 2010 an extreme storm event occurred in the headwaters of Clinton Creek, estimated to have a recurrence interval (RI) of between 100 and 200 years. The resulting flows down the spillway channel caused severe damage to the lower steps of DS4 and initiated head cutting in the channel downstream of DS4 that resulted in additional channel incision on the order of 4 m, undermining and destroying the spillway structure from its terminus back to approximately half the distance up DS4 (see Figure 3). The erosion and undercutting along the south bank triggered numerous additional failures in the waste rock pile (see Figure 4).

Figure 3 The failed drop structure 4 (DS4) following the August 2010 storm (Wingrove, 2011)

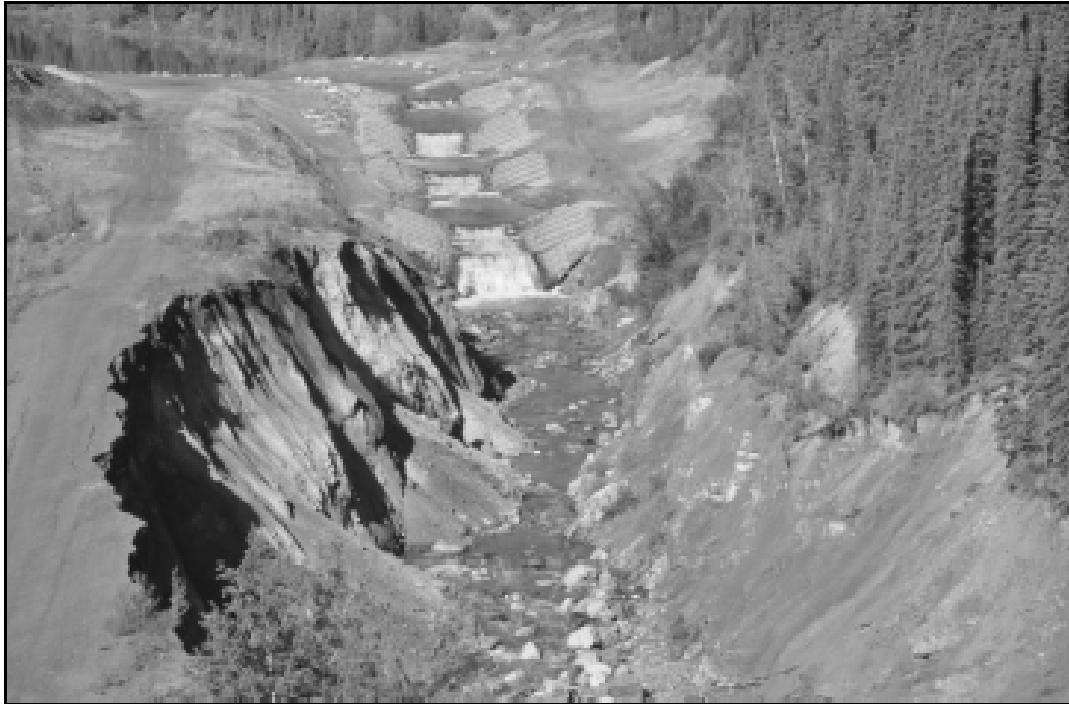
Figure 4 Additional failures in the waste rock slopes downstream of DS4 (Wingrove, 2011)

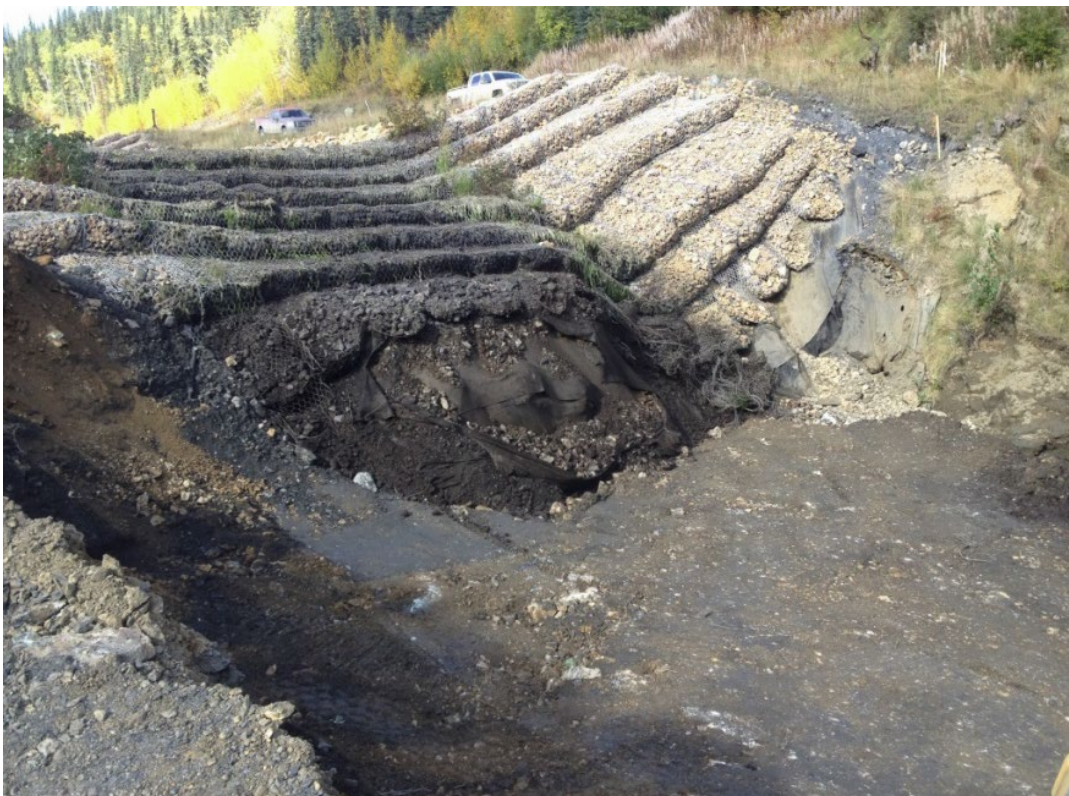
Due to access and safety issues, repairs were not completed until September of 2015. The measure consisted of backfilling the head scarp below DS4 (see Figure 5), and forming a channel chute armored by articulating concrete block (ACB) mats. By the spring of 2016 the ACB Chute was already showing signs of deformation that signalled the onset of potential failure mechanisms that would eventually result in unacceptable displacements of blocks/mats (see Figure 6).

Figure 5 The failed surface of DS4 (ADVISIAN, 2015)

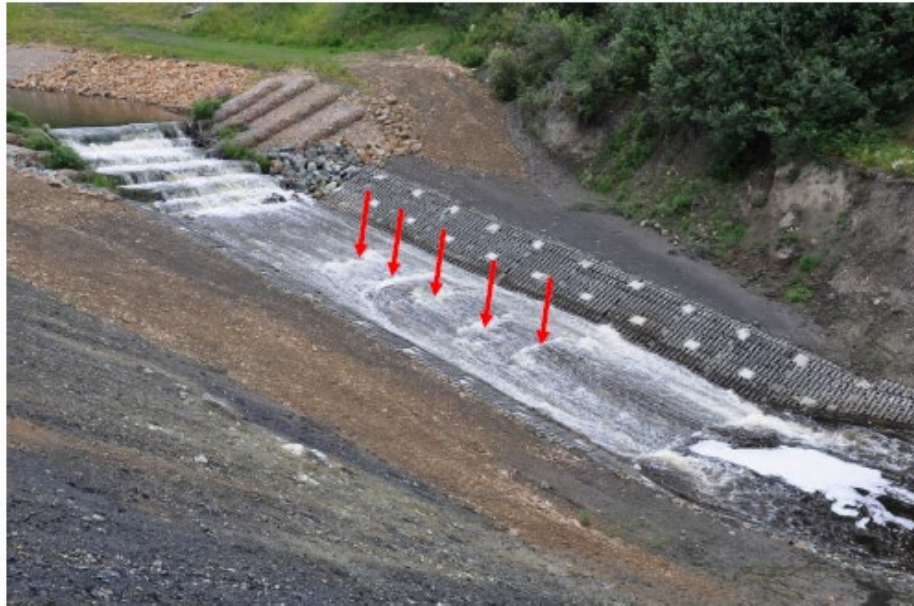
Figure 6 Displacements observed in the chute channel in 2016 (BGC, 2016)

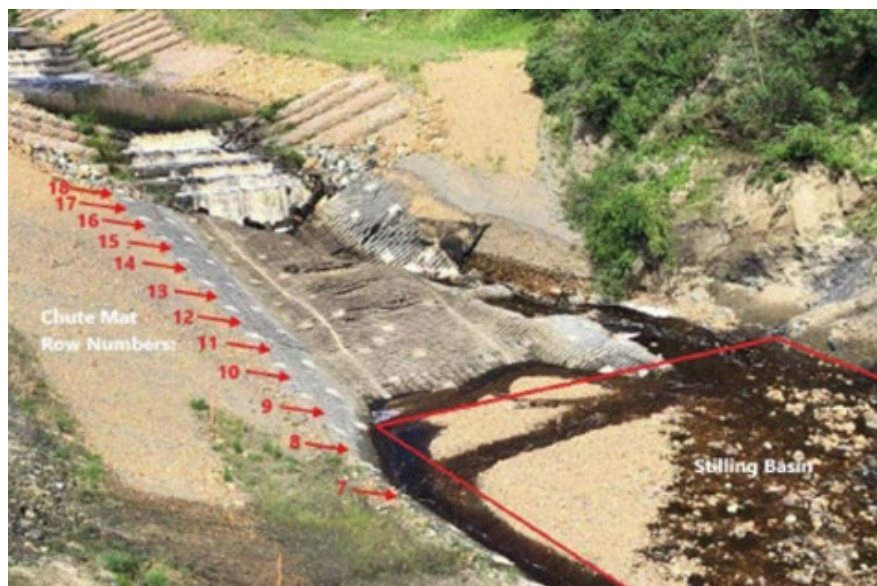
By the spring of 2018, peak flows during the 2018 freshet resulted in the near catastrophic failure of the ACB mats and caused sections of the north bank slope to fail, with the channel eroding severely (see Figure 7).

Figure 7 Failed configuration of the ACB mat chute structure in the spring/summer of 2018

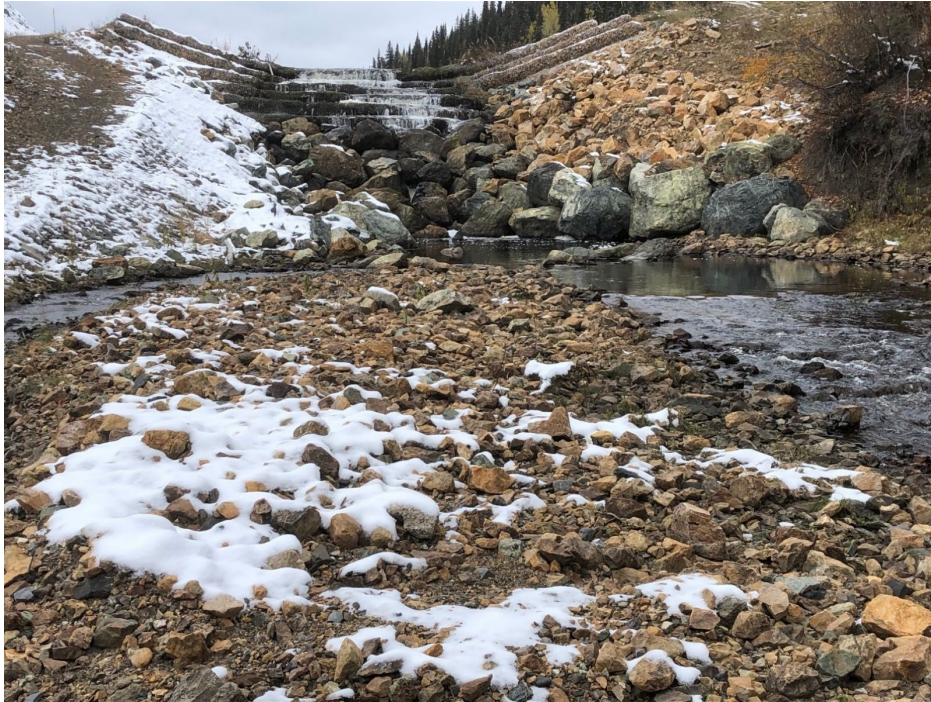
Figure 8 shows the current configuration of DS4 as of a site inspection conducted by Parsons and MINES Group/GLA personnel in September of 2021, which visually showed minimal changes in the condition of DS4 and the channel reach immediately downstream since the emergency field fit repairs completed by Tetra Tech in 2018. The failure surface in the lower portion of DS4 has been armored with very large boulders of durable rock. The current project intends to provide a formal design for the repair of the damage from the 2018 failure of the DS4 drop structure and the ACB Mat lined chute that will provide the needed interim protection of the Clinton Creek landslide dam and spillway structure until such time as the final spillway facility can be designed, funded, and implemented at the site. The design should be capable of passing the largest practical peak design flood flow that can be accommodated within the existing canyon floor and regrading the waste rock slopes above the canyon floor to a stable configuration.

Figure 8 View of the current configuration of the Clinton Creek channel below DS4

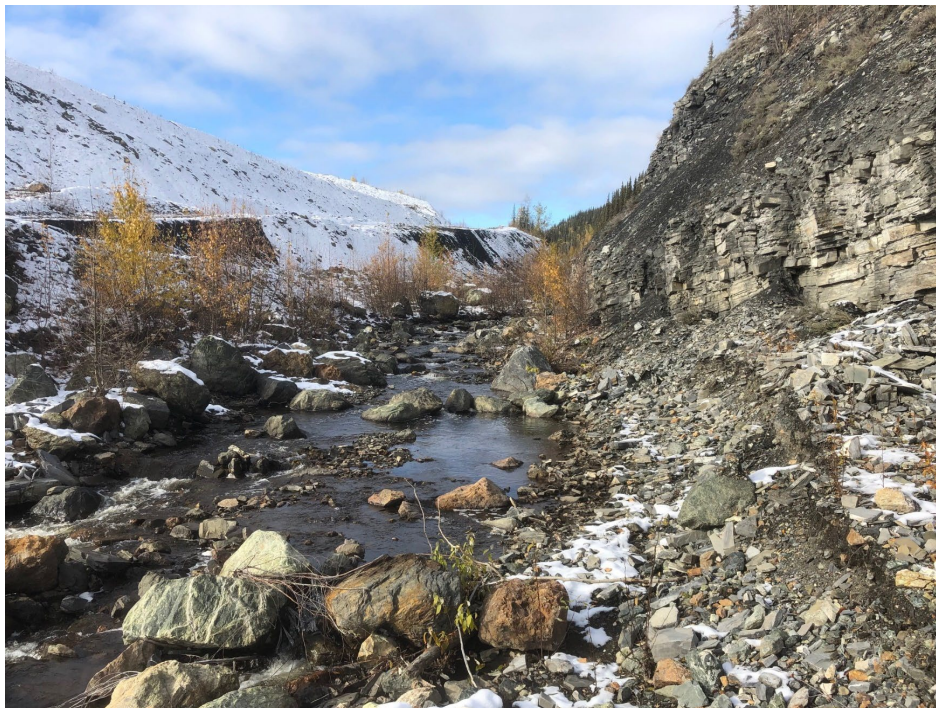
The bedrock unit exposed in the Clinton Creek channel is an argillite unit (Pza) described mainly as a fragile carbonaceous argillite with well-defined cleavage. However, the unit exhibits multiple facies including limy argillite, limestone, and limy sandstone (see Figure 9). The limestone and sandstone facies, although sufficiently durable to inhibit erosion, are still subject to hydraulic plucking and transport during extreme events due to the thin bedded, and platy nature of the structure (see Figure 10).

Figure 9 Exposure of the limestone facies of the argillite unit

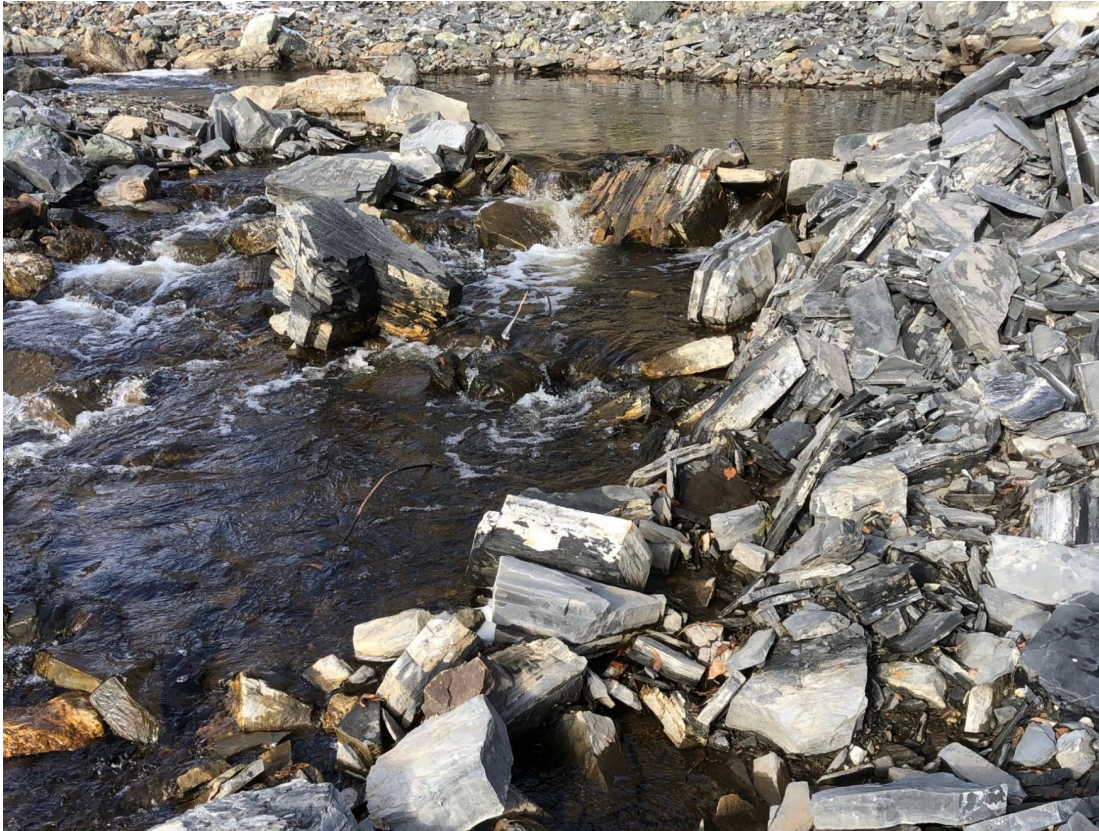
Figure 10 Chaotic piles of platy bedmaterial deposited on flat shelves of intact rock

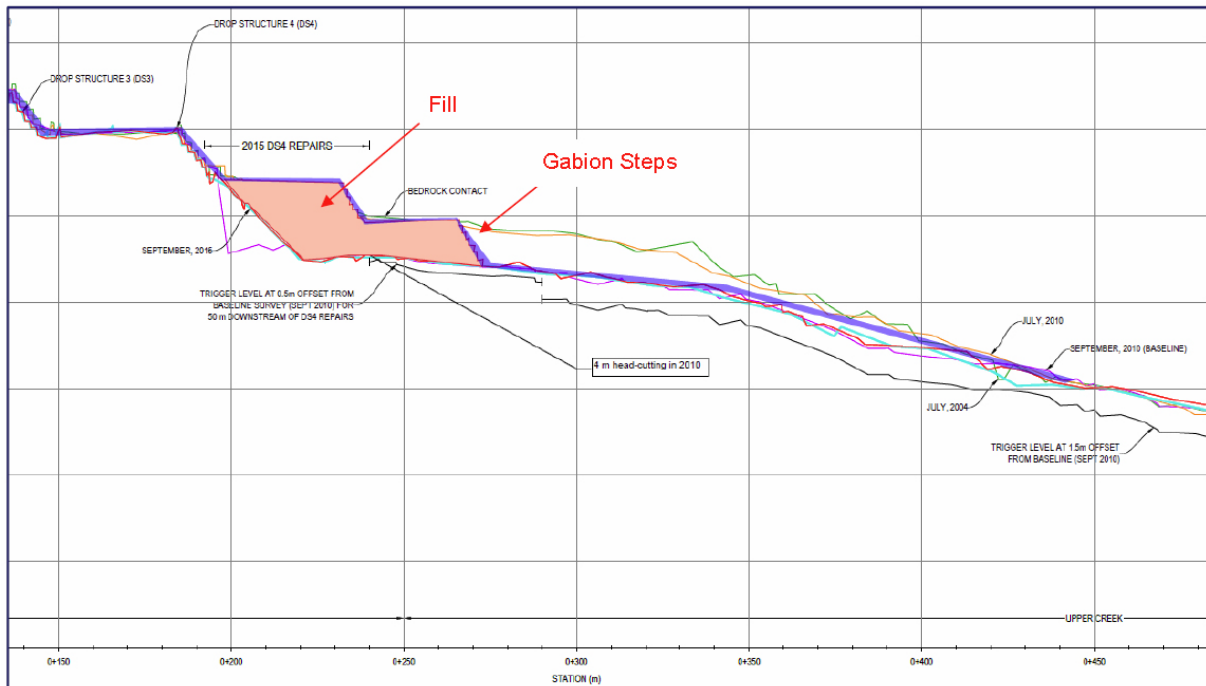
Figure 11 Schematic representation of option 1, drop structures with fill (JACOBS, 2019)

The concept of Option 1 is to construct a series of additional drops, similar to those used in drop structures 1 through 3, to safely deliver the flow to the current elevation of the Clinton Creek channel bed (Jacobs,2019, see Figure 11). Based on a review of the performance of the original drop structure configuration during the 2010 flood event and the more recent failure of the ACB mat and plunge pool structure, it was recommended that the design of the repair of the reach below DS4 consider the following general principles:

1. Limit the hydraulic head drop at each of the drop structures (based on the performance of DS1, DS2, and DS3 a maximum drop of 2.5 m was recommended).
2. Provide a horizontal apron of sufficient length to dissipate the energy of the drop (again, based on the performance of DS1, DS2, and DS3 a minimum length on the order of 30 m was recommended).
3. Extend the profile of the hydraulic drop to meet the downstream slope.

This approach relies heavily on consistency with the generally successful performance of the existing structures upstream (DS1, DS2, and DS3). It requires the filling of the existing channel bed scoured by the head cutting event of 2010 to pick up the remnants of DS4 forming the first in a series of smaller drops and extends the sequence of new drop structures downstream until the final plunge pool and apron can deliver subcritical flow into the current Clinton Creek channel bed. This option is believed to provide the highest degree of reliability and lowest risk of failure among all of the considered options for the interim spillway.

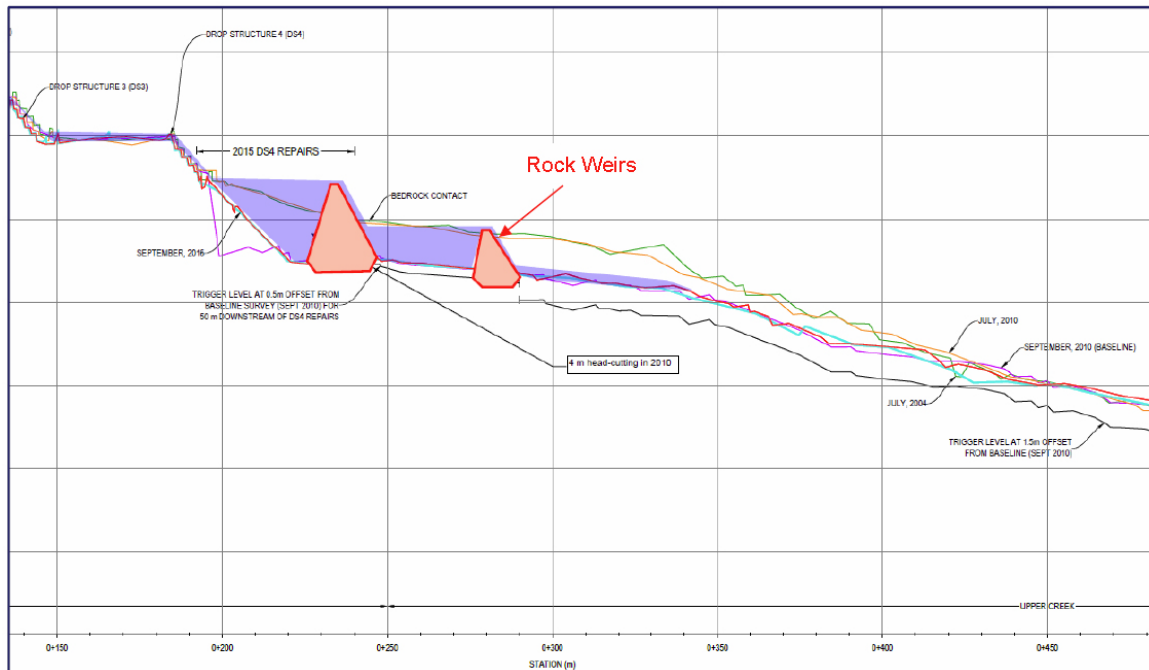
This option is similar to Option 1, except that the drop sections consist of a standalone rock weir with no fill material in between (Jacobs, 2019, see Figure 12). Regardless of the seepage capacity of the embankments, during high flows the small reservoirs will be full and the dams will be experiencing an overtopping flow during the design flow event. Therefore, the downstream face of the dams must be designed to safely accommodate this overtopping (which would strongly favor the use of gabions over rockfill). Rock chutes and riprap lined surfaces will often fail first not in a hydraulic transport mechanism but in a mass wasting type of failure or slide (usually a thin, uniform thickness referred to as an ‘infinite slope’ failure). This represents a significant risk for this option, even for a downstream slope that mimics the slope of the gabion drops (25% or 14°). An estimate of the Factor of Safety against an infinite slope type of mass failure during the passage of the design discharge event is 0.80 (assuming a layer thickness of 1.4 m, a flow depth of 0.7 m, seepage parallel to the slope, and an effective stress friction angle equal to the angle of repose estimated to be 42°). For all the above-described reasons, it is believed that the risks associated with this option are considerably higher than those associated with Option 1.

Figure 12 Schematic representation of option 2, drop structures with no fill (JACOBS, 2019)

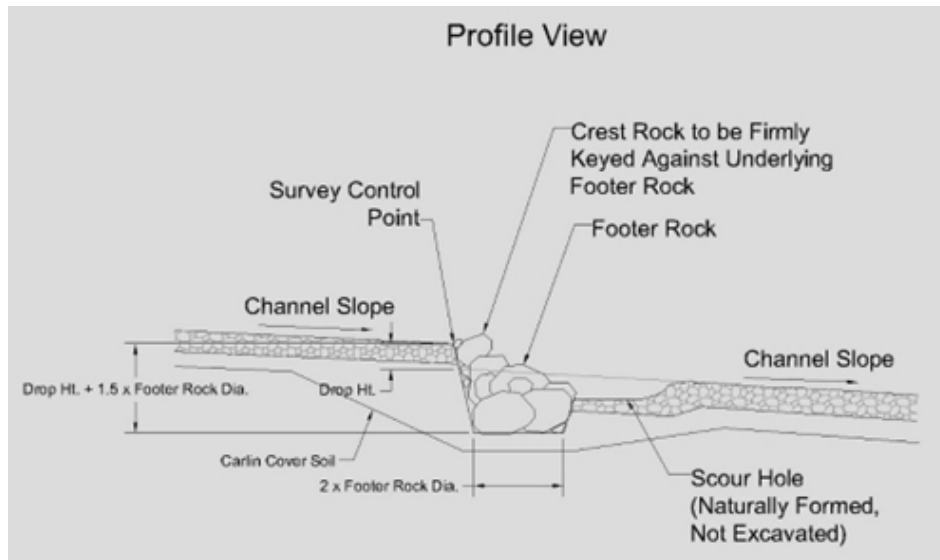
Figure 13 Rock vortex weir grade control structure creating steps in the step-pool channel (Parsons,2021)

The creation of a more natural step-pool channel profile in Clinton Creek (see Figure 13) and an associated ‘in regime’ channel approaching a condition of dynamic equilibrium is an excellent alternative that would provide any number of benefits in addition to merely providing energy dissipation and improving erosional stability. One of the benefits to this type of geomorphic design and channel restoration is that the channel is no longer a single purpose feature (i.e., not just a ditch to pass water). It is now a self-sustaining and self-maintaining stream with aquatic habitat consistent with unimpacted natural channels. One can even incorporate features like riffles for the production of invertebrate communities (fish food). Vegetation can often be used to create self-sustaining erosion protection and to create riparian habitat that will allow the stream corridor to function near its peak potential. Water quality can be improved by minimizing bed and bank erosion. Often a temporary diversion channel designed for operations will require further modification prior to final reclamation and abandonment. The restored channel system will already be adapted to the watershed and the natural channel systems, will be revegetated, and will have natural function and habitat values restored. It will often require no further modification prior to closure and abandonment and thus will eliminate those costs at the time of final reclamation.

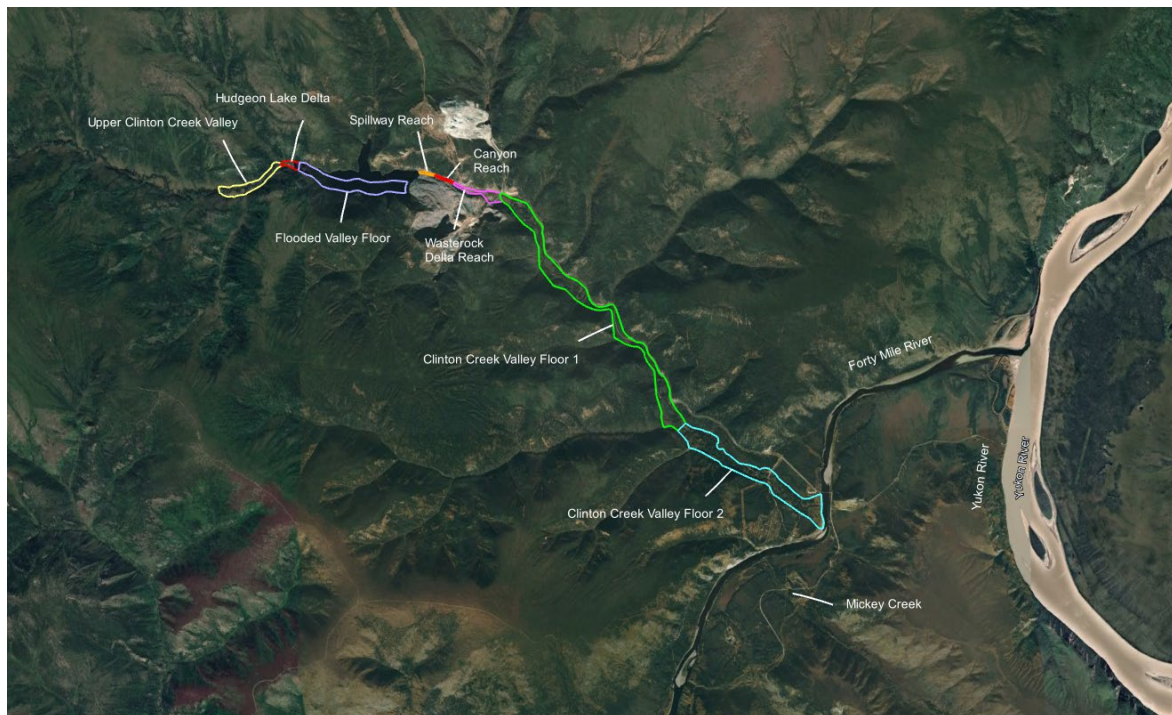
For the purpose of describing the fluvial geomorphology of the Clinton Creek channel, we divided the channel into seven (7) reaches with distinctly different characteristics (see Figure 14). The transect locations were chosen based on the following criteria:

Small flows are passed with little erosion on the low flow channel in the argillite/limestone, but large flows reach the easily eroded waste rock at the toe of the south bank and start cutting out the toe. This initiates a common cycle of channel type transition. A Type G channel (erosion gulley) forms at the toe of the waste rock pile. This type of channel is narrow and deep with maximum stream power and sediment transport capacity and quickly cuts below the existing channel bed diverting most or all of the flow into the formation of a headcut. Once the headcutting reaches its limit (peak flow subsides, caving of the bank inhibits further down cutting, etc.) a new base level is formed, and the channel begins adjusting to the new condition. Now the channel transitions from a Type G channel to a Type F channel which is focused not on deepening the channel, but on widening the channel in an attempt to reform a floodplain. Eventually, if the cycle were allowed to progress to completion, a new active floodplain would be formed, and a Type B or Type C meandering channel would be formed within the limits of the floodplain restoring the channel to an in-regime condition and long-term dynamic equilibrium/stability. However, the Clinton Creek channel has not been able to complete the cycle before yet another headcutting erosional event restarts the cycle. This accounts for the presence of the Type F channels in the Canyon Reach with abnormally high gradients, and in the upper portion of the Waste Rock Delta Reach and is consistent with the history of multiple destructive headcutting events in the channel.

Figure 14 The seven stream reaches of Clinton Creek
