Risk considerations for Brazilian tailings dam closure

DG Ritchie SLR Consulting (Canada) Ltd., Canada

This paper discusses the dam closure risk considerations and experience on various dam safety audits carried out by SLR Consulting (Canada) on behalf of MPMG. The audits involved dams raised by a variety of methods including the upstream method founded on deposited tailings. In general, the focus of the technical audits included geotechnical characterization of the dam and foundation, dam design and construction stewardship, public and worker safety, and emergency preparedness, from the perspectives of both Brazilian regulations and international tailings and dam safety practice. Case studies are presented within three groupings to highlight various experiences: modifications introduced for works that had been carried out prior to commencing the audits, works designed and executed during the audit oversight, and design and planning considerations for closure works that are in progress for high-risk upstream-raised tailings dams. For all cases, the long-term risks, credible failure modes, and operational controls during construction are discussed.

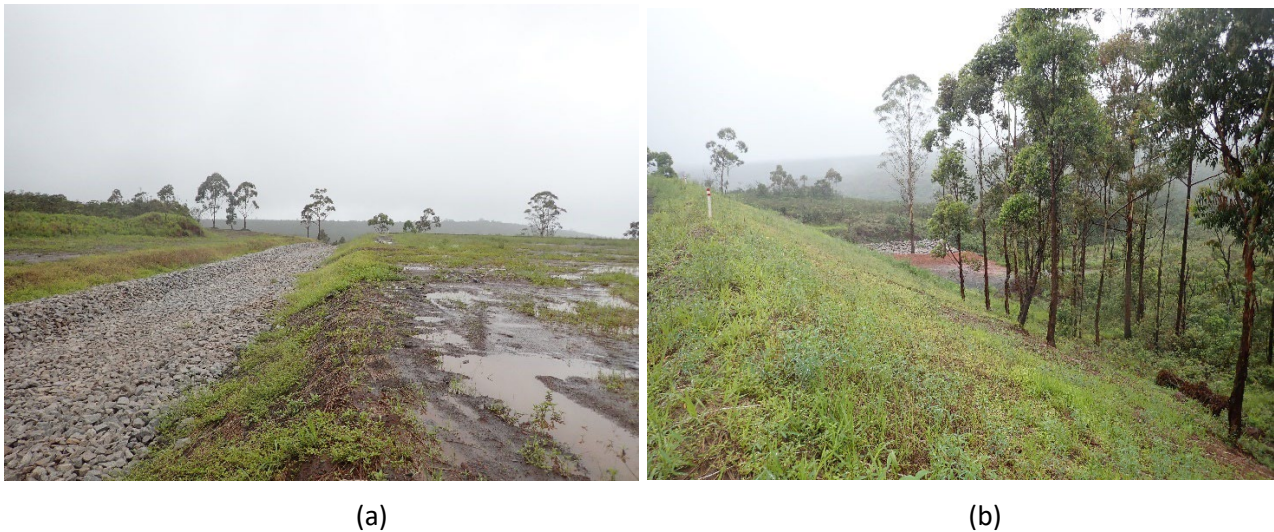
The decommissioning project regraded the surface of the sediments retained behind the dyke with a 1% slope toward the perimeter channel on left flank of the basin that passes through the left abutment of the embankment (Figure 1). During the initial site visit it was observed that surface settlement had resulted in ponding and therefore increased infiltration.

Upon commencing the audits, the dam had no instrumentation to record the phreatic level within the dam or track deformation trends. Through discussions it was also determined that the spillway design and construction did not consider the potential for erosion of the weathered rock profile below the erosion protection forming the spillway invert.

Figure 1 December 3, 2019 photographs of Cobras Dam. (a) Surface ponding and rock lined channel at left flank / dam abutment; (b) Downstream slope of the dam and spillway chute in background

- spillway channel erosion leading to abutment and dam slope instability,
- slope instability due to lower than expected fill shear strength, and
- overtopping during the design flood generated from the probable maximum precipitation.

SLR recommended that Vale update the stability analysis considering the lower friction angle and reduced apparent cohesion values, and consider a downstream slope with a flatter gradient to reduce the risk with respect to long term, progressive and erosional failures on the slope, and reduce maintenance requirements.

In 2022, Vale installed four piezometers in the Cobras structure, with three piezometers in the dam fill and one in the foundation. Piezometric data has not been evaluated by SLR to determine if additional instruments should be installed.

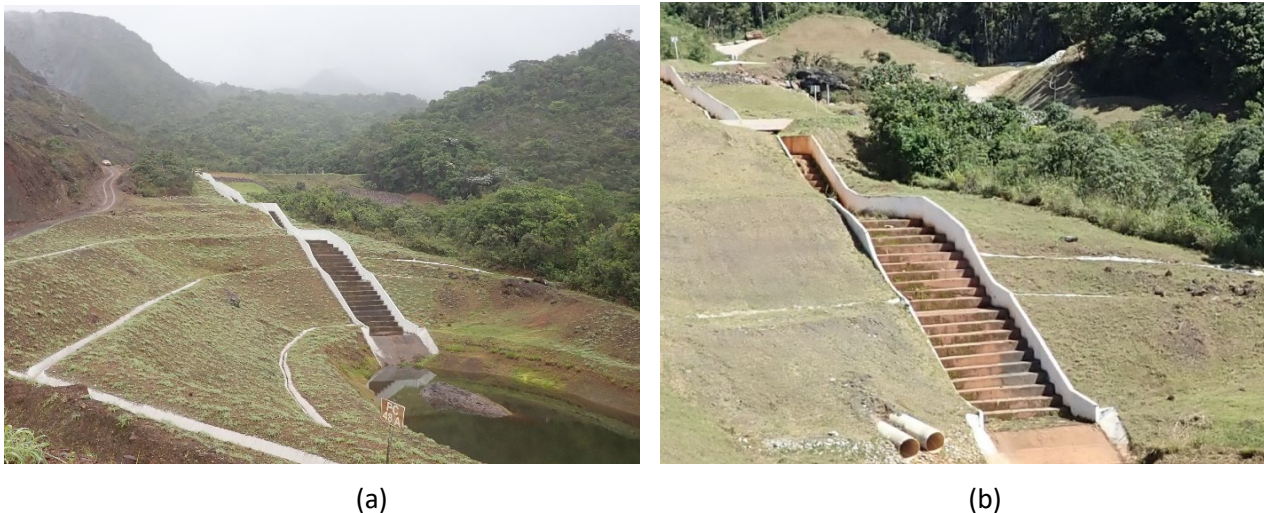
The dam condition at the start of the audit program is shown on Figure 2(a).

Vale installed the twin pipelines comprising the secondary spillway evident on Figure 2(b), however construction challenges related to the steep terrain and deficiencies with adequate pipe bedding and cover compaction meant several dam safety issues were raised including potential pipe failure leading to erosion and failure of the dam. Additionally, a portion of the upstream slope slumped after Vale excavated the sediments upstream of the dam and abrupt piezometric responses in the dam were observed following a storm and a rapid pond level increase suggesting the presence of construction defects. Vale quickly constructed a low permeability soil cover on the upstream dam slope to impede further flow into the dam and no serious consequences occurred.

Figure 2(b) shows the dam structure has been completely removed. No credible failure modes have been identified for the decharacterized structure.

Figure 2 Photographs of Paracatu Dam. (a) Original condition, December 3, 2019; (b) After dam removal May 2, 2023. Note the two buried pipes near the stepped spillway chute.

Considering the secondary spillway pipeline dam safety issues, poor dam design and construction stewardship, Vale elected to remove the dam completely and control surface runoff with an excavated sediment pond and concrete drainage channel. Precipitation runoff from the upstream catchment flows through a sediment pond excavated in the natural ground upstream of the former dam location and discharges into a reinforced concrete channel and reports to the original energy dissipation basin. This example illustrates the benefit of adequate geotechnical characterization and dam design stewardship in the decision process.

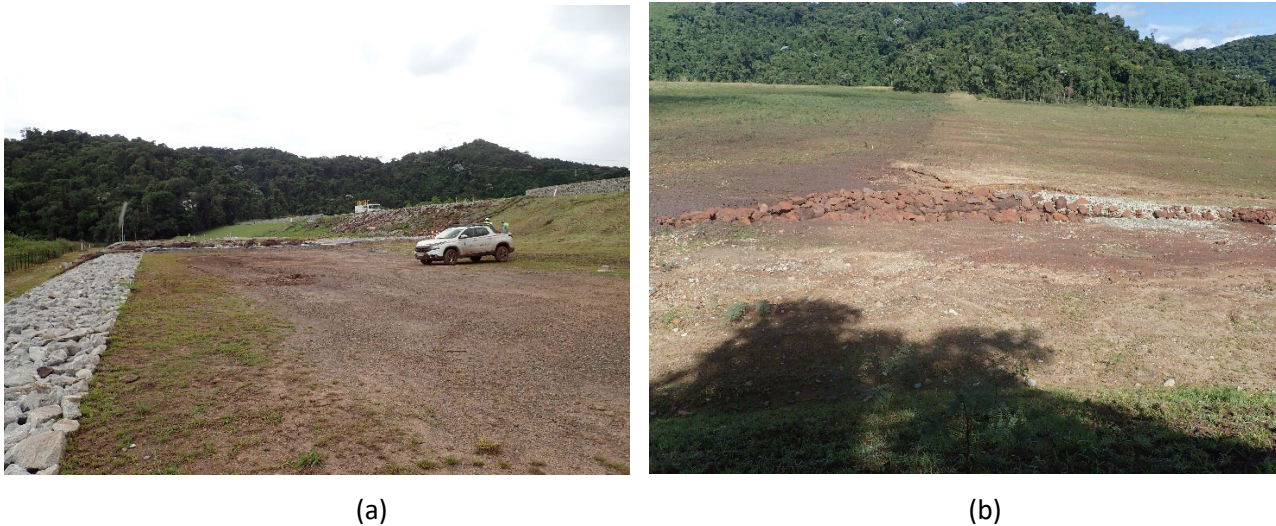
Figure 3(a) shows the Auxiliary Dyke in 2021.

Figure 3 Photographs of MAC B5 Auxiliary Dyke. (a) Original condition, November 19, 2021 with lower upper terrace at the right; (b) Sloping tailings surface and drainage swale April 17, 2023.

As an upstream raise, the only option for Auxiliary Dyke closure was full removal. The closure design comprised excavating tailings from upstream of the Auxiliary Dyke, placing the excavated tailings downstream of the Auxiliary Dyke and removing most of the Auxiliary Dyke fill to create a 4% slope from upstream to downstream.

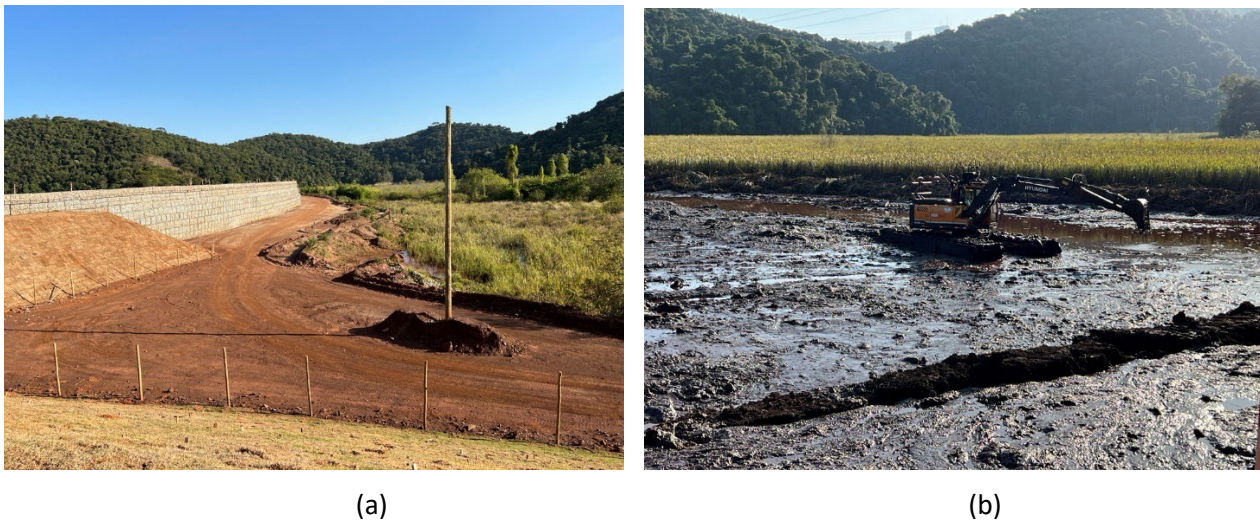
Upon commencing closure construction, Vale experienced difficulty lowering the water table in the tailings and managing water within the tailings excavation area which inhibited excavator movement. Vale continued to maintain deep ditches upstream of the excavation area and along the left margin of the impoundment, but the shallow ditches were not constructed, and ballast was used to support truck movement closer to the excavation area. Due to the inability to place and compact saturated tailings, imported soil was used to complete the downstream fill section. This example highlights the benefit of options studies and maintaining flexibility and contingencies when developing the construction execution plans.

Figure 4 Photographs of MAC (a) Gabion wall on Dam 5 crest, May 30, 2022; (b) Challenges moving amphibious excavator upstream of Auxiliary Dyke due to saturated tailings, May 30, 2022.

Regardless of the execution option, Vale constructed a 7 m high (Elev. 927 m) gabion wall on the crest of Dam 5 to protect against potential overtopping in the event of an Auxiliary Dyke failure and tailings mobilization. Tailings removal commenced only after the gabion wall construction was complete.

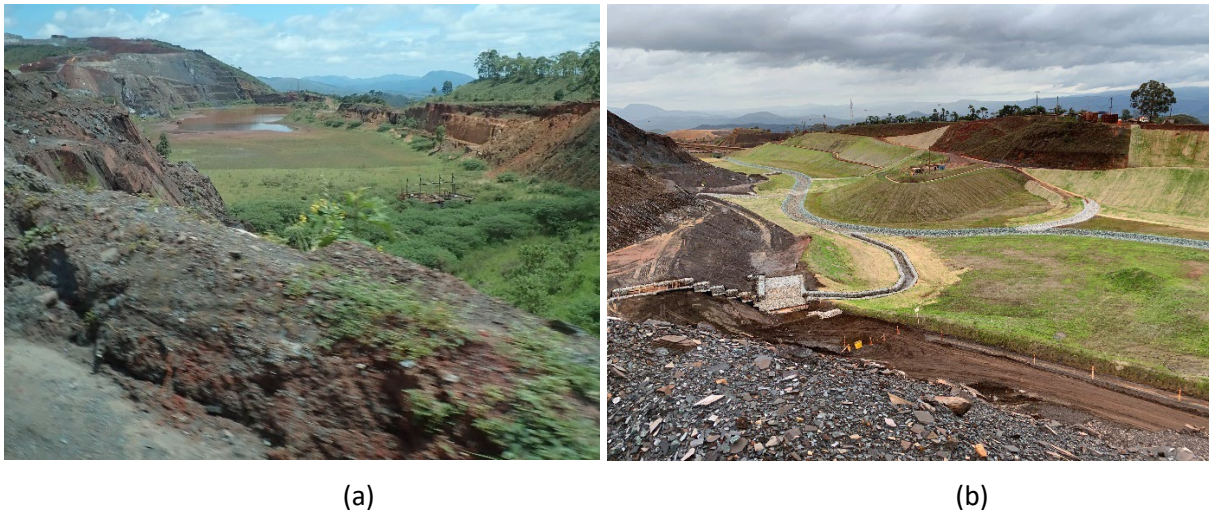
Construction execution planning for Fernandinho closure considered the possibility of tailings liquefaction induced by construction equipment vibrations, with a higher risk near the dam. Vale conducted a vibration test on the Fernandinho tailings several hundred meters upstream of the dam to measure peak particle velocities and induced porewater pressures. The phreatic level in the Fernandinho Dam and tailings was sufficiently deep that no significant risks were identified with the induced vibrations. However, vibration test results were evaluated and standoff distances from the dam crest were set as a precaution.

Figure 5 Photographs of Fernandinho. (a) Prior to closure, January 15, 2020; (b) Advanced closure implementation, November 19, 2021.

Fernandinho closure construction was completed in 2021 including full removal of the dam, construction of a central drainage channel, and vegetation of the tailings surface and basin (former pit wall) slopes.

No significant construction monitoring activities were required because the dam had a low phreatic level and no significant pond. Tailings were excavated and hauled to mined out open pits. The central channel over the remaining tailings was designed to convey the 10,000-year flood with energy-dissipation prior to entry into the mined-out open pit located downstream. Design considerations included stabilization of the impoundment rim slopes after tailings removal, the stability on adjacent mine infrastructure and buildings, water management and revegetation.

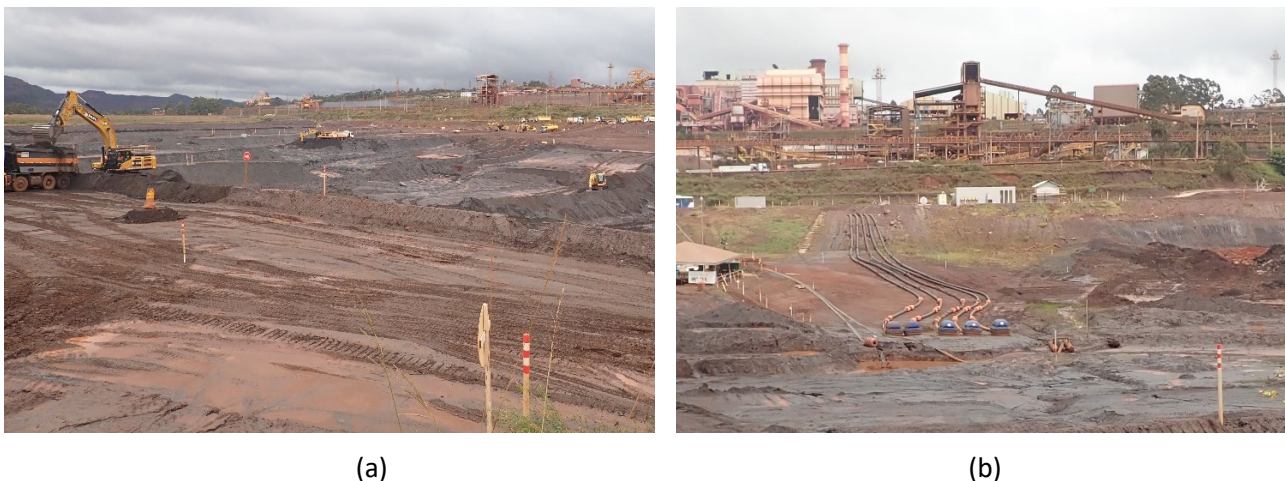
Vargem Grande is currently at Emergency Level 1 because of susceptibility of failure due to tailings liquefaction. Since 2019, Vale has conducted continuous improvements to the dam including pumping out the pond, reconstitution of the foundation drainage outlet, surface drainage improvements and installation of sediment control measures. Channels have been cut into the tailings to better manage drainage from the beaches and from within the upper tailings.

Safety concerns during closure construction include dam slope instability due to tailings liquefaction or softening due to induced vibrations or high water levels. The relatively complex dam foundation conditions that have been approached differently by various reviewers, auditors and designers has resulted in various opinions of the dam safety conditions. Similarly, poor installation of dam instrumentation and a lack of stewardship of the data obtained has resulted in uncertainty regarding stability.

Figure 6 Photographs of Vargem Grande, April 19, 2023 (a) Low drainage channels allow excavation of drained tailings; (b) The operational sump level at elevation 1,293 m is approximately 9 m below the working tailings surface, and standby pumps ready for the rainy season.

Vale has adopted a pragmatic approach to excavating the tailings progressively, starting from the upstream side of the basin and working towards the dam in order to take advantage of experience that will be gained through the work to minimize risk.

Based on lessons learned from Fernandinho, channel excavation and lowering of the water table before excavating the partially drained tailings are being implemented successfully. A sump was established in natural ground prior to commencing significant tailings excavation. Drainage channels discharging to the sump are completed in a grid fashion prior to commencing tailings excavation (Figure 6). The water level is maintained approximately 5.5 m below working tailings and drains readily to the sump which is about 3 m lower.

Safe limits have been set for the overall slope height and inclination to limit shearing and strain within the tailings to mitigate static liquefaction concerns.

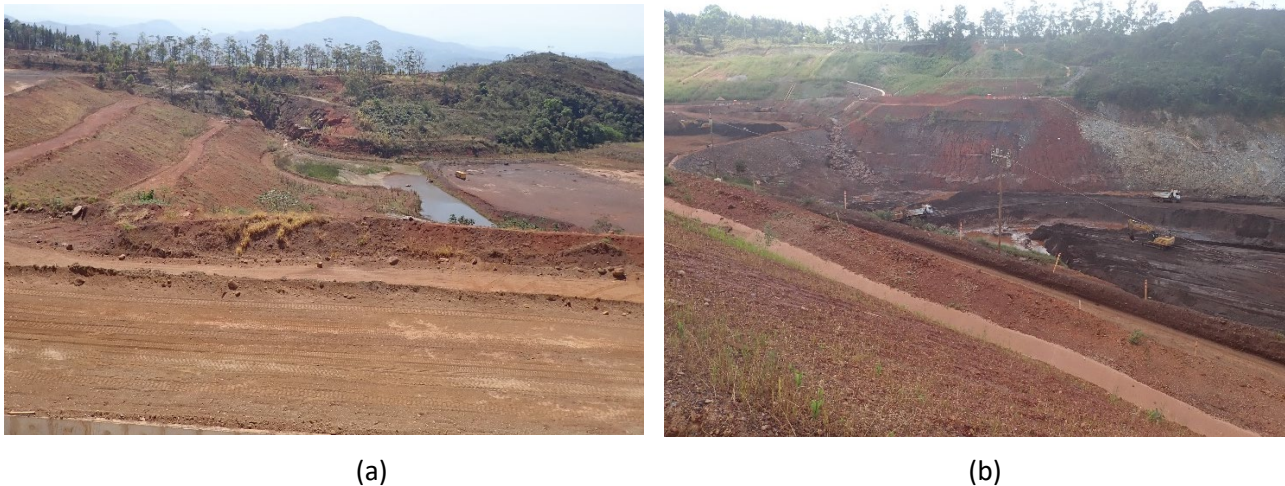
The dam was at Emergency Level 3 because the static slope stability requirements are not satisfied, and the retained solids are in a contractive state and therefore prone to static and dynamic (seismic) liquefaction.

The emergency spillway is also not sufficient to protect the dam by safely passing runoff from extreme storm events.

Figure 7 Photographs of B3/B4. (a) PDE X and pond, September 23, 2019; (b) Sump located near original ground level, PDE X, and depth of tailings removal on the left flank, April 18, 2023.

Prior to commencing any excavation Vale constructed a rockfill backup dam approximately 10 km downstream of B3/B4 that provides adequate storage to contain a total release of the B3/B4 tailings, the dam fill, and a portion of PDE X along with storm runoff reporting with the released tailings. Citizens within the potential inundation zone were evacuated and work on the dam and within the potential inundation zone is performed using remotely operated equipment. In this sense the work did not proceed until there was no risk to citizens or workers.

The decommissioning plan involves removal of B3/B4 and the upstream tailings slowly in stages so as to avoid triggering liquefaction. The initial works involved removing a portion of PDE X to expose natural ground (weathered rock) at the toe of the stockpile thereby creating a separation between the tailings and mine waste.

Maximum slope height and inclination limits have been set for excavation in the tailings to limit shearing risk, and instrumentation has been installed in the dams and around the perimeter of the tailings to measure the vibration levels induced by the construction equipment to mitigate liquefaction risks. The current dam instrumentation is appropriate for detecting conditions that could lead to the failure modes identified, except seismic liquefaction. Diversion channel and PDE Oeste slope inspections are carried out to identify concerns related to slope instability and ditch blockage, particularly in the rainy season.
