Development of a site-specific, relative hazard prioritization tool at a legacy mine district in British Columbia

J Nikl WSP Canada Inc., Canada

M Slater Teck Metals Ltd., Canada

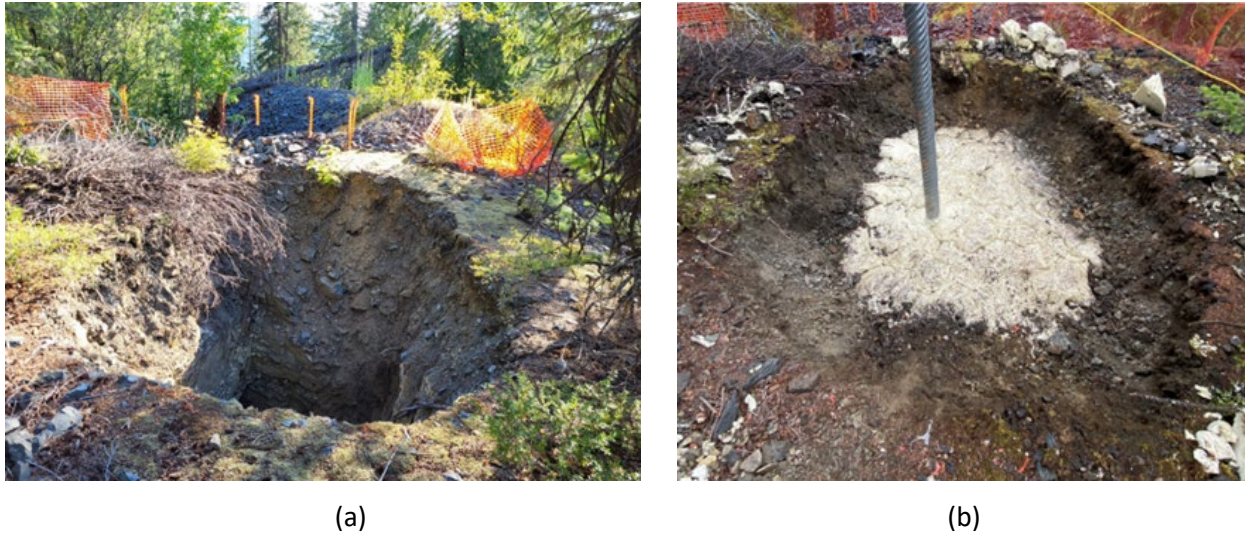
Example Feature A is a shaft which historical records indicate was sunk prior to 1915 and for which mitigation records indicate it has been backfilled by the owner twice in the past. Between the 2018 and 2019 annual monitoring programs, the backfill had collapsed to a depth of around 7 m (Figure 6a). The relative priority can be evaluated for two scenarios for the shaft feature: (1) 2022 condition, pre-mitigation, and (2) 2022 condition, during mitigation.

Figure 6 Example Feature A: shaft surface feature with failed waste rock backfill: (a) Scenario 1: 2022 condition, pre-mitigation; (b) Scenario 2: 2022 condition, during mitigation (Sandve et al. 2023)

The flowchart in Figure 5 is then used to evaluate the relative hazard rating. For the first scenario, illustrated in Figure 6a, the shaft feature falls within the farthest category to the right (no mitigation or failed historical temporary mitigation), which places the shaft within column F. Column F is designed to be the most critical possible category, as open features such as shafts and stopes represent the highest relative hazard to the public for the surface features recorded the Site's GIS database.

Using the accessibility factor and relative hazard rating, Example Feature A can therefore be plotted on the hazard prioritization tool chart shown in Figure 7. For Scenario 1 (failed backfill/open shaft), the shaft plots as 6F, high relative priority.

For Scenario 2, the shaft feature falls within the second category from the left on the Figure 5 flowchart (investigation confirmed geometry and, if open to surface, engineered temporary mitigation). Figure 6b shows the mitigation with a polyurethane foam plug prior to the cover placement. Further information on the engineered temporary mitigation of Example Feature A is provided by Sandve et al. (2023). Moving down the flowchart, no surface expression is observed, placing the mitigated shaft feature within column C.

Using the accessibility factor and relative hazard rating, Example Feature A can therefore be plotted on the hazard prioritization tool chart (Figure 7) following the engineered temporary mitigation. For Scenario 2, the shaft plots as 6C, low relative priority.

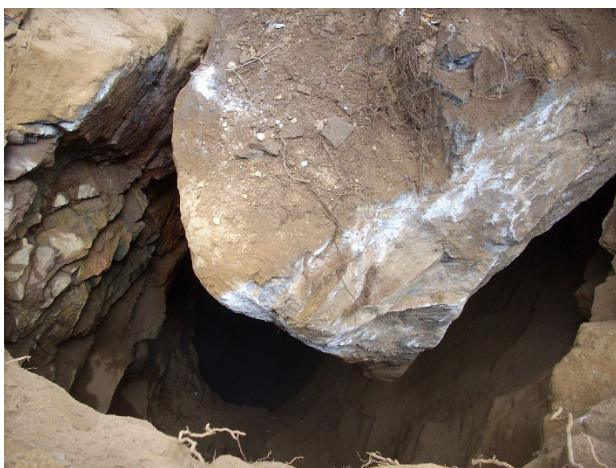
(a)

Example Feature B, shown in Figure 8, was an open shaft feature which had been previously temporarily backfilled with boulders and waste rock. In 2008, there was concern with migration of the backfill to deeper mine workings and a permanent mitigation solution was required. The shaft opening was observed during the investigation to be 3.9 m by 1.8 m by at least 13 m deep with a large boulder partially blocking the surface opening (Figure 8a). An engineered, reinforced concrete cap was constructed over the shaft (Figure 8b). Following the concrete cap construction this feature was also included in the permanent perimeter fence installation around the main property. The relative priority can be evaluated for two scenarios for the shaft feature: (1) pre-mitigation condition, and (2) post-mitigation condition.

- Closest known access type: 1 (unmarked trail access).
- Proximity to access: 4 (≥ 10 m to < 25 m, the distance from the shaft to the trail, measured in the GIS database).
- Correction factor for fenced sites: 1 (no correction factor applied).
- Relative Hazard Rating Flowchart: F (historical temporary mitigation starting to fail).

Using the information above, Scenario 1 for Example Feature B can be evaluated as 4F, high relative priority, on the hazard prioritization tool chart shown in Figure 7.

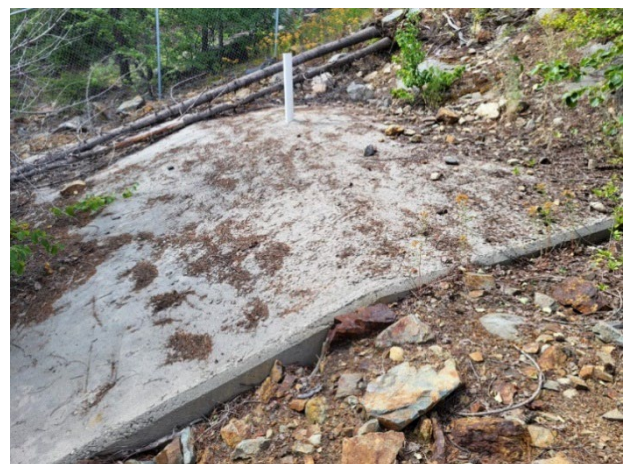
(b)

For Scenario 2, a correction factor for fenced sites of 0.5 is applied to the accessibility factor as this feature was included in the permanent perimeter fence around several of the claims on the property. The feature was investigated, the geometry was confirmed and hence, the Relative Hazard Rating following the installation of the engineered concrete cap is A.

Using the information above, Example Feature B for Scenario 2 can therefore be evaluated as 2A, low relative priority, on the hazard prioritization tool chart shown in Figure 7.

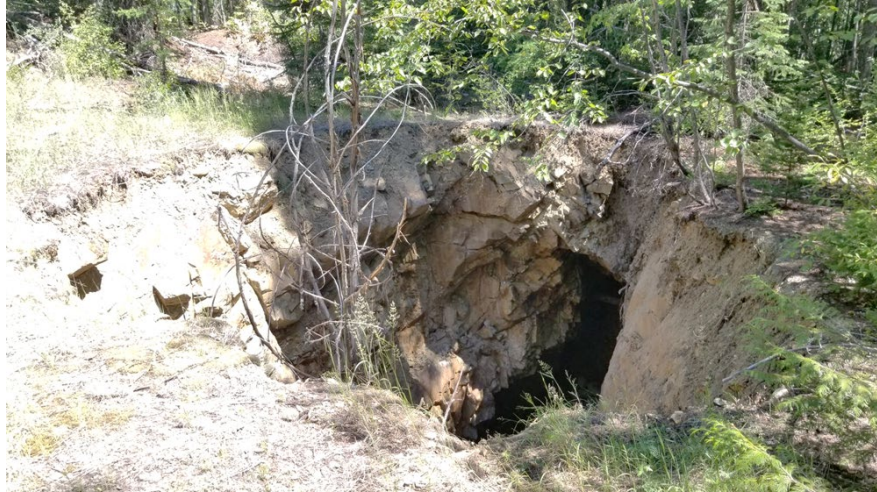
Example Feature C, shown in Figure 9, represents a slope that, based on historical records, appears to have been mined partially to surface (i.e., a gloryhole). It was possibly backfilled with waste rock and debris in the early 1990's. The backfill collapsed in recent years, resulting in an oval surface expression up to 8 m long by 5 m wide with an unknown depth. In its present condition, the feature has the following inputs to the accessibility factor and the relative hazard rating:

- Closest known access type: 3 (unpaved road access, owner's private road within permanent perimeter fenced area).
- Proximity to access: 5 (≥ 5 m to < 10 m).

- Correction factor for fenced sites: 0.35 (multiplied by two factors, 0.5 and 0.7; the permanent perimeter fence around several of the claims on the property surrounds this feature, and an additional fence around the feature itself).
- Relative Hazard Rating Flowchart: F (failed historical temporary mitigation).

Using the information above, Example Feature C can therefore be evaluated as 5F, high relative priority, on the hazard prioritization tool chart shown in Figure 7.

Figure 9 Example Feature C: previously backfilled, collapsed stope feature

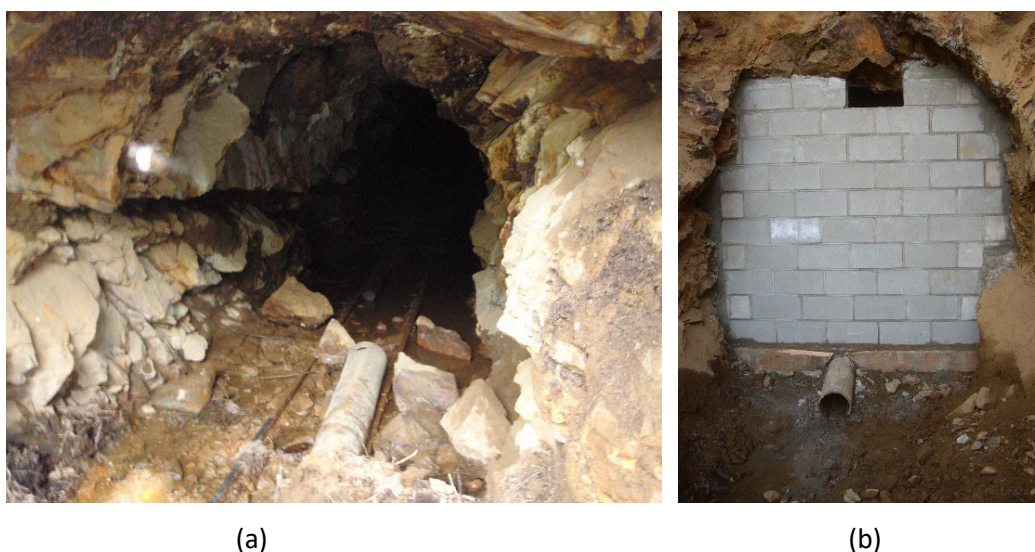
Example Feature D, shown in Figure 10, represents a portal that, based on historical records, had been previously backfilled with waste rock in 2000. The waste rock showed signs of settlement, creating an opening at the crown 1 m by 0.5 m. Two scenarios are discussed for this example; Scenario 1, for the pre-mitigation condition with partially failed backfill, and Scenario 2, for the post-mitigation condition. Figure 10a shows the portal during investigation following removal of the waste rock backfill with dimensions of 2.4 m high by 2.5 m wide and extending into the slope for an unknown distance. Figure 10b was taken following scaling of loose rock around the portal entrance and installation of an engineered, block wall at the portal entrance.

- Closest known access type: 1 (unmarked trail access).
- Proximity to access: 6 (0 m to < 5 m, the distance from portal to the unmarked trail, measured in the GIS database).
- Correction factor for fenced sites: 1 (no correction factor applied).

The flowchart in Figure 4 is then used to evaluate the relative hazard rating. For Scenario 1, the portal feature falls within the farthest category to the right (failed backfill/opening into portal), which places the portal within column F.

Using the accessibility factor and relative hazard rating, Example Feature D can therefore be plotted on the hazard prioritization tool chart shown in Figure 7. For Scenario 1, the shaft plots as 6F, high relative priority.

For the Scenario 2, the portal feature falls within category A on the Figure 4 flowchart (investigation, confirmed geometry and remediated). Moving down the flowchart, no deterioration is observed, placing the remediated portal feature within column A.

Using the accessibility factor and relative hazard rating, Example Feature D can therefore be plotted on the hazard prioritization tool chart (Figure 7) following the engineered block wall installation. For Scenario 2, the portal plots as 6A, low relative priority.

Figure 10 Example Feature B: portal feature which had previously been temporarily backfilled with waste rock. (a) during mitigation provided for better view of feature – note that Scenario 1 corresponds to pre-mitigation. (b) Scenario 2: post-mitigation
