# Implementing a stability monitoring system at a legacy mine site—case study

O Gibbons SRK Consulting Inc., Canada AG Hartzenberg SRK Consulting Inc., Canada A Joaquim SRK Consulting Inc., Canada T Coleman SRK Consulting Inc., Canada

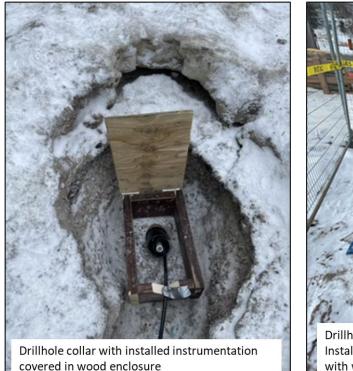
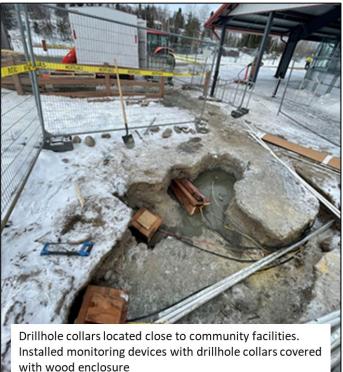
Portland cement was originally used for the grouting, and in some cases, significant grout losses were experienced. It is believed that this could have been as a result of extreme cold weather conditions and / or the occurrence of underground features. These features might include geologic structures and blasting fractures exposed along the drillholes and also identified during geotechnical data collection. Grouting was originally done with the drill rig, and a combination of bentonite chips and AMC Gel (Bentonite) were used to try and mitigate the grout losses. Due to the delays experienced, it was decided that a Water Cut Off grout should be used, and a grouting crew and an additional grout pump were brought to site by the contractor to continue with the grouting. Grouting was performed using the diamond drill.

As a result of the very low grouting rates, a decision was made to stop grouting for the 2021 winter season and to return to the site in 2022. The drillhole collars on the FW side could remain open; however, the drillhole collars located on the HW side in between community facility buildings had to be filled on request of the community. In anticipation of having to locate the collars for the 2022 spring season, a local carpenter created wooden boxes that were placed over the collars and the areas were filled in with mostly sand material or cold mix asphalt, as seen in Figure 3.

Figure 3 Drillhole collars at the end of the 2021 field season; wood enclosures were created to cover the drillhole collars in order to locate them during the 2022 field season

Grouting resumed in the spring of 2022, when a contractor used a grout plant rather than a drill rig for grouting purposes. Due to the significant grout losses experienced during the 2021 season, the grout supplier suggested the use of grout socks to mitigate these challenges.

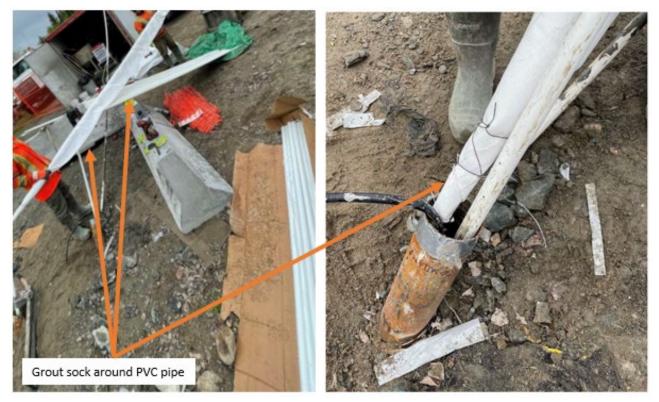
Figure 4 (left) Grout sock secured around PVC pipe prior to installation in the drillhole; (right) lowering the PVC pipe and grout sock into the drillhole for grouting

Figure 4 shows the grout socks that were used during the 2022 season. The grout socks were used in highly fragmented rock mass. A poly-cotton mix textile that had low permeability, but high elasticity was used for the manufacturing of the grout sock. In the process of the sock being filled with grout, the solid particles clogged within the sock and filled the drillhole. The cementitious water that filtered through the grout sock

The grouting process was still time consuming, even with the use of grout socks. At the start of the 2022 field season, grout socks were only used where challenges were experienced in grouting, and grout gain would often be approximately the length of the grout sock used in the drillhole. By the end of the season, long grout socks were used to complete the program within the planned 2022 schedule. Grout socks were found to be more effective than G-Stop, bentonite chips, or bentonite pellets in this setting.

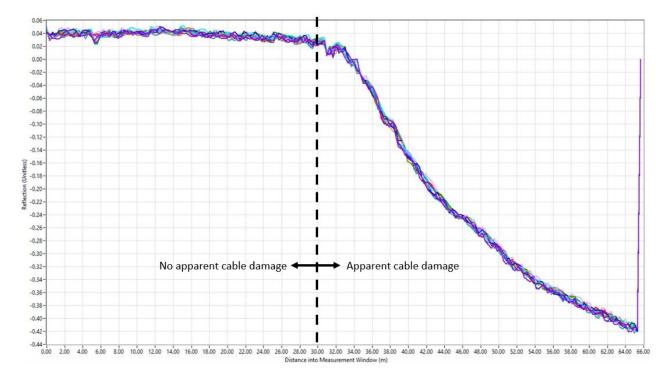
The TDR system includes 16 new TDRs and eight historical TDRs. Of the new TDRs, three appear to be damaged based on the waveform shapes, with possible causes including water ingress or a short circuit (Figure 7). Reliability in communication has also been an intermittent issue. The reception from the surrounding cell towers appears to be poor at the data logger locations. Antennae have been moved to try to point as directly as possible to the closest tower, but communication is still lost intermittently.

# Figure 7 Example of TDR data with possible water ingress or a short circuit around 30 m distance along the cable

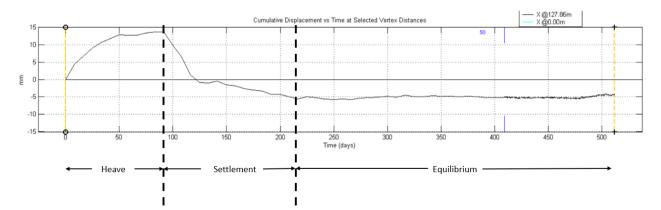
The two ShapeArray instruments have been fully functional since installation. Measurements showed initial movement and heave, followed by subsequent settlement as the site normalized to equilibrium after the first freeze-thaw cycle (Figure 8). The data suggests that the instruments were nearing equilibrium around half a year following the installation, with settlement to statis following this period. The most recent half year shows the system being mostly static.
