# Estimate of ground support response under dynamic loads at El Teniente mine, Codelco, Chile

MS Celis *Codelco, Chile*

RA Parraguez *Codelco, Chile*

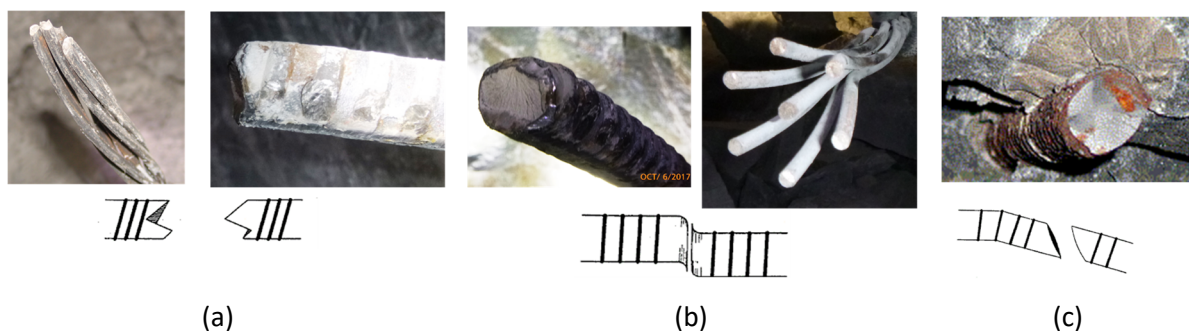
Regarding the failure modes for bolts and cable bolts, failures due to shear stress, tensile stress or a combination of both have been observed in the field, as presented in Figure 3.

**Figure 3** Bolt and cable bolts failure modes. (a) Tension; (b) Shear; (c) Tension and shear

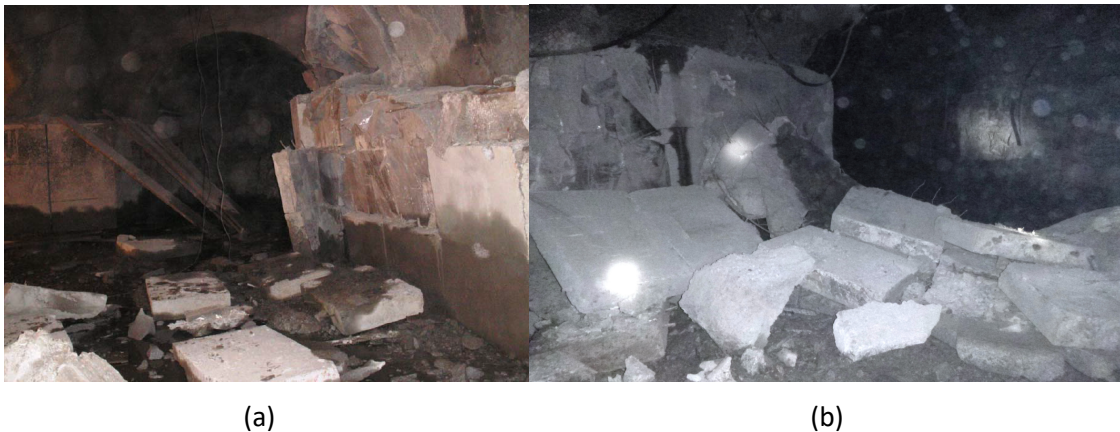
It is very difficult to estimate  $ve$  in the field because it is not possible to define the point from which a block or particle is projected. However, at Pilar Norte, Esmeralda and Reno mines at El Teniente (Table 3), the projection of concrete blocks (Figure 4) with known geometry was recorded, for which it was easy to calculate ( $ve$ ) values with projectile motion Equation 5. These are currently used as references for this analysis (Rojas et al. 2020; Van Sint Jan 2005).

**Figure 4** Concrete mass ejection in Pilar Norte El Teniente. (a) January 2010; (b) February 2017

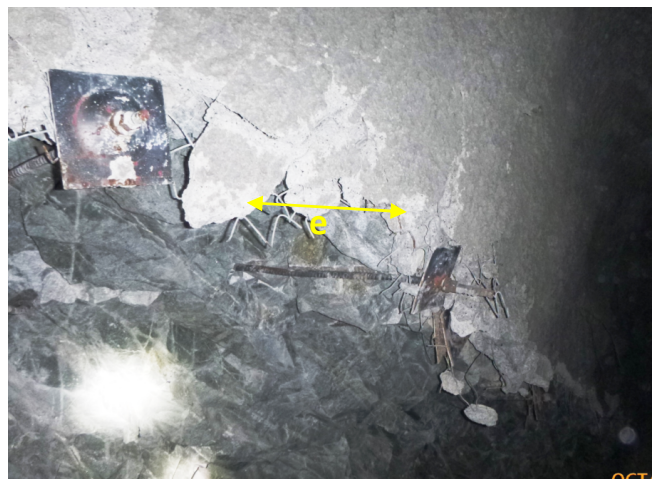
In the case of the damage thickness ( $e$ ), it is easier to obtain its value in the field (an example of which is presented in Figure 5), since the overbreak resulting from the projection of rock mass blocks can be measured, and then, with that value and taking into account the rock density  $2.7 \text{ t/m}^3$ , the mass ( $m$ ) per area unit will be quantified.

**Figure 5** Ground thickness of damage

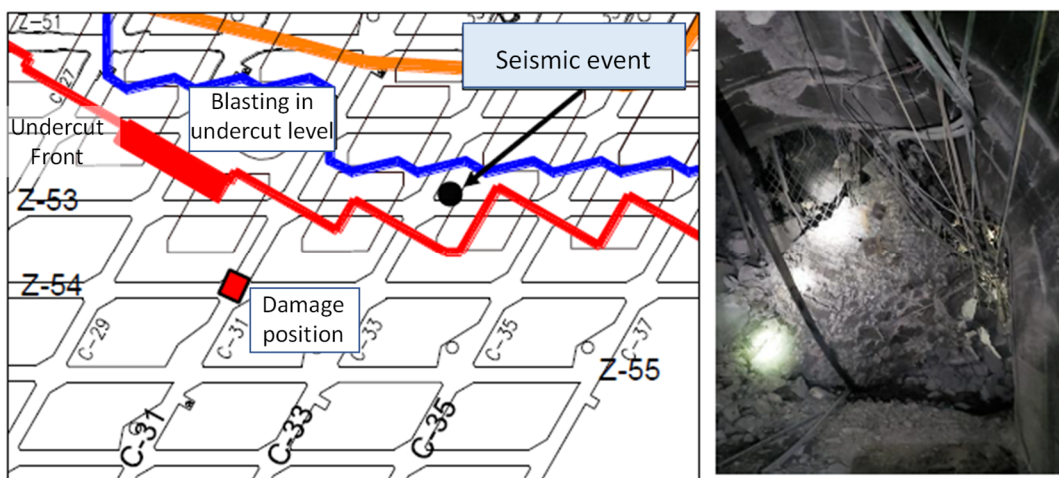
**Figure 9** Damage position

The strong damage associated with this rockburst was located at the production level of Esmeralda mine, at the intersection of two drifts (C-31 with Z-54), as seen in Figure 9.

Damage in intersection C-31/Z-54

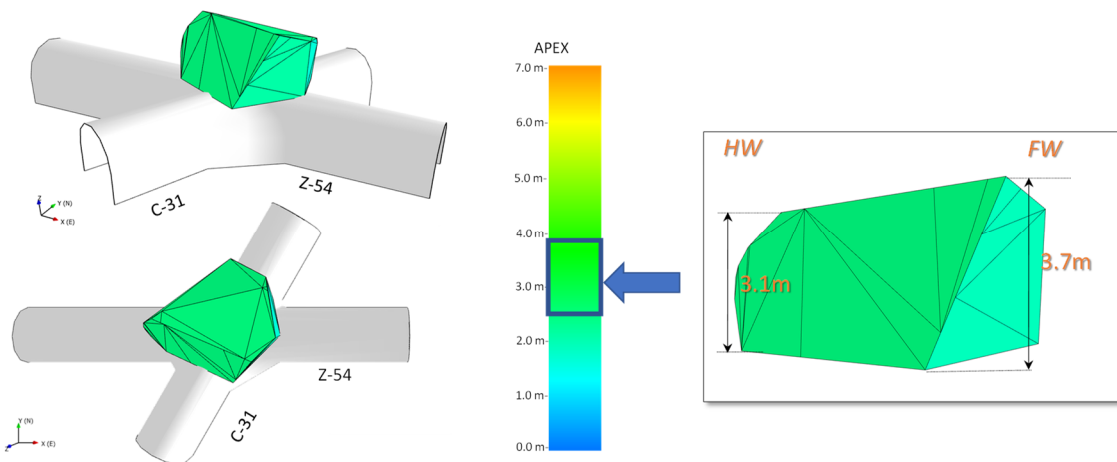
**Figure 10** Estimation of the released volume

The fallen volume limit (apex around 3 m) exceeds the design length of the bolts (2.3 m), so the bolts could not support the weight for this loading and were not considered in the analysis. In the field, complete bolts were observed in the material on the floor (Figure 11). The mass of the fallen volume was estimated at 152 t and the area of the damaged zone was estimated at 30 m<sup>2</sup>.

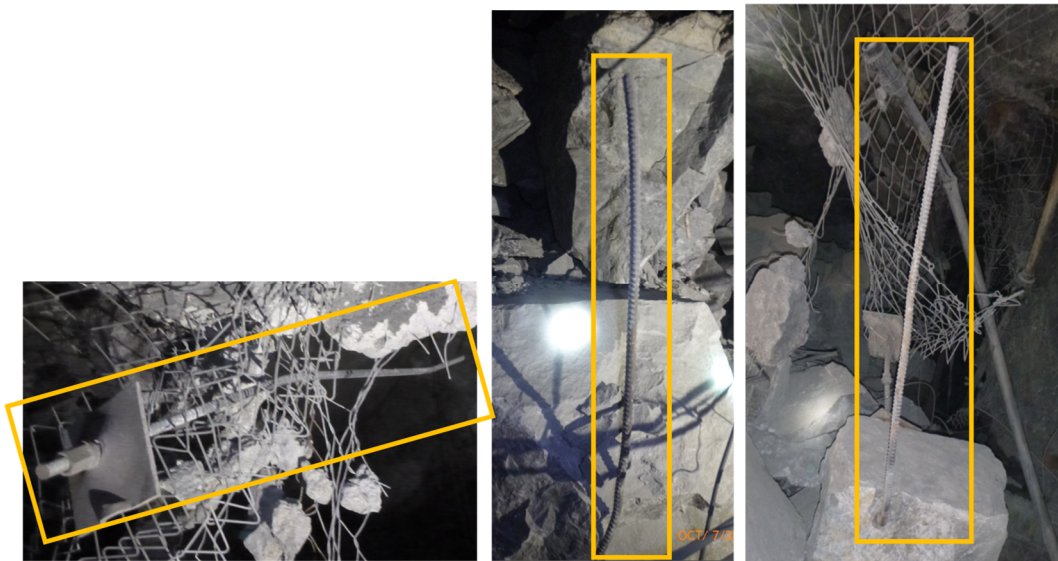
**Figure 11 Complete bolt inside released volume**

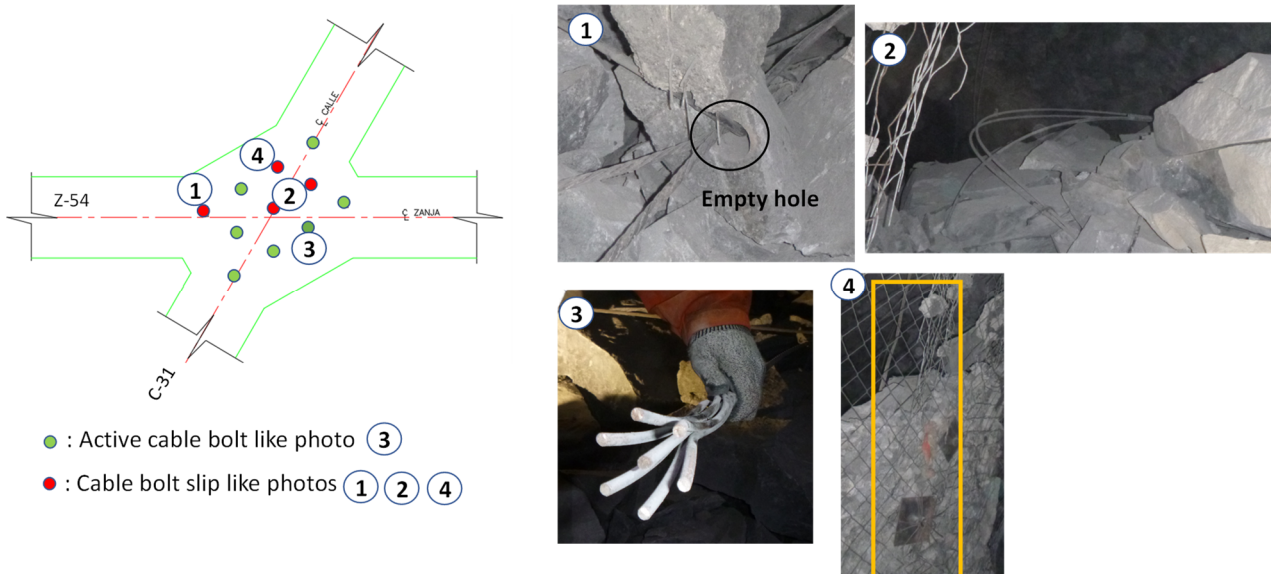
**Figure 12 Cable bolt condition**

In the field, 36% of the design cable bolts slipped due to poor installation quality since these cables were without cement grout or inner anchorage (evidence of empty hole shown in Figure 12).

- The ground support design systematically considers the installation of bolts that are complemented in greater sections with cable bolts, which allow deeper anchoring, where, due to the excavation geometry, the conditions for the formation of larger wedges or landslides occur at greater depth.
- The falling of the volume of rock at the intersection of C-31 with Z-54 at the production level is because 36% of the cable bolts did not achieve their design function since they slipped due to the absence of grout along the cable bolts (poor installation quality).

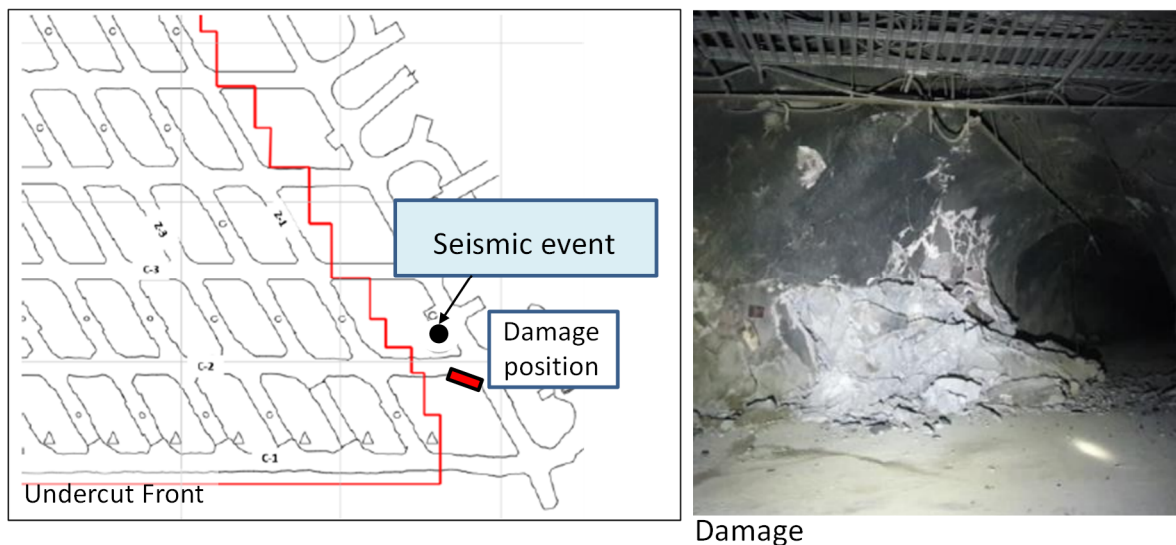
**Figure 13 Damage position**

The strong damage associated with this rockburst (7 m in length) is located at the production level of Pacífico Superior mine in the pillar of an intersection (Figure 13).

After cleaning the sector, a damage thickness of 1.2 m was identified, and a set of geological structural planes parallel to the face where the rock mass slide occurs was observed.

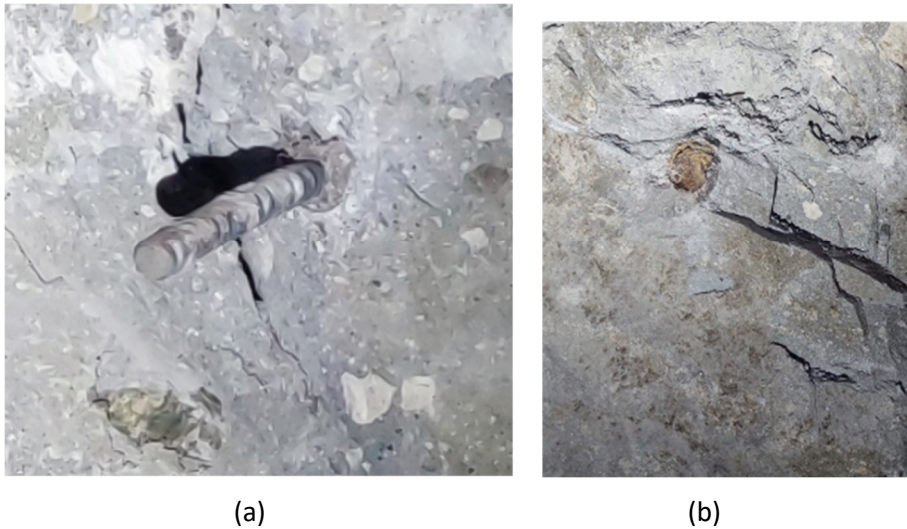
Regarding the bolts, failure due to shear stress was identified and in other bolts on the floor of the previous cut (oxidised failure plane) due to impacts from equipment traffic (refer to Figure 14).

**Figure 14 Bolt failure. (a) Shear bolt failure; (b) Corrosion of bolt in failure**

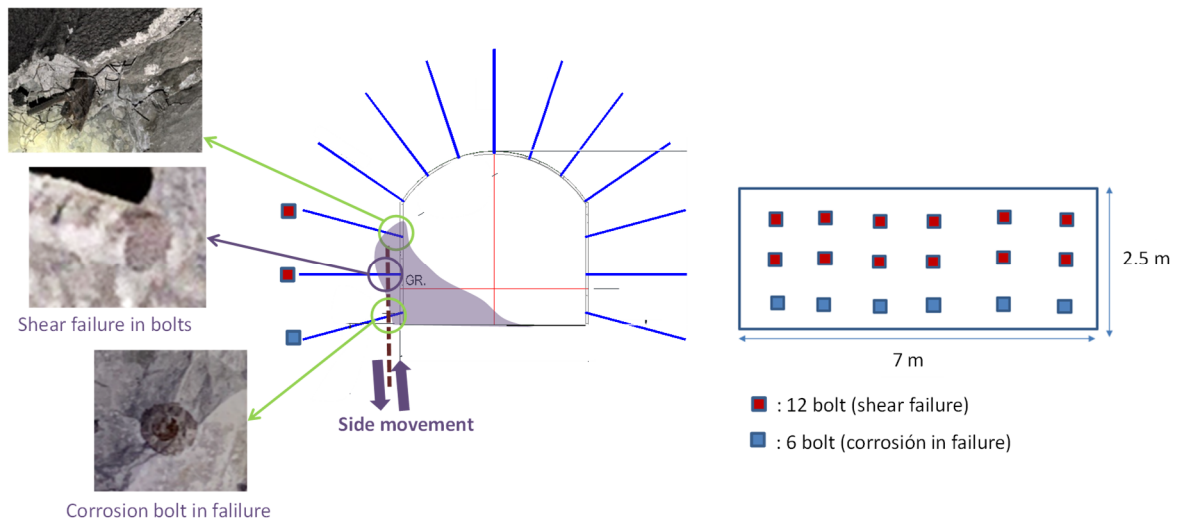
Figure 15 schematically shows the response of the ground support in the ground, where it can be concluded that the shear stress in the bolts is caused by the sliding of the rock mass through structural planes parallel to the drift.

**Figure 15 Support failure mode**

- The statistics of combinations of the rockburst events magnitude–energy (Figure 7) shows that for an event of  $M_w 1.4$  and energy of  $2.6 \times 10^5$  J such as that of this rockburst, no damage happens in the bolts, mesh and shotcrete ground support as the one installed by design.
- Therefore, the occurrence of the damage is explained by the sliding of the rock mass through geological structural planes parallel to the drift that creates shear stress in the bolts, limiting the capacity of the support (FS around 0.9), which explains the failure observed in the field.

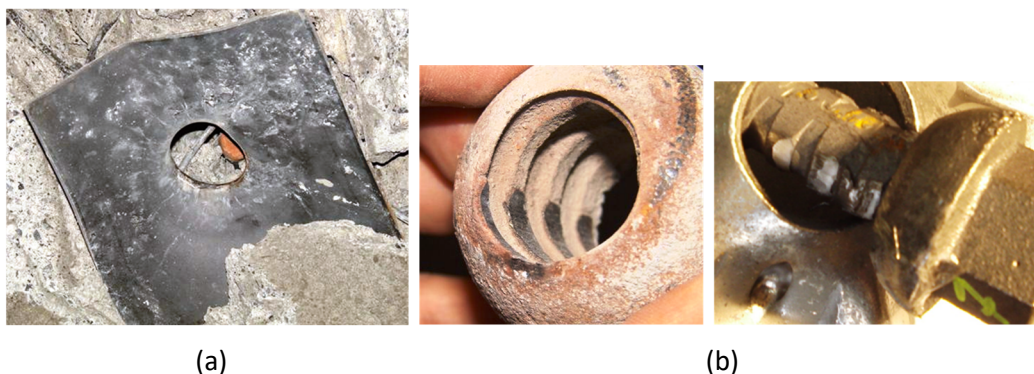
For the system that makes up the bolt with its external anchor plate–nut, the failure of the plate was detected in the field (deformation of the central perforation) which caused the nut to pass through it. The nut also got stuck in the bolt shoulders, affecting the strength of the system (bolt tear out). Examples of this are shown in Figure 16.

**Figure 16 Failures in support system. (a) Plate deformation; (b) Bolt tearing**

To avoid this, the height of the bolt shoulders was increased, the height of the nut was increased, with which a greater grip or bolt–nut contact surface was sought, the thickness was increased and the steel quality of the plate changed. This modification began to be implemented as of 2012 in all the drifts of the mine and as a back-analysis, and this type of failure has not been observed again (Rojas et al. 2020).
