Evolution of the pit slope design process at Western Mesquite Mines

HW Newcomen *BGC Engineering, Canada*

E Schmidt *BGC Engineering, Canada*

S Sabo *Western Mesquite Mines, USA*

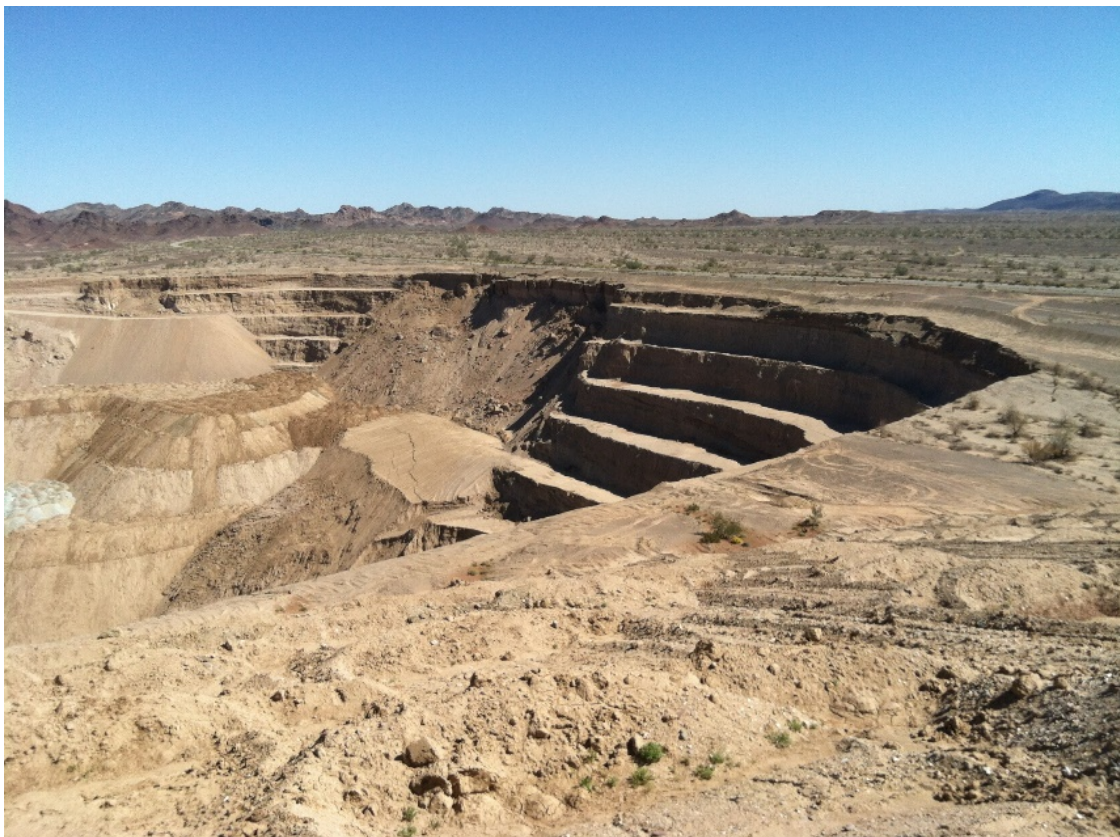
Slope movements in the Rainbow Pit east wall were ongoing until 2012, with surface cracking evident approximately 60 m east of the highway and settlement within the highway right-of-way. During this time there were also several small instabilities between the east wall of the pit and the highway. Due to concerns about the integrity of the highway, a waste fill buttress was proposed to limit movements and improve the long-term stability of the east wall. The Rainbow Pit east wall instability during the early stages of buttress construction is shown with the highway in the background (Figure 3).

Figure 3 Instability in the tertiary conglomerate gravels materials on the east wall of the Rainbow Pit

To design the buttress, historical geotechnical reports and laboratory testing data were reviewed and used to estimate the strength and deformability parameters of the TCGs and the HBG bedrock for stability analyses of the east wall. The stability analysis models included northwest-striking faults (nor'westers) in the TCG sediments. The HBG rock mass was assigned an unconfined compressive strength of 38 MPa and a tensile strength of 3 MPa, with discontinuities assigned a strength of $\phi = 37^\circ$ and $c = 0$ kPa. Historical surface movements measured in the TCGs and the underlying bedrock were used to calibrate the numerical model.

Two-dimensional (Slope/W) and 3D (FLAC3D) modelling was conducted to assess the effectiveness of the proposed buttress and explore opportunities to optimise the buttress design. The modelling results were subsequently used to estimate potential displacements within the highway right-of-way and develop recommendations regarding buttress sequencing and size. Long-term displacements along the highway were also estimated.

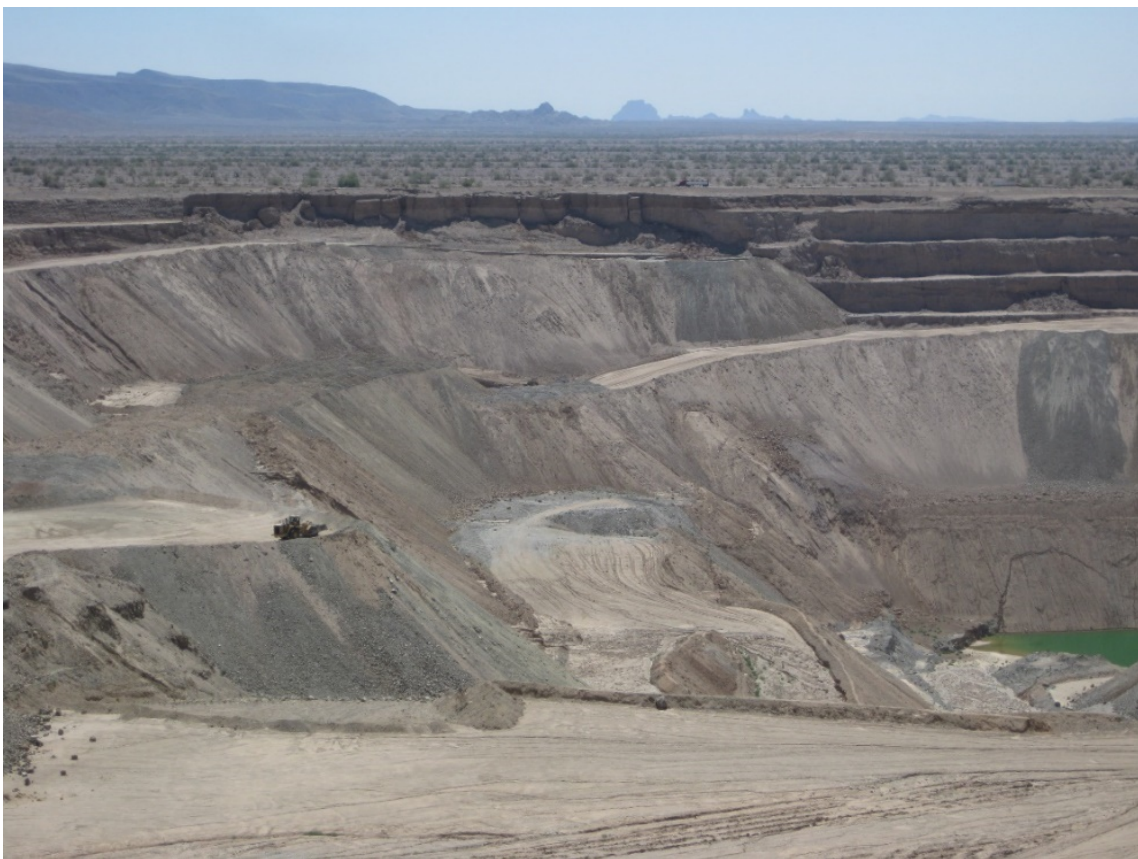
Figure 4 Completed buttress below the east wall of the Rainbow Pit

The completed buttress is shown in Figure 4. Buttress construction successfully mitigated the displacements along the highway and, despite numerous heavy rainfall events since it was constructed, the buttress has been effective.

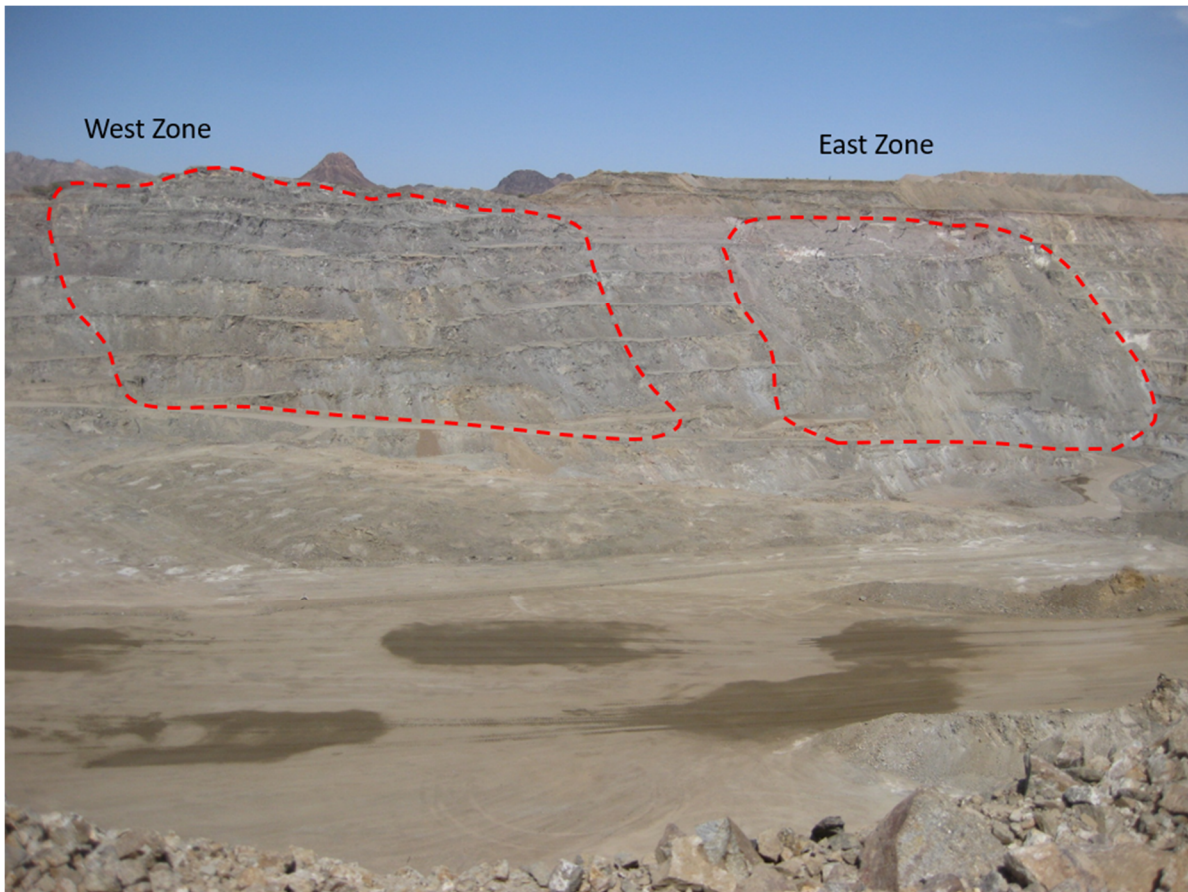
In 2014 an instability of approximately 150 m high developed in the BB2 Pit north wall in heavily faulted HBG bedrock. The instability resulted in the loss of most of the catch benches in this area (Figure 5), with tension cracks observed up to approximately 150 m from the crest of the slope and with notable heave along the ramp at the toe of the slope. The failure mode was interpreted as large-scale toppling along steeply dipping east–west trending strike-slip faults (Figure 2) subparallel to the north wall of the pit.

Figure 5 Toppling failure in the BB2 Pit north wall

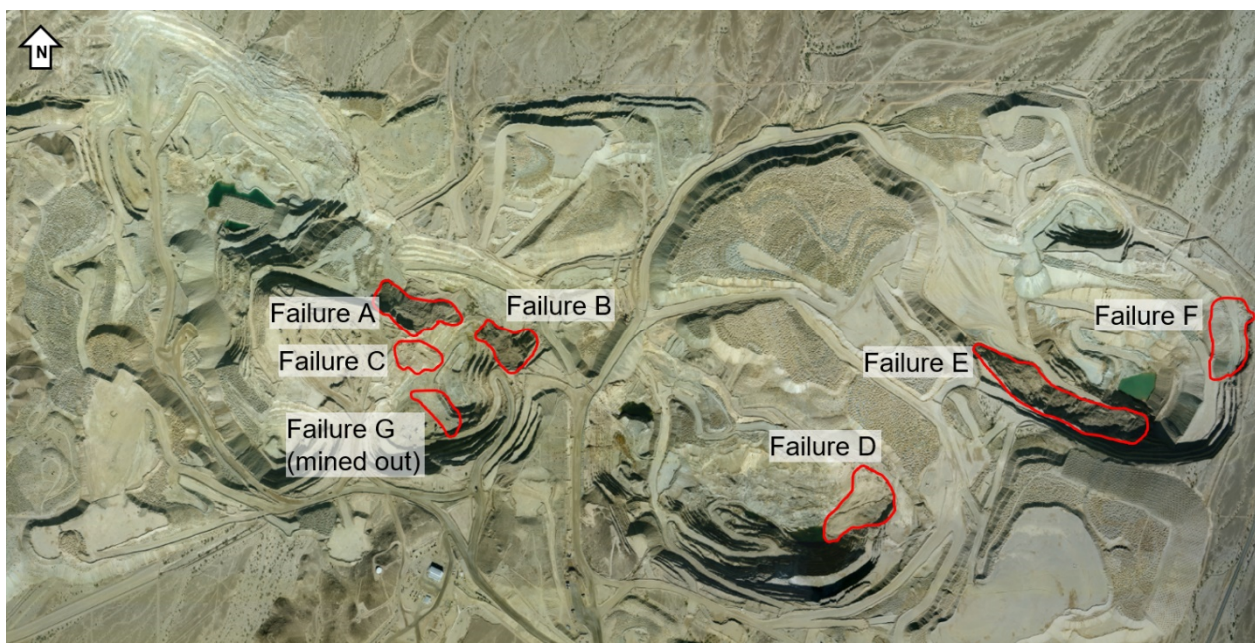
A slope failure database for the TCG unit was compiled from orthophoto and topographic survey data. Operationally disruptive failures in the TCG occurred approximately once per year, generally initiating in low (i.e. less than 40 m), double-benched slopes and becoming larger as the pit was deepened. The failures present in the pit in 2014 can be seen in Figure 6.

Figure 6 Outlines of failures in tertiary conglomerate gravels materials in the 2014 pit

Slope geometries for each of the failures in the TCG unit (Figure 6) are summarised in Table 4. Pre-failure slope geometries were estimated from topographic survey information.

Prior to failure, measurements of overall slope angles indicated that slopes in the TCG were excavated at angles between 40° and 44° (Table 4), consistent with the historic design angles. Post-failure angles in the TCGs ranged from 21° to 30° (the median post-failure angle was 24°). The slope failures were back-analysed assuming a friction angle of 29° in the TCG, resulting in an average cohesion of 24 kPa for these materials.

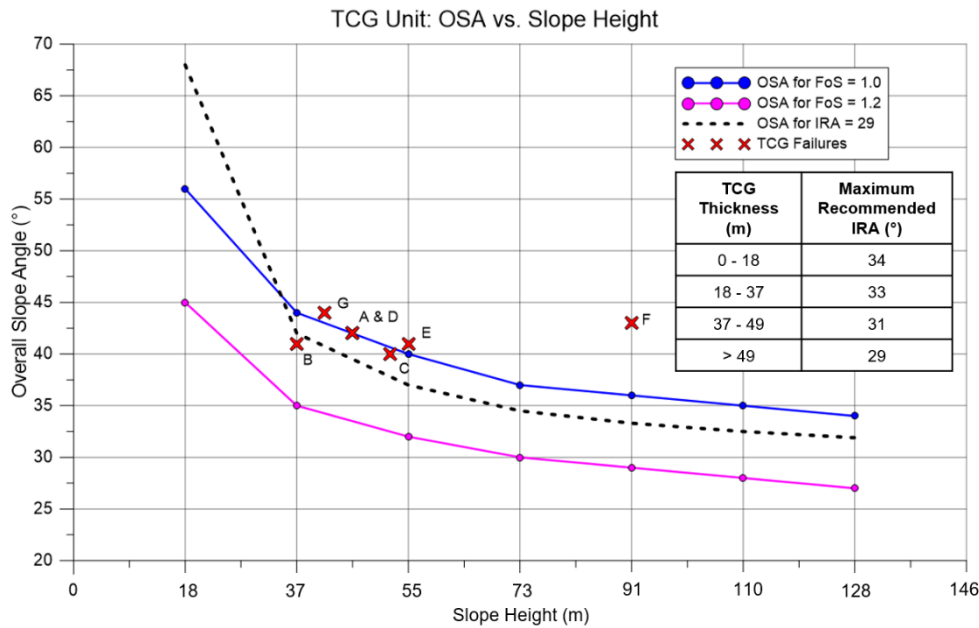
Based on the performance of the TCG materials, design curves and corresponding inter-ramp angle (IRA) guidance were developed based on slope height (Figure 7).

Figure 7 Back-analysis results and overall slope angle versus slope height design curves. Table indicates the maximum recommended IRA for short-term slopes in tertiary conglomerate gravels materials

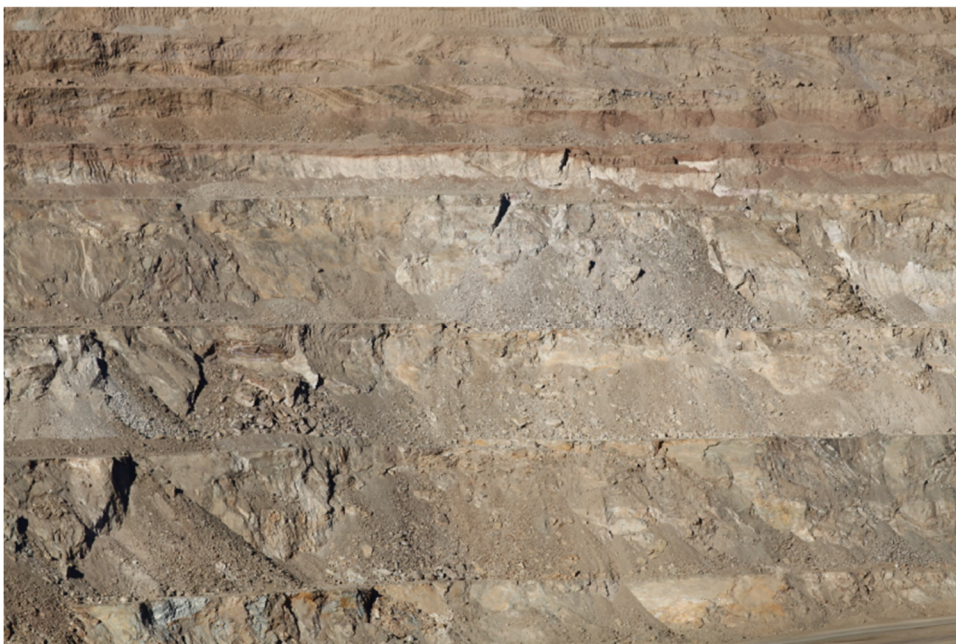
- North wall – poor performance due to pervasive bench scale instability (Figure 8) and localised inter-ramp instability along foliation and through poor-quality rock resulting in achievable IRAs between 32° and 38°.
- East wall – moderately good performance with limited bench scale instability resulting in an achievable IRA of 38°.
- South wall – good performance with a measured IRA of 42°.

Figure 8 Bench and inter-ramp instabilities on the north wall of the proposed Lola Pit

Stability analyses indicated that the inter-ramp angles were not limited by the stability of the overall slopes. Previously mined north wall benches were failing along well-defined, south-southwest dipping foliation and thus the inter-ramp design was limited by the bench width required to retain bench failure. The existing benches on the historic east and south walls were noted to be sufficiently wide to collect rockfall debris and contain typical bench failures, and had experienced minimal breakback, indicating that the berm width was appropriate for the structural geologic controls assumed. Based on the bench performance and the kinematic analysis, the inter-ramp slope angles in the east and south walls were increased from 38° to 40° and 42°, respectively. The north wall slope angle was kept at 38° due to the poor performance of the historic slopes.

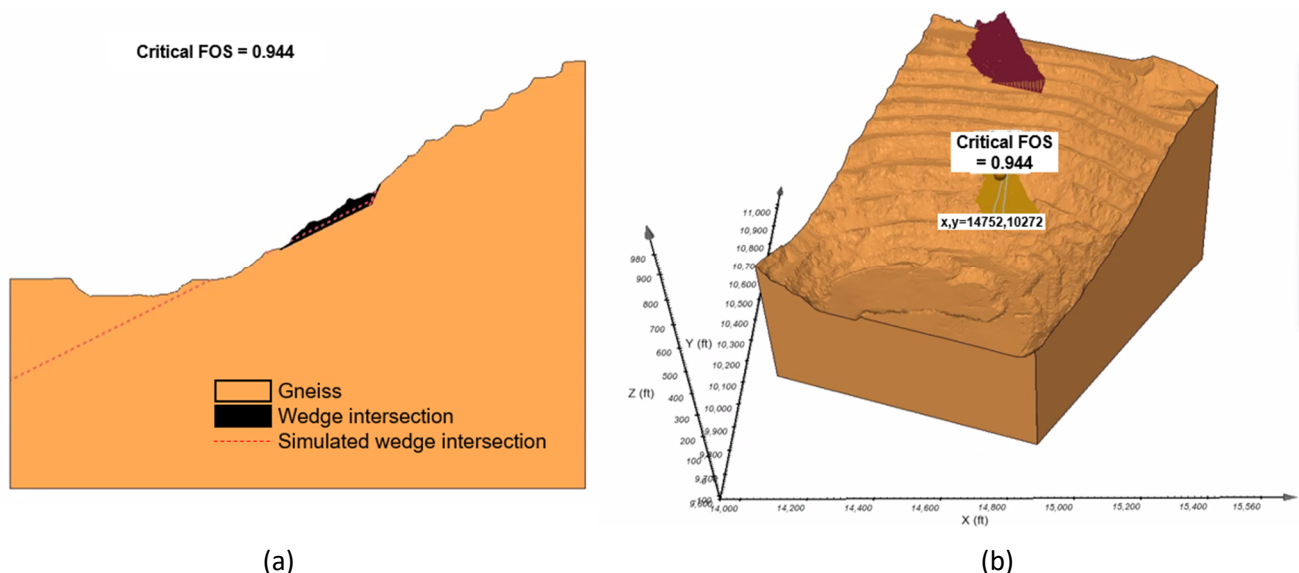
Historical failure mechanisms in the rock slopes of the existing open pits were often complex, involving sliding along faults combined with failure through a weak rock mass. This made it difficult to use back-analyses to estimate the shear strength of the faults without assuming a rock mass strength, or vice versa. However, one rock slope failure in the VW2 pit was entirely bounded by faults on three sides and considered suitable for back-analysis. This wedge was modelled in the three-dimensional limit equilibrium software SVSLOPE® with an assumed FoS of 1.0. The back-analysis produced an estimated frictional strength of 29° on the fault surfaces (Figure 11).

Figure 11 Results of VW2 wedge failure back-analysis. (a) Cross-section parallel to wedge intersection; (b) 3D view of simulated wedge (burgundy colour), sliding surface (yellow) and critical Factor of Safety of 0.94 for $\phi_r = 29^\circ$ and $c = 0$ kPa

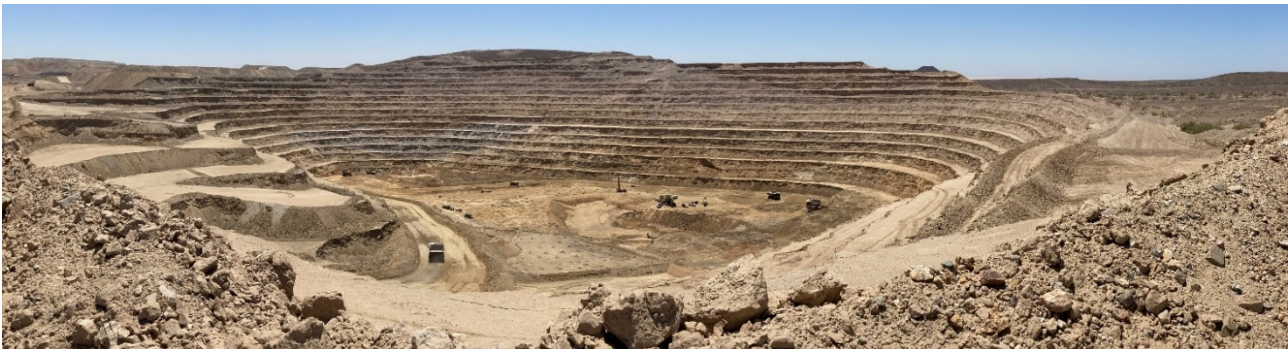
It should be noted that although the Brownie design slope angles range from being steeper to shallower than those previously applied to pit slopes at Mesquite, the designs are now better fit for purpose than in previous iterations. Weak units, including the TCG2 and MS, have been delineated and treated as their own units with unique slope angles, and the stronger TCG1 and favourably oriented bedrock have accordingly been assigned higher inter-ramp angles. The benefits of this approach are illustrated in Figure 12, which shows the mined slope configuration of the first phase of the Brownie Pit. No inter-ramp or overall instabilities were observed in the Phase 1 Brownie Pit walls, and bench scale instabilities were sparse and operationally manageable.

Figure 12 View of the mined Phase 1 Brownie Pit walls, looking southwest
