Evolution of the pit slope design process at Western Mesquite Mines

HW Newcomen *BGC Engineering, Canada*

Abstract

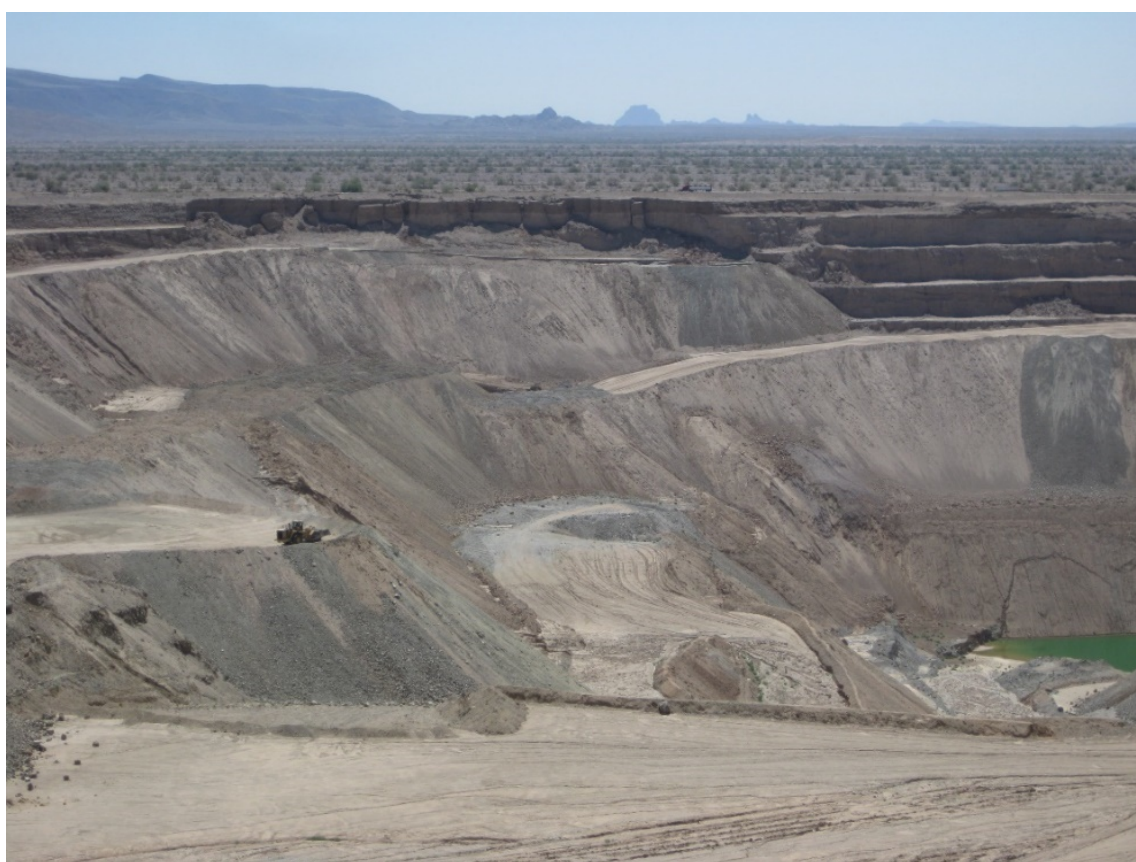
The completed buttress is shown in Figure 4. Buttress construction successfully mitigated the displacements along the highway and, despite numerous heavy rainfall events since it was constructed, the buttress has been effective.

Figure 4 Completed buttress below the east wall of the Rainbow Pit

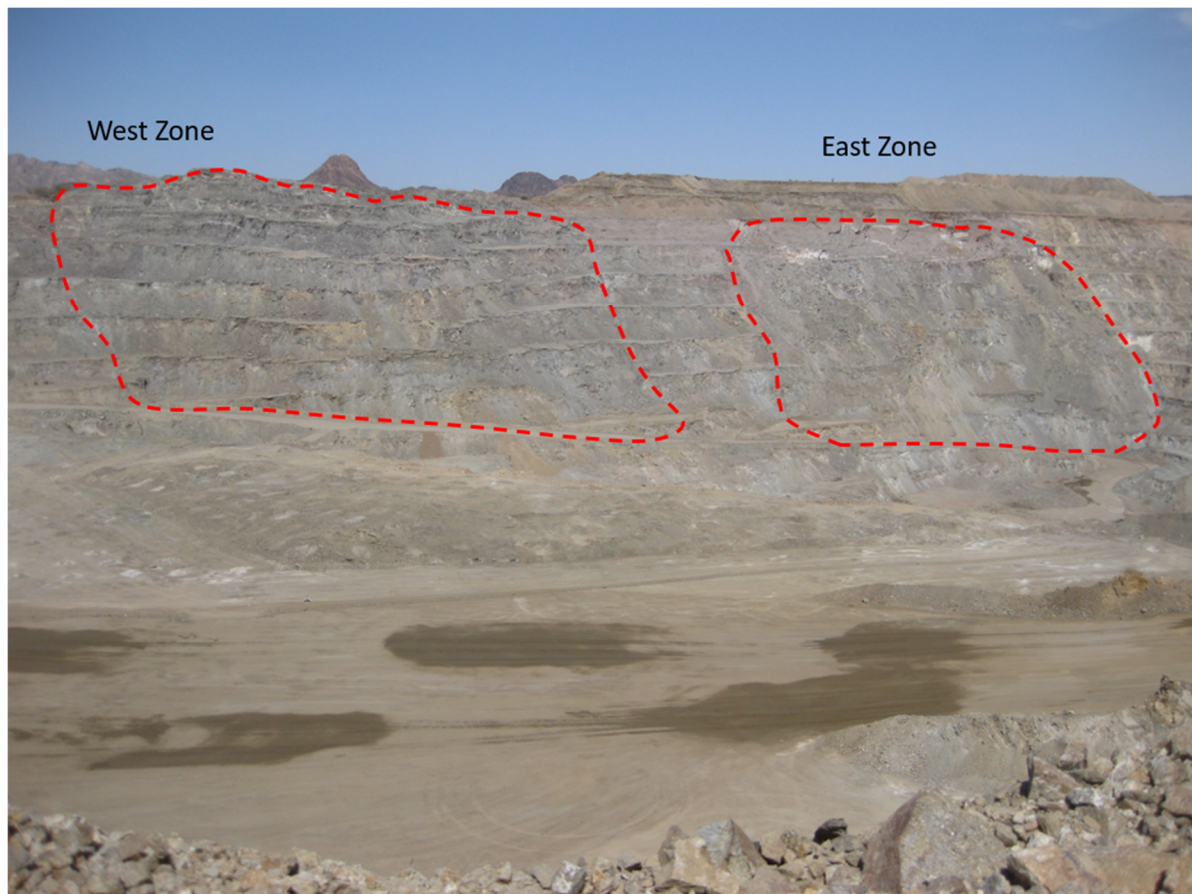
In 2014 an instability of approximately 150 m high developed in the BB2 Pit north wall in heavily faulted HBG bedrock. The instability resulted in the loss of most of the catch benches in this area (Figure 5), with tension cracks observed up to approximately 150 m from the crest of the slope and with notable heave along the ramp at the toe of the slope. The failure mode was interpreted as large-scale toppling along steeply dipping east–west trending strike-slip faults (Figure 2) subparallel to the north wall of the pit.

Figure 5 Toppling failure in the BB2 Pit north wall

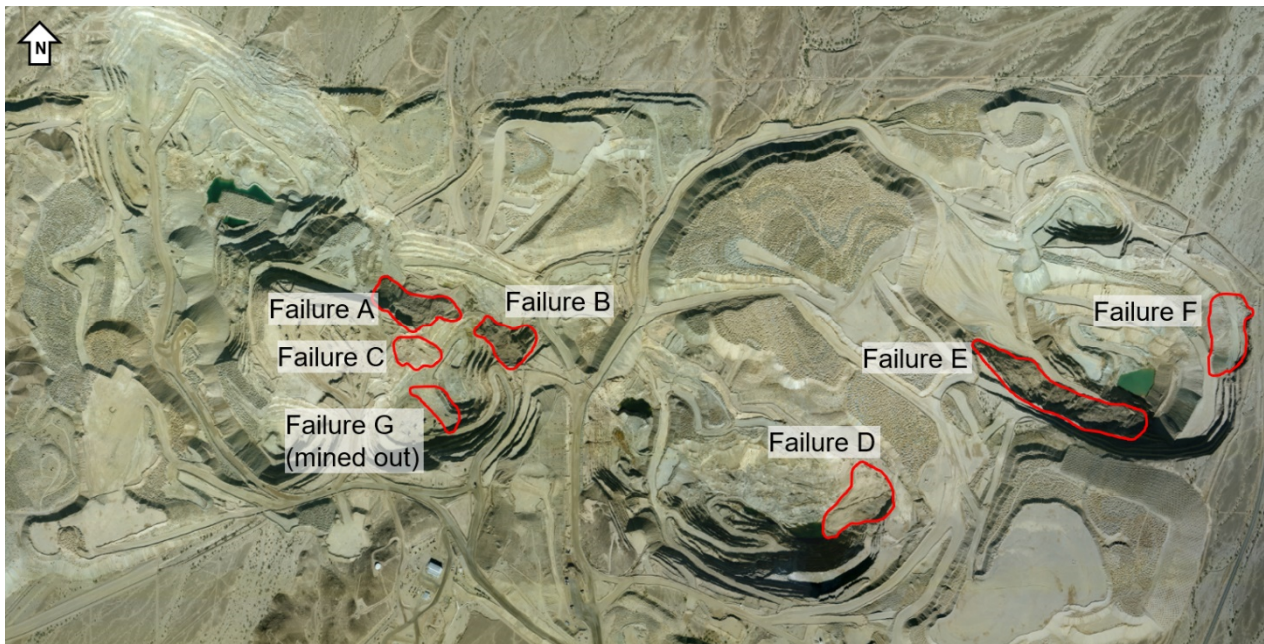
A slope failure database for the TCG unit was compiled from orthophoto and topographic survey data. Operationally disruptive failures in the TCG occurred approximately once per year, generally initiating in low (i.e. less than 40 m), double-benched slopes and becoming larger as the pit was deepened. The failures present in the pit in 2014 can be seen in Figure 6.

Figure 6 Outlines of failures in tertiary conglomerate gravels materials in the 2014 pit

Slope geometries for each of the failures in the TCG unit (Figure 6) are summarised in Table 4. Pre-failure slope geometries were estimated from topographic survey information.

Prior to failure, measurements of overall slope angles indicated that slopes in the TCG were excavated at angles between 40° and 44° (Table 4), consistent with the historic design angles. Post-failure angles in the TCGs ranged from 21° to 30° (the median post-failure angle was 24°). The slope failures were back-analysed assuming a friction angle of 29° in the TCG, resulting in an average cohesion of 24 kPa for these materials.

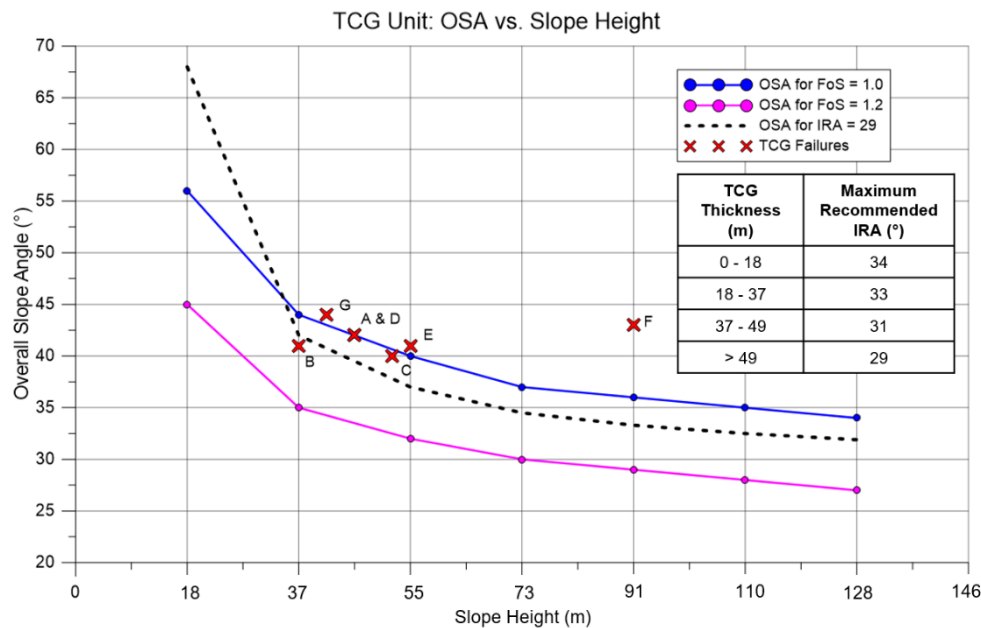
Based on the performance of the TCG materials, design curves and corresponding inter-ramp angle (IRA) guidance were developed based on slope height (Figure 7).

Figure 7 Back-analysis results and overall slope angle versus slope height design curves. Table indicates the maximum recommended IRA for short-term slopes in tertiary conglomerate gravels materials

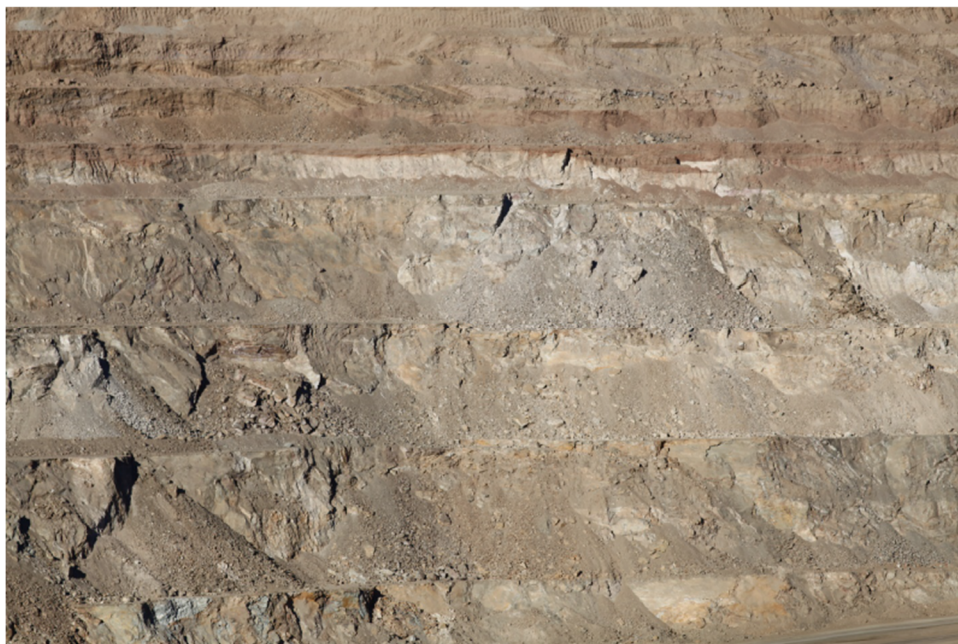
- North wall – poor performance due to pervasive bench scale instability (Figure 8) and localised inter-ramp instability along foliation and through poor-quality rock resulting in achievable IRAs between 32° and 38°.
- East wall – moderately good performance with limited bench scale instability resulting in an achievable IRA of 38°.
- South wall – good performance with a measured IRA of 42°.

Figure 8 Bench and inter-ramp instabilities on the north wall of the proposed Lola Pit

Stability analyses indicated that the inter-ramp angles were not limited by the stability of the overall slopes. Previously mined north wall benches were failing along well-defined, south-southwest dipping foliation and thus the inter-ramp design was limited by the bench width required to retain bench failure. The existing benches on the historic east and south walls were noted to be sufficiently wide to collect rockfall debris and contain typical bench failures, and had experienced minimal breakback, indicating that the berm width was appropriate for the structural geologic controls assumed. Based on the bench performance and the kinematic analysis, the inter-ramp slope angles in the east and south walls were increased from 38° to 40° and 42°, respectively. The north wall slope angle was kept at 38° due to the poor performance of the historic slopes.

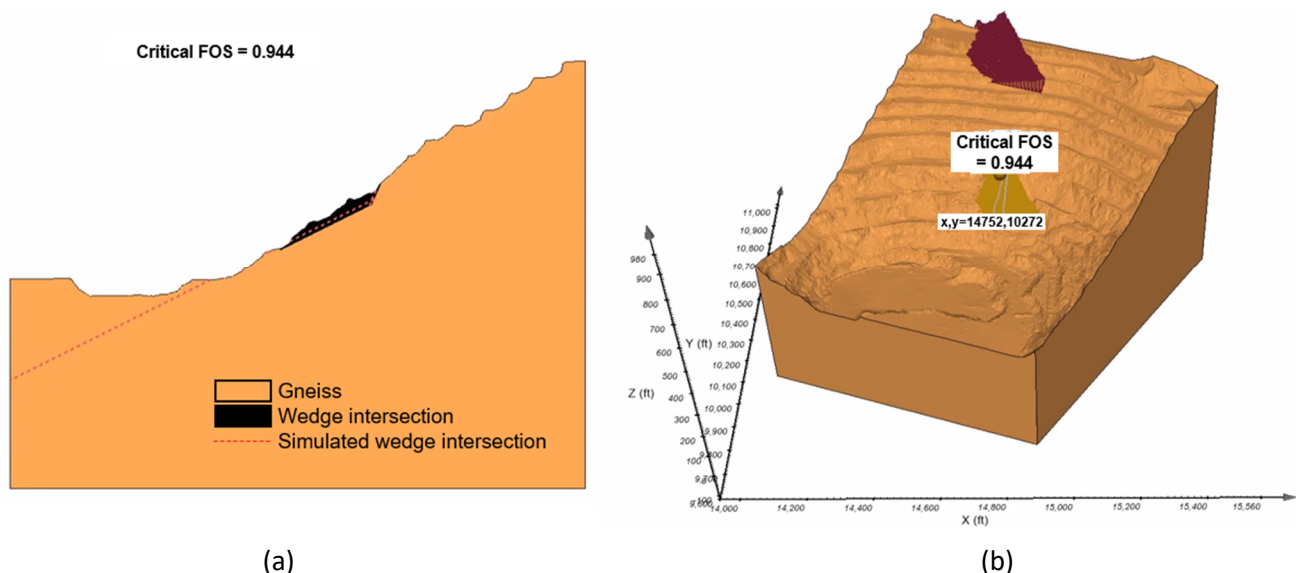
Historical failure mechanisms in the rock slopes of the existing open pits were often complex, involving sliding along faults combined with failure through a weak rock mass. This made it difficult to use back-analyses to estimate the shear strength of the faults without assuming a rock mass strength, or vice versa. However, one rock slope failure in the VW2 pit was entirely bounded by faults on three sides and considered suitable for back-analysis. This wedge was modelled in the three-dimensional limit equilibrium software SVSLOPE® with an assumed FoS of 1.0. The back-analysis produced an estimated frictional strength of 29° on the fault surfaces (Figure 11).

Figure 11 Results of VW2 wedge failure back-analysis. (a) Cross-section parallel to wedge intersection; (b) 3D view of simulated wedge (burgundy colour), sliding surface (yellow) and critical Factor of Safety of 0.94 for $\phi_r = 29^\circ$ and $c = 0$ kPa

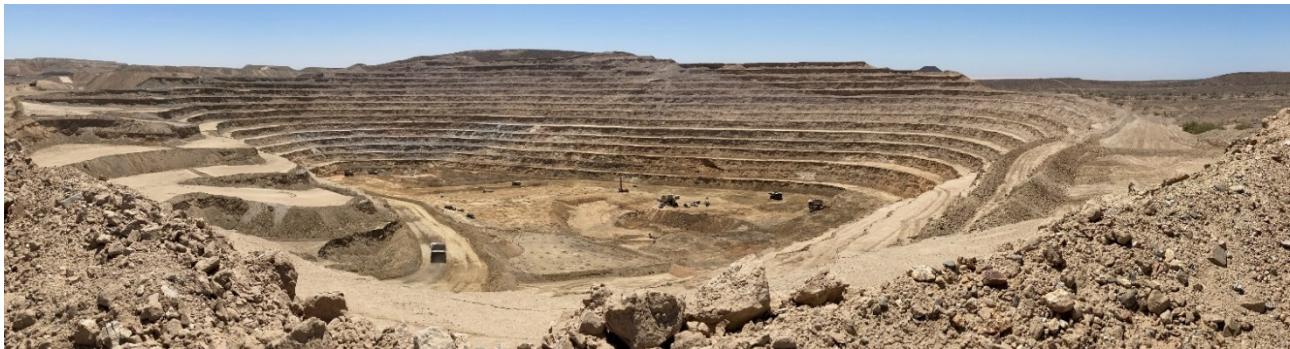
It should be noted that although the Brownie design slope angles range from being steeper to shallower than those previously applied to pit slopes at Mesquite, the designs are now better fit for purpose than in previous iterations. Weak units, including the TCG2 and MS, have been delineated and treated as their own units with unique slope angles, and the stronger TCG1 and favourably oriented bedrock have accordingly been assigned higher inter-ramp angles. The benefits of this approach are illustrated in Figure 12, which shows the mined slope configuration of the first phase of the Brownie Pit. No inter-ramp or overall instabilities were observed in the Phase 1 Brownie Pit walls, and bench scale instabilities were sparse and operationally manageable.

Figure 12 View of the mined Phase 1 Brownie Pit walls, looking southwest
