# Geotechnical risks in natural recreational areas: a case study of potential geotechnical hazards in a Western Australian national park and other parts of the world

G Owusu-Bempah *Rio Tinto, Australia*

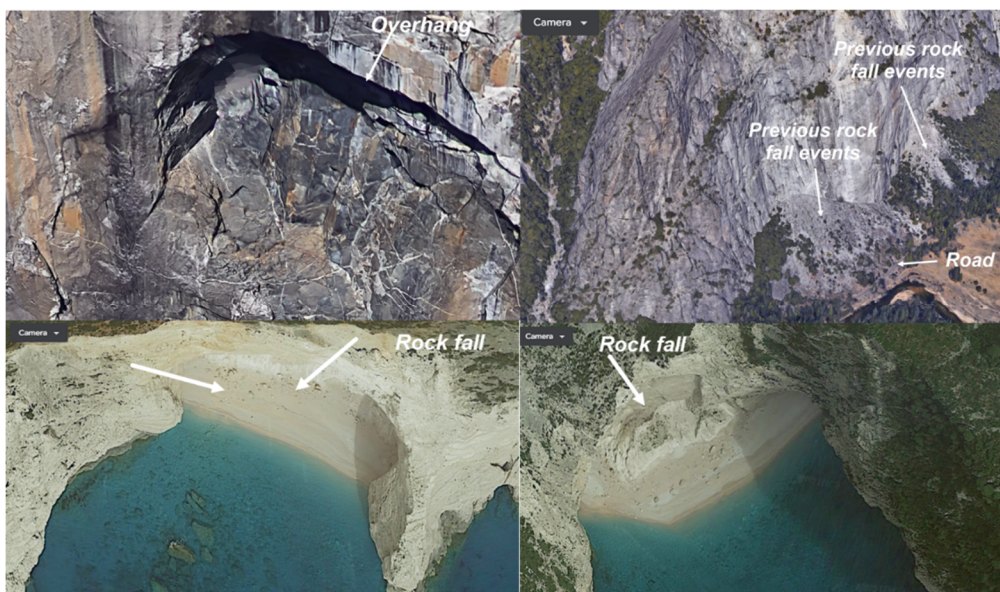
**Figure 2** Google Earth Studio camera image of Yosemite National Park igneous rocks in USA showing joint structural defects and overhang on the top photograph and slope failure and rockfall in limestone in Naviago Beach in Zakynthos Island, Greece, bottom photograph

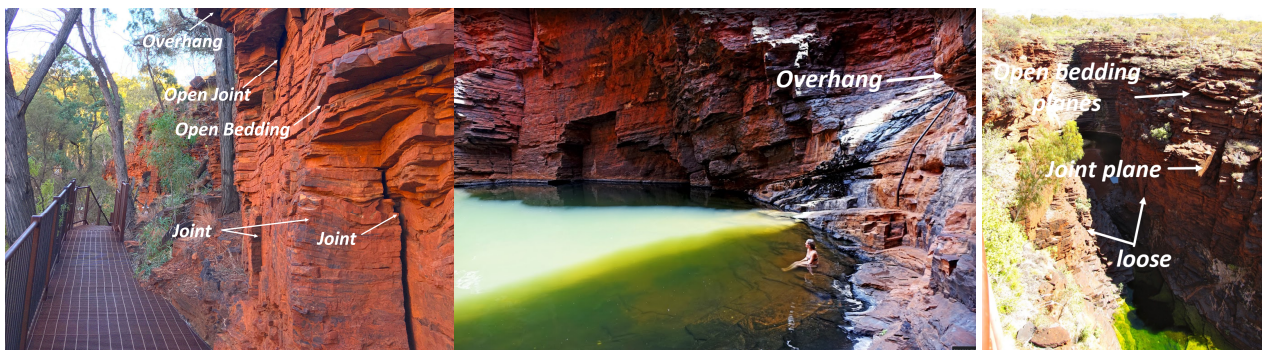
Karijini is a well-known tourist destination in the Pilbara region frequented by locals, mining workers and visitors seeking picturesque scenery, adventure and a place to unwind. However, it is essential to note that some areas within the park have a high-risk of rockfall, which poses a severe threat to visitors. This risk is due to the morphology of the exposed rocks, which are characterised by tension cracks, hydration and ruggedness exacerbated by the region's extreme weather conditions. In 2015 a 19-year-old man was killed when the 7 m-high ledge he was sitting on collapsed. Moreover, the growth of vegetation roots in these cracks also exacerbates the risk of rockfalls. Figure 3 shows a tourist walkway under overhanging rock with visible multiple joints and tension cracks; a leading cause of rockfall instabilities. The bedded rock with jointing is part of a weathered rock within the Hamersley Group in the Pilbara. Details of the Hamersley Group stratigraphic geology have been defined in the streamlining geotechnical slope reconciliation for the open pit in Brockman 2 in the Pilbara paper (Owusu-Bempah 2020). Even though the authorities at Karijini National Park have displayed rockfall signs at certain locations, it does not indicate areas of severe rockfall or exclusion zones. Often the rockfall areas are the access points to the next location within the park.

**Figure 3** Google Earth-registered photograph of the rockfall risk over a walkway grating with exposed bedding and joints in Karijini National Park in the Pilbara, Western Australia

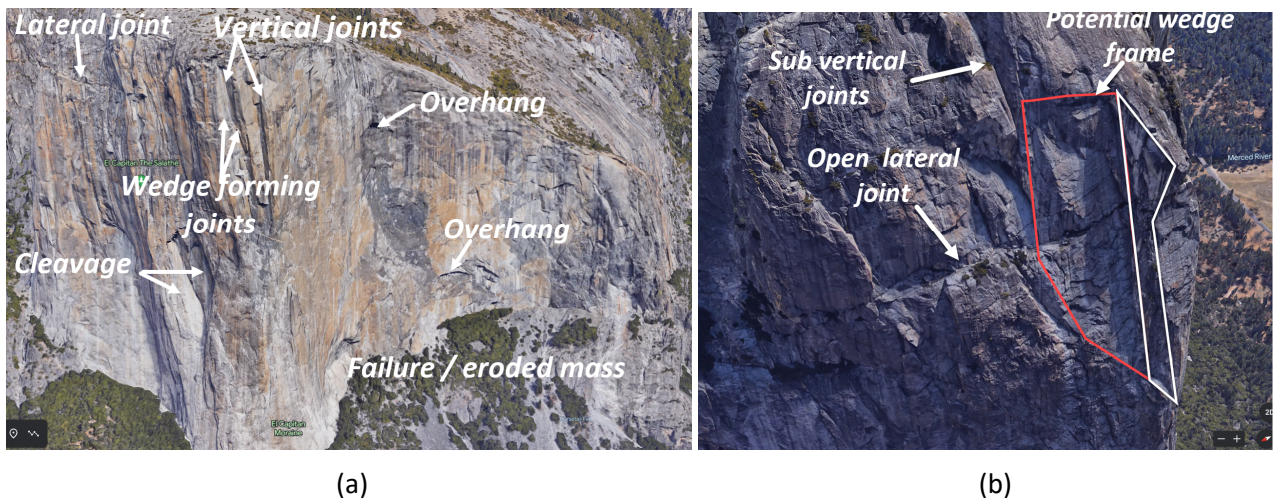
The geology of El Capitan is composed predominantly of pale, coarse-grained granite approximately 100 Ma old. The western portions of Yosemite Valley are mainly composed of a separate granitic body called Taft granite. Both kinds of granite had been documented as having dark-vein dolerite intrusion, which is prominent in the area known as North America Wall, having the greatest influence on rockfall risk in the area. Although granitic rock is unbroken on a small-scale, on a larger scale the rock is broken by joints which are planar cracks commonly found as sets of parallel fractures in the rock (Huber 1987). The joint structures are plausible for present rockfall events and the risk of overhangs could result in future potential rockfalls. Figure 4 shows a Google Earth satellite image of the Yosemite granite with multiple intersecting joints.

**Figure 4** Google Earth Studio satellite image of Yosemite National Park igneous rock. (a) Intersecting parallel joint discontinuities and overhang; (b) Camera image of the rock at different angle showing the potential wedge frame

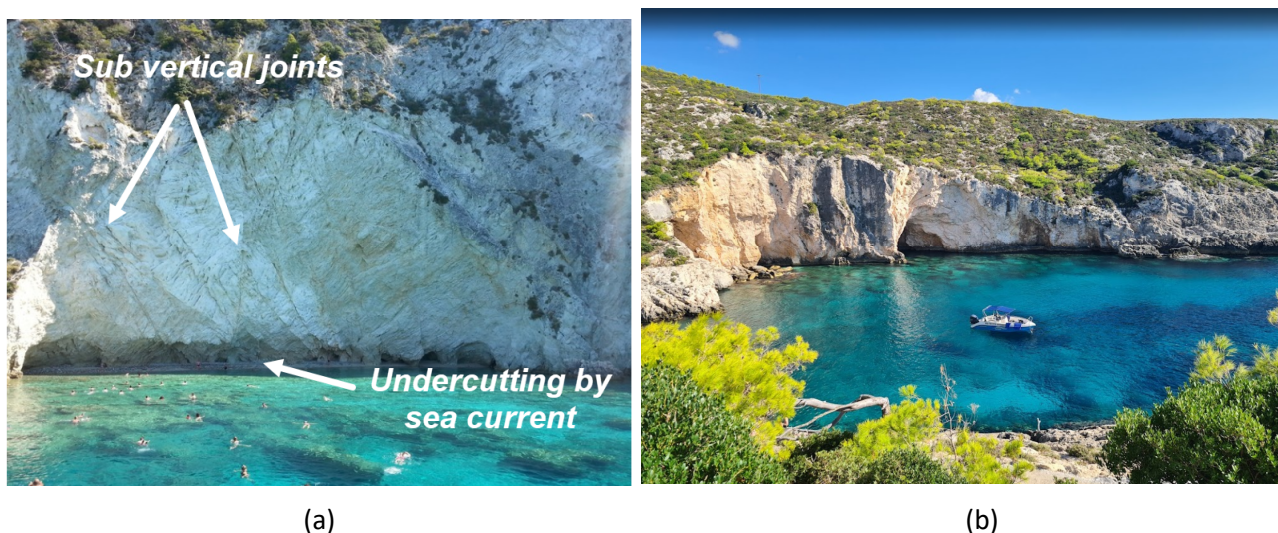
Zante beach in Greece is a well-known location that experienced an unfortunate rockfall event when seven tourists were injured due to tonnes of rock falling after an earthquake. Rockfall events are generally common there and often associated with other controlling factors at the beach because of the geology, climatic conditions and high vertical slope face. From the photographs in Figure 5, it appears the area is predominantly comprised of weathered limestone with multiple discontinuities. The exposed face of the rocks shows converging sub-vertical joint sets forming various block sizes for potential wedge instability. Erosion, caused by ocean wave currents which scour the rock face and form cavities, brings the sub-vertical joints into tension and results in the potential collapse or fall of ground. The unsupported roof of the cavities subsequently cause potential rockfalls. Frequently these pockets of eroded cavities are popular tourist attractions, which exposes visitors to rockfall impact zones.

**Figure 5** Google Earth-registered photographs of a beautiful clear blue ocean with limestone rock at Zakynthos Island, Greece: (a) Sub-vertical and intersecting joints with potential for a wedge-forming block; (b) Distance photograph of the landscape and eroded cavities

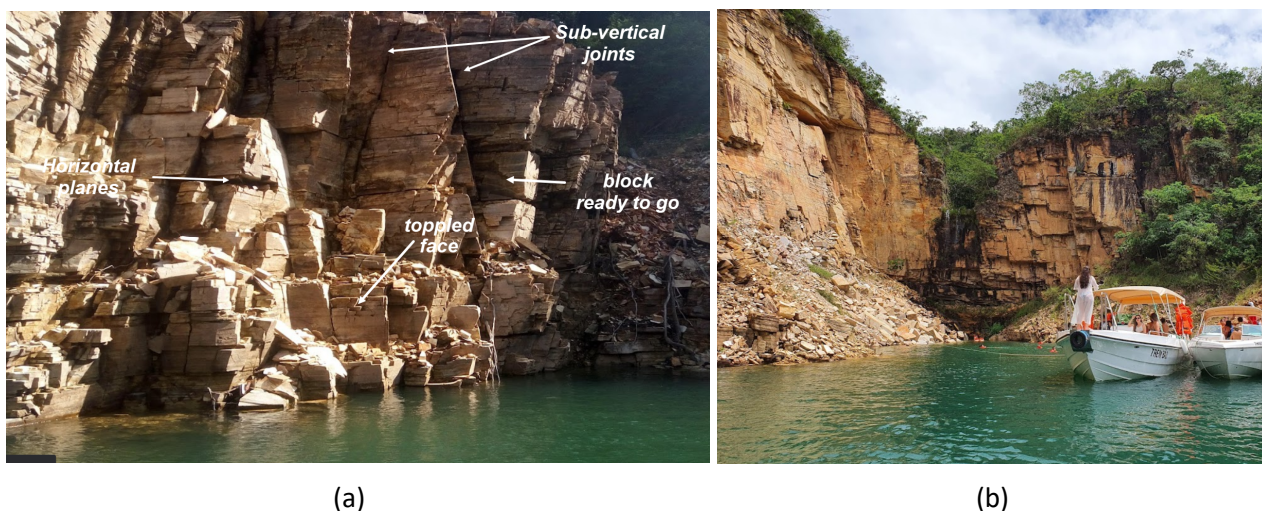
Lake Furnas in Minas Gerais, Brazil, serves as a hydroelectric dam. The area around the dam has many attractive canyons and waterfalls that attract tourists. Unfortunately, tragedy struck early in 2022 when a rockfall event killed 10 tourists on a speed boat cruising around the exposed face of the canyon rock. The video from the scene indicated a toppling failure mechanism. The head of Brazil's geological services had 'warned that the location has been subjected to centuries of erosion, leaving it vulnerable to rain, heat, and cold'. Ongoing natural erosion is likely to cause more rockfalls during the rainy months of December and January' (CBS News 2022). However, the warnings from authorities seemed not to have been heard by adventure seekers and local operators, or at least did not prevent tourists wanting to get closer to the rock face. A closer examination of Google Earth-registered photographs reveals that the cliff face is in an area with adverse geotechnical conditions characterised by both horizontal and vertical joint sets, as shown in Figure 6. Some of the vertical joints are nearly 90° and have long trace lengths, making them particularly susceptible for toppling rockfall and sliding failure mechanisms during inclement weather conditions; thereby rendering the area geotechnically unstable. It is crucial for tourists to exercise caution when visiting these areas and to pay attention to any warnings from local authorities.

**Figure 6** Google Earth-registered photograph of Furnas Lake, Minas Gerais, Brazil, showing (a) Sub-vertical joints and horizontal plane openings susceptible to wedge and toppling failures; (b) A far-view photograph of failed material and overhang rocks

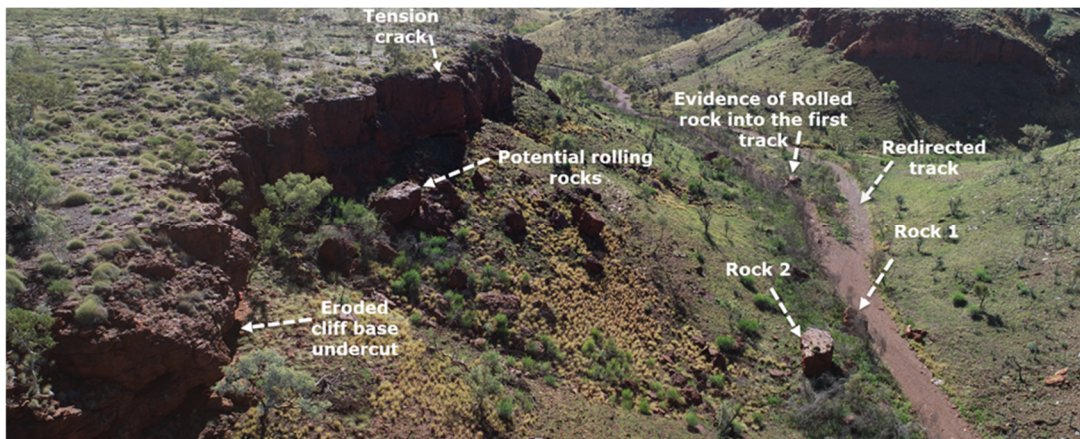
The walking track in a valley behind a mining village (see Section 1) spans nearly 2 km and is confined by approximately 40 m-high slopes on both sides, with facades. The physical geology of the area generally consists of huge crumbled hydrated rock from the facade, with rockfall hazards typically associated with the western side of the cliff. However, certain areas of the track have been impacted by rocks, making it more precarious in those locations. In places where rocks have rolled onto or blocked parts of the track, the track has been diverted to manage the increased risk; highlighting the importance of managing risks in tourist locations with prevalent rockfall hazards. Measures must be taken to mitigate the risk of rockfalls for personnel who use the track regularly. Figure 7 shows the walking track and locations of the detached rocks, including rocks used in rockfall simulations.

**Figure 7** An aerial photograph of the slope and the walking track showing loose rocks from the facade used in rockfall simulation, behind a mining village in the Pilbara, Western Australia

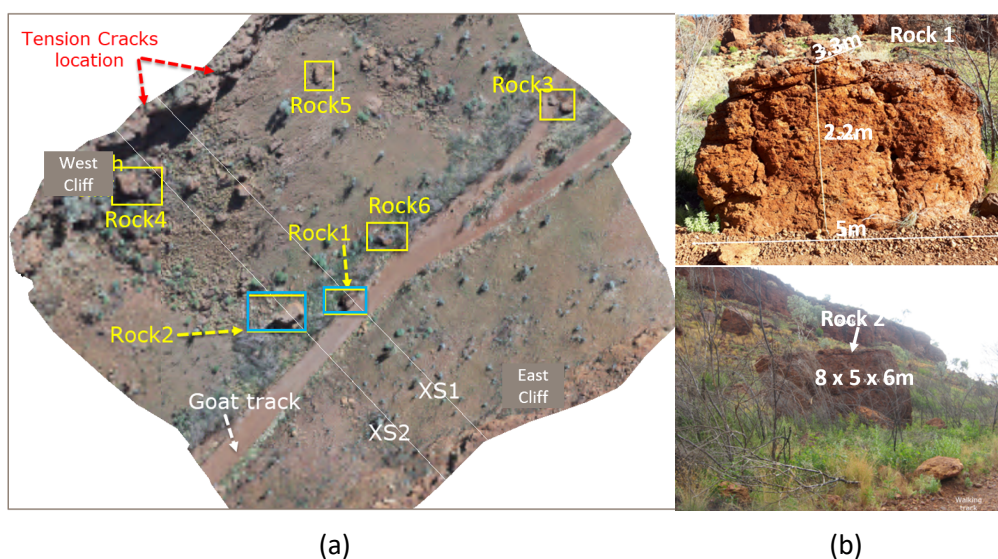
The slopes were analysed in two topographical cross-sections for rocks 1 and 2, as shown in Figure 8b. The analyses were performed mainly on the west slope of the valley, where Pilbara hydrated rocks are seen to have detached from the cliff at 574 RL and landed at 535 RL. The slope profiles from the detachment zones have a steeper slope angle and transitioned into an average slope gradient with a few centimetres-high vegetation cover. The vegetation cover on the slope was conservatively modelled at 10 cm-high in rigid body analysis.

**Figure 8** (a) Two topographical cross-sections (XS1 and XS2) of Rocks 1 and 2 used in a rockfall simulation; (b) Photographs of actual rocks and resting positions

Table 1 summarises the physical dimensions of the two analysed rocks (seeder) with other rocks within the rockfall zone. Results from the back-analyses are detailed in Section 5.2 for rigid body and lump mass simulations. The average kinetic energies determined indicate that the intensity of the rocks from the sources to the resting position do not dissipate energy and represent the forces rolling rocks could have on the impact. The estimated energy could be useful for selecting a potential rockfall stabilisation mesh or rockfall fence, creating an exclusion zone or rock scaling to save lives.

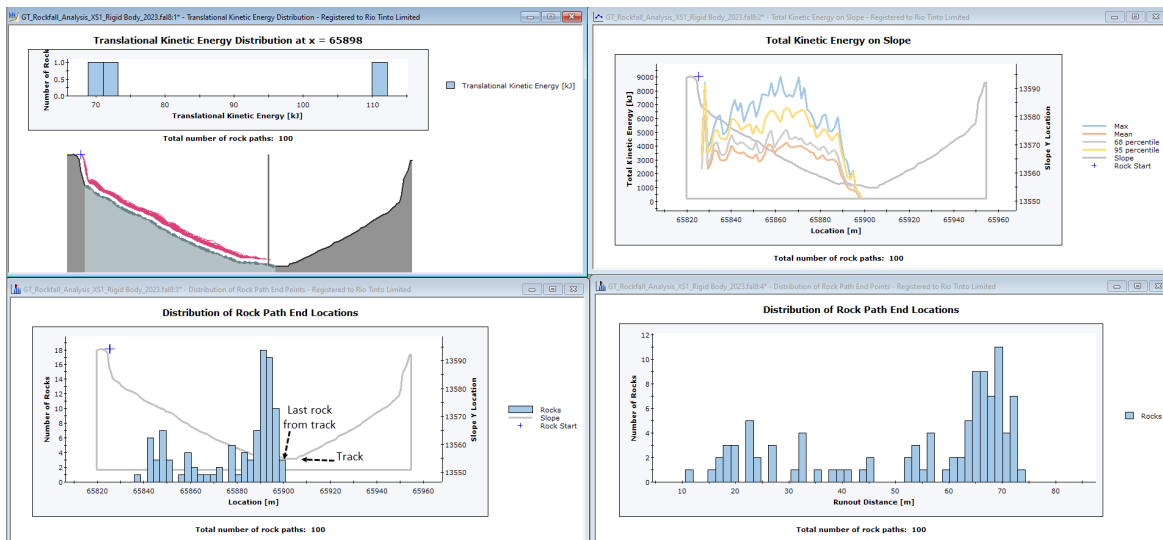
**Figure 9 Chart distribution showing rigid body back-analysis results of estimated energies of the endpoints and a runout distance of cross-section 1 for Rock 1**

The simulation results for cross-section 1 demonstrate that the last rock came to rest near the edge of the walking track, consistent with field observations. The rigid body simulation indicates that the last rock for this section came to rest at approximately 74 m, representing the runout distance and end point location from the cliff. For the lump mass simulation of Rock 1, a runout distance of 76 m was obtained. The difference in runout distances between the rigid body and lump mass simulations is approximately 2 m. The total kinetic energy obtained at the resting position from Rock 1 at the edge of the walking track was 201.4 kJ for the rigid body simulation and 499.9 kJ for the lump mass simulation.

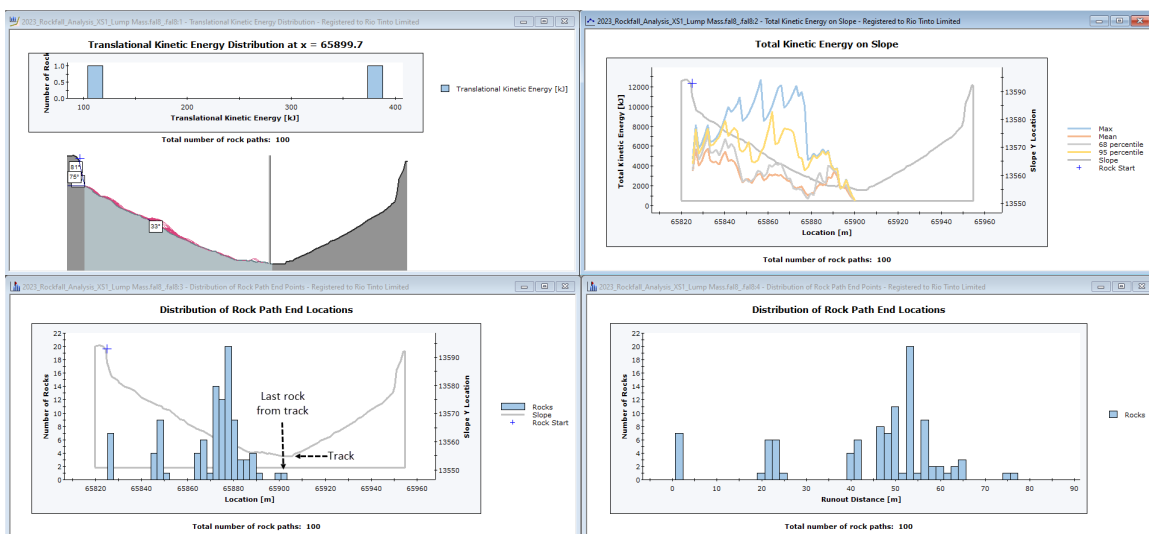
**Figure 10 Chart distribution showing lump mass back-analysis results of estimated energies of the endpoints and a runout distance of cross-section 1 for Rock 1**

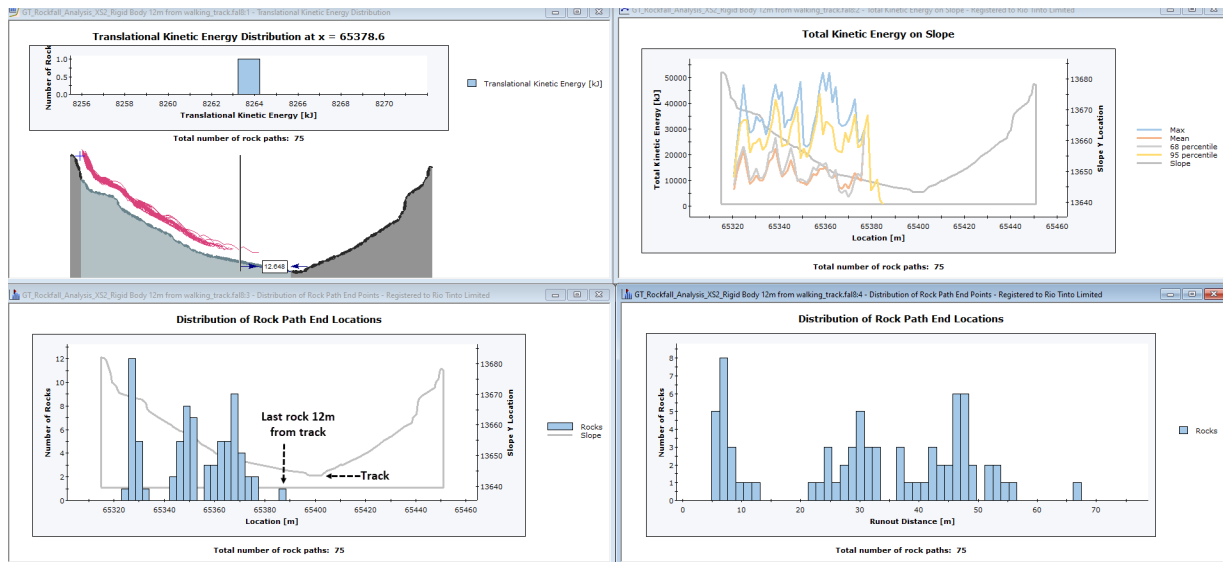
**Figure 11** Chart distribution showing rigid body back-analysis results of estimated energies of the endpoints and a runout distance of cross-section 2 for Rock 2

Regarding cross-section 2, the simulation results indicate that the last rock rested at approximately 12 m from the walking track, consistent with field observations for Rock 2. For the rigid body simulation, the end point of Rock 2 came to rest at approximately 67 m, representing the runout distance. The lump mass simulation resulted in a runout distance of 68 m for Rock 2. The difference in runout distances between the

rigid body and lump mass simulations is approximately 1 m. The total kinetic energy of the rocks at the resting position was 10682.7 kJ for the rigid body simulation and 12792 kJ for the lump mass simulation.

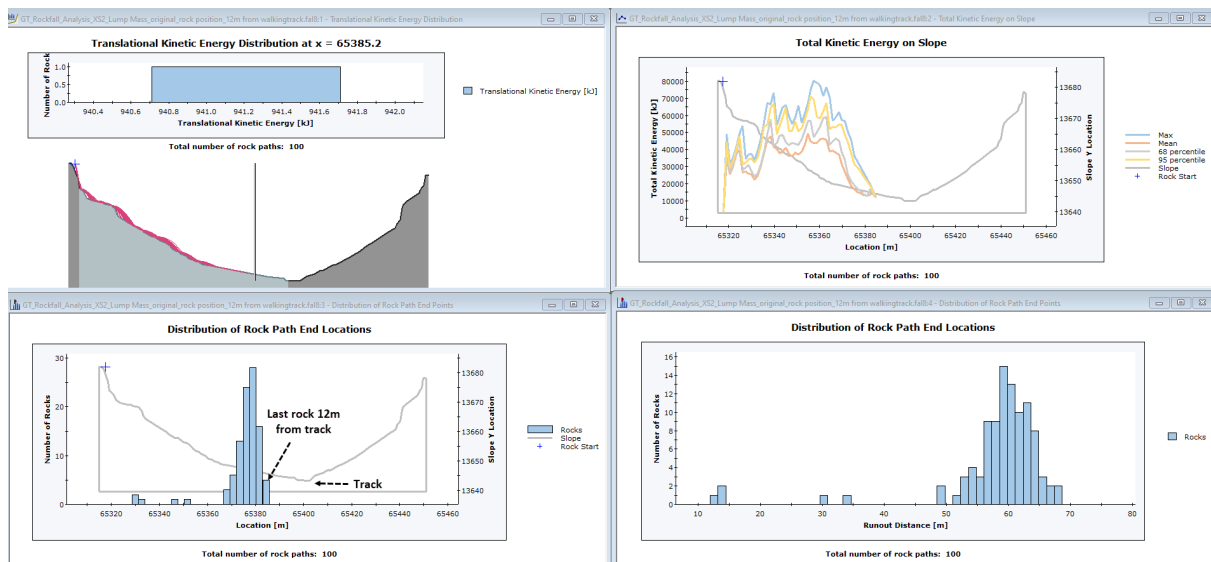
**Figure 12** Chart distribution showing lump mass back-analysis results of estimated energies of the endpoints and a runout distance of cross-section 2 for Rock 2

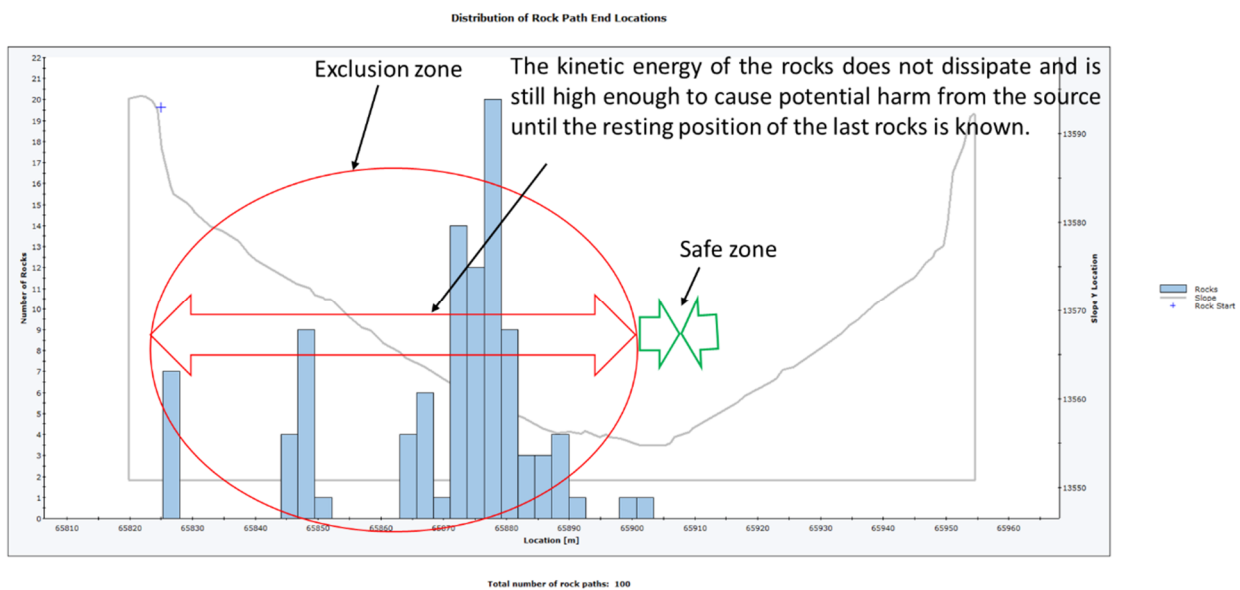
Overall, the simulations for both cross-sections indicate that energy from falling rocks is not dissipated between the starting and end point, making any area between the starting point on the facade and the last rocks unsafe. Thus this area could be designated as a high-risk/exclusion zone, with the area beyond Rock 1 considered safer for people. It is also noted that the impact within the transition zone could be severe. Figure 13 illustrates the rockfall simulation trajectory indicating a potential designated a high-risk/exclusion zone and a safer zone.

**Figure 13** Distribution of rock path end point locations showing a rockfall intensity no-go zone as an exclusion zone, and a safe zone beyond the last rock on the track
