Geotechnical risks in natural recreational areas: a case study of potential geotechnical hazards in a Western Australian national park and other parts of the world

G Owusu-Bempah *Rio Tinto, Australia*

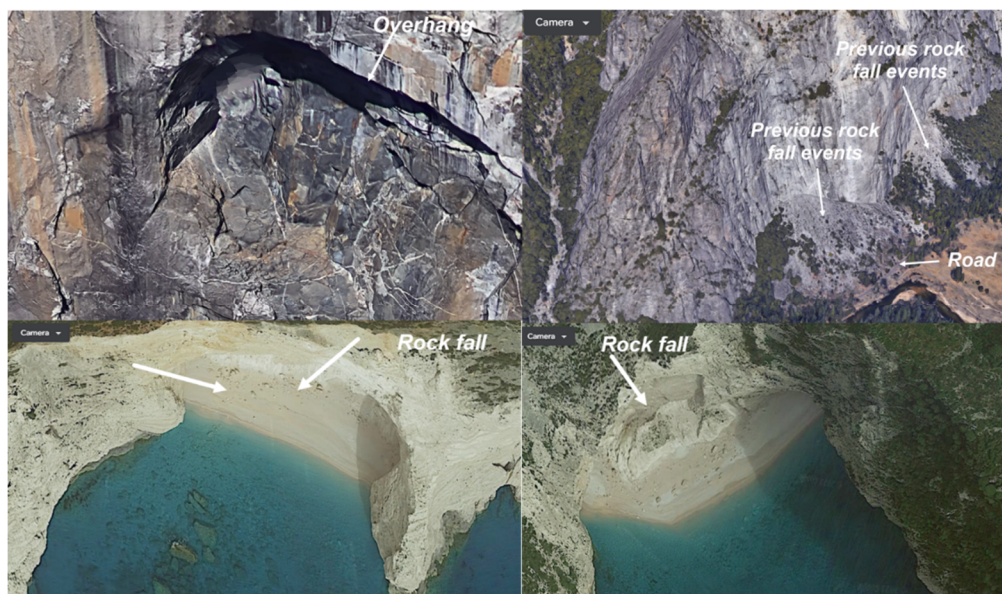
In this paper, both Google Earth Studio, a browser-based animated applications tool for Google Earth 3D, and satellite imagery were used to provide clear photogrammetry images with fine details for describing geotechnical risks in remote holiday locations. The application allows remote assessment to describe geological characteristics so as to understand stability conditions. Generally, most of the populous tourist destinations are found on Google Earth 3D. Google Earth Studio has a camera functionality that can focus on a preferred angle and direction for capturing a remote photograph from a Google 3D satellite image. In this paper, some of the pictures taken with a Google Studio camera have been presented in Section 4 and subsequent sections. In the locations where the Google Earth Studio 3D image is blurry due to reduced resolution from zooming, GPS-registered photographs of the area taken by individuals on Google Earth were utilised as sources for photographs to describe the geotechnical risk and rock features. The images enable a closer view to identify the risk of rockfalls and plausible structural characteristics culpable for inducing instabilities. Also, a near-accurate persistence of the structures can be measured to support part of the remote assessment. Figure 2 shows Google Earth Studio camera photographs of Yosemite National Park igneous rocks in the USA, with cracks and overhang, and slope instability in limestone in Naviago Beach, Zakynthos Island, Greece.

Figure 2 Google Earth Studio camera image of Yosemite National Park igneous rocks in USA showing joint structural defects and overhang on the top photograph and slope failure and rockfall in limestone in Naviago Beach in Zakynthos Island, Greece, bottom photograph

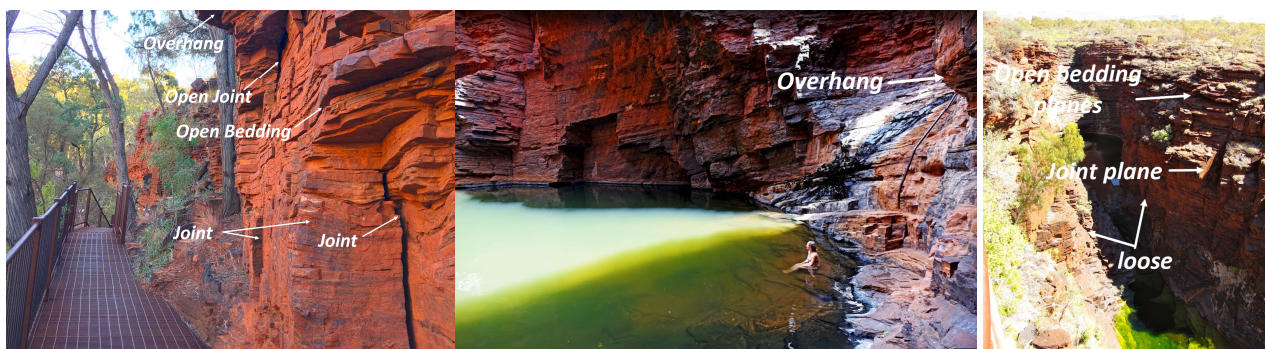
Karijini is a well-known tourist destination in the Pilbara region frequented by locals, mining workers and visitors seeking picturesque scenery, adventure and a place to unwind. However, it is essential to note that some areas within the park have a high-risk of rockfall, which poses a severe threat to visitors. This risk is due to the morphology of the exposed rocks, which are characterised by tension cracks, hydration and ruggedness exacerbated by the region's extreme weather conditions. In 2015 a 19-year-old man was killed when the 7 m-high ledge he was sitting on collapsed. Moreover, the growth of vegetation roots in these cracks also exacerbates the risk of rockfalls. Figure 3 shows a tourist walkway under overhanging rock with visible multiple joints and tension cracks; a leading cause of rockfall instabilities. The bedded rock with jointing is part of a weathered rock within the Hamersley Group in the Pilbara. Details of the Hamersley Group stratigraphic geology have been defined in the streamlining geotechnical slope reconciliation for the open pit in Brockman 2 in the Pilbara paper (Owusu-Bempah 2020). Even though the authorities at Karijini National Park have displayed rockfall signs at certain locations, it does not indicate areas of severe rockfall or exclusion zones. Often the rockfall areas are the access points to the next location within the park.

Figure 3 Google Earth-registered photograph of the rockfall risk over a walkway grating with exposed bedding and joints in Karijini National Park in the Pilbara, Western Australia

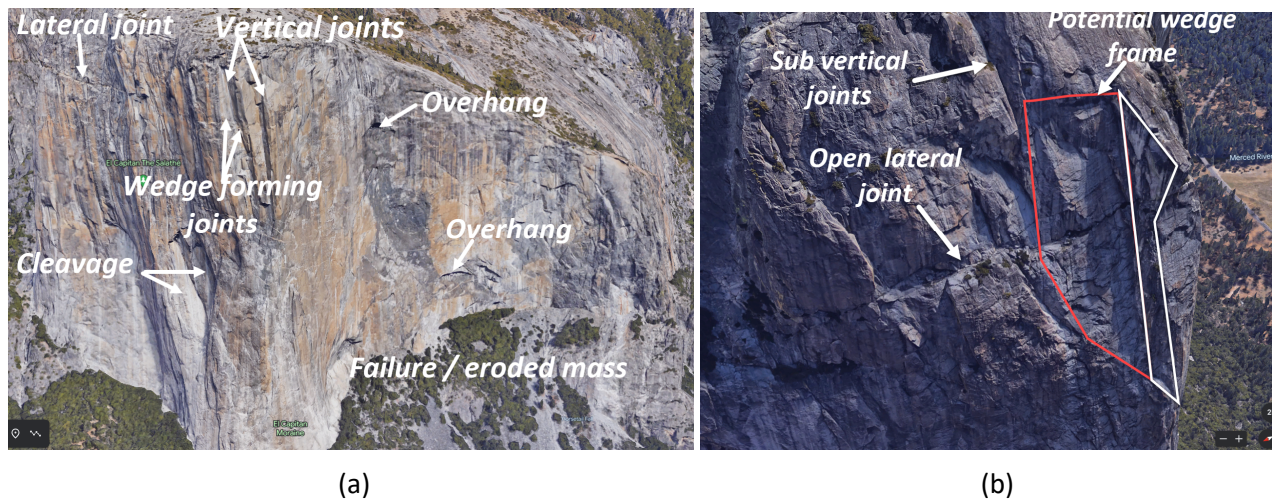
The geology of El Capitan is composed predominantly of pale, coarse-grained granite approximately 100 Ma old. The western portions of Yosemite Valley are mainly composed of a separate granitic body called Taft granite. Both kinds of granite had been documented as having dark-vein dolerite intrusion, which is prominent in the area known as North America Wall, having the greatest influence on rockfall risk in the area. Although granitic rock is unbroken on a small-scale, on a larger scale the rock is broken by joints which are planar cracks commonly found as sets of parallel fractures in the rock (Huber 1987). The joint structures are plausible for present rockfall events and the risk of overhangs could result in future potential rockfalls. Figure 4 shows a Google Earth satellite image of the Yosemite granite with multiple intersecting joints.

Figure 4 Google Earth Studio satellite image of Yosemite National Park igneous rock. (a) Intersecting parallel joint discontinuities and overhang; (b) Camera image of the rock at different angle showing the potential wedge frame

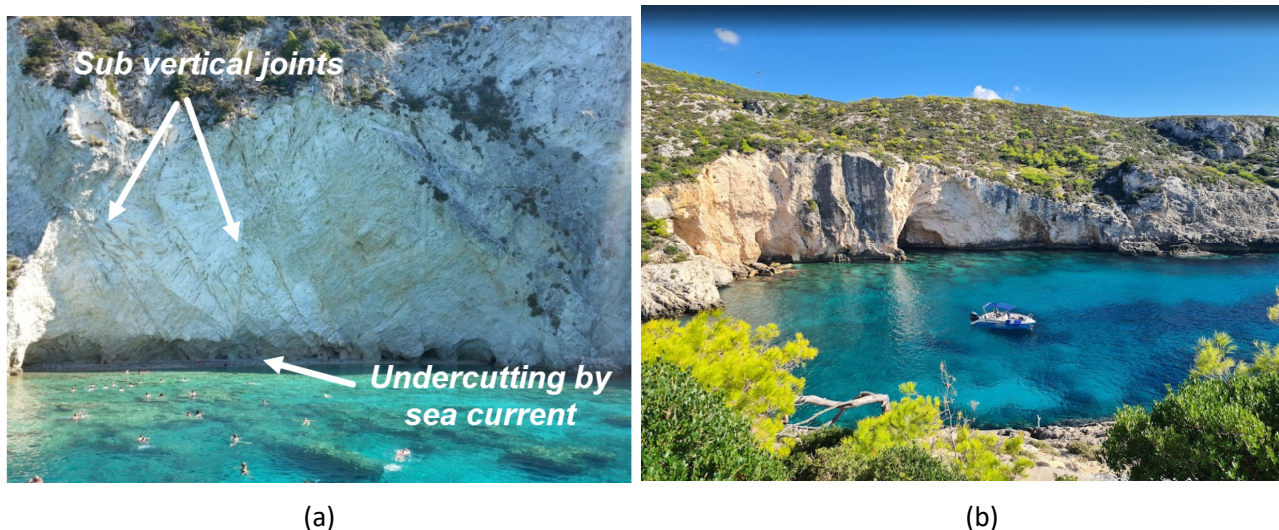
Zante beach in Greece is a well-known location that experienced an unfortunate rockfall event when seven tourists were injured due to tonnes of rock falling after an earthquake. Rockfall events are generally common there and often associated with other controlling factors at the beach because of the geology, climatic conditions and high vertical slope face. From the photographs in Figure 5, it appears the area is predominantly comprised of weathered limestone with multiple discontinuities. The exposed face of the rocks shows converging sub-vertical joint sets forming various block sizes for potential wedge instability. Erosion, caused by ocean wave currents which scour the rock face and form cavities, brings the sub-vertical joints into tension and results in the potential collapse or fall of ground. The unsupported roof of the cavities subsequently cause potential rockfalls. Frequently these pockets of eroded cavities are popular tourist attractions, which exposes visitors to rockfall impact zones.

Figure 5 Google Earth-registered photographs of a beautiful clear blue ocean with limestone rock at Zakynthos Island, Greece: (a) Sub-vertical and intersecting joints with potential for a wedge-forming block; (b) Distance photograph of the landscape and eroded cavities

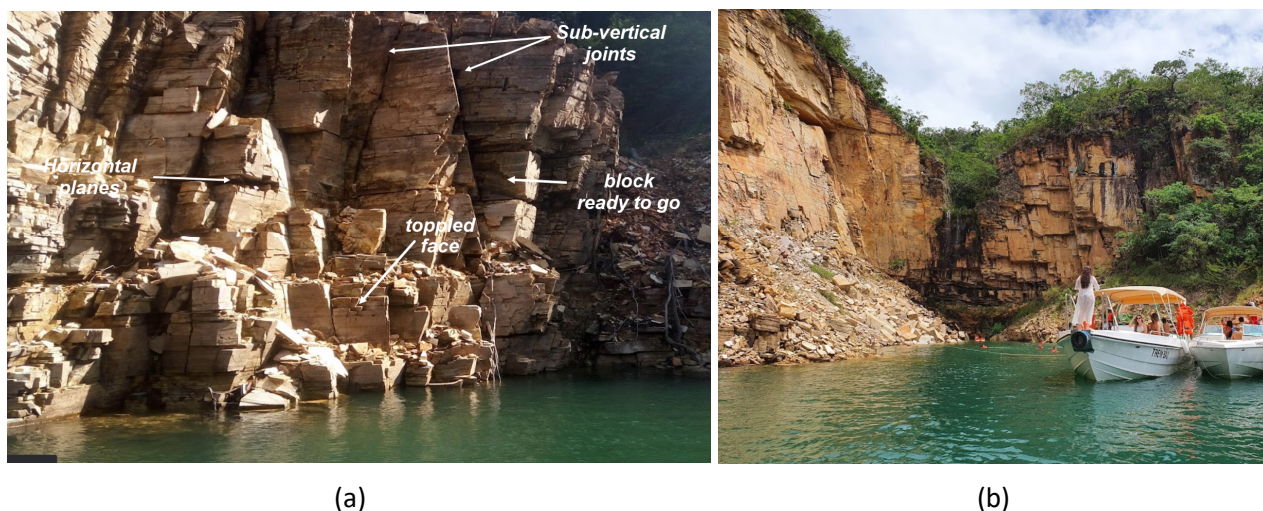
Lake Furans in Minas Gerais, Brazil, serves as a hydroelectric dam. The area around the dam has many attractive canyons and waterfalls that attract tourists. Unfortunately, tragedy struck early in 2022 when a rockfall event killed 10 tourists on a speed boat cruising around the exposed face of the canyon rock. The video from the scene indicated a toppling failure mechanism. The head of Brazil's geological services had 'warned that the location has been subjected to centuries of erosion, leaving it vulnerable to rain, heat, and cold'. Ongoing natural erosion is likely to cause more rockfalls during the rainy months of December and January' (CBS News 2022). However, the warnings from authorities seemed not to have been heard by adventure seekers and local operators, or at least did not prevent tourists wanting to get closer to the rock face. A closer examination of Google Earth-registered photographs reveals that the cliff face is in an area with adverse geotechnical conditions characterised by both horizontal and vertical joint sets, as shown in Figure 6. Some of the vertical joints are nearly 90° and have long trace lengths, making them particularly susceptible for toppling rockfall and sliding failure mechanisms during inclement weather conditions; thereby rendering the area geotechnically unstable. It is crucial for tourists to exercise caution when visiting these areas and to pay attention to any warnings from local authorities.

Figure 6 Google Earth-registered photograph of Furnas Lake, Minas Gerais, Brazil, showing (a) Sub-vertical joints and horizontal plane openings susceptible to wedge and toppling failures; (b) A far-view photograph of failed material and overhang rocks

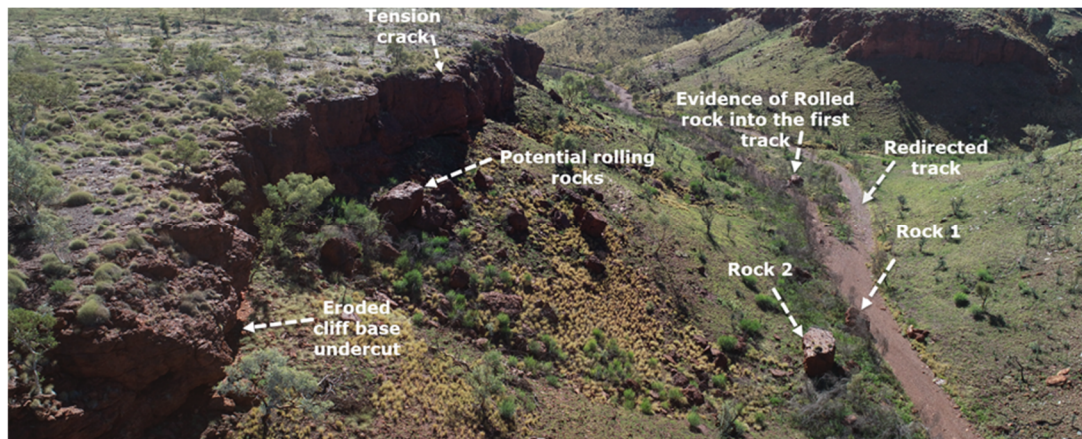
The walking track in a valley behind a mining village (see Section 1) spans nearly 2 km and is confined by approximately 40 m-high slopes on both sides, with facades. The physical geology of the area generally consists of huge crumbled hydrated rock from the facade, with rockfall hazards typically associated with the western side of the cliff. However, certain areas of the track have been impacted by rocks, making it more precarious in those locations. In places where rocks have rolled onto or blocked parts of the track, the track has been diverted to manage the increased risk; highlighting the importance of managing risks in tourist locations with prevalent rockfall hazards. Measures must be taken to mitigate the risk of rockfalls for personnel who use the track regularly. Figure 7 shows the walking track and locations of the detached rocks, including rocks used in rockfall simulations.

Figure 7 An aerial photograph of the slope and the walking track showing loose rocks from the facade used in rockfall simulation, behind a mining village in the Pilbara, Western Australia

Table 1 summarises the physical dimensions of the two analysed rocks (seeder) with other rocks within the rockfall zone. Results from the back-analyses are detailed in Section 5.2 for rigid body and lump mass simulations. The average kinetic energies determined indicate that the intensity of the rocks from the sources to the resting position do not dissipate energy and represent the forces rolling rocks could have on the impact. The estimated energy could be useful for selecting a potential rockfall stabilisation mesh or rockfall fence, creating an exclusion zone or rock scaling to save lives.

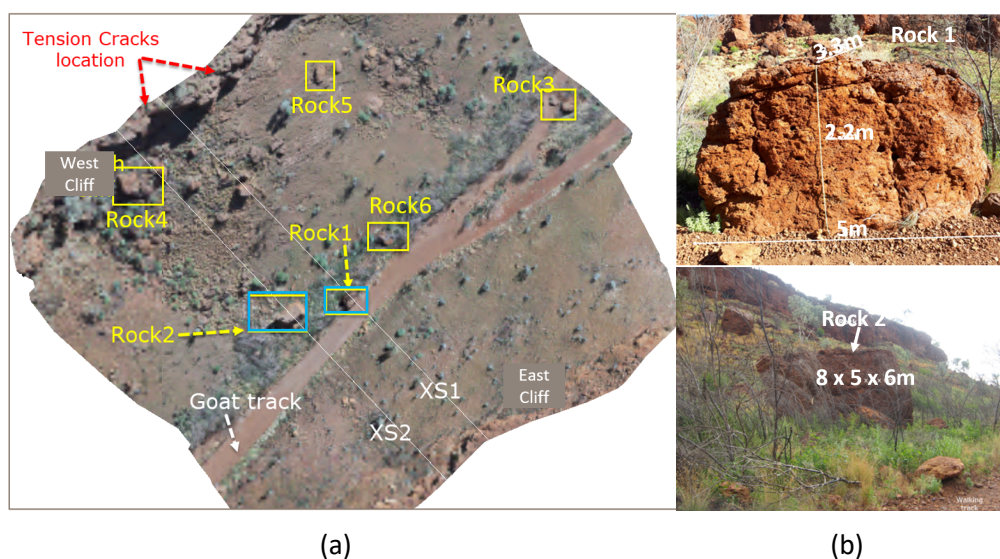
Rockfall analyses were undertaken on this walking leisure track to assess rockfall hazards and establish a safe zone to prevent rockfalls from impacting on people. The slope profiles in the models were obtained from an UAV, and point cloud data were generated and processed in Maptek Vulcan, as shown in Figure 8a. Back-analysis on lump mass and rigid body methods was performed in Rocscience, Rockfall2.f18. The energy and end point locations were determined by simulating the trajectory of the two rocks close to the walking track.

The slopes were analysed in two topographical cross-sections for rocks 1 and 2, as shown in Figure 8b. The analyses were performed mainly on the west slope of the valley, where Pilbara hydrated rocks are seen to have detached from the cliff at 574 RL and landed at 535 RL. The slope profiles from the detachment zones have a steeper slope angle and transitioned into an average slope gradient with a few centimetres-high vegetation cover. The vegetation cover on the slope was conservatively modelled at 10 cm-high in rigid body analysis.

Figure 8 (a) Two topographical cross-sections (XS1 and XS2) of Rocks 1 and 2 used in a rockfall simulation; (b) Photographs of actual rocks and resting positions

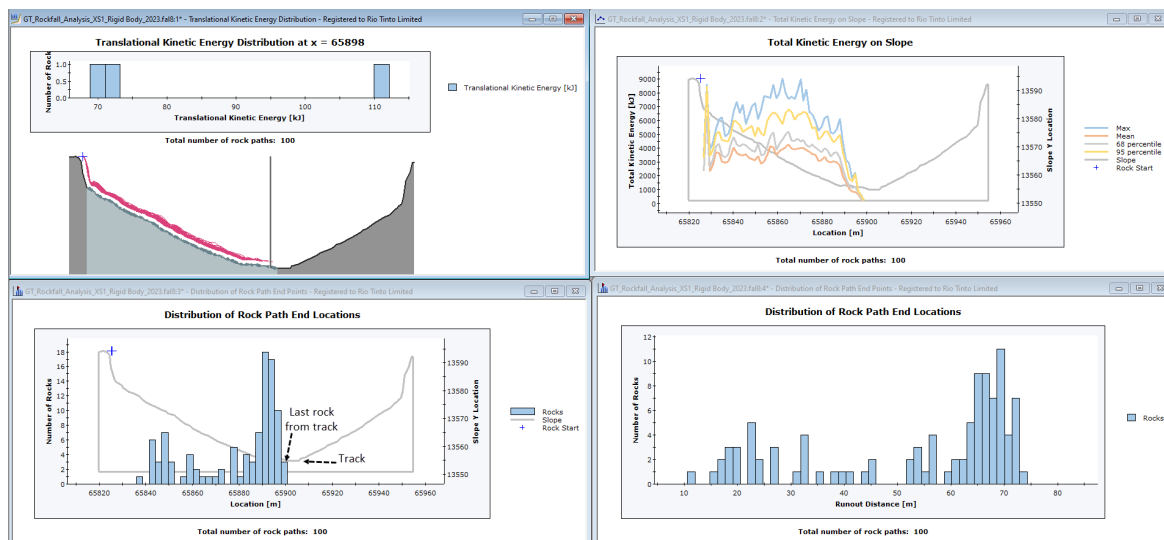
**Figure 9 Chart distribution showing rigid body back-analysis results of estimated energies of the endpoints and a runout distance of cross-section 1 for Rock 1**

The simulation results for cross-section 1 demonstrate that the last rock came to rest near the edge of the walking track, consistent with field observations. The rigid body simulation indicates that the last rock for this section came to rest at approximately 74 m, representing the runout distance and end point location from the cliff. For the lump mass simulation of Rock 1, a runout distance of 76 m was obtained. The difference in runout distances between the rigid body and lump mass simulations is approximately 2 m. The total kinetic energy obtained at the resting position from Rock 1 at the edge of the walking track was 201.4 kJ for the rigid body simulation and 499.9 kJ for the lump mass simulation.

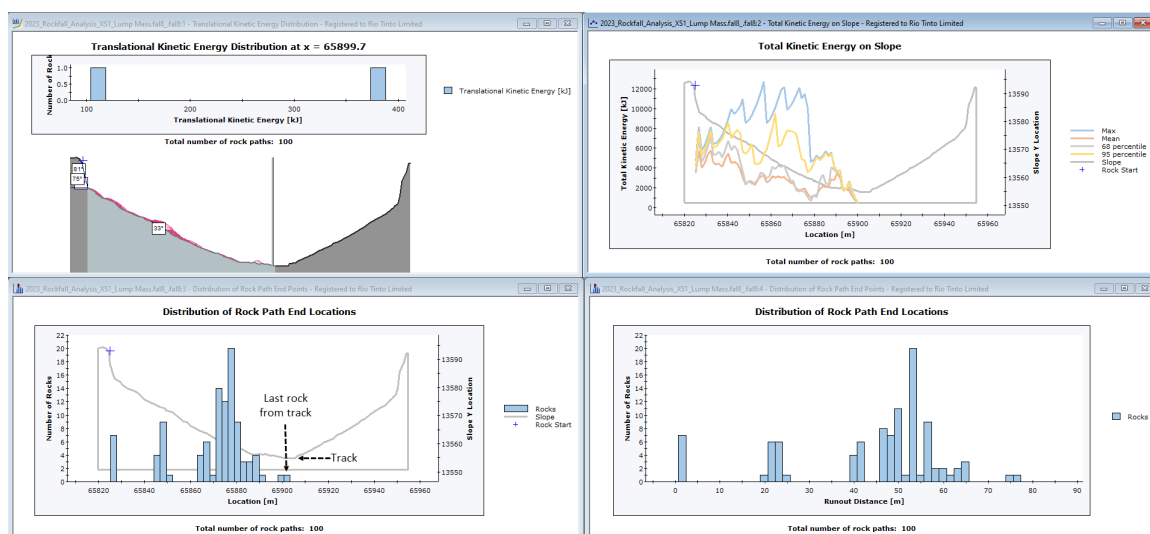
**Figure 10 Chart distribution showing lump mass back-analysis results of estimated energies of the endpoints and a runout distance of cross-section 1 for Rock 1**

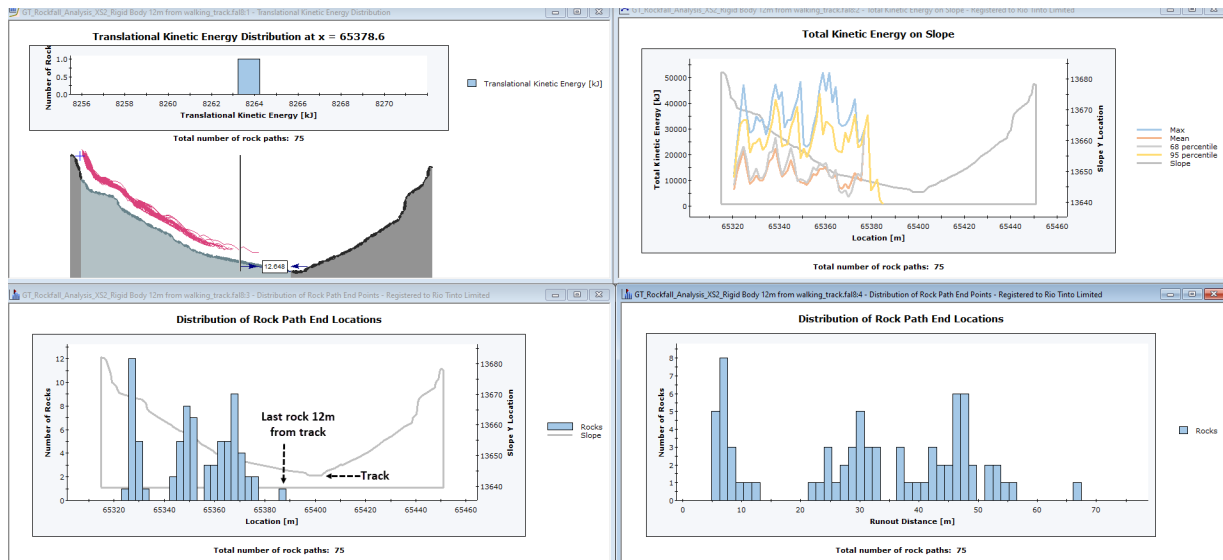
Figure 11 Chart distribution showing rigid body back-analysis results of estimated energies of the endpoints and a runout distance of cross-section 2 for Rock 2

Regarding cross-section 2, the simulation results indicate that the last rock rested at approximately 12 m from the walking track, consistent with field observations for Rock 2. For the rigid body simulation, the end point of Rock 2 came to rest at approximately 67 m, representing the runout distance. The lump mass simulation resulted in a runout distance of 68 m for Rock 2. The difference in runout distances between the

rigid body and lump mass simulations is approximately 1 m. The total kinetic energy of the rocks at the resting position was 10682.7 kJ for the rigid body simulation and 12792 kJ for the lump mass simulation.

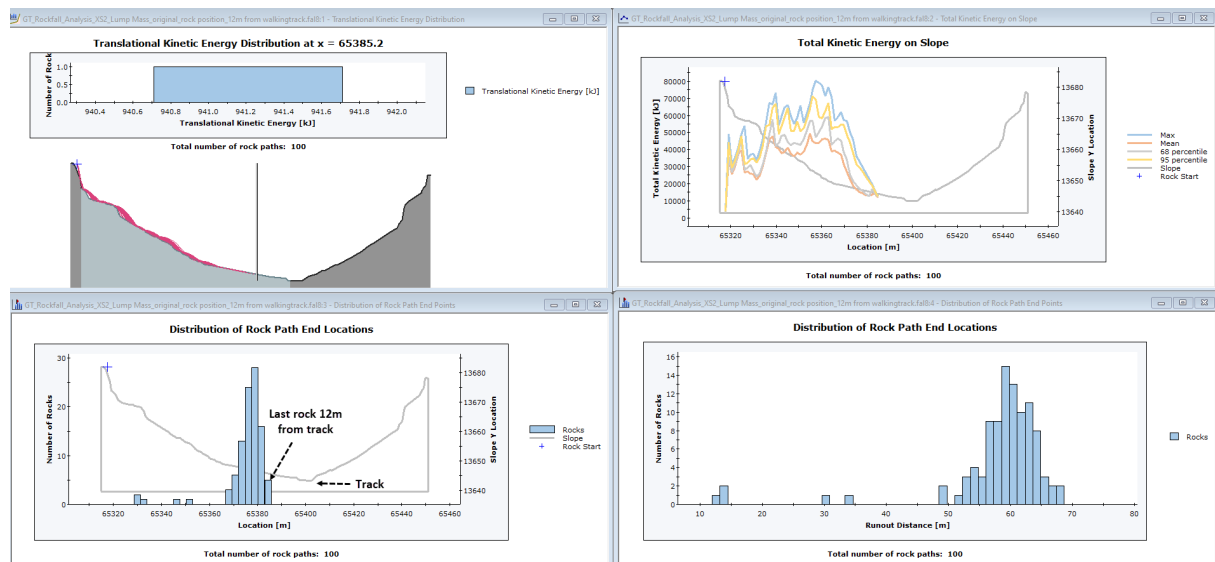
Figure 12 Chart distribution showing lump mass back-analysis results of estimated energies of the endpoints and a runout distance of cross-section 2 for Rock 2

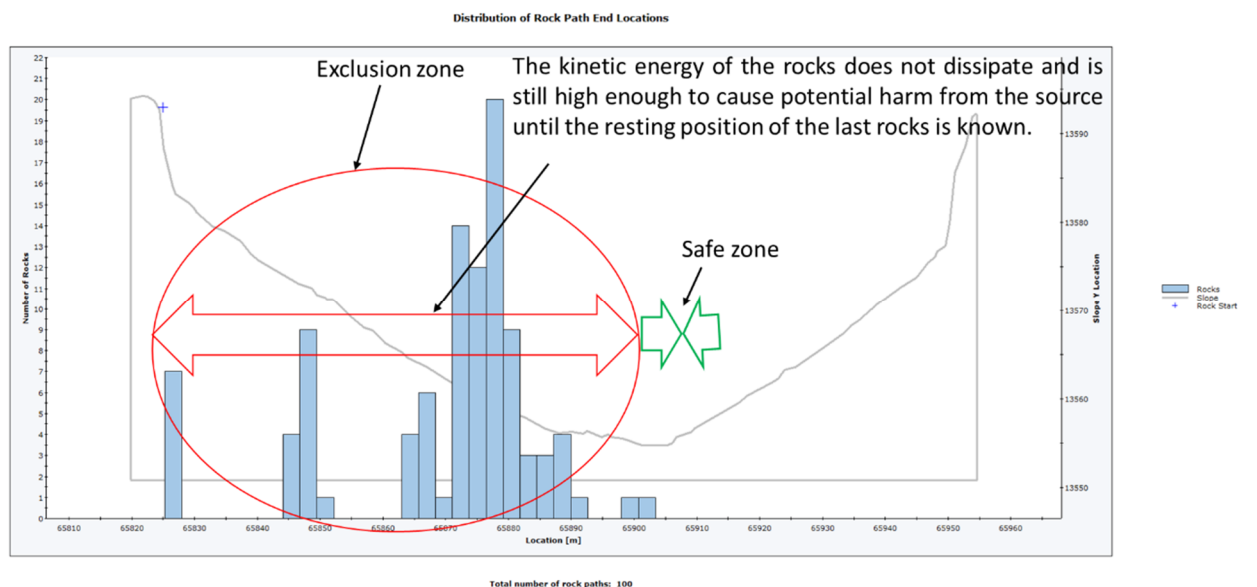
Overall, the simulations for both cross-sections indicate that energy from falling rocks is not dissipated between the starting and end point, making any area between the starting point on the facade and the last rocks unsafe. Thus this area could be designated as a high-risk/exclusion zone, with the area beyond Rock 1 considered safer for people. It is also noted that the impact within the transition zone could be severe. Figure 13 illustrates the rockfall simulation trajectory indicating a potential designated a high-risk/exclusion zone and a safer zone.

Figure 13 Distribution of rock path end point locations showing a rockfall intensity no-go zone as an exclusion zone, and a safe zone beyond the last rock on the track
