Stabilisation of open pit wall movements detected by InSAR using horizontal drains

P Ramakrishnan *SkyGeo, Netherlands*

J du Toit *First Quantum Minerals, Zambia*

Abstract

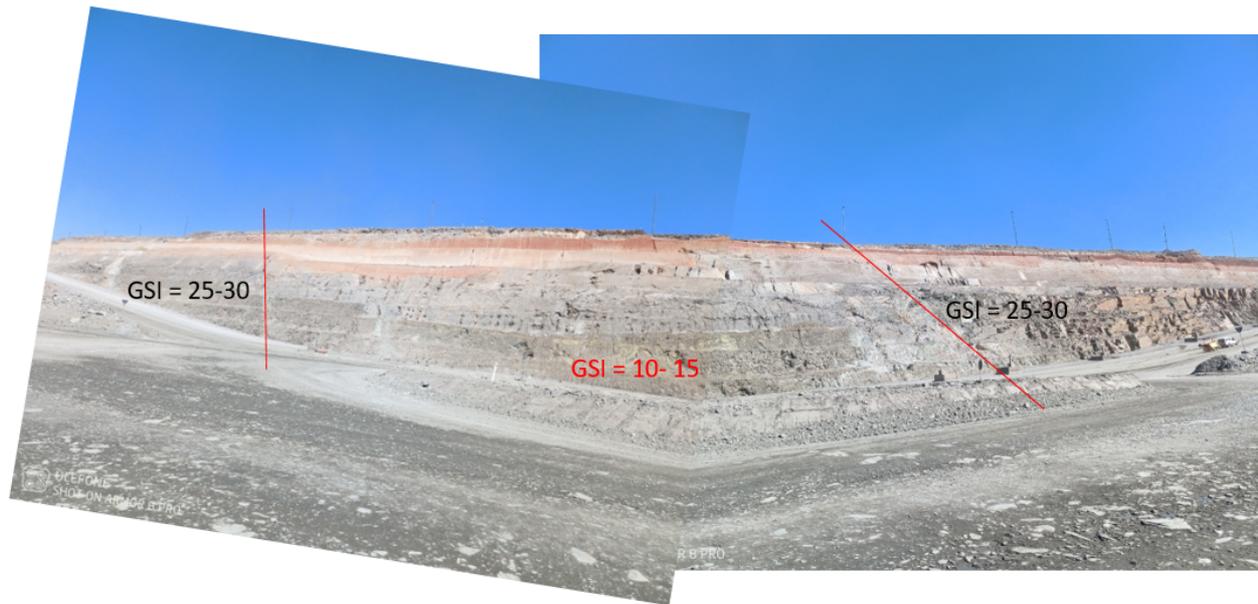
Window mapping was conducted on the Main 15 upper wall. Field observations indicate that the area of movement is confined by two fault planes to the north and south. In Figure 3, the slope and the materials on either side of the fault planes exhibit weathering (GSI = 25 to 30), while the material within the fault zone is highly weathered (GSI = 10 to 15). The rock mass rating (Bieniawski 1989) for the materials was determined to be 32 (weathered rock) and 14 (fault zone). The underlying mode of failure was identified as wedge failure; however, due to the high degree of weathering, it is believed that the failure mechanism may exhibit more complex behaviour, resembling a circular failure. The susceptibility of slopes to failure is influenced by a combination of internal and external factors, including slope geometry, rock type, geological discontinuities, groundwater conditions, surface drainage, rainfall, seismicity and human activities (First Quantum Minerals 2022).

Figure 3 Main 15 ramp intersection showing the difference in material quality

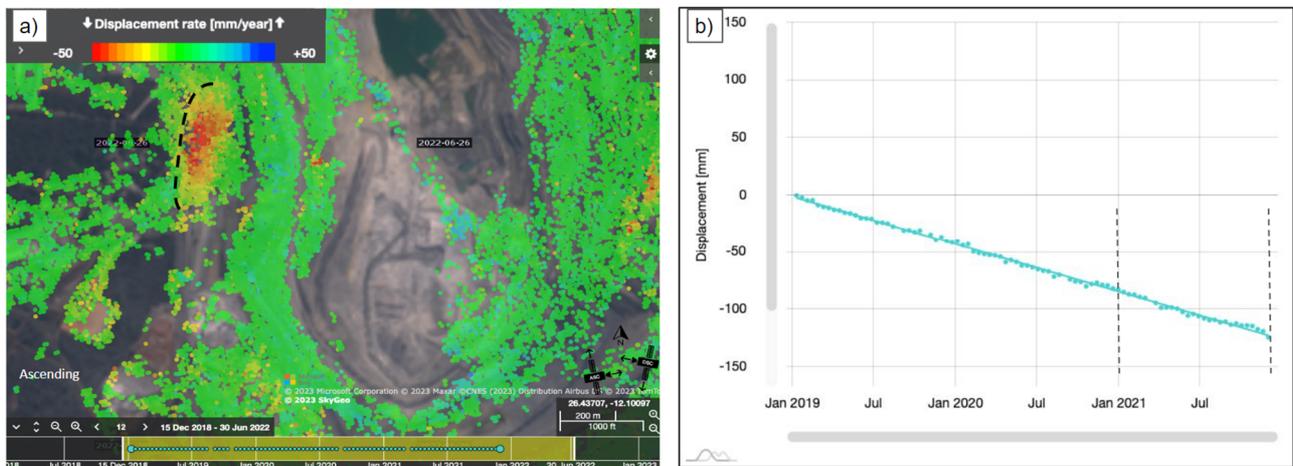
The Sentinel-1 data over the area of interest shows steady subsidence over time with no significant changes to the spatial extent of displacements (Figure 8). During the active mining of the waste-rock dump from May to August 2021, a slight reduction in the displacement rate was observed (from -41 mm/year to -39 mm/year).

Figure 8 Sentinel-1 ascending data over the area of interest, showing the time series of displacements from 2019 to 2022. (a) A heatmap of the rate of displacement over the same period; (b) The rate of displacement is an estimated average of 40 mm/year away from the line of sight of the satellite, which can be interpreted as subsidence

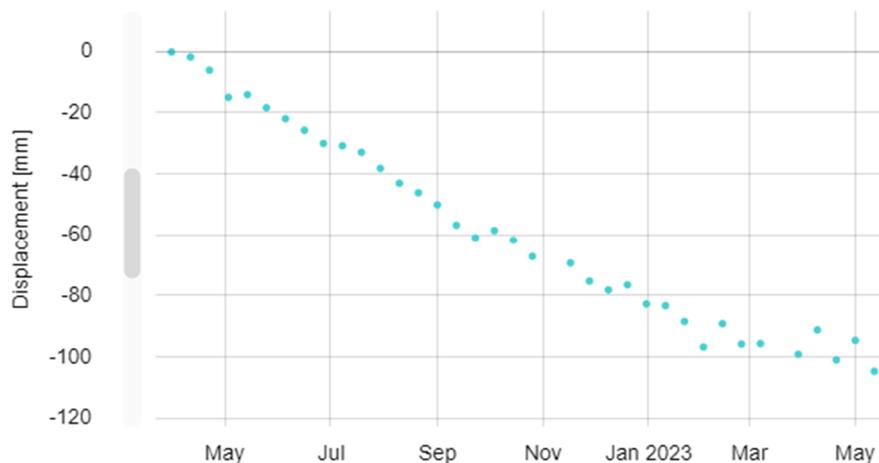
This section focuses on displacement estimations from the TerraSAR-X ascending satellite, which is particularly sensitive to slope displacements along the M15 wall due to its line of sight being parallel to the downward slope. The first early warning alert was issued by SkyGeo in June 2022 during the first quarterly review of pit displacements. Displacement rates between 30 March 2022 and 26 June 2022 were found to be around -85 mm/year, surpassing the historical baseline displacement rates of approximately -40 mm/year. In the subsequent quarterly report of September 2022, the M15 west pit was again flagged for accelerated displacements. Notably, the M15 west wall experienced a subsidence of over 3 cm between June and September 2022, marking the most significant subsidence observed on the wall face during the monitoring period, as indicated by Figure 9.

Figure 9 The time series and cumulative displacement from TerraSAR-X ascending indicated over 10 cm of displacement occurred during the entire time period between March 2022 and April 2023

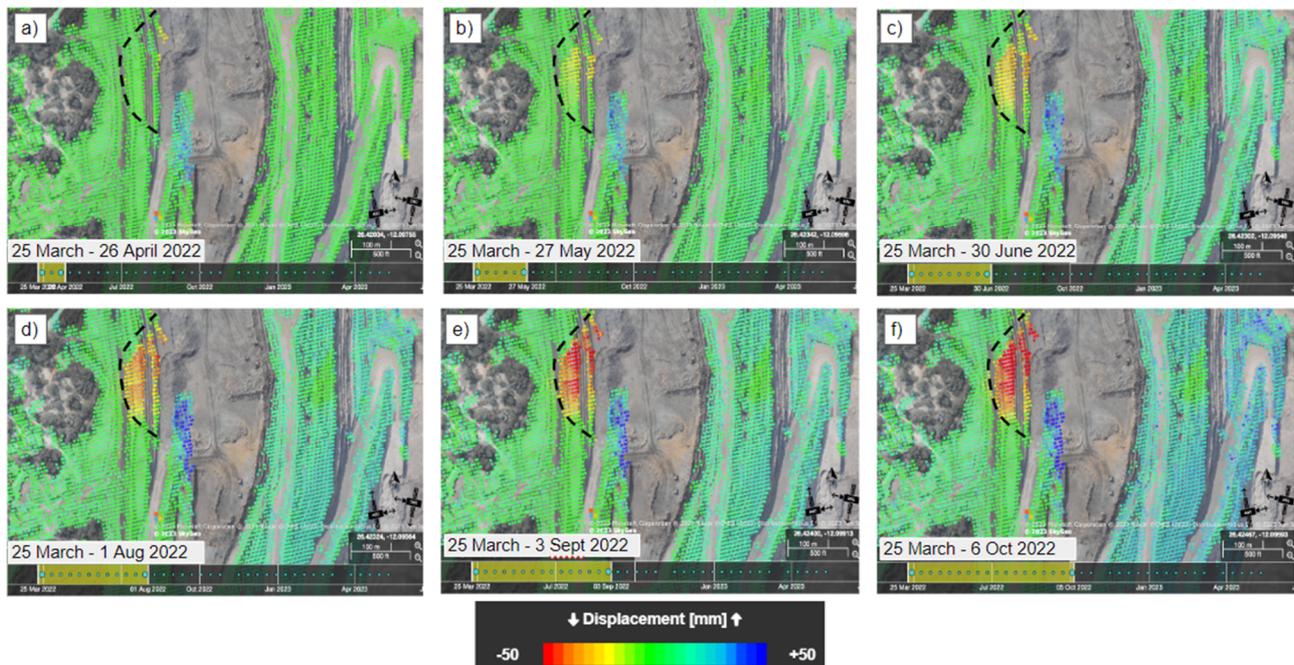
In addition to the increased magnitude of displacements, notable spatial patterns were detected, as depicted in Figure 10. Movement was observed on multiple benches, starting from the base of the wall and spreading radially and laterally, resulting in a circular subsidence pattern. This was considered a precursor to a planar failure along the slope face. Given that many types of failures are influenced by groundwater conditions and seismicity, the presence of groundwater daylighting structures and nearby blasting activity led to the hypothesis that these factors contributed to the failure mode. Consequently, the monitoring reports were updated to a monthly frequency and eventually a biweekly frequency to track the failure precursor in a more timely manner.

Figure 10 TerraSAR-X ascending data indicating the changing displacement rate and spatial extent of displacements on the M15 wall between March and October 2022 (a to e). Semi-circular subsidence pattern indicated by the black dashed line

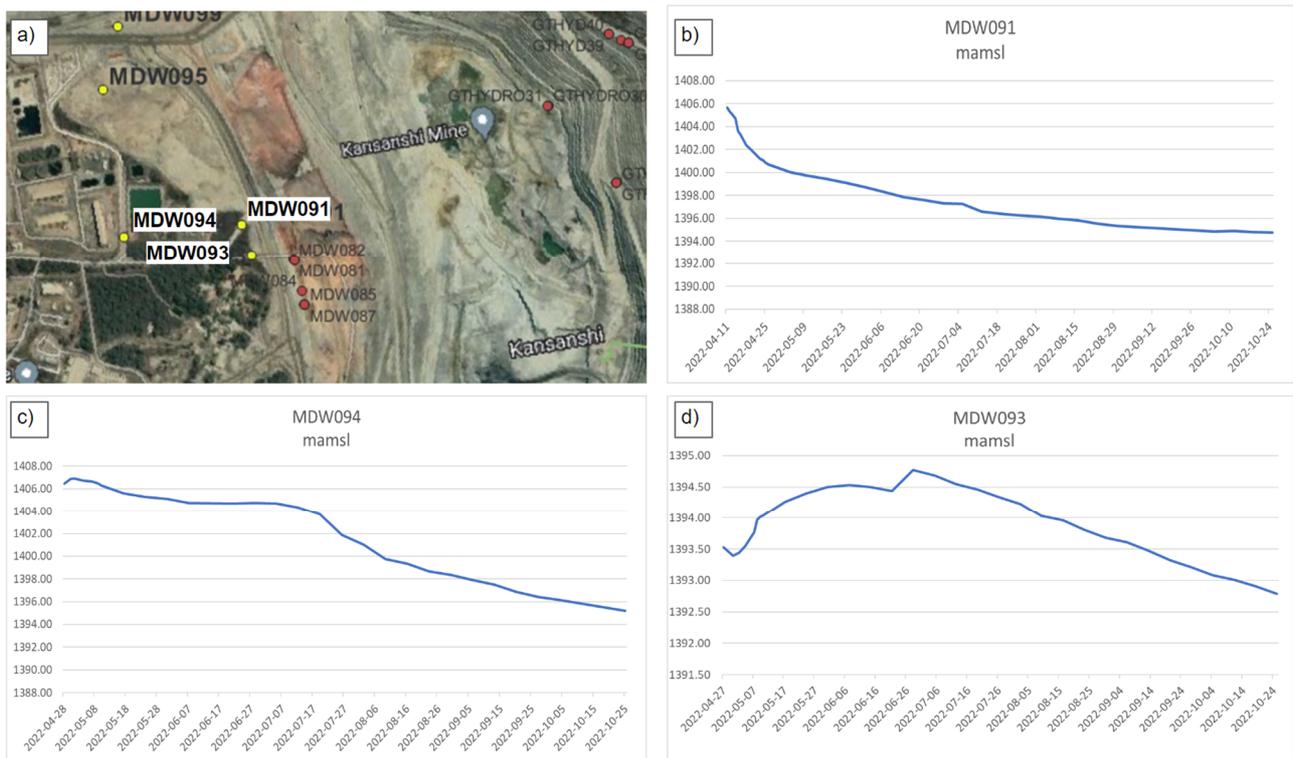
Figure 11 The location (a) and the time series of three VVPs: (b) MDW091; (c) MDW093; (d) MDW094

The drainage commenced in November 2022, with horizontal drains installed to a depth of 120 m and spaced 150 m apart at -5° inclination in specific locations. The drains were not cased. The response to groundwater elevations were monitored using the VWP network over the mine, as shown in Figure 11.

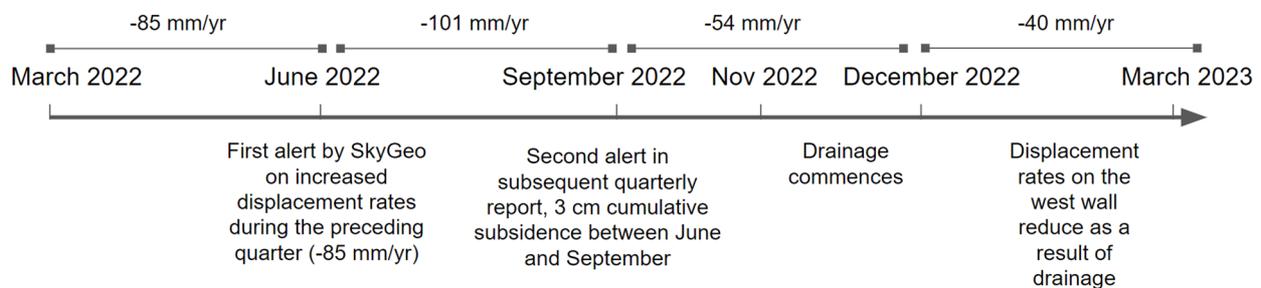
The depressurisation drilling began in November 2022 and lasted until December 2022. During this period, the rate of displacement estimated with InSAR on the wall showed major reduction going from -101 mm/year to -53.4 mm/year as depicted in Figure 12.

Figure 12 Timeline of events and displacement rates over the M15 west pit wall. Approximate location of displacement rates are shown in Figure 13

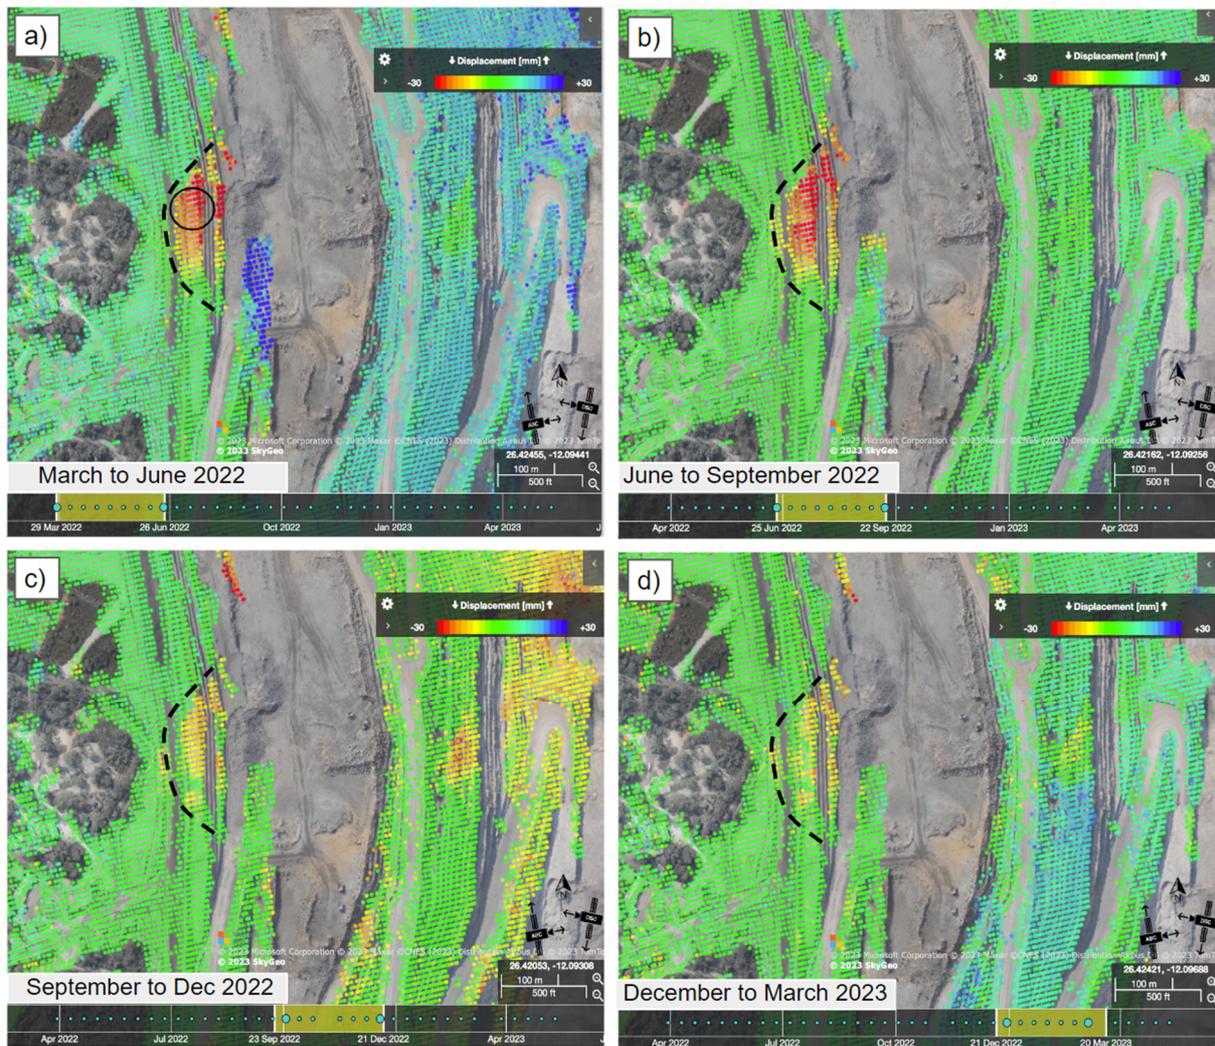
The circular spatial subsidence pattern was replaced by local spots of continued displacement. These regions were at the base of the pit wall, at the crest and on certain benches further south of the originally displacing area, where other mining activities were ongoing. This is depicted in Figure 13.

Figure 13 Evolution of the circular subsidence pattern on M15 West Pit wall. (a) March to June 2022; (b) June to September 2022; (c) September to December 2022; (d) December 2022 to March 2023. The black circle on (a) refers to the approximate location of the displacement rates quoted in Figure 12

It was well noted that despite the impact of the rainy season, displacement rates did not return to pre-intervention levels, indicating that the slope had been successfully stabilised. This is highlighted in Figure 13 where the displacement rates stabilise around -56.3 mm/year with a further reduction to -40.3 mm/year, which is in sync with the abatement of the rainy period.

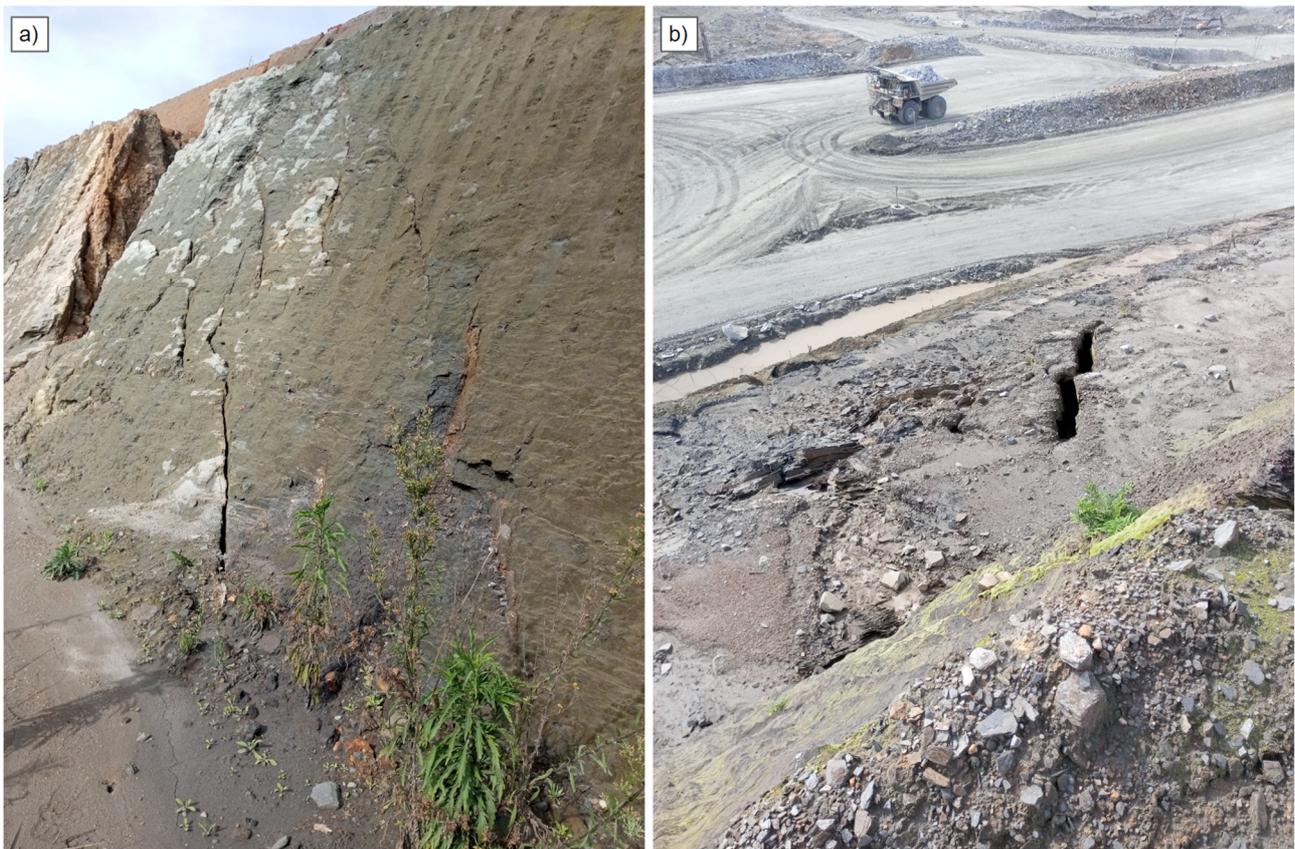
The deterioration of the Main 15 upper area, due to rainfall, is shown in Figures 15 and 16. Displacement recorded from the GBR shows an increase in displacement rate during both rainfall seasons 2021/2022 and 2022/2023, shown in Figure 17. The material does show delayed acceleration in the 2022/2023 season. The total movement recorded was 317 mm over 19 months, with a velocity of 0.56 mm/day. This displacement is not seen during daily operations, and if it were not for the InSAR monitoring, focus would not have been placed on this area until it was too late to remediate the area. The erosion and infiltration of rainwater reactivated the material and caused acceleration of the material mass during the 2022/2023 wet season.

Figure 15 Images (a) and (b) show open joints and erosional gullies

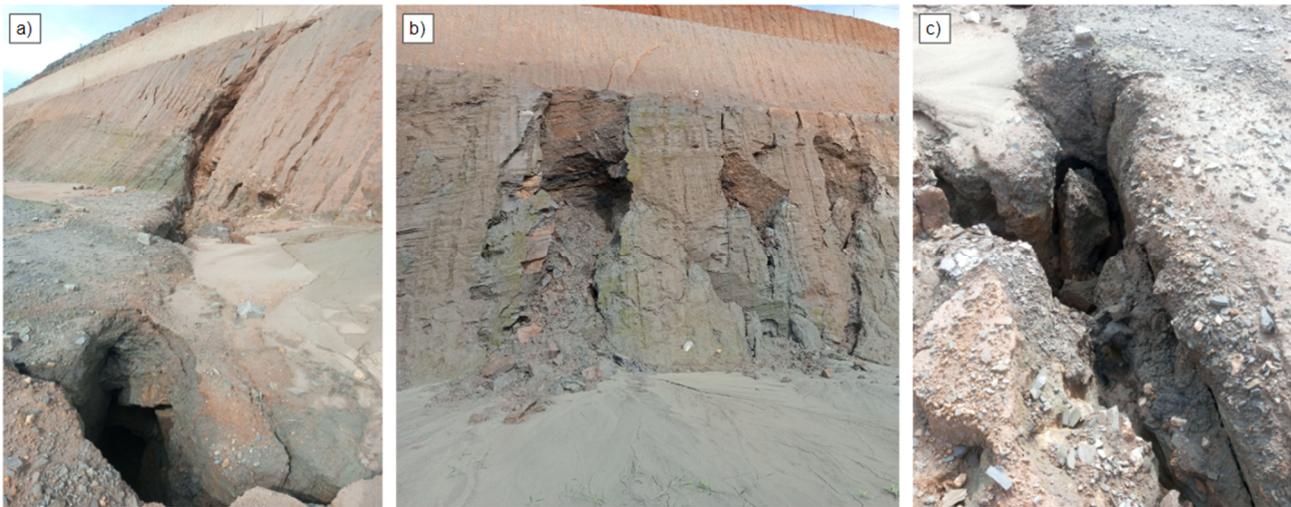
Figure 16 The effect of rainfall on the dispersive saprolites, showing piping in the slope. (a) Erosional channel through the joint; (b) Fall-out of saprolite material from the joints; (c) Erosion channel

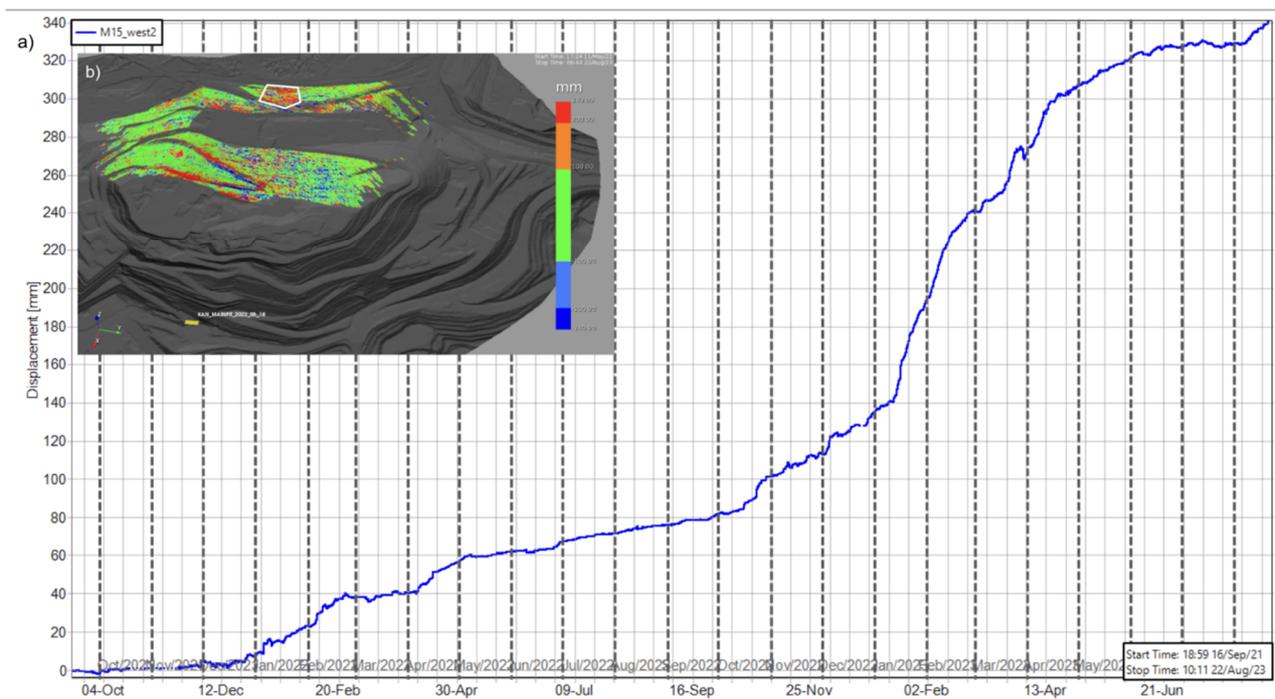
Figure 17 Main 15 ground-based radar data. (a) Average time series graph from 16 September 2021 to 22 August 2023; (b) Inset displays the slope face area, for which the time series graph was generated, overlain on a displacement heat map from 11 May 2022 to 22 August 2023 set to ± 240 mm colour scale (blue is -240 mm, red is $+240$ mm) in line of sight of the radar

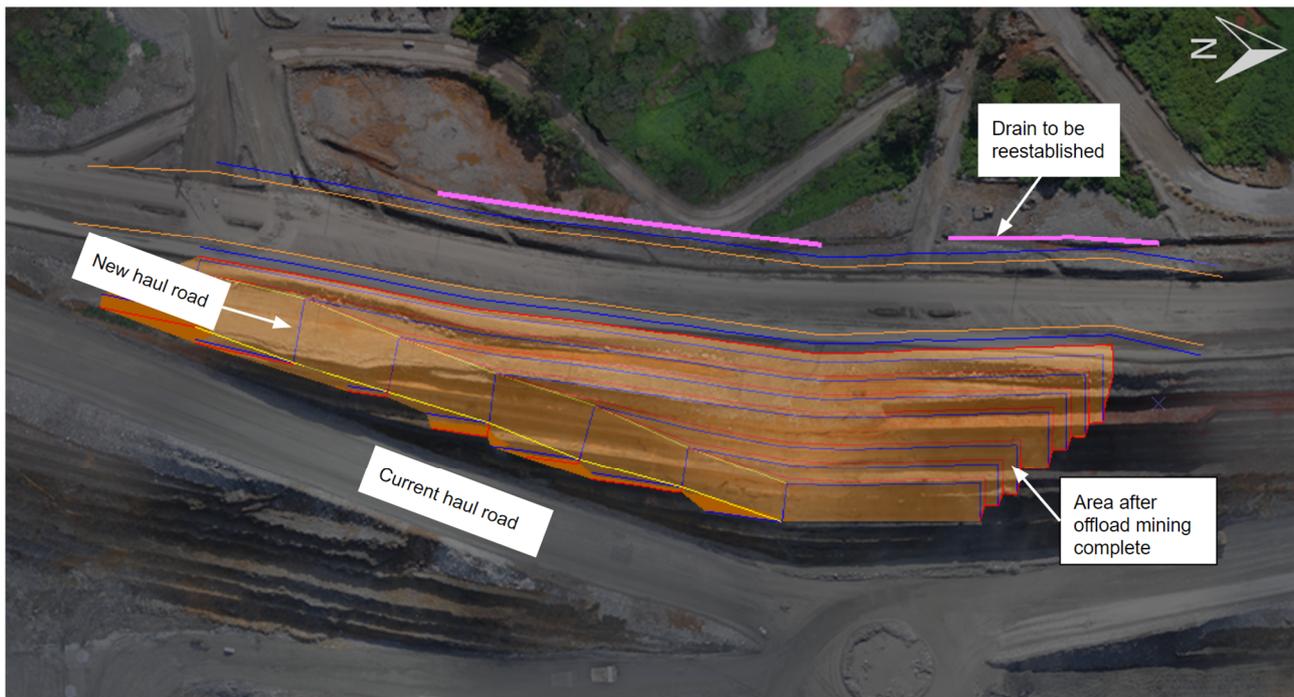
Figure 18 M15 fault zone crest unloading

Ultimately, the decision was made to unload the crest region to ensure stability of the area until the end of the cut's mining life. The planned layout of the area is shown in Figure 18.
